Visual Site Inspection Report

Project Name	H-600 Pipeline Spread H	AFE	124300138	Spread	H-600 Pipeline Spread H	
Contractor	Precision			Report #	15621	
Inspector	Pat Davis			Date/Time	4/9/2019 6:39 PM	
Permit #	TBD	Inspection Type	VA SWPP	Station Begin	+0	
State	VA	Inspection Area	Partial	Station End	+0	
County	Montgomery	Ground	Muddy	Temperature (°F)	77.00	
Municipality	N/A	Weather	Cloudy	Rain Gauge (in)	0.40	
				Rain Accumulation Time (days)	0.00

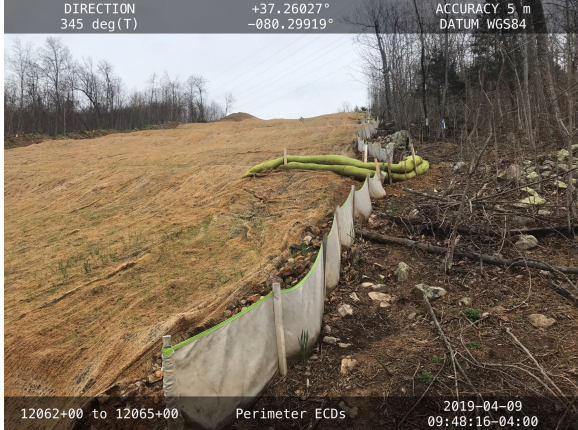
<p>DIRECTION 345 deg(T) +37.26027° -080.29919° ACCURACY 5 m DATUM WGS84</p> <p>12062+00 to 12065+00 Perimeter ECDs 2019-04-09 09:48:16-04:00</p>				
GPS Location 37.27		Field Station# 12007+00		GPS Location 37.27		Field Station# 12065+00	
Description		See photo for gps data. Photo shows the rain gauge at Catawba Road. 0.4" of rainfall.		Description		See photo for gps data. Photo shows the perimeter ECDs from about 12062+00 to 12065+00.

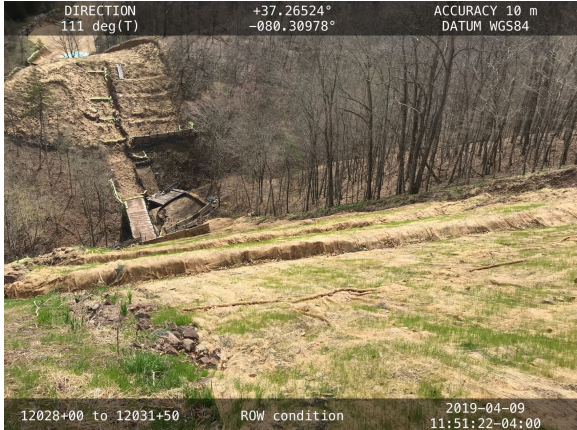
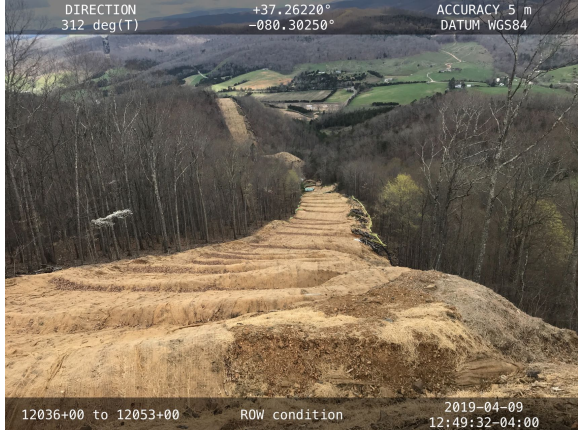
GPS Location 37.27		Field Station# 12028+00		GPS Location 37.27		Field Station# 12053+00	
Description		See photo for gps data. Photo shows the ROW condition from about 12028+00 to 12031+50.		Description		See photo for gps data. Photo shows the ROW condition from about 12036+00 to 12053+00.

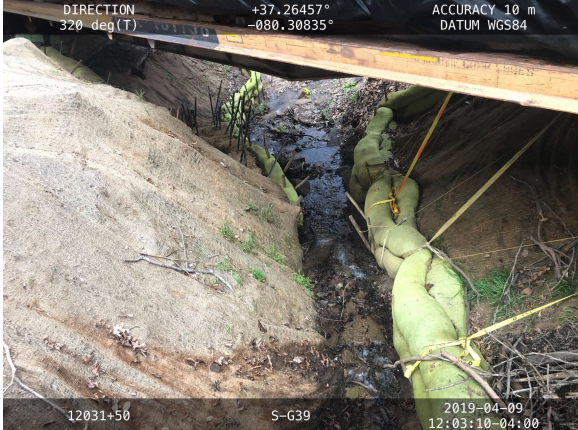
<p>DIRECTION 320 deg(T) +37.26457° -080.30835° ACCURACY 10 m DATUM WGS84</p> <p>12031+50 S-G39 2019-04-09 12:03:10-04:00</p>				
GPS Location 37.27		Field Station# 12053+00		GPS Location 37.27		Field Station# 12031+50	
Description		See photo for gps data. Photo shows the sump at 12053+00 after the contractor removed the sloughed material out.		Description		See photo for gps data. Photo shows stream S-G39 below the bridge at about 12031+50.

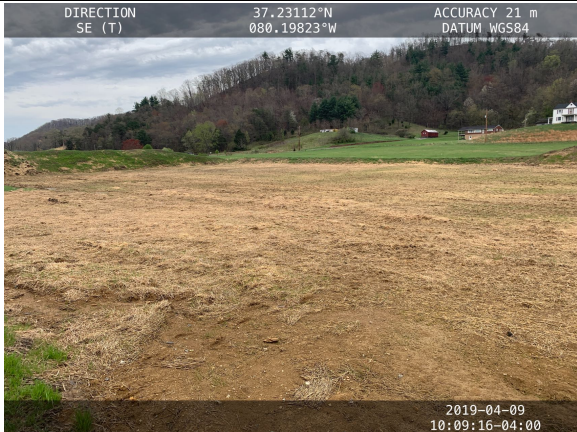
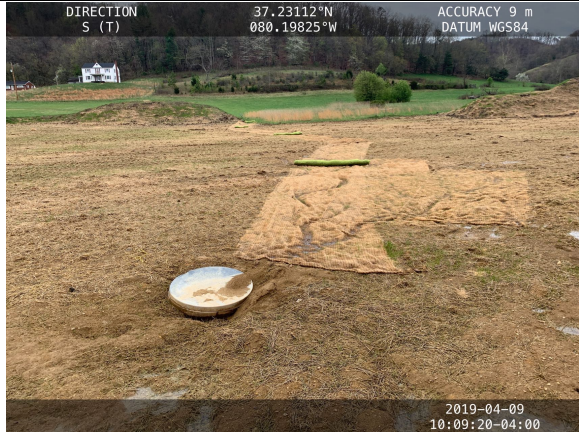
GPS Location		37.33		Field Station#		12446+00		GPS Location		37.33		Field Station#		12445+59									
Description		Stabilized ROW. Looking SE. See picture for GPS data.										Description		Curlexed channel where rain run off crossed row. Looking S. See picture for GPS data.

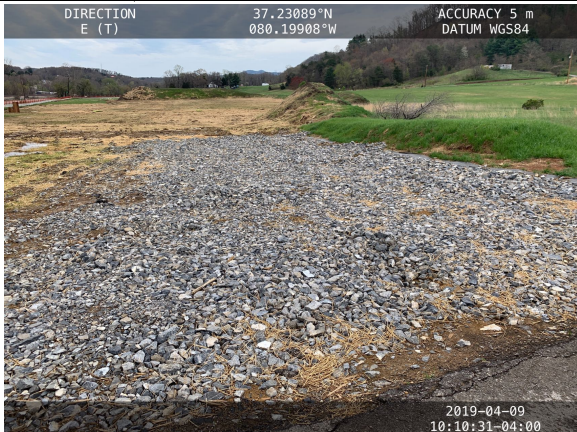
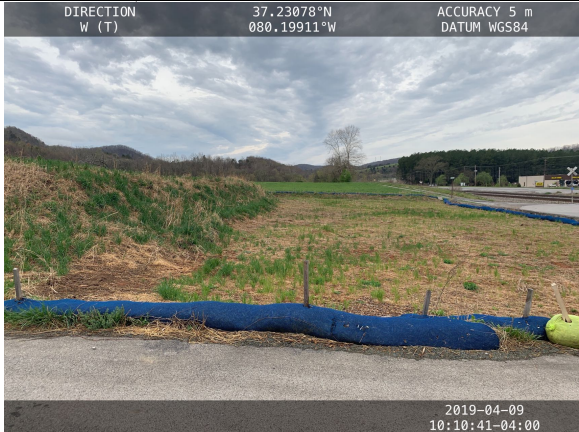
GPS Location		37.33		Field Station#		12448+12		GPS Location		37.33		Field Station#		12448+41									
Description		RCE. Looking E. See picture for GPS data.										Description		Stabilized disturbed variance. Looking W. See picture for GPS data.

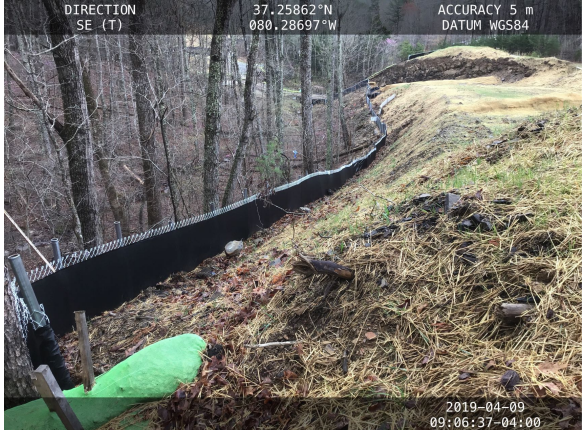
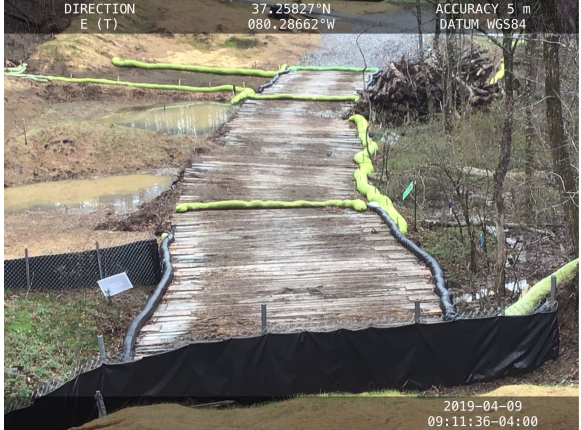
GPS Location	37.25	Field Station#	12105+00	GPS Location	37.25	Field Station#	12107+50
Description	Facing southeast. SSF is in satisfactory condition and functioning properly.			Description	Stream S-F15, facing east.

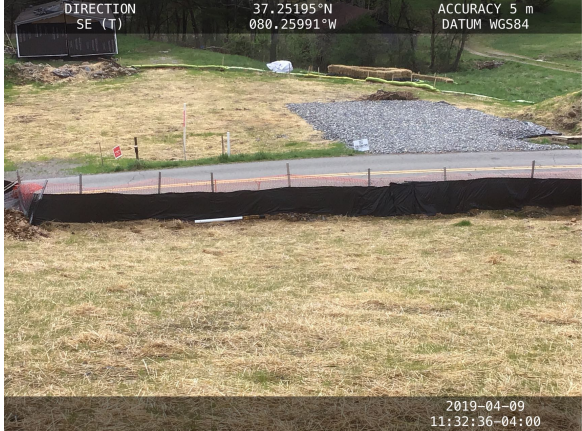
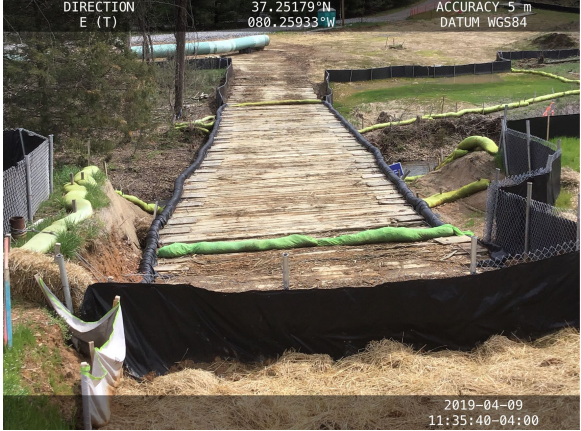
GPS Location	37.25	Field Station#	12190+00	GPS Location	37.25	Field Station#	12192+00
Description	Facing southeast. No issues at the Bradshaw Road crossing.			Description	Stream S-C21, Bradshaw Creek, facing east.

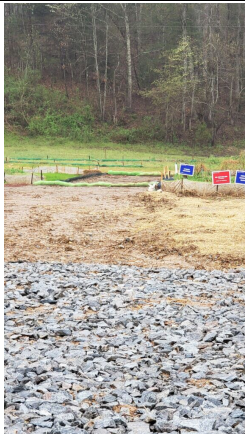
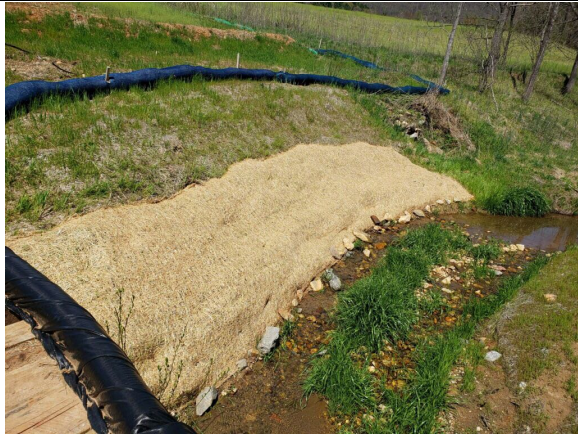
GPS Location		36.97		Field Station#		13643+66		GPS Location		36.97		Field Station#		13550+72	
Description		ECD's fictional and sign in place at S-E28						Description		Curlex installed to stop bank erosion at S-II11

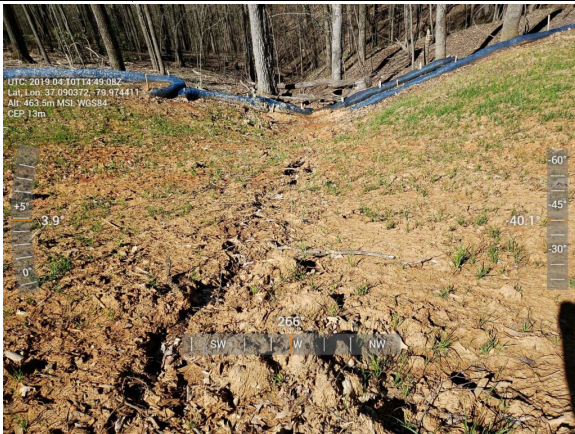
Insert image here									
GPS Location		36.97		Field Station#		13605+75		GPS Location				Field Station#			
Description		Erosion channel with sediment build up on CFS. Repair erosion and replace section of CFS.						Description
