Visual Site Inspection Report

Project Name	H-600 Pipeline Spread H	AFE	124300138	Spread	H-600 Pipeline Spread H
Contractor	Precision			Report #	17125
Inspector	John Brcic			Date/Time	5/13/2019 6:52 AM
Permit #	TBD	Inspection Type	VA SWPP	Station Begin	12071+00
State	VA	Inspection Area	Partial	Station End	12195+50
County	Montgomery	Ground	Wet	Temperature (°F)	64.00
Municipality	N/A	Weather	Sunny	Rain Gauge (in)	1.00
				Rain Accumulation Time (days)	3.00

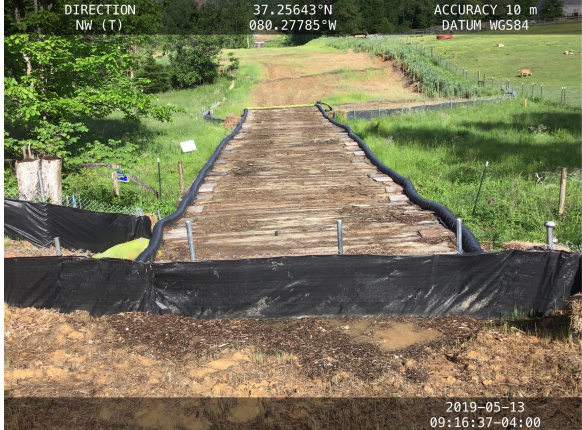
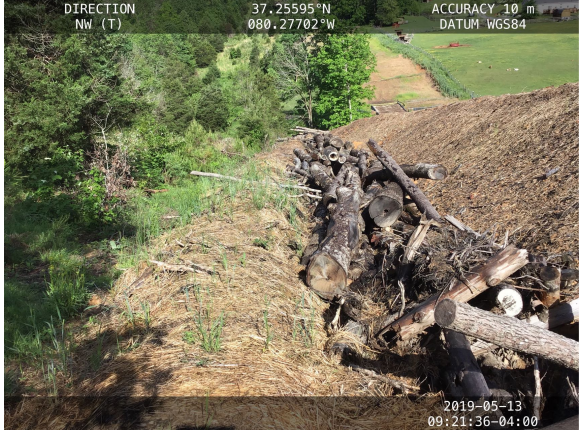
GPS Location		37.25		Field Station#		12132+73		GPS Location		37.25		Field Station#		12136+00	
Description		Stream S-C29, facing northwest. No impacts to stream or BMPs from weekend rain events.						Description		Diversion berm only moderately vegetated, but stable nonetheless with no signs of erosion.

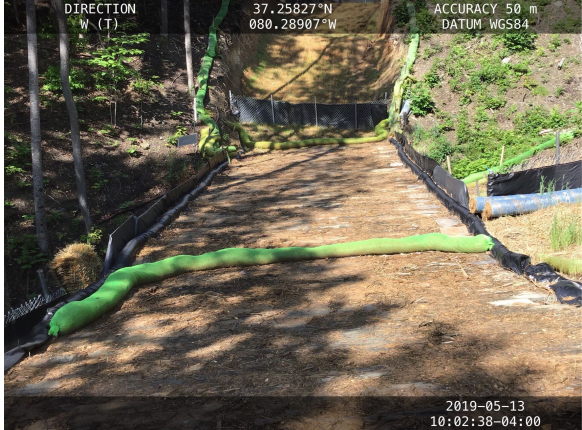
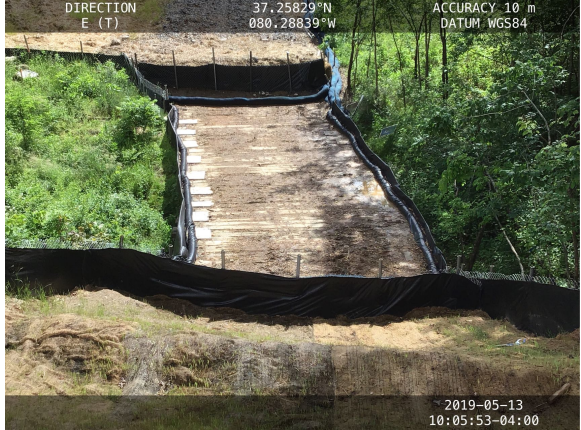
GPS Location		37.25		Field Station#		12098+44		GPS Location		37.25		Field Station#		12101+57	
Description		Stream S-MM13, facing west. No indications of impacts to stream or ECDs due to rain events over the weekend.						Description		Stream S-MM11, facing east. Stream, bridge, and ECDs in satisfactory condition at this crossing.

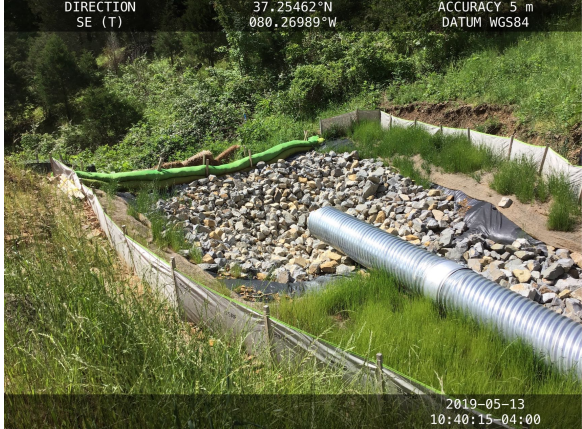
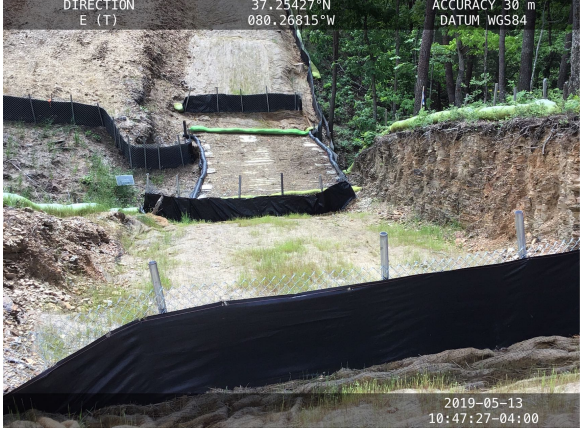
GPS Location		37.25		Field Station#		12157+50		GPS Location		37.25		Field Station#		12163+05	
Description		Clean water diversion pipe outlet and plunge pool in good condition with surrounding area well stabilized.						Description		Stream S-C25, facing east. No impacts were observed in or around stream as a result of rain events over the weekend.

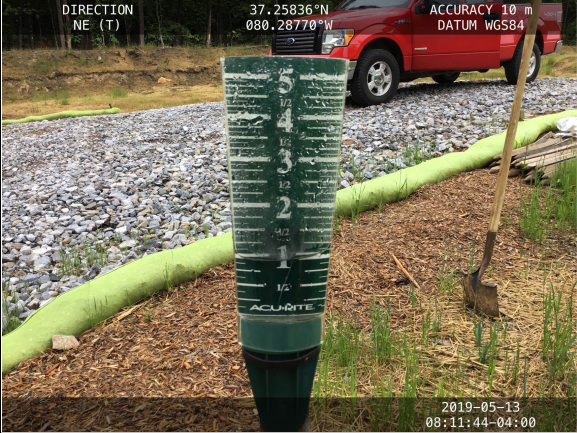
<p>Insert image here</p>			
GPS Location	37.22	Field Station#	12102+75	GPS Location	
Description	The rain gauge at Half Acre Rock Road registered 1.0 inches of precipitation this morning.		Description		
<p>Insert image here</p>			<p>Insert image here</p>		
GPS Location		Field Station#		GPS Location	
Description			Description		
<p>Insert image here</p>			<p>Insert image here</p>		
GPS Location		Field Station#		GPS Location	
Description			Description		
<p>Insert image here</p>			<p>Insert image here</p>		
GPS Location		Field Station#		GPS Location	
Description			Description

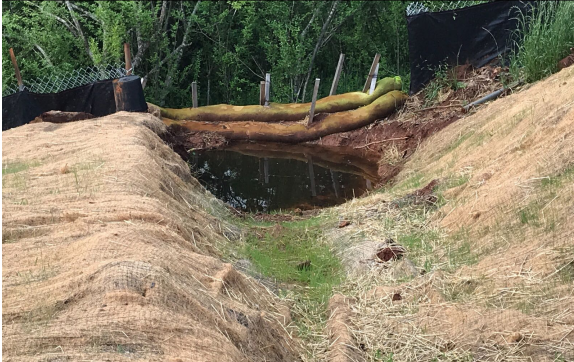
<div>13344+50_051319_PCD Sump full of water 2019-05-13 11:10:10-04:00</div>			<div>DIRECTION SE (T)</div> <div>+37.10378° -080.04287°</div> <div>ACCURACY 16 ft DATUM WGS84</div>

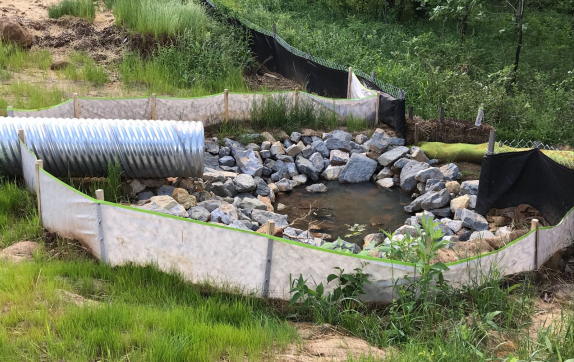
<div>13345+00_051319_PCD Condition of plunge pool 2019-05-13 11:11:13-04:00</div>				
GPS Location	37.27	Field Station#	13344+50	GPS Location	37.27	Field Station#	13345+00
Description	13344+50_051319 sumps contained stormwater. Looking S. See photo for gps data.			Description	12245+00_051319 condition of plunge pool. Looking SE. See photo for gps data.		
<div>DIRECTION SE (T)</div> <div>+37.10336° -080.04205°</div> <div>ACCURACY 33 ft DATUM WGS84</div>

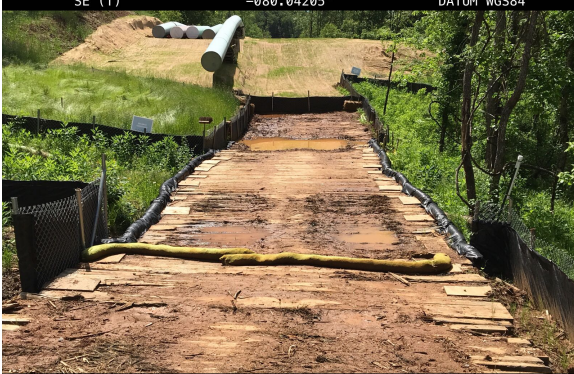
<div>13348+46_051319_PCD S-RR08 mat bridge clean & closed 2019-05-13 11:13:32-04:00</div>			<div>DIRECTION SE (T)</div> <div>+37.10285° -080.04169°</div> <div>ACCURACY 16 ft DATUM WGS84</div>

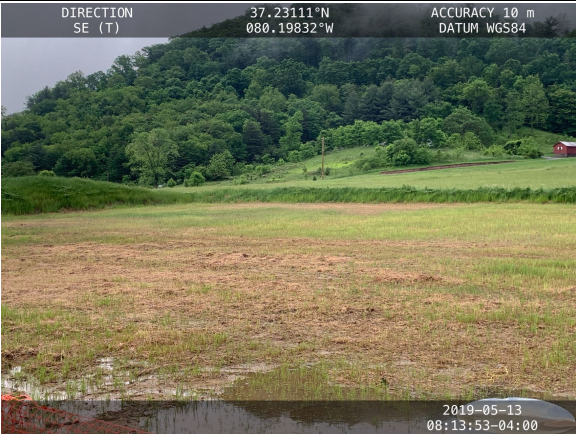
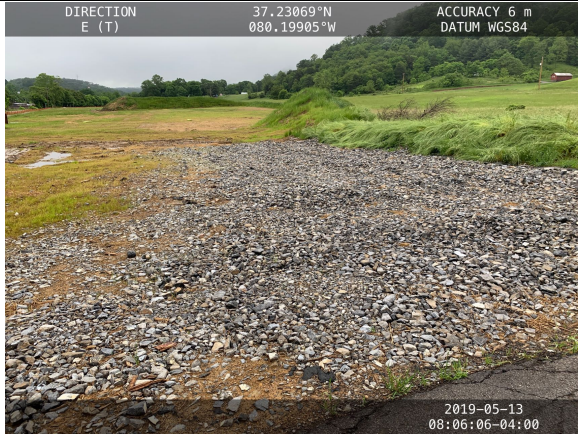
GPS Location		37.33		Field Station#		12445+86		GPS Location		37.33		Field Station#		12448+12	
Description		Stabilized ROW. Looking SE. See picture for GPS data.						Description		RCE. Looking E. See picture for GPS data.

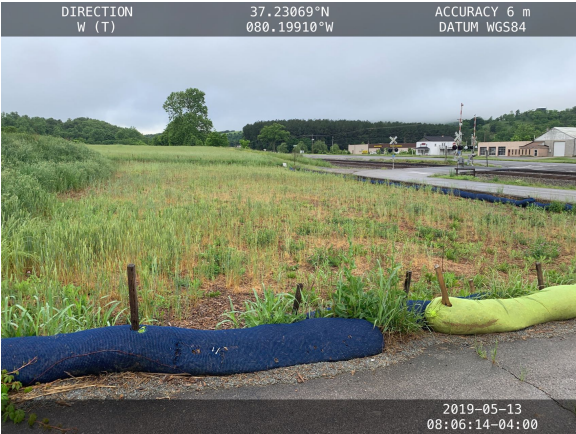
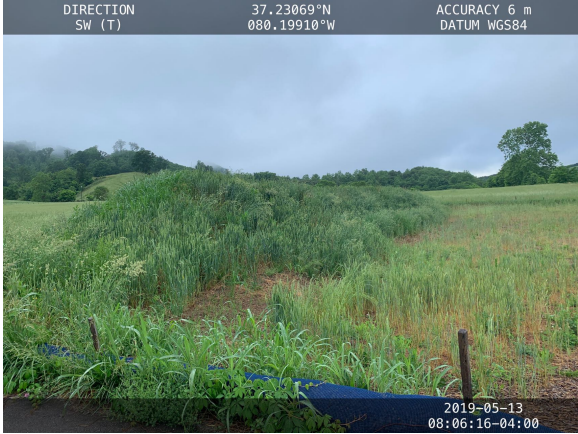
GPS Location		37.33		Field Station#		12448+50		GPS Location		37.33		Field Station#		12448+50	
Description		Stabilized ROW. Looking W. See picture for GPS data.						Description		Stabilized topsoil pile. Looking SW. See picture for GPS data.

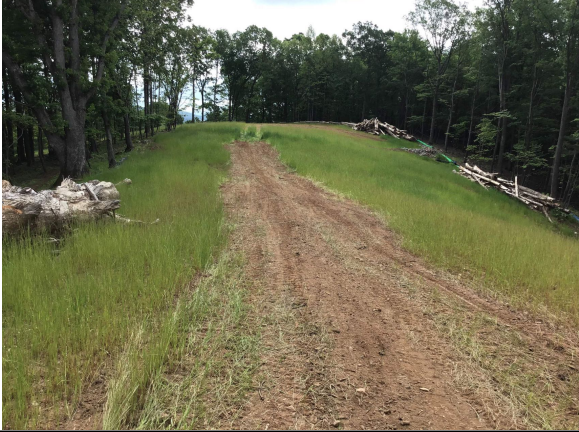
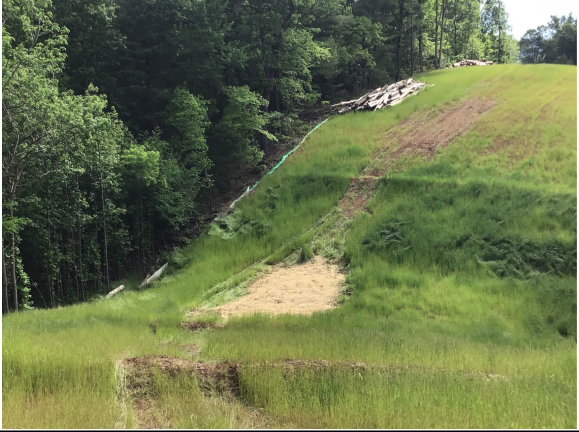
GPS Location	37.05	Field Station#	13605+23	GPS Location	37.05
Field Station#	13609+00	Description	Contractor repairing rutting on ROW.

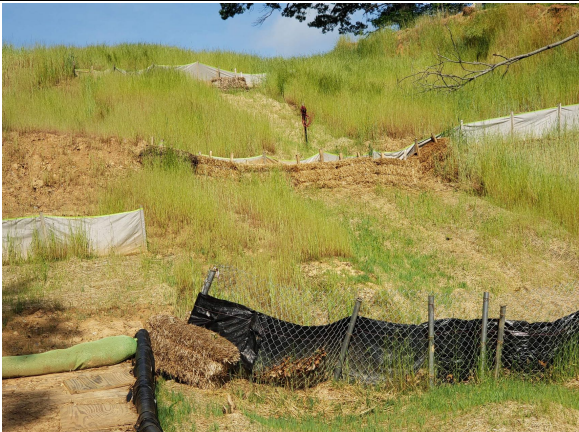
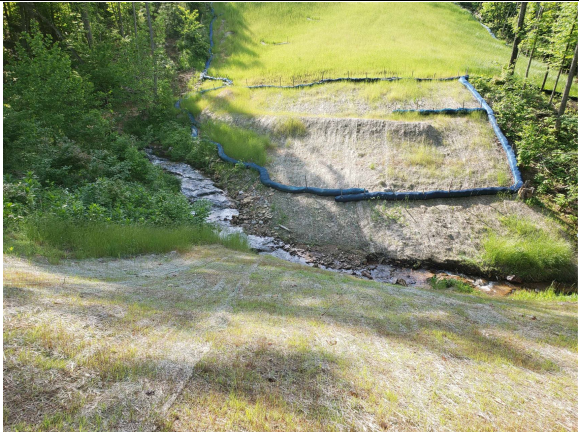
GPS Location	37.05	Field Station#	13543+11	GPS Location	37.05
Field Station#	13425+01	Description	Hillside stabilized. ECDs installed and functioning correctly at time of inspection.

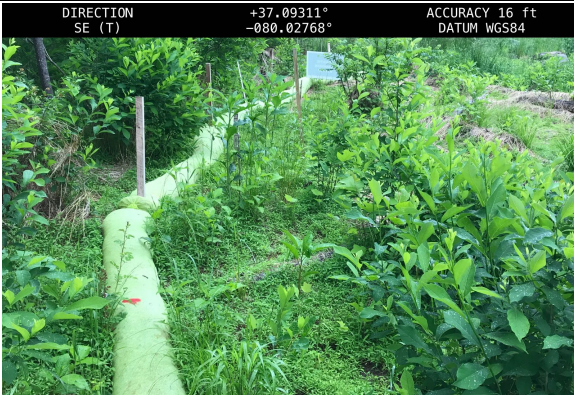
<p>DIRECTION SE (T) +37.09311° -080.02768° ACCURACY 16 ft DATUM WGS84</p> <p>13413+25_051719 Condition of CFS along boundary 2019-05-17 09:39:23-04:00</p>

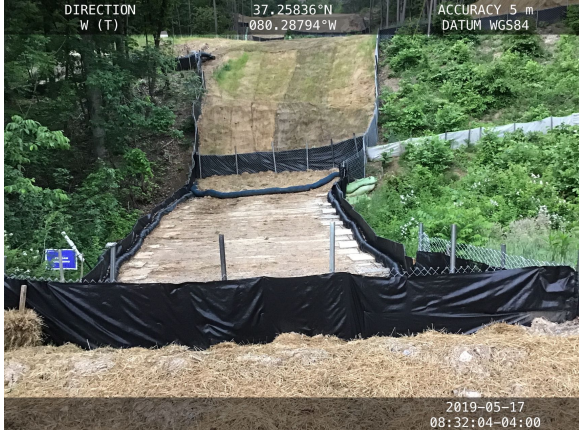
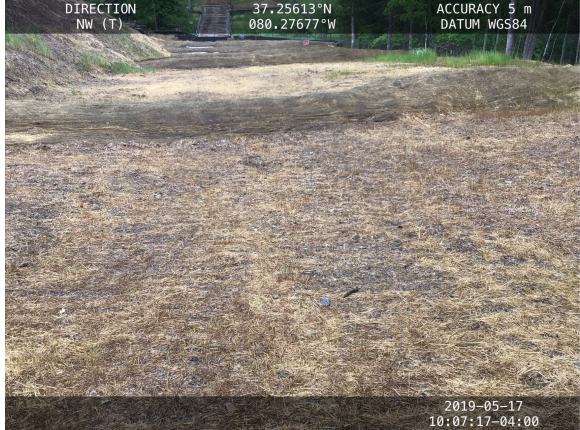
GPS Location	37.25	Field Station#	12101+57	GPS Location	37.25	Field Station#	12137+00
Description	Stream S-MM11, facing west. Bridge and ECDs in acceptable condition.			Description	Vegetation is minimal, but straw mulch is still maintaining stability.

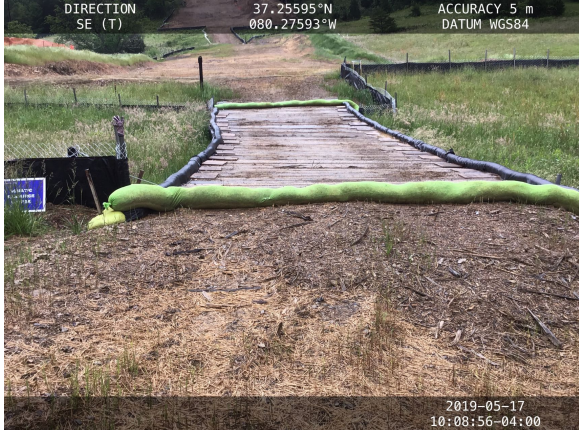
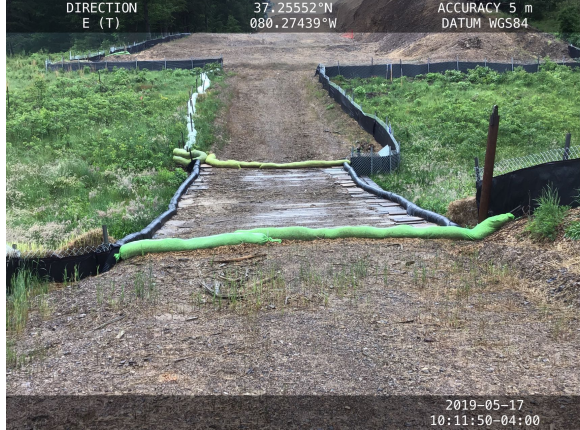
GPS Location	37.25	Field Station#	12140+00	GPS Location	37.25	Field Station#	12143+60
Description	Wetland W-C6, facing southeast. ECDs still intact and functioning as needed.			Description	Wetland W-C5, facing east. ECDs in satisfactory condition and working properly.

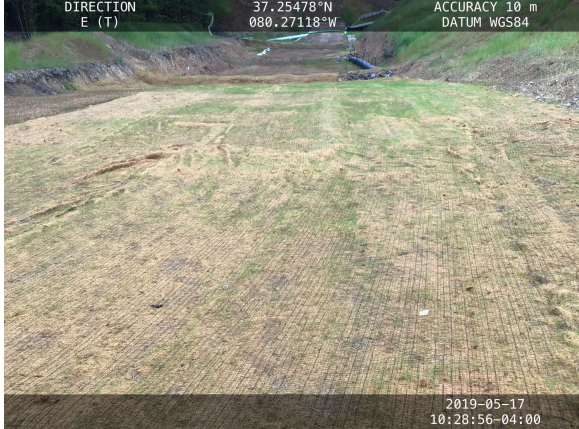
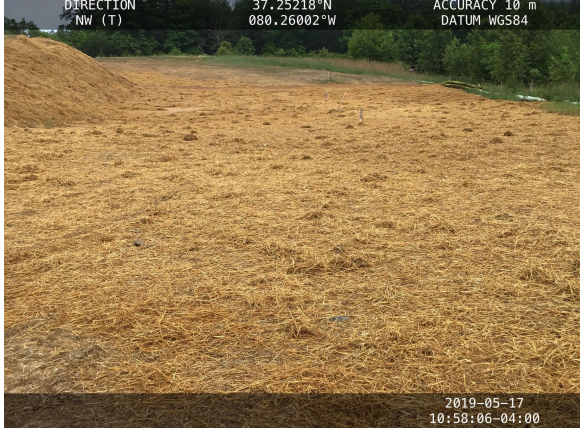
GPS Location	37.25	Field Station#	12154+00	GPS Location	37.25	Field Station#	12188+00
Description	Slope on the going away side of access road MVP-MN-273 that was recently restabilized is showing significant vegetation growth.			Description	Matt Myers' environmental crew seeded and mulched the area where they moved stockpiles and a water bar for AEP access.

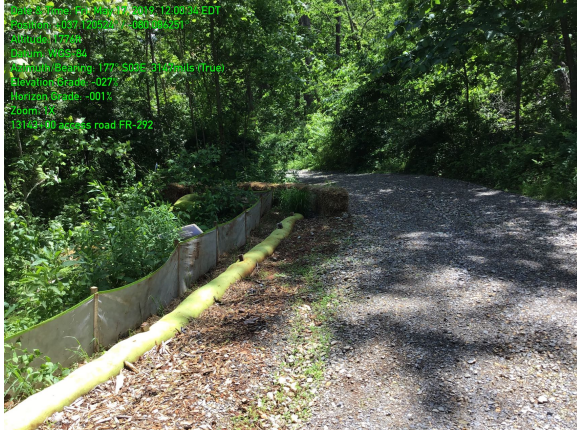
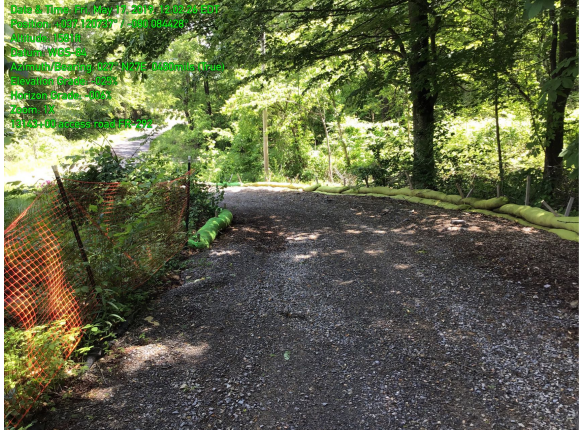
GPS Location	37.29	Field Station#	13143+00	GPS Location	37.29	Field Station#	13143+00
Description	ECD's installed along access road FR-292 were in compliance.			Description	Installed ECD's near Adney Gap road remain in good condition with no deficiencies.

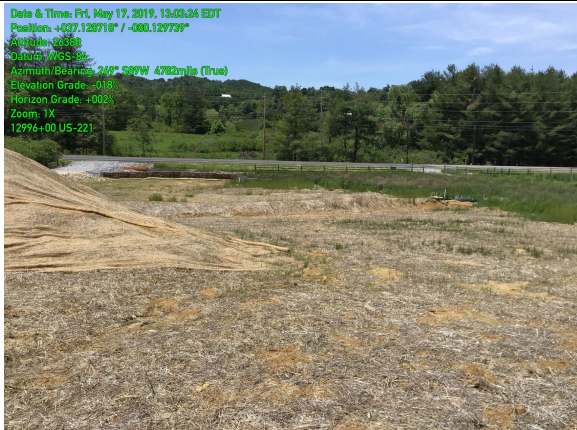
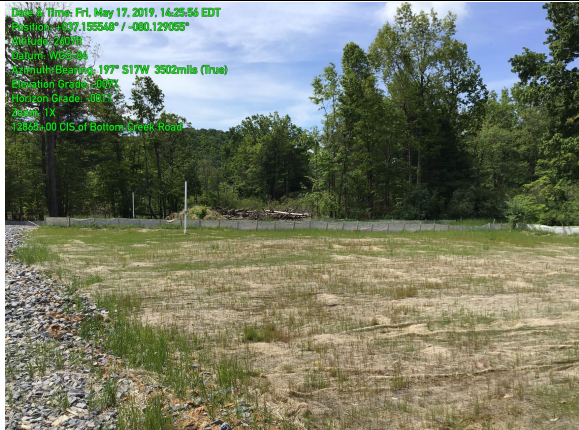
GPS Location	37.29	Field Station#	12996+00	GPS Location	37.29	Field Station#	12865+00
Description	No issues or impacts observed near US-221.			Description	No issues or impacts found at Bottom Creek road.

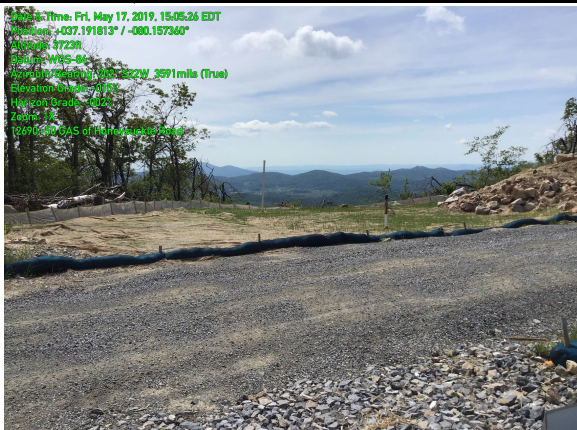
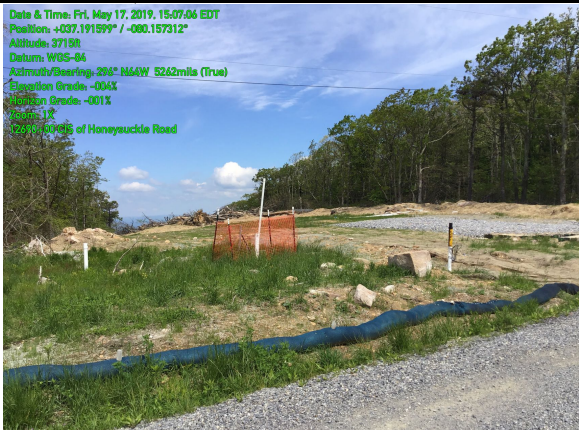
GPS Location	37.29	Field Station#	12690+50	GPS Location	37.29	Field Station#	12690+00
Description	GAS of Honeysuckle Road had no issues or impacts.			Description	CIS of Honeysuckle Road no deficiencies or impacts observed.
