Visual Site Inspection Report

Project Name	H-600 Pipeline Spread H	AFE	124300138	Spread	H-600 Pipeline Spread H
Contractor	Precision			Report #	17482
Inspector	Charles Head			Date/Time	5/20/2019 2:26 PM
Permit #	TBD	Inspection Type	VA SWPP	Station Begin	13415+51
State	VA	Inspection Area	Full	Station End	13670+00
County	Franklin	Ground	Dry	Temperature (°F)	84.00
Municipality	N/A	Weather	Sunny	Rain Gauge (in)	0.00
				Rain Accumulation Time (days)	1.00

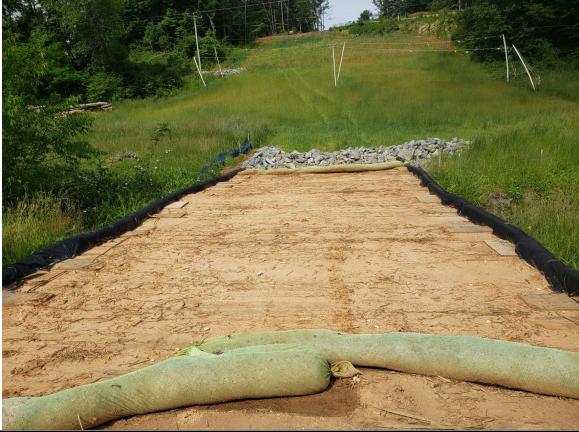
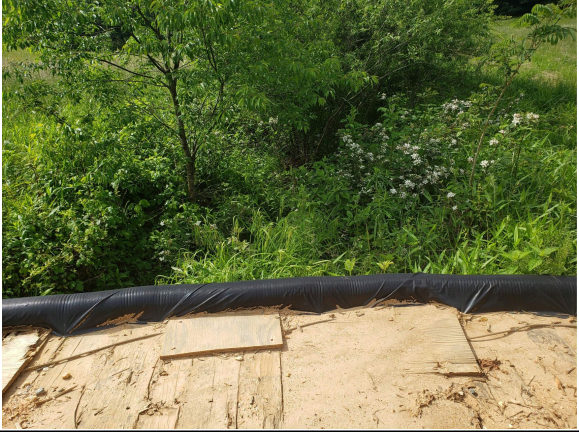
GPS Location	36.98	Field Station#	13565+30	GPS Location	36.98
Field Station#	13565+30	GPS Location	36.98	Field Station#	13565+30
Description	Approximately 13565+30. Resource boundary ECDs installed and functioning correctly at time of inspection.		Description	Approximately 13565+30. Downstream view of stream. Banks well vegetated and stream running clean and clear of sediment at time of inspection.

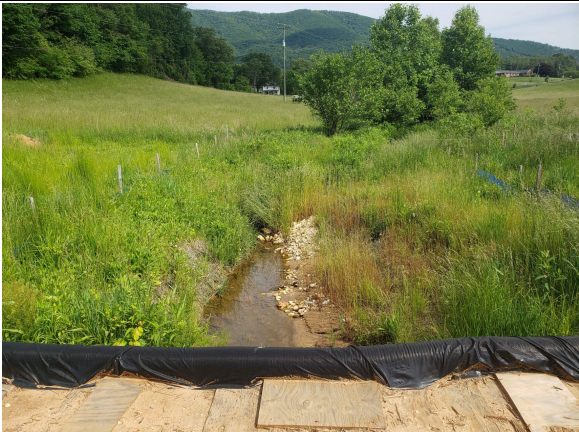
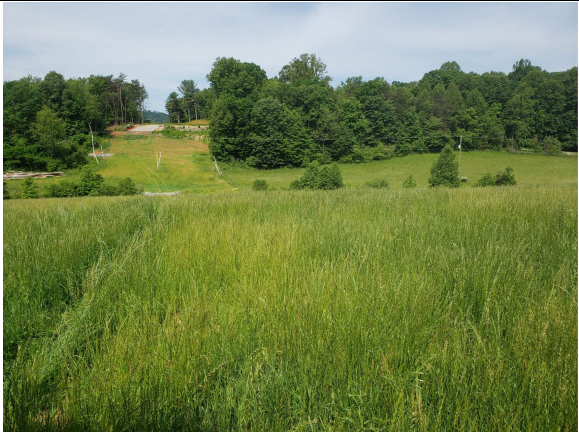
GPS Location	36.98	Field Station#	13565+30	GPS Location	36.98
Field Station#	13565+30	GPS Location	36.98	Field Station#	13572+00
Description	Approximately 13565+30. Upstream view of stream from equipment bridge. Banks vegetated and stream flowing unobstructed.		Description	Approximately 13572+00. Overview of ROW. ROW stabilized and has good vegetation.	
<p>Insert image here</p>			<p>Insert image here</p>		
GPS Location		Field Station#		GPS Location

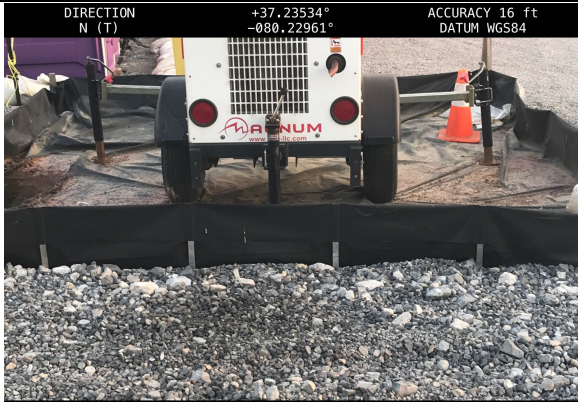
<div>MVP-PY-006_052319_PCD Containment under light plant 2019-05-23 06:31:36-04:00</div></div>					
GPS Location		37.23		Field Station#		+0		GPS Location		37.23	
Description		MVP-PY-006_052319 condition of compost filter sock along boundary. Looking E. See photo for gps data.						Description		MVP-PY-006_052319 condition of containment under light plant. Looking N. See photo for gps data.	
<div><div>DIRECTION N (T)</div><div>+37.23539° -080.22863°</div><div>ACCURACY 16 ft DATUM WGS84</div>

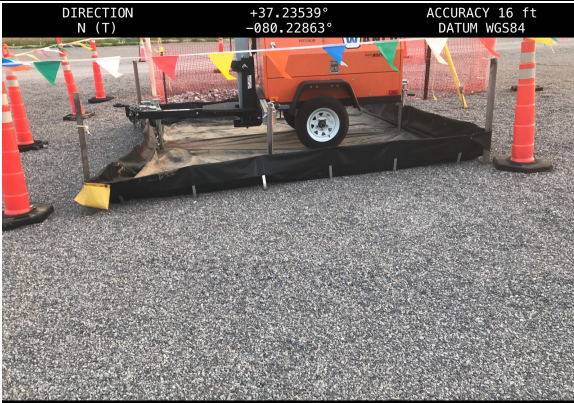
<div>MVP-PY-006_052319_PCD Containment under light plant 2019-05-23 06:32:56-04:00</div></div>						<div><div>DIRECTION NE (T)</div><div>+37.23552° -080.22874°</div><div>ACCURACY 16 ft DATUM WGS84</div> <div>MVP-PY-006_052319_PCD Flagging & buffer for feature 2019-05-23 06:33:19-04:00</div></div>

GPS Location		37.23		Field Station#		+0		GPS Location		37.23	
Description		MVP-PY-006_052319 condition of containment under light plant. Looking N. See photo for gps data.						Description		MVP-PY-006_052319 flagging and buffer for feature. Looking NE. See photo for gps data.	
<div><div>DIRECTION NE (T)</div><div>+37.23557° -080.22701°</div><div>ACCURACY 33 ft DATUM WGS84</div> <div>MVP-PY-006_052319 No fluid deposits on stone by tanks 2019-05-23 07:49:47-04:00</div></div>						<div><div>DIRECTION SW (T)</div><div>+37.23577° -080.22669°</div><div>ACCURACY 16 ft DATUM WGS84</div>

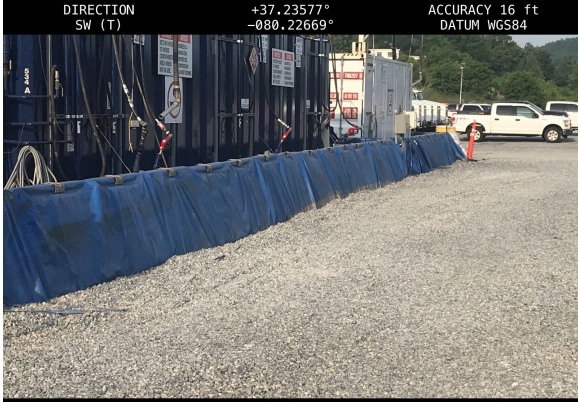
<div>MVP-PY-006_052319_PCD No fluid deposits on stone by tanks 2019-05-23 07:50:10-04:00</div></div>					
GPS Location		37.23		Field Station#		+0		GPS Location		37.23	
Description		MVP-PY-006_052319 no fluid deposits on the south side of bulk fuel tanks. Looking NE. See photo for gps data.						Description		MVP-PY-006_052319 no fluid deposits on the north side of the bulk fuel tanks. Looking SW. See photo for gps data.

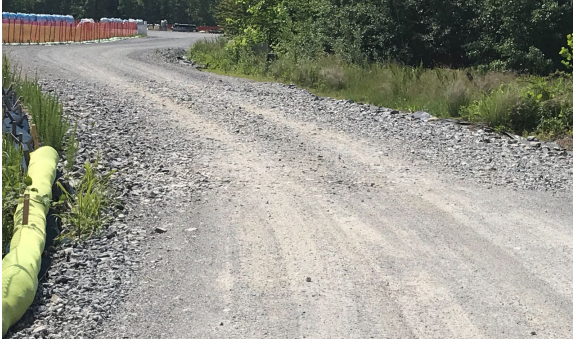
<div>MVP-LY-049_052319_PCD Rock entrance on center drive 2019-05-23 10:54:33-04:00</div>			<div>DIRECTION SW (T)</div> <div>+37.27157° -080.12231°</div> <div>ACCURACY 16 ft DATUM WGS84</div>

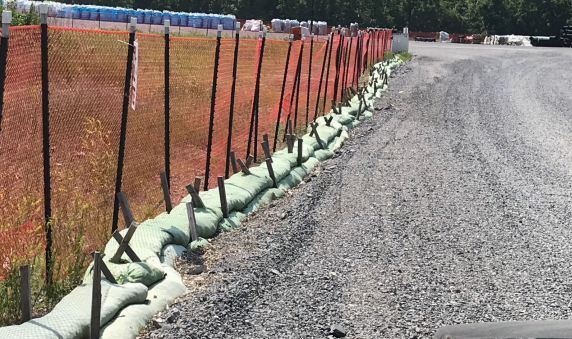
<div>MVP-LY-049_052319_PCD CFS along center drive 2019-05-23 10:55:01-04:00</div>				
GPS Location 37.27		Field Station# +0		GPS Location 37.27		Field Station# +0	
Description		MVP-LY-049_052319 condition of rock entrance on north drive. Looking S. See photo for gps data.		Description		MVP-LY-049_052319 condition of compost filter sock along drive. Looking SW. See photo for gps data.	
<div>DIRECTION E (T)</div> <div>+37.27095° -080.12185°</div> <div>ACCURACY 16 ft DATUM WGS84</div>

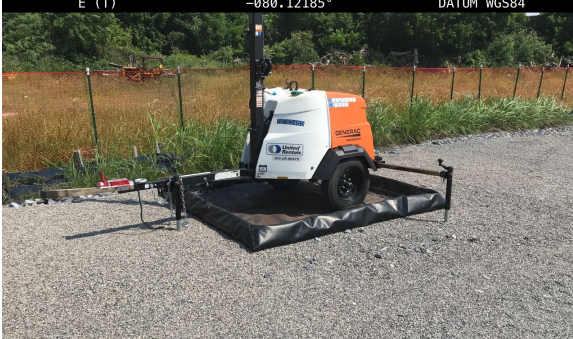
<div>MVP-LY-049_052319_PCD Containment under light plant 2019-05-23 10:55:31-04:00</div>			<div>DIRECTION SE (T)</div> <div>+37.27117° -080.12155°</div> <div>ACCURACY 16 ft DATUM WGS84</div>

GPS Location 37.27		Field Station# +0		GPS Location 37.27		Field Station# +0	
Description		MVP-LY-049_052319 condition of containment under light plant. Looking E. See photo for gps data.		Description		MVP-LY-049_052319 condition of compost filter sock along north boundary. Looking SE. See photo for gps data.	
<div>DIRECTION NW (T)</div> <div>+37.27004° -080.12360°</div> <div>ACCURACY 16 ft DATUM WGS84</div>

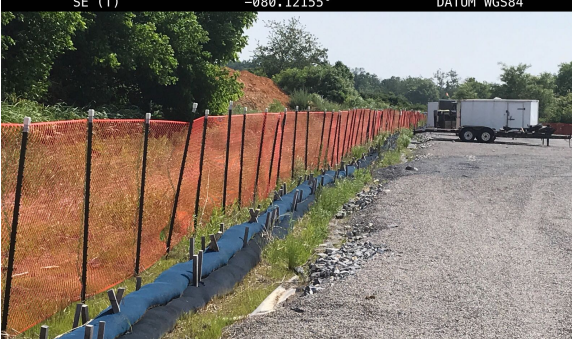
<div>MVP-LY-049_052319_PCD CFS along N boundary 2019-05-23 10:55:58-04:00</div>

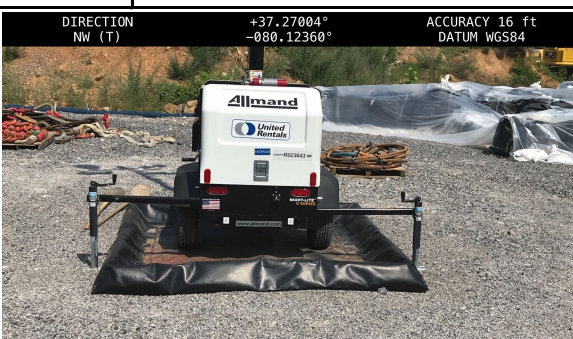
<div>MVP-LY-049_052319_PCD Containment under light plant 2019-05-23 11:01:51-04:00</div>			<div>DIRECTION NE (T)</div> <div>+37.27163° -080.12309°</div> <div>ACCURACY 16 ft DATUM WGS84</div>

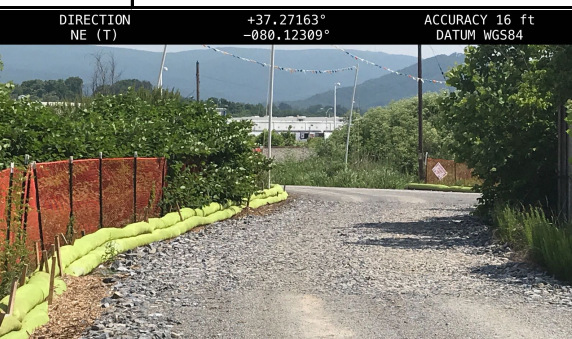
<div>MVP-LY-049_052319_PCD Rock entrance on N drive 2019-05-23 11:07:58-04:00</div>				
GPS Location 37.27		Field Station# +0		GPS Location 37.27		Field Station# +0	
Description		MVP-LY-049_052319 condition of containment under light plant. Looking NW. See photo for gps data.		Description		MVP-LY-049_052319 condition of rock entrance on north drive. Looking NE. See photo for gps data.

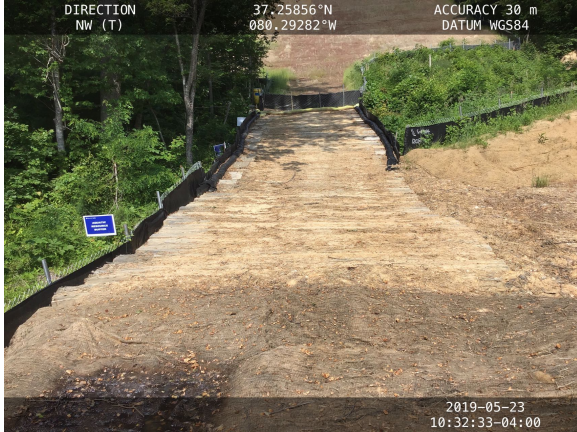
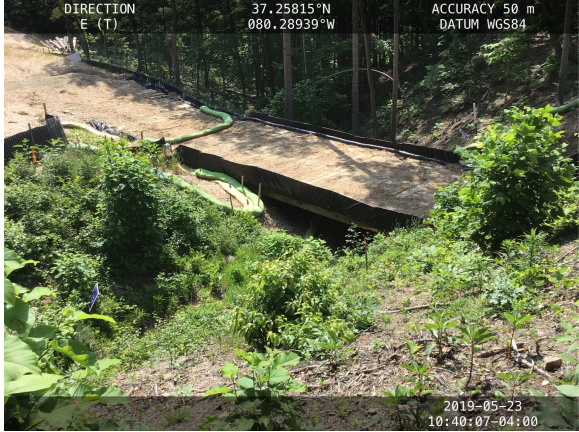
GPS Location		37.25		Field Station#		12086+56		GPS Location		37.25	
				Field Station#		12098+44					
Description		Stream S-MM14, facing northwest.						Description		Stream S-MM13, facing east.

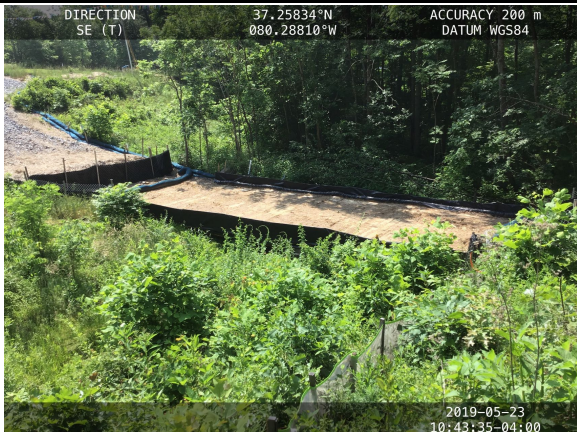
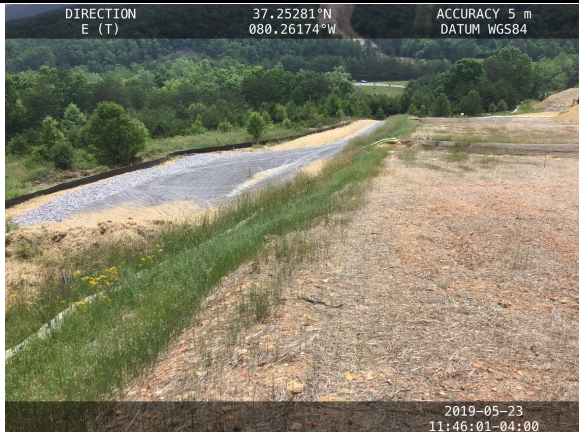
GPS Location		37.25		Field Station#		12101+57		GPS Location		37.25	
				Field Station#		12183+00					
Description		Stream S-MM11, facing southeast.						Description		Construction has been completed on AEP access road and pad adjacent to MVP ROW on coming in side of Bradshaw Road.

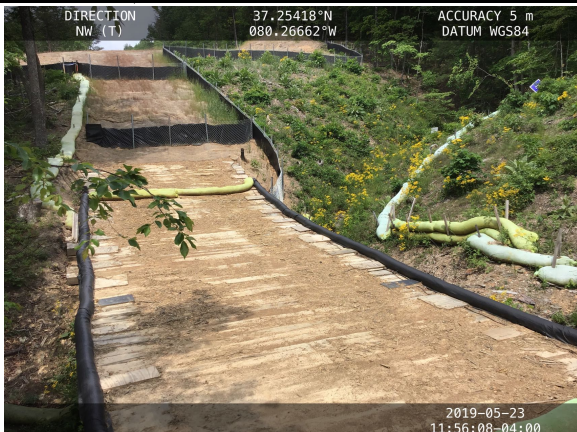
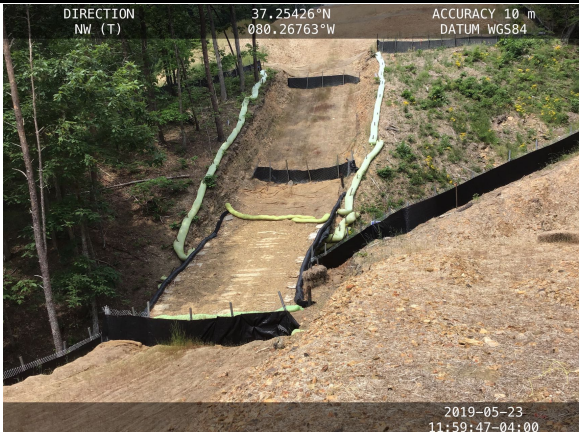
GPS Location		37.25		Field Station#		12166+47		GPS Location		37.25	
				Field Station#		12163+05					
Description		Stream S-C24, facing northwest.						Description		Stream S-C25, facing northwest.

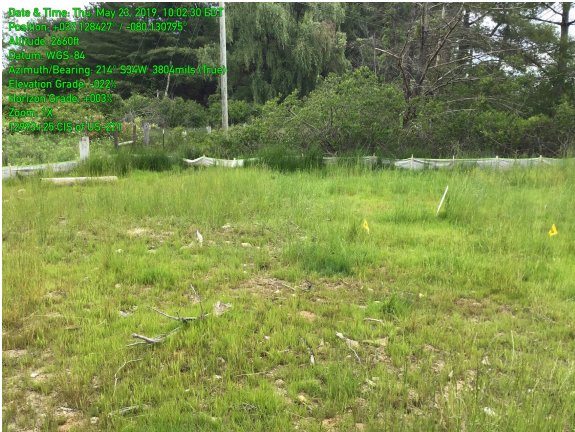
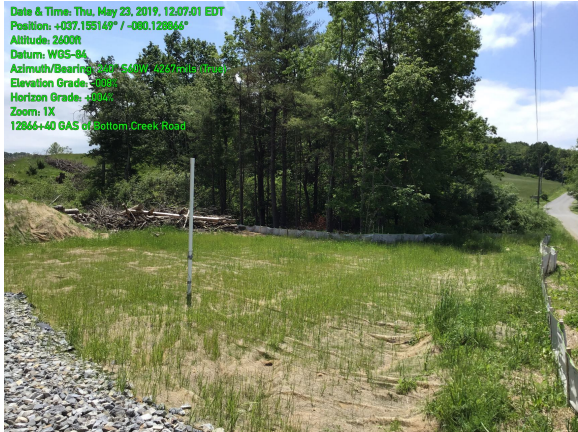
GPS Location	37.12	Field Station#	12993+25	GPS Location	37.12	Field Station#	12866+40
Description	No ECD deficiencies, no impacts throughout the area near US-221.			Description	No compliance issues found on the GAS of Bottom Creek Road.

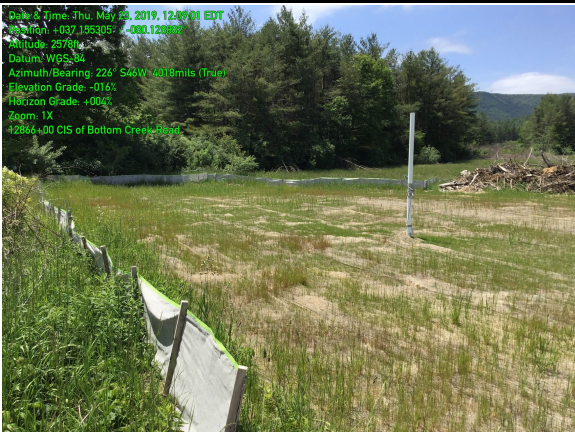
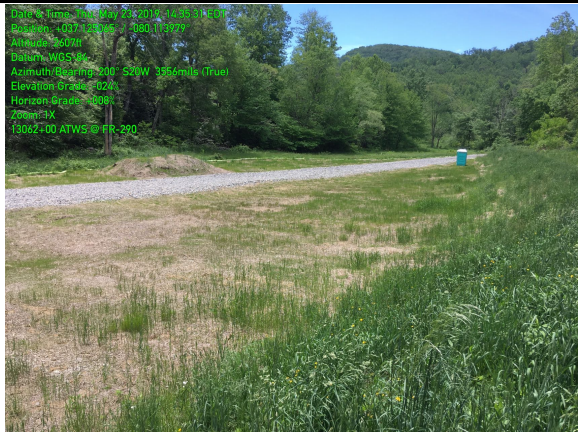
GPS Location	37.12	Field Station#	12866+00	GPS Location	37.12	Field Station#	13062+00
Description	No issues or impacts observed on the CIS of Bottom Creek Road.			Description	The ATWS on access road FR-290 had no visible impacts or compliance issues today.

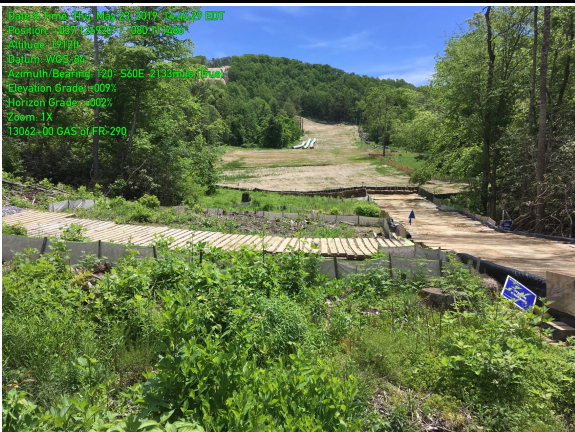
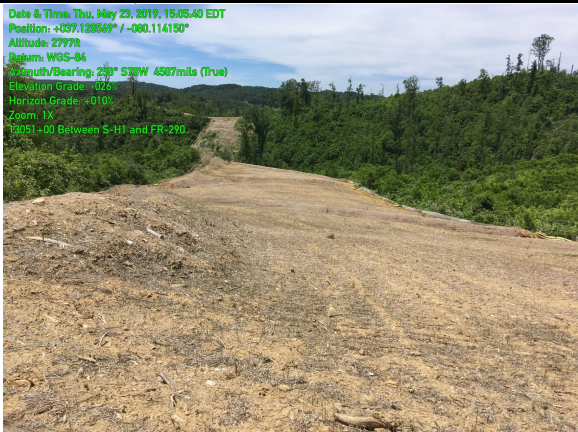
GPS Location	37.12	Field Station#	13062+00	GPS Location	37.12	Field Station#	13051+00
Description	Streams S-G26 and S-G27 showed no signs of impact from the project and surrounding ROW was in compliance.			Description	No issues or impacts found throughout the area between FR-289 and FR-290.

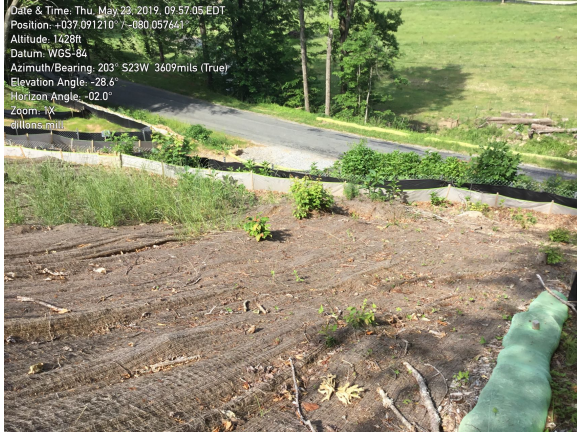
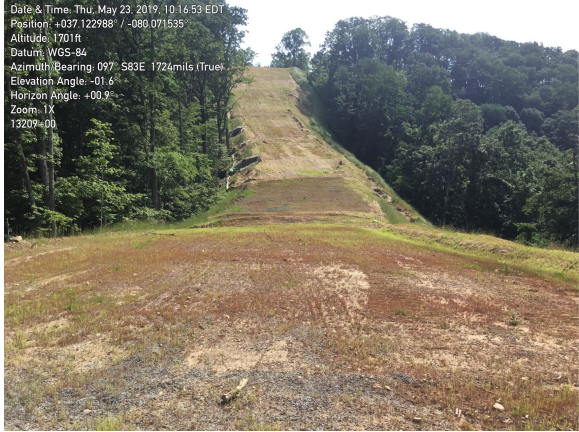
</div></div>				
GPS Location	37.32	Field Station#	13198+00	GPS Location	37.32	Field Station#	13209+00
Description	Please see photo for accurate coordinates. Dillon's Mill, ROW stabilized, ECDs in acceptable condition at road crossing.			Description	Please see photo for accurate coordinates. ROW, temporary vegetation establishing, waterbars and perimeter controls acceptable.

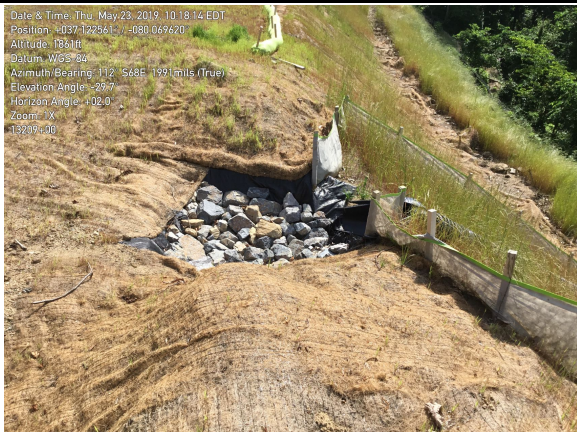
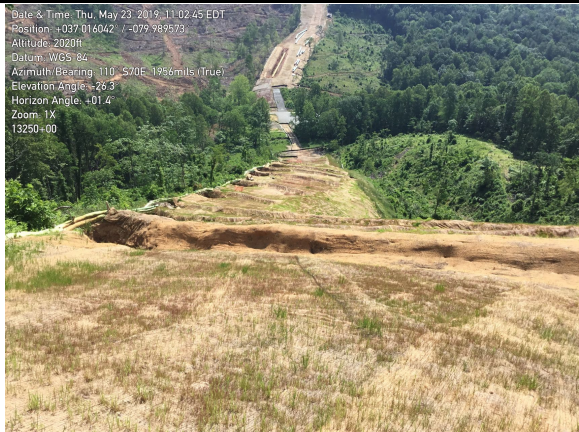
</div></div>				
GPS Location	37.32	Field Station#	13209+00	GPS Location	37.32	Field Station#	13250+00
Description	Please see photo for accurate coordinates. ROW, inlet protection clear, no environmental concerns noted.			Description	Please see photo for accurate coordinates. ROW stabilized, waterbars, sumps and end treatments functioning acceptably.		
<div><div><div>Date & Time: Thu, May 23, 2019, 11:25:24 EDT Position: +037.115723 / -080.060110 Altitude: 1422ft Datum: WGS-84 Azimuth/Bearing: 246° N14W 4911mils (True) Elevation Angle: -41.2° Horizon Angle: +01.0° Zoom: 1X 13261+28</div>

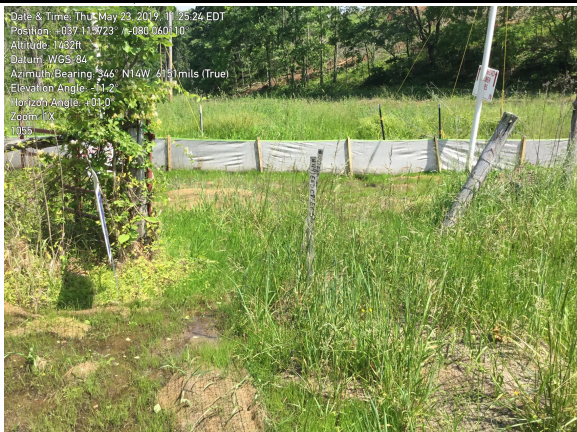
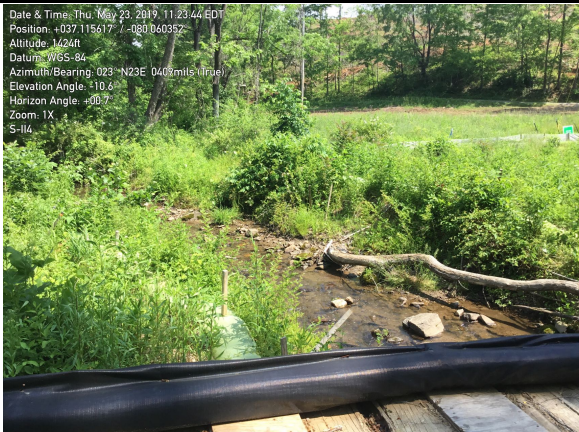
GPS Location	37.32	Field Station#	13261+28	GPS Location	37.32	Field Station#	13260+70
Description	Please see photo for accurate coordinates. W-II4 and ATWS-1055, standing water observed in ATWS from prior sheet flow, ground stable			Description	Please see photo for accurate coordinates. S-II4, looking upstream, ECDs along stream banks maintained, no issues noted.

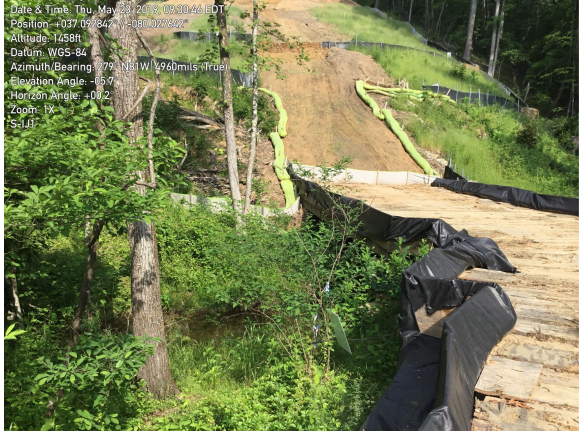
GPS Location	37.32	Field Station#	13415+00	GPS Location	37.32	Field Station#	13413+13
Description	Please see photo for accurate coordinates. Rain gauge total was 0 inches.			Description	Please see photo for accurate coordinates. S-IJ1, equipment bridge maintained, ECDs along stream functioning acceptably.		
<p>Date & Time: Thu, May 23, 2019, 09:58:00 EDT Position: +037.092705° / -080.027221° Altitude: 1458ft Datum: WGS-84 Azimuth/Bearing: 143° S37E 2542mils (True) Elevation Angle: -11.5° Horizon Angle: -00.4° Zoom: 1X cahas</p>  		<p>Date & Time: Thu, May 23, 2019, 12:54:23 EDT Position: +037.103453° / -080.042577° Altitude: 1541ft Datum: WGS-84 Azimuth/Bearing: 244° S64W 4338mils (True) Elevation Angle: -20.9° Horizon Angle: +02.8° Zoom: 1X 13345+10</p>

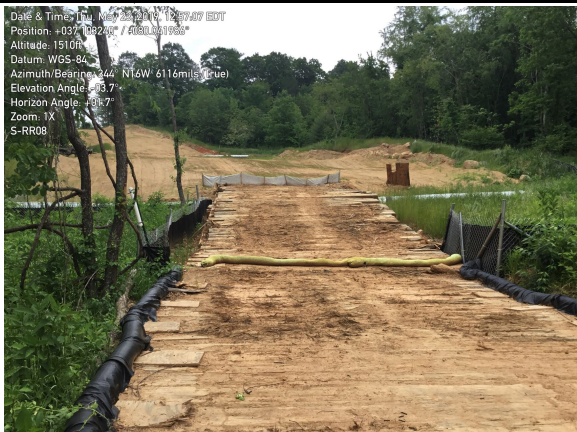
GPS Location	37.32	Field Station#	13413+13	GPS Location	37.32	Field Station#	13345+10
Description	Please see photo for accurate coordinates. ROW, mat bridge across low area maintained, no environmental concerns noted.			Description	Please see photo for accurate coordinates. ROW, outlet and clean water diversion pipe functioning acceptably.		
<p>Date & Time: Thu, May 23, 2019, 12:57:07 EDT Position: +037.103246° / -080.041996° Altitude: 1510ft Datum: WGS-84 Azimuth/Bearing: 244° N16W 6116mils (True) Elevation Angle: -13.7° Horizon Angle: +01.7° Zoom: 1X S-RR08</p>

<p>Date & Time: Thu, May 23, 2019, 12:59:16 EDT Position: +037.102889° / -080.041512° Altitude: 1520ft Datum: WGS-84 Azimuth/Bearing: 177° S03E 3147mils (True) Elevation Angle: -12.2° Horizon Angle: +00.2° Zoom: 1X S-RR09</p>  					
GPS Location	37.32	Field Station#	13348+46	GPS Location	37.32	Field Station#	13351+00
Description	Please see photo for accurate coordinates. S-RR08, ECDs functioning acceptably along stream, equipment bridge maintained.			Description	Please see photo for accurate coordinates. CIS S-RR09, temporary vegetation establishing, ECDs functioning acceptably.

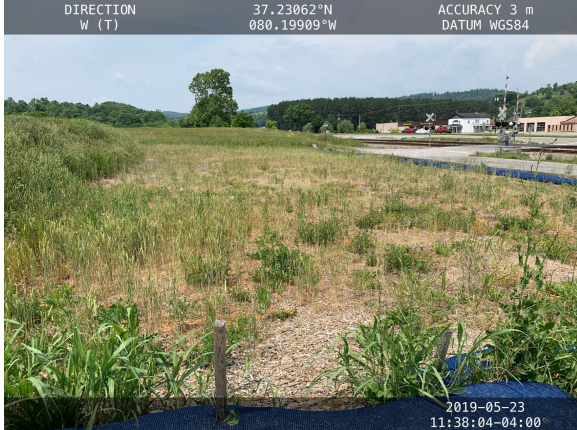
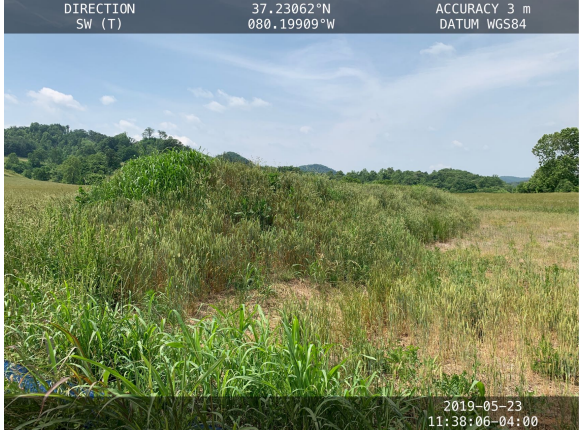
GPS Location		37.33	Field Station#		12448+50		GPS Location		37.33	Field Station#		12448+50	
Description		Stabilized ROW. Looking W. See picture for GPS data.				Description		Stabilized topsoil pile. Looking SW. See picture for GPS data.					
<div>DIRECTION E (T)</div> <div>37.23063°N 080.19904°W</div> <div>ACCURACY 5 m DATUM WGS84</div>

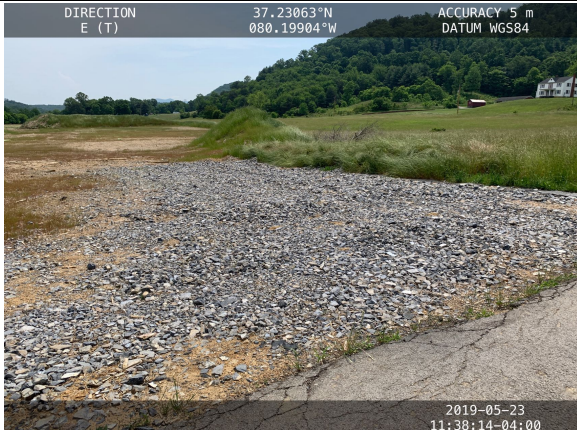
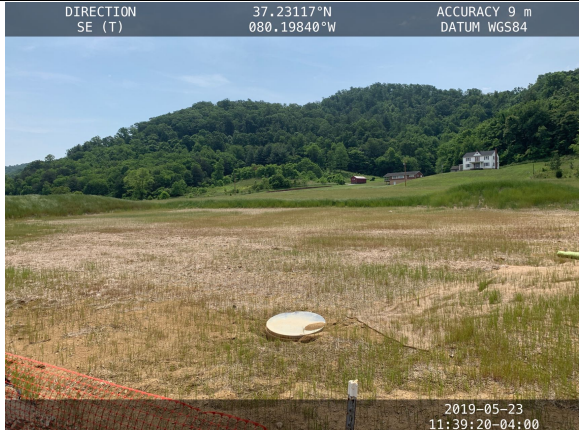
GPS Location		37.33	Field Station#		12448+12		GPS Location		37.33	Field Station#		12445+86	
Description		RCE. Looking E. See picture for GPS data.				Description		Stabilized row. Looking SE. See picture for GPS data.

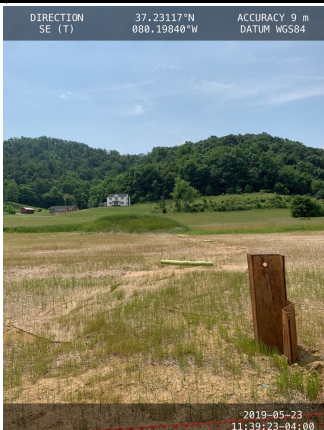
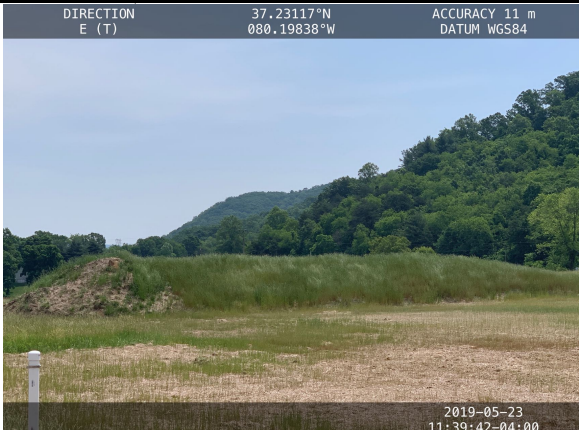
GPS Location		37.33	Field Station#		12445+86		GPS Location		37.33	Field Station#		12445+86	
Description		Curlexed channel for rain water to cross the LOD. Looking SE. See picture for GPS data				Description		Stabilized topsoil pile. Looking E. See picture for GPS data.

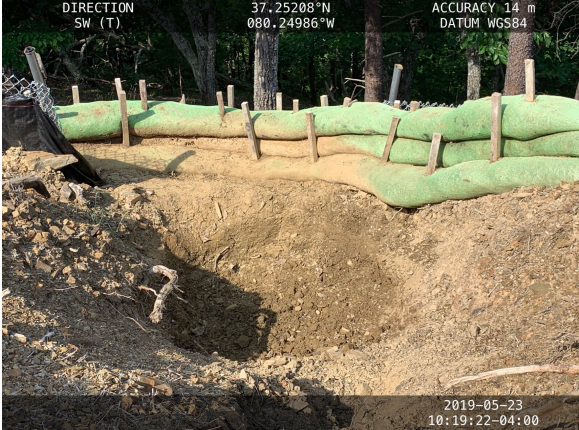
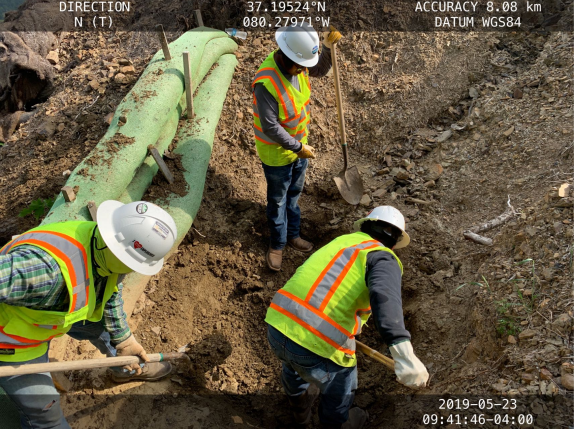
GPS Location	37.33	Field Station#	12223+00	GPS Location	37.33
		Field Station#	12223+00		
Description	Sump pit that was cleaned out by shovel. Looking SW. See picture for GPS data.			Description	Crew removing sediment from sump pit as pointed out by DEQ. Looking N. See picture for GPS data.

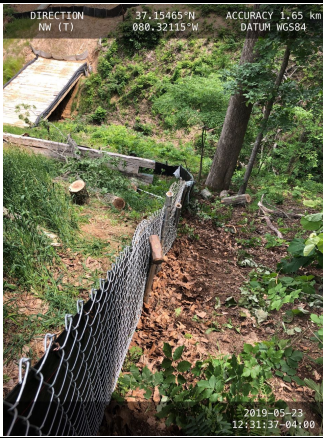
GPS Location	37.33	Field Station#	12399+00	GPS Location	37.33
		Field Station#	12399+00		
Description	Labor seeding bare ground. Looking SE. See picture for GPS data.			Description	Fallen tree was removed and SSF repaired. Looking NW. See picture for GPS data.

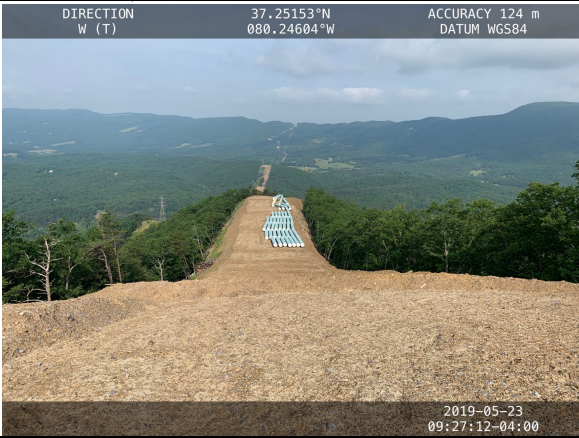
GPS Location	37.33	Field Station#	12230+00	GPS Location	37.33
		Field Station#	12230+00		
Description	Stabilized ROW with pipe staged. Looking W. See picture for GPS data.			Description	Mulched area where old sock and fence were located. Looking NW. See picture for GPS data.
