# Visual Site Inspection Report

<b>Project Name</b>	H-600 Pipeline Spread G	<b>AFE</b>	124300137	<b>Spread</b>	H-600 Pipeline Spread G
<b>Contractor</b>	Precision			<b>Report #</b>	11245
<b>Inspector</b>	Clinton Banks			<b>Date/Time</b>	11/26/2018 3:35 AM
<b>Permit #</b>	TBD	<b>Inspection Type</b>	VA SWPP	<b>Station Begin</b>	11552+77
<b>State</b>	VA	<b>Inspection Area</b>	Full	<b>Station End</b>	11436+00
<b>County</b>	Craig	<b>Ground</b>	Wet	<b>Temperature (°F)</b>	49.00
<b>Municipality</b>	N/A	<b>Weather</b>	Cloudy	<b>Rain Gauge (in)</b>	0.00
<b>GPS Location</b>	37.3214820027699, -80.4356293939803			<b>Rain Accumulation Time (days)</b>	1.00

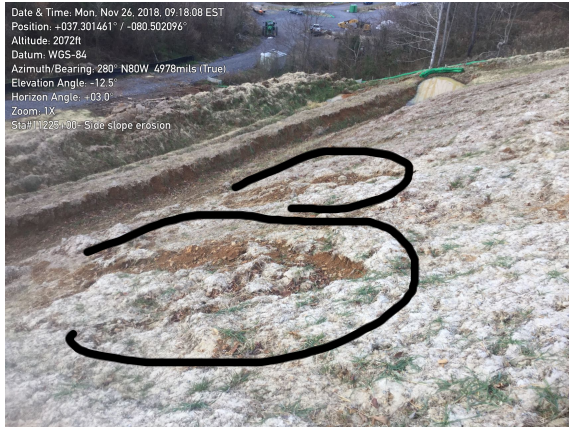
Inspection area; Sta#11254+88 to 10931+00. - MP- 213 to 206.2  
Sta#11225+00- Side slope has some erosion, ( see photo).  
Sta#11254+00 to 11162+00- ECD's in this area are in good working condition, this section has good growth so there is very little sediment movement, which helps with keeping sump pits clean.  
Sta#11151+00 to 11122+00- Row has been reseeded & mulched & mulch has been crimped for stabilization.  
Sta#11109+75- SSF fabric not attached to fence.  
Sta#11090+00 to 11069+00- Row has been reseeded & mulched, mulch has been crimped.  
Sta#11069+00 to 11045+00- Row has been reseeded & mulched but has not been stabilized by crimping or helicopter.  
Sta#11045+00 to 11012+00- Row has been reseeded, mulched & crimped.  
Sta#11029+00- Fabric has been reattached to SSF.  
Sta#11254+88 to 10931+00- ECD's in this area are working & in good condition, with the exception of, sta#11109+75, SSF fabric detached from fence.

A/E	124300137	Date/Time	11/26/2018 6:17 AM	Report #	11339
Pictures					
<p>Date &amp; Time: Mon, Nov 26, 2018, 09:18:08 EST Position: +037.301461° / -080.502096° Altitude: 2072ft Datum: WGS-84 Azimuth/Bearing: 280° N80W 4978mils (True) Elevation Angle: -12.5° Horizon Angle: -03.0° Zoom: 1X Sta#11225+00- Side slope erosion</p>

GPS Location	37.3014466977094, -80.5021566432719	GPS Location	37.3092113994409, -80.5150349345808		
Description	Sta#- 11225+00- Side slope erosion.	Description	Sta#11172+00- Slope drain, CFS checks, sumps & end treatment are in good working condition.

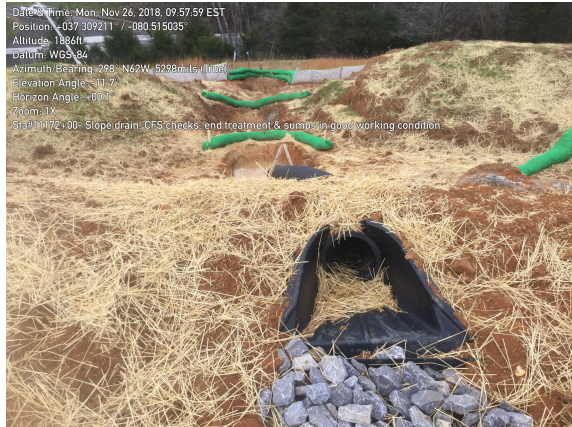
<p>Date &amp; Time: Mon, Nov 26, 2018, 09:57:59 EST Position: +037.309211° / -080.515035° Altitude: 1826ft Datum: WGS-84 Azimuth/Bearing: 298° N52W 5228mils (True) Elevation Angle: -11.7° Horizon Angle: -00.1° Zoom: 1X Sta#11172+00- Slope drain, CFS checks, end treatment &amp; sumps in good working condition</p>

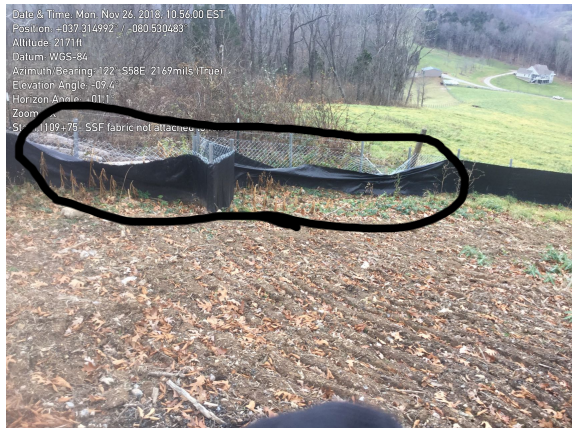
<p>Date &amp; Time: Mon, Nov 26, 2018, 10:56:00 EST Position: +037.314992° / -080.530483° Altitude: 2171ft Datum: WGS-84 Azimuth/Bearing: 122° S58E 2149mils (True) Elevation Angle: -09.4° Horizon Angle: -01.1° Zoom: 1X Sta#11109+75- SSF fabric not attached to fence</p>

GPS Location	37.3137499066417, -80.5224329699581	GPS Location	37.3149289051418, -80.5303894915437		
Description	Sta#11138+00 to 11122+00- Row has been reseeded & mulched, mulch has been crimped for stabilization.	Description	Sta#11109+75- SSF fabric not attached to fence.		
<p>Date &amp; Time: Mon, Nov 26, 2018, 13:13:51 EST Position: +037.324774° / -080.562983° Altitude: 2550ft Datum: WGS-84 Azimuth/Bearing: 299° N61W 5316mils (True) Elevation Angle: -10.8° Horizon Angle: +01.8° Zoom: 1X Sta#10993+00 to 10986+00- Row reseeded &amp; mulched, has not been crimped or stabilized.</p>

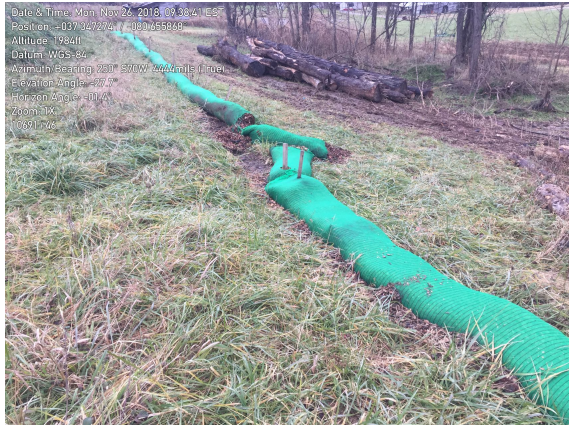
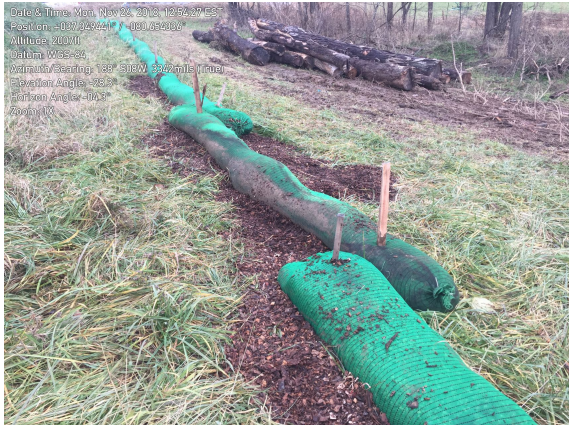
<b>GPS Location</b>	37.3700012360116, -80.6876124535507	<b>GPS Location</b>	37.3700012360116, -80.6876124535507		
<b>Description</b>	Access 241 10691+46 damaged sock by land owner off Buffalo Anklets Rd called crew to repair use photo gps	<b>Description</b>	Repaired filter sock off Buffalo Anklets and Access 241 10691+46 use photo gps

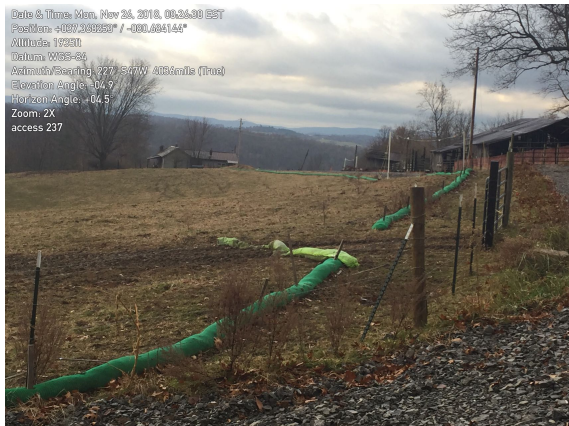
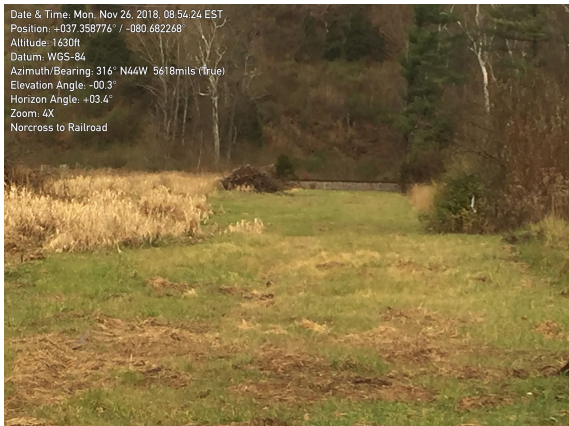
<b>GPS Location</b>	37.3699209792888, -80.6874179095781	<b>GPS Location</b>	37.3699209792888, -80.6874179095781		
<b>Description</b>	Access 237 land owner damage to access waddle use photo Gps	<b>Description</b>	Norcross Rd to Railroad at Big Stony Creek, no Issues use photo gps

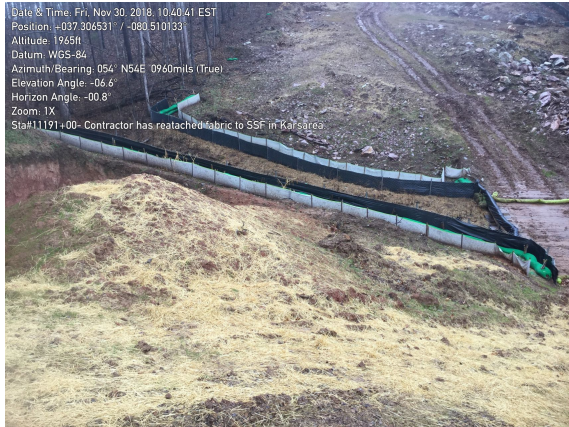
A/E	124300137	Date/Time	11/30/2018 6:25 AM	Report #	11517
Pictures					
<p>Date &amp; Time: Fri, Nov 30, 2018, 10:40:41 EST Position: +037.306531° / -080.510133° Altitude: 1965ft Datum: WGS-84 Azimuth/Bearing: 054° N54E 0960mils (True) Elevation Angle: -06.6° Horizon Angle: -00.8° Zoom: 1X Sta#11191+00- Contractor has reattached fabric to SSF in Karst area.</p>

GPS Location	37.3075012816464, -80.5117793195699	GPS Location	37.3074982222517, -80.511731961817		
Description	Sta#11191+00- Contractor has reattached fabric to SSF in Karst area.	Description	Sta#11184+00- CWD and plunge pool.

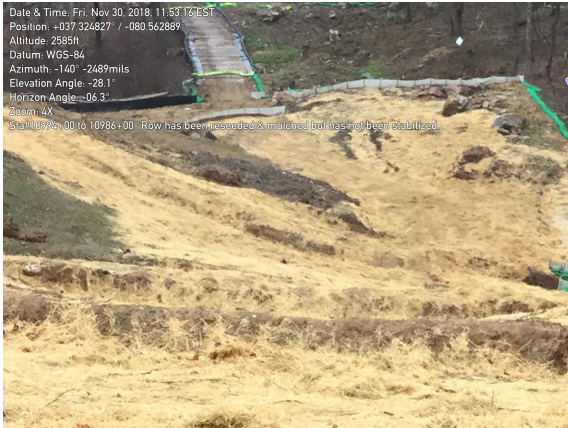
<p>Date &amp; Time: Fri, Nov 30, 2018, 11:53:16 EST Position: +037.324827° / -080.562889° Altitude: 2585ft Datum: WGS-84 Azimuth: -140° -2489mils Elevation Angle: -28.1° Horizon Angle: -06.3° Zoom: 4X Sta#10994+00 to 10986+00- Row has been reseeded &amp; mulched but has not been stabilized.</p>

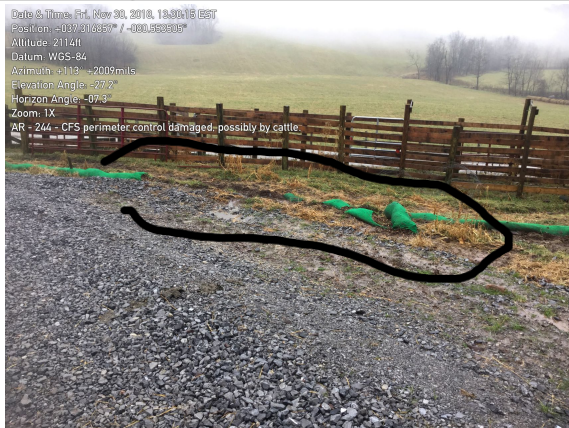
GPS Location	37.3234460503211, -80.5547913909709	GPS Location	37.3248265078639, -80.5628887285297		
Description	Sta#11015+00- Stream RR - 5, No issues at stream.	Description	Sta#10994+00 to 10986+00- Row has been reseeded & mulched, has not been stabilized.		
<p>Date &amp; Time: Fri, Nov 30, 2018, 13:30:16 EST Position: +037.316829° / -080.553536° Altitude: 2114ft Datum: WGS-84 Azimuth: +113° -2009mils Elevation Angle: -27.2° Horizon Angle: -07.3° Zoom: 1X AR - 244 - CFS perimeter control damaged, possibly by cattle.</p>

GPS Location	37.3168291245003, -80.5535536353295	GPS Location	37.32758615, -80.486177		
Description	AR- 244- CFS perimeter control damaged, possibly by cattle.	Description	Sta#10983+00- P 1 is holding water, but has not failed yet.

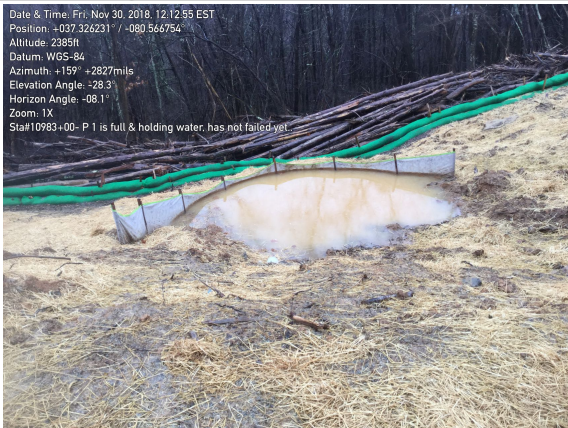
<p>Date &amp; Time: Fri, Nov 30, 2018, 12:12:55 EST Position: +037.326231° / -080.566754° Altitude: 2385ft Datum: WGS-84 Azimuth: +159° -2827mils Elevation Angle: -28.3° Horizon Angle: -08.1° Zoom: 1X Sta#10983+00- P 1 is full &amp; holding water, has not failed yet.</p>
