# Visual Site Inspection Report

<b>Project Name</b>	H-600 Pipeline Spread G	<b>AFE</b>	124300137	<b>Spread</b>	H-600 Pipeline Spread G
<b>Contractor</b>	Precision			<b>Report #</b>	11673
<b>Inspector</b>	Rob Robertson			<b>Date/Time</b>	12/3/2018 3:52 PM
<b>Permit #</b>	TBD	<b>Inspection Type</b>	VA SWPP	<b>Station Begin</b>	10458+91
<b>State</b>	VA	<b>Inspection Area</b>	Full	<b>Station End</b>	10459+03
<b>County</b>	Giles	<b>Ground</b>	Damp	<b>Temperature (°F)</b>	56.00
<b>Municipality</b>	N/A	<b>Weather</b>	Sunny	<b>Rain Gauge (in)</b>	0.00
<b>GPS Location</b>	37.1340199609013, -80.3943157922492			<b>Rain Accumulation Time (days)</b>	1.00

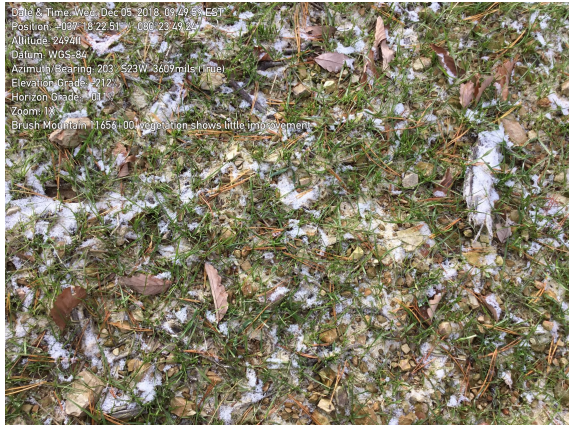
<b>AFE</b>	124300137	<b>Date/Time</b>	12/5/2018 1:40 PM	<b>Report #</b>	11768
<b>Pictures</b>					
<p>Date &amp; Time: Wed, Dec 05, 2018, 09:49:56 EST Position: +037°18'22.51"N, -080°23'50.54"W Altitude: 227ft Datum: WGS-84 Azimuth/Bearing: 203° 52'W 2459mils (16 miles) Elevation Grade: +212 Horizon Grade: +112 Zoom: 1X Brush Mountain 11651+00. Vegetation shows little improvement.</p>

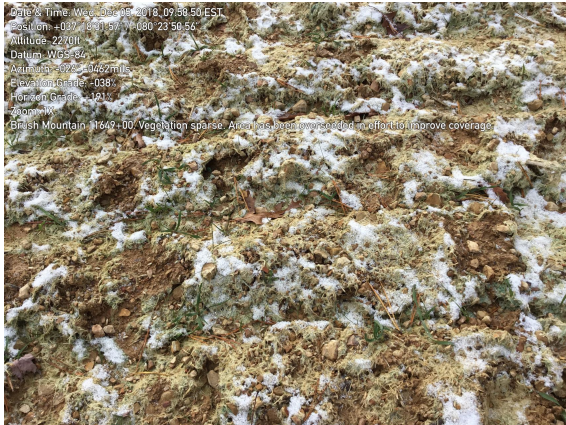
<p>Date &amp; Time: Wed, Dec 05, 2018, 09:58:50 EST Position: +037°18'23.63"N, -080°23'50.54"W Altitude: 227ft Datum: WGS-84 Azimuth/Bearing: 203° 52'W 2459mils (16 miles) Elevation Grade: +038 Horizon Grade: +121 Zoom: 1X Brush Mountain 11649+00. Vegetation sparse. Areas with sparse snow could use effort to improve coverage.</p>

<b>GPS Location</b>	37.1164266625765, -80.4145903979246	<b>GPS Location</b>	37.1164266625765, -80.4145903979246		
<b>Description</b>	Correct coordinates on photo. Vegetation good in some areas.	<b>Description</b>	Correct coordinates on photo. Vegetation sparse in some areas.

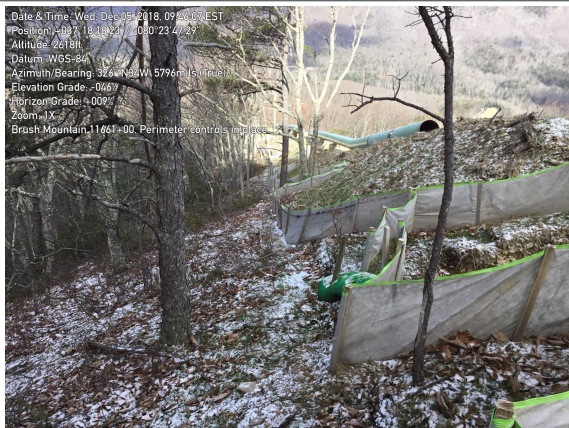
<p>Date &amp; Time: Wed, Dec 05, 2018, 09:52:11 EST Position: +037°18'23.63"N, -080°23'51.16"W Altitude: 226ft Datum: WGS-84 Azimuth/Bearing: 326° 56'W 5796mils (16 miles) Elevation Grade: -046 Horizon Grade: +009 Zoom: 1X Brush Mountain 11651+00. Perimeter controls in place and functional.</p>

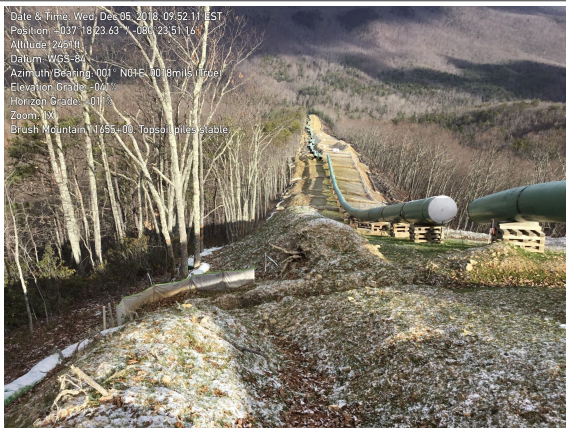
<p>Date &amp; Time: Wed, Dec 05, 2018, 09:52:11 EST Position: +037°18'23.63"N, -080°23'51.16"W Altitude: 226ft Datum: WGS-84 Azimuth/Bearing: 001° N04E 1008mils (16 miles) Elevation Grade: -046 Horizon Grade: +017 Zoom: 1X Brush Mountain 11655+00. Topsoil piles are stable.</p>

<b>GPS Location</b>	37.1164266625765, -80.4145903979246	<b>GPS Location</b>	37.1164266625765, -80.4145903979246		
<b>Description</b>	Correct coordinates on photo. Perimeter controls in place and functional.	<b>Description</b>	Correct coordinates on photo. Topsoil piles are stable. Vegetation minimal on some piles.

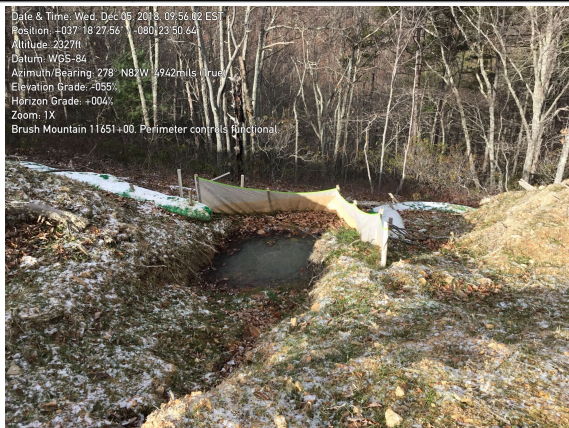
<p>Date &amp; Time: Wed, Dec 05, 2018, 09:56:02 EST Position: +037°18'27.56"N, -080°23'50.64"W Altitude: 232ft Datum: WGS-84 Azimuth/Bearing: 278° N82W 1942mils (16 miles) Elevation Grade: +059 Horizon Grade: +004 Zoom: 1X Brush Mountain 11651+00. Perimeter controls functional.</p>

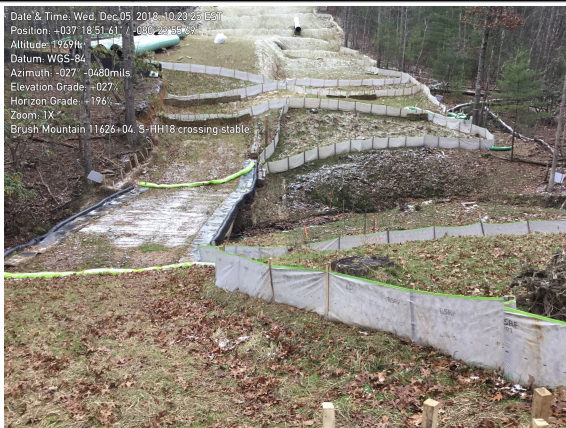
<p>Date &amp; Time: Wed, Dec 05, 2018, 10:23:05 EST Position: +037°18'51.61"N, -080°24'36.00"W Altitude: 1939ft Datum: WGS-84 Azimuth/Bearing: +027° 0480mils Elevation Grade: +027 Horizon Grade: +196 Zoom: 1X Brush Mountain 11626+04. S-HH18 crossing stable.</p>

<b>GPS Location</b>	37.1164266625765, -80.4145903979246	<b>GPS Location</b>	37.1168413991454, -80.4147948325429		
<b>Description</b>	Correct coordinates on photo. End treatments functional.	<b>Description</b>	Correct coordinates on photo. S-HH18 crossing is stable.

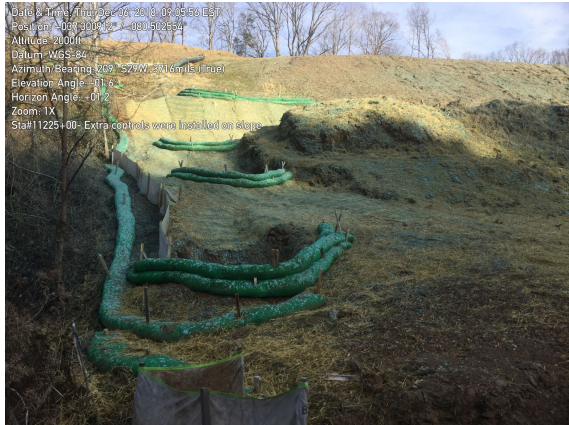
A/E	124300137	Date/Time	12/6/2018 6:26 AM	Report #	11789
Pictures					
<p>Date &amp; Time: Thu, Dec 06, 2018, 09:58:00 EST Position: +037.300934 102421 / -80.502604 0692632 Altitude: 2000ft Datum: WGS-84 Azimuth/Bearing: 019° S 29° W 1.1mils (True) Elevation Angle: -01.6° Horizon Angle: -01.2° Zoom: 1X Sta#11225+00- Extra controls were installed on slope.</p>

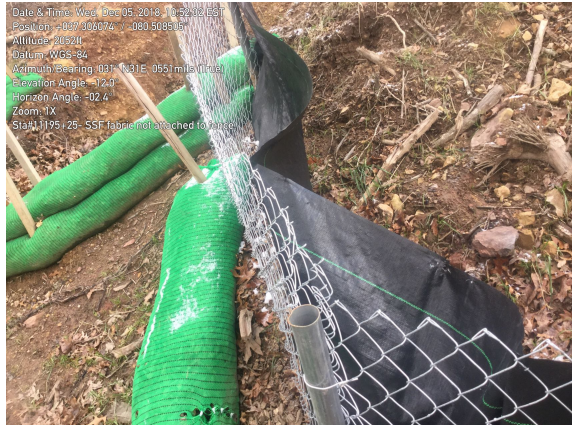
<p>Date &amp; Time: Wed, Dec 05, 2018, 10:24:10 EST Position: +037.306822 30558 / -80.512591 7774444 Altitude: 1029ft Datum: WGS-84 Azimuth/Bearing: 031° S 31° E 0.951mils (True) Elevation Angle: -02.4° Horizon Angle: -02.4° Zoom: 1X Sta#11195+25- SSF fabric not attached to fence.</p>

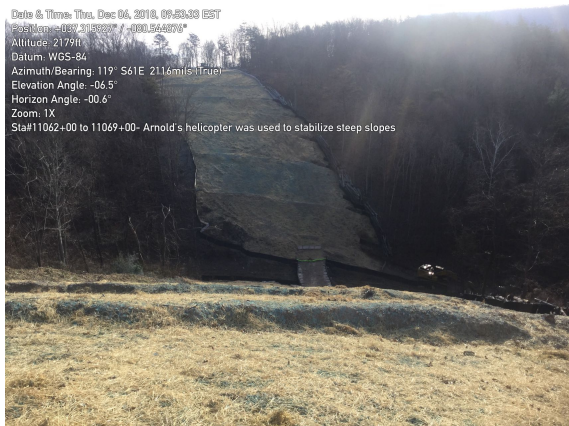
GPS Location	37.300934102421, -80.5026040692632	GPS Location	37.30682230558, -80.5125917774444		
Description	Sta#11225+00- Extra controls were installed on slope.	Description	Sta#11195+25- SSF fabric is detached from fence		
<p>Date &amp; Time: Thu, Dec 06, 2018, 09:58:00 EST Position: +037.315927 1479 / -80.544875 6833379 Altitude: 2179ft Datum: WGS-84 Azimuth/Bearing: 119° S 61° E 211.6mils (True) Elevation Angle: -06.5° Horizon Angle: -00.6° Zoom: 1X Sta#11062+00 to 11069+00- Arnold's helicopter was used to stabilize steep slopes</p>

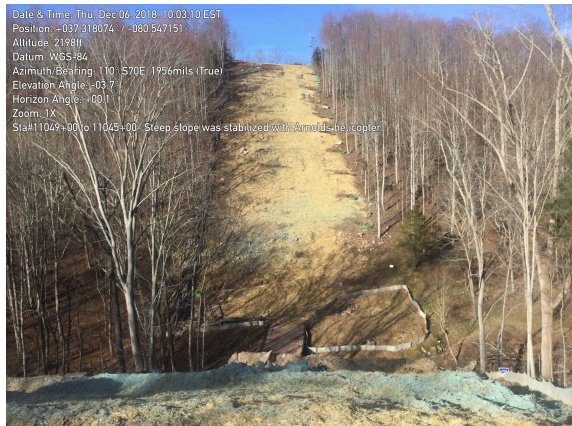
<p>Date &amp; Time: Thu, Dec 06, 2018, 10:03:10 EST Position: +037.318050 1582449 / -80.547153 2140677 Altitude: 2198ft Datum: WGS-84 Azimuth/Bearing: 110° S 70° E 199.6mils (True) Elevation Angle: -03.7° Horizon Angle: -00.1° Zoom: 1X Sta#11049+00 to 11045+00- Steep slope was stabilized with Arnold's helicopter.</p>

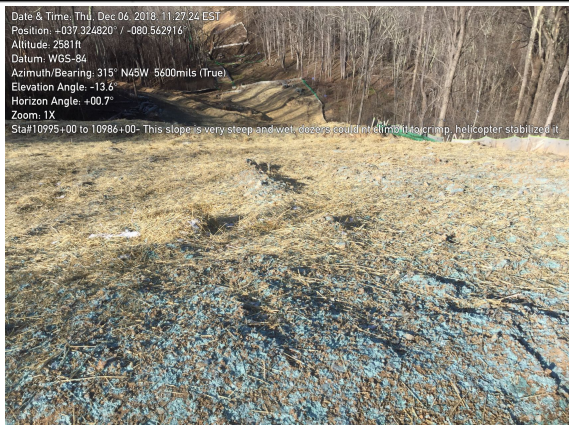
GPS Location	37.3159271479, -80.5448756833379	GPS Location	37.3180501582449, -80.5471532140677		
Description	Sta#11062+00 to 11069+00- Helicopter was used to stabilize steep slopes instead of dozer crimping.	Description	Sta#11049+00 to 11045+00- Steep slope was stabilized with Arnold's helicopter.		
<p>Date &amp; Time: Thu, Dec 06, 2018, 11:27:24 EST Position: +037.324834 3030338 / -80.562922 4237805 Altitude: 2581ft Datum: WGS-84 Azimuth/Bearing: 315° N 45° W 560.0mils (True) Elevation Angle: -13.6° Horizon Angle: +00.7° Zoom: 1X Sta#10995+00 to 10986+00- This slope is very steep and wet, dozers could not do the crimping, helicopter stabilized it.</p>

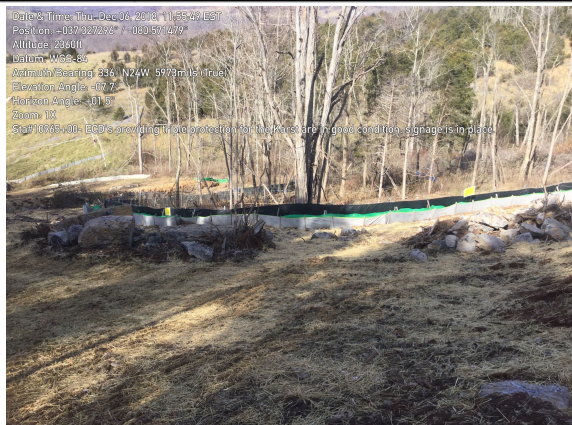
<p>Date &amp; Time: Thu, Dec 06, 2018, 11:35:49 EST Position: +037.327396 6927429 / -80.571283 5398322 Altitude: 2940ft Datum: WGS-84 Azimuth/Bearing: 88.6° N 24° W 59.9mils (True) Elevation Angle: -07.2° Horizon Angle: -01.1° Zoom: 1X Sta#10965+00- ECD's protecting Karst are in good condition.</p>

GPS Location	37.3248343030338, -80.5629224237805	GPS Location	37.3273966927429, -80.5712835398322		
Description	Sta#10995+00 to 10986+00- helicopter stabilization on steep wet slope.	Description	Sta#10965+00- ECD's protecting Karst are in good condition.

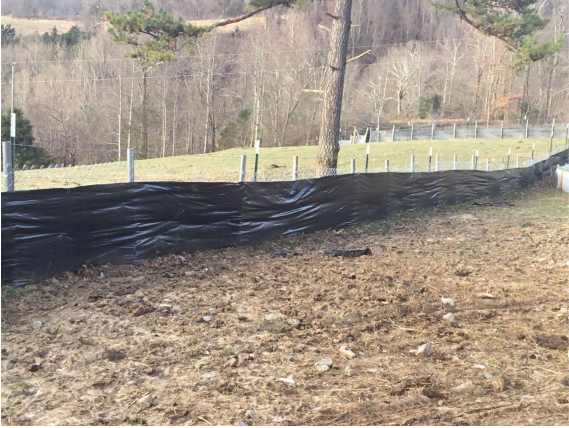
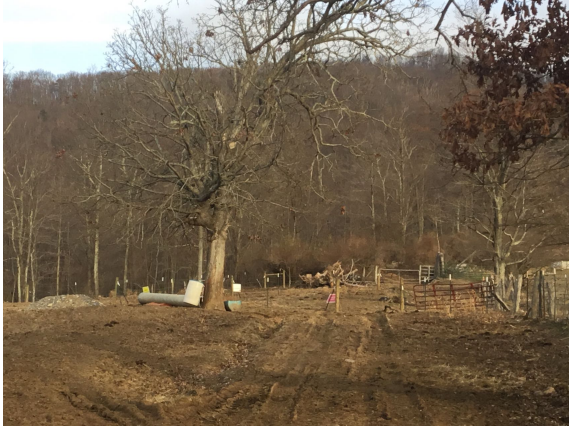
<b>GPS Location</b>	37.3752280651008, -80.6792926602817	<b>GPS Location</b>	37.3756028199916, -80.6794502400613		
<b>Description</b>	ATWS and Access 234 10511+00 no Issues	<b>Description</b>	Access 234 10510+50 culture access disturbance by land owners Mp 198.9

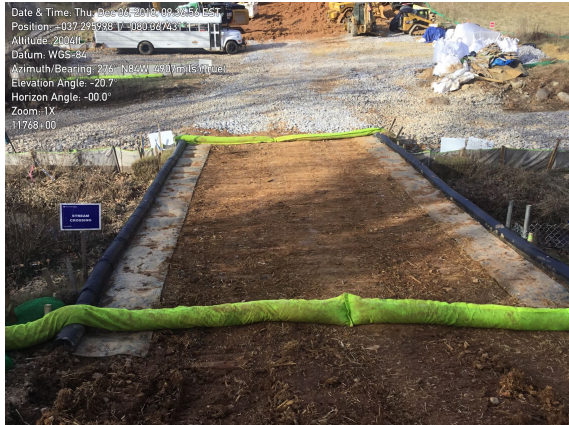
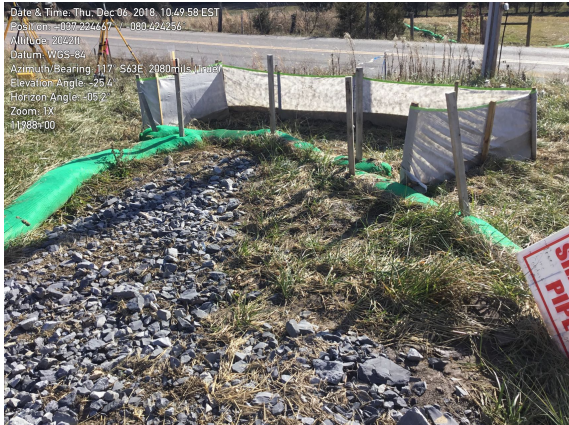
GPS Location	37.333838775829, -80.750223569969	GPS Location	37.3338260246116, -80.7503225052199		
Description	11768+00 bridge cleaned of mud	Description	Culvert outlet protection 11988+00

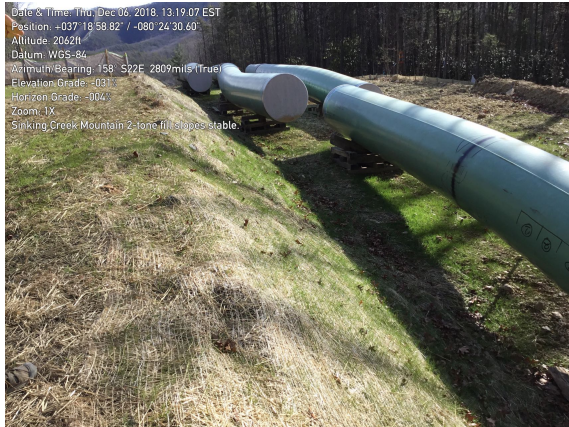
A/E	124300137	Date/Time	12/6/2018 4:15 PM	Report #	11821
Pictures					
<p>Date &amp; Time: Thu, Dec 06, 2018, 13:19:07 EST Position: +037°18'58.82" / -080°24'30.60" Altitude: 2062ft Datum: WGS-84 Azimuth/Bearing: 158° S28E 2809mils (True) Elevation Grade: +031° Horizon Grade: +004° Zoom: 1X Sinking Creek Mountain 2-tone fill slopes stable.</p>

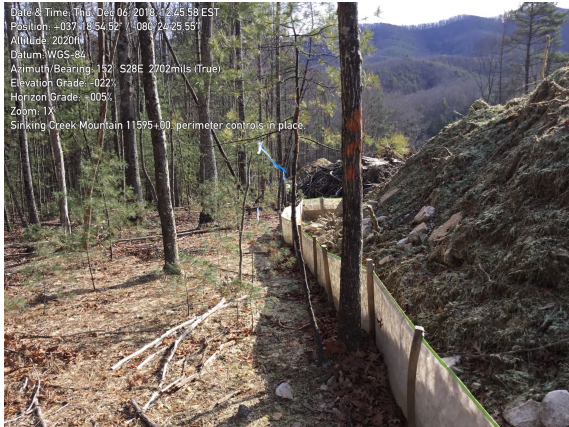
<p>Date &amp; Time: Thu, Dec 06, 2018, 13:25:59 EST Position: +037°18'54.92" / -080°24'25.55" Altitude: 2020ft Datum: WGS-84 Azimuth/Bearing: 152° S28E 2702mils (True) Elevation Grade: +022° Horizon Grade: +005° Zoom: 1X Sinking Creek Mountain 11595+00 perimeter controls in place.</p>

GPS Location	37.1330994414511, -80.3943735827509	GPS Location	37.1330994414511, -80.3943735827509		
Description	Correct coordinates on photo. Sinking Creek Mountain. Erosion blanket on 2-tone areas are stable.	Description	Correct coordinates on photo. Sinking Creek Mountain. Perimeter controls are in place.

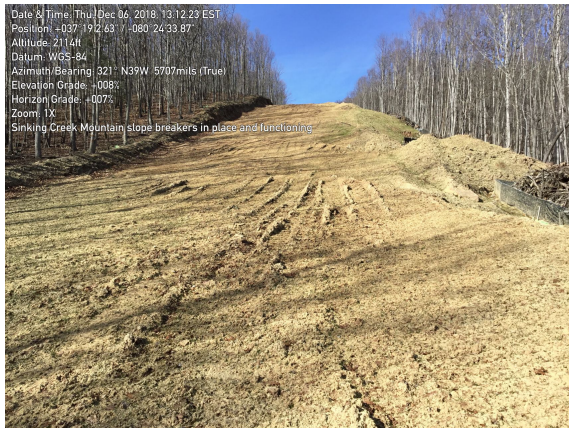
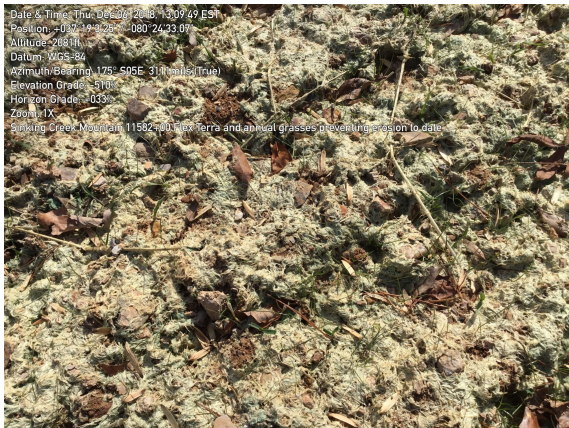
<p>Date &amp; Time: Thu, Dec 06, 2018, 13:09:49 EST Position: +037°18'54.92" / -080°24'33.87" Altitude: 2081ft Datum: WGS-84 Azimuth/Bearing: 175° S05E 3111mils (True) Elevation Grade: +510° Horizon Grade: +033° Zoom: 1X Sinking Creek Mountain 11582+00 low terra and annual grasses preventing erosion to date.</p>

GPS Location	37.1330471802849, -80.3944957070801	GPS Location	37.1330471802849, -80.3944957070801		
Description	Correct coordinates on photo. Sinking Creek Mountain. Slope breakers in place. Hydro mulch and grasses controlling sediment movement.	Description	Correct coordinates on photo. Sinking Creek Mountain. Grasses are sparse and appear stunted by cold weather.

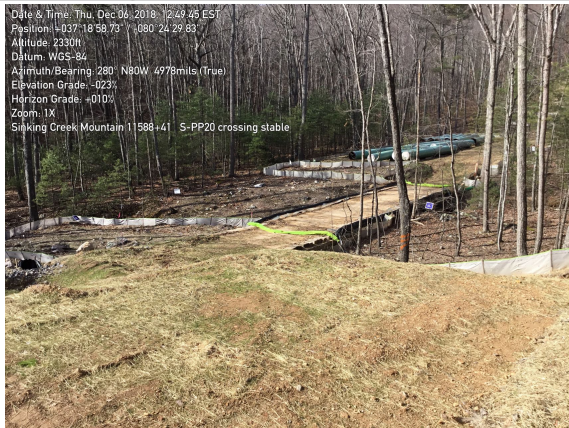
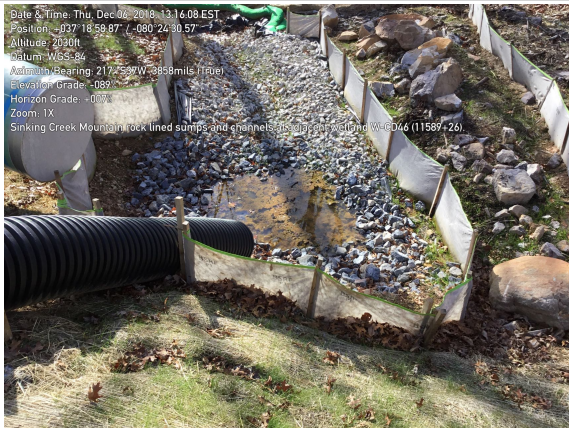
<p>Date &amp; Time: Thu, Dec 06, 2018, 13:14:08 EST Position: +037°18'58.97" / -080°24'30.57" Altitude: 2020ft Datum: WGS-84 Azimuth/Bearing: 217° S39W 3858mils (True) Elevation Grade: +089° Horizon Grade: +007° Zoom: 1X Sinking Creek Mountain rock lined sumps and channels for stormwater W-046 (11589+26).</p>

GPS Location	37.1330471802849, -80.3944957070801	GPS Location	37.1330471802849, -80.3944957070801		
Description	Correct coordinates on photo. Sinking Creek Mountain. Resources show no impact.	Description	Correct coordinates on photo. Sinking Creek Mountain. ECDs in place and functioning.
