# Visual Site Inspection Report

<b>Project Name</b>	H-600 Pipeline Spread G	<b>AFE</b>	124300137	<b>Spread</b>	H-600 Pipeline Spread G	
<b>Contractor</b>	Precision			<b>Report #</b>	12568	
<b>Inspector</b>	Brian Shields			<b>Date/Time</b>	1/2/2019 12:03 PM	
<b>Permit #</b>	TBD	<b>Inspection Type</b>	VA SWPP	<b>Station Begin</b>	+0	
<b>State</b>	VA	<b>Inspection Area</b>	Partial	<b>Station End</b>	+0	
<b>County</b>	Giles	<b>Ground</b>	Damp	<b>Temperature (°F)</b>	46.00	
<b>Municipality</b>	N/A	<b>Weather</b>	Cloudy	<b>Rain Gauge (in)</b>	0.00	
<b>GPS Location</b>	37.3631716613074, -80.6766270474351			<b>Rain Accumulation Time (days)</b>	1.00

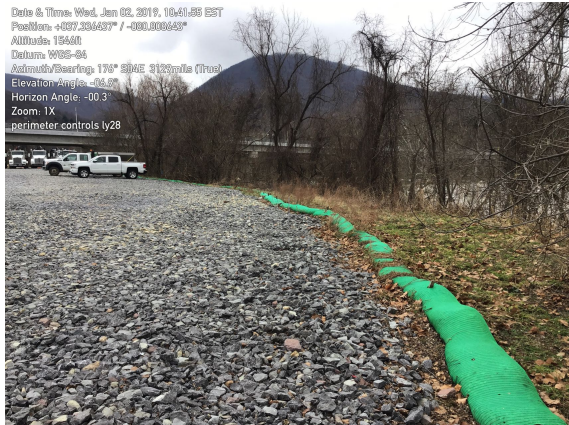
<b>AFE</b>	124300137	<b>Date/Time</b>	1/2/2019 12:03 PM	<b>Report #</b>	12568
<b>Pictures</b>					
<p>Date &amp; Time: Wed, Jan 02, 2019, 10:41:55 EST Position: +437.334437° / -80.677234° Altitude: 1554ft Datum: WGS-84 Azimuth/Bearing: 179° S84E 3123mils (True) Elevation Angle: -04.5° Horizon Angle: -00.3° Zoom: 1X perimeter controls ly28</p>

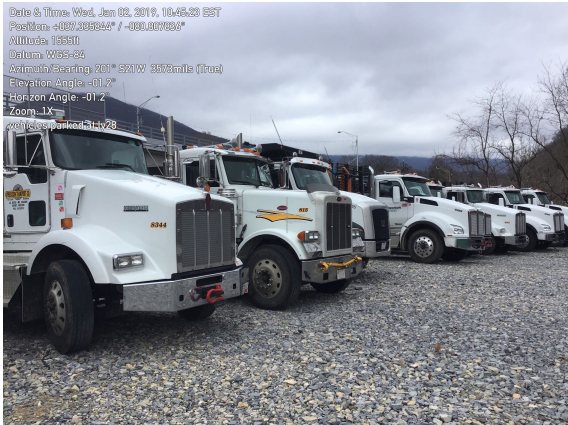
<p>Date &amp; Time: Wed, Jan 02, 2019, 10:45:33 EST Position: +437.335244° / -80.677234° Altitude: 1553ft Datum: WGS-84 Azimuth/Bearing: 201° S20W 3302mils (True) Elevation Angle: -01.2° Horizon Angle: -01.2° Zoom: 1X perimeter controls ly28</p>

<b>GPS Location</b>	37.3621323472237, -80.677234735415	<b>GPS Location</b>	37.3622082034474, -80.6772632338858		
<b>Description</b>	Perimeter controls installed along ly28	<b>Description</b>	Staged vehicles at ly28		
<p>Date &amp; Time: Wed, Jan 02, 2019, 11:04:16 EST Position: +437.318530° / -80.677234° Altitude: 1800ft Datum: WGS-84 Azimuth/Bearing: 080° N80E 1422mils (True) Elevation Angle: -05.9° Horizon Angle: -02.1° Zoom: 1X fuel storage ly26</p>

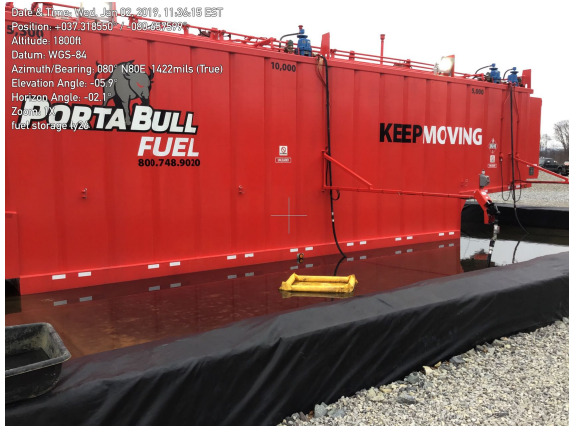
<b>GPS Location</b>	37.3622133164083, -80.6773032155639	<b>GPS Location</b>	37.362090772984, -80.6772421953088		
<b>Description</b>	Fuel storage at ly26	<b>Description</b>	Perimeter controls at ly26		
<p>Date &amp; Time: Wed, Jan 02, 2019, 11:50:14 EST Position: +437.262455° / -80.677234° Altitude: 1497ft Datum: WGS-84 Azimuth/Bearing: 044° N44E 1133mils (True) Elevation Angle: -00.5° Horizon Angle: -07.0° Zoom: 1X perimeter controls ly29</p>

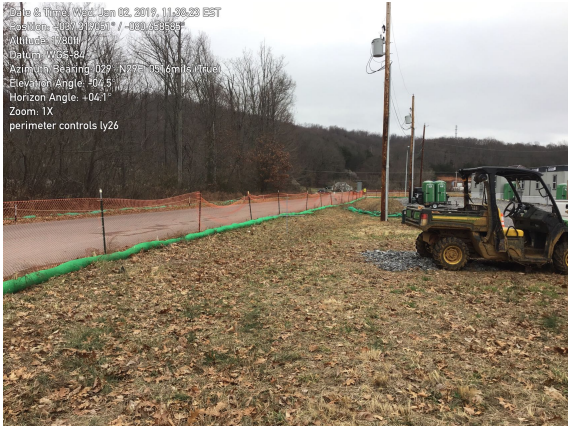
<p>Date &amp; Time: Wed, Jan 02, 2019, 11:06:33 EST Position: +437.318530° / -80.677234° Altitude: 1800ft Datum: WGS-84 Azimuth/Bearing: 029° N79E 1422mils (True) Elevation Angle: -04.5° Horizon Angle: +04.1° Zoom: 1X perimeter controls ly26</p>

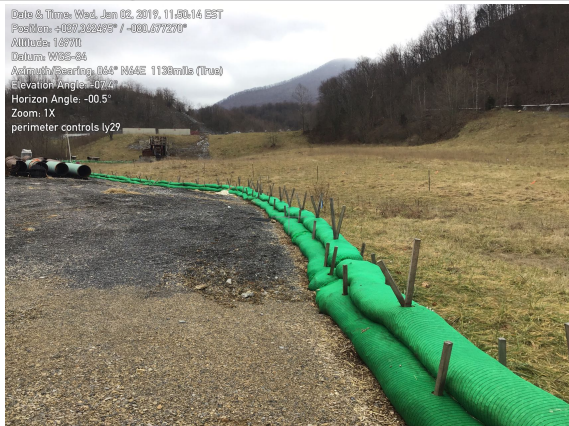
<b>GPS Location</b>	37.3621639050891, -80.6771858689195	<b>GPS Location</b>	37.3621155834173, -80.6771466416127		
<b>Description</b>	Perimeter controls at ly29	<b>Description</b>	LY29 rock and perimeter controls

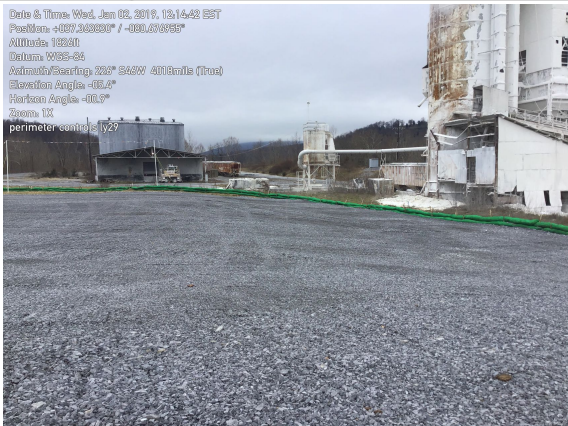
<p>Date &amp; Time: Wed, Jan 02, 2019, 12:14:42 EST Position: +437.263320° / -80.677234° Altitude: 1493ft Datum: WGS-84 Azimuth/Bearing: 323° S43W 4016mils (True) Elevation Angle: -02.4° Horizon Angle: -00.5° Zoom: 1X perimeter controls ly29</p>

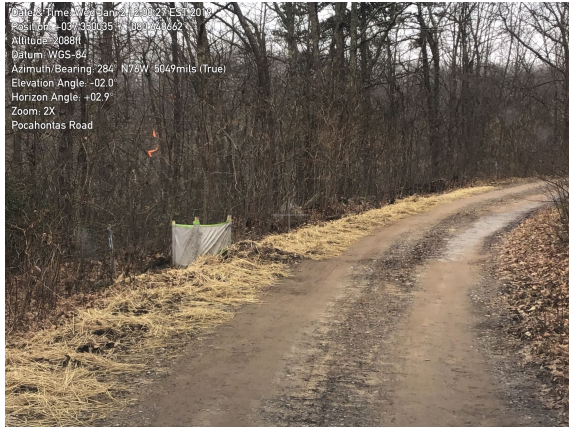
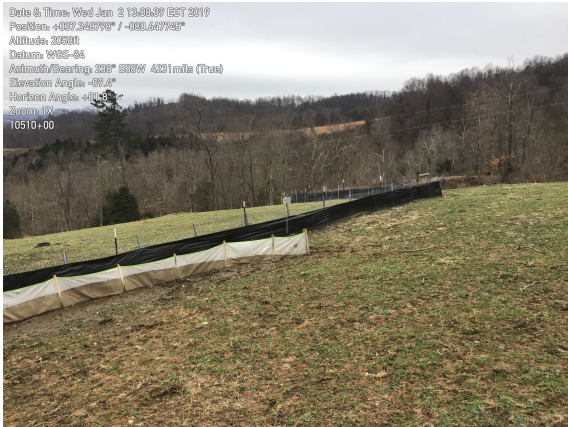
GPS Location	37.3193795797184, -80.6577700125065	GPS Location	37.3194079270793, -80.6577539730327		
Description	Pocahontas Road waterbar and end treatment in place.	Description	See photo for GPS location and station number. Reinforced silt fence in place.

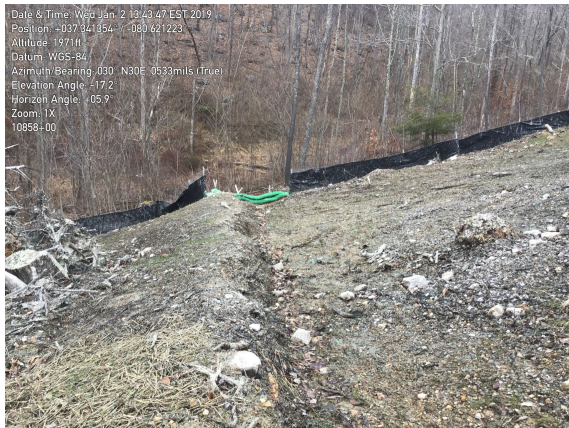
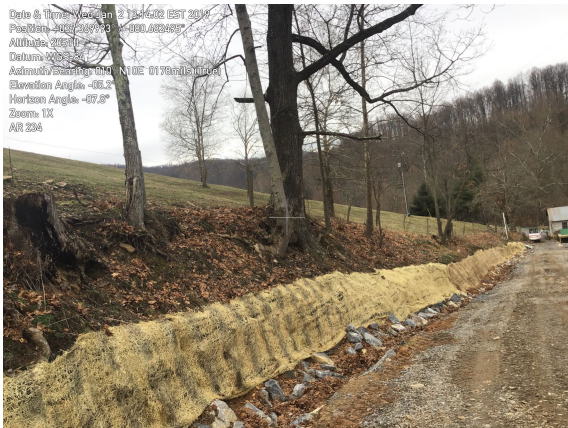
GPS Location	37.319413878205, -80.6577486445865	GPS Location	37.3194136647882, -80.6577488361883		
Description	See photo for GPS location and station number. Water bar and end treatment in place.	Description	See photo for GPS location and station number. Erosion control blanket and rock filter in ditch along AR234.

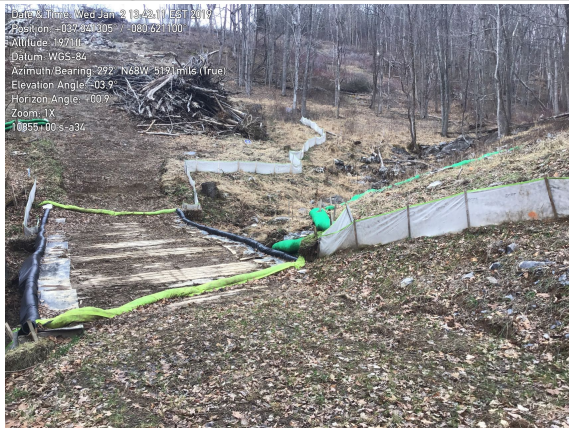
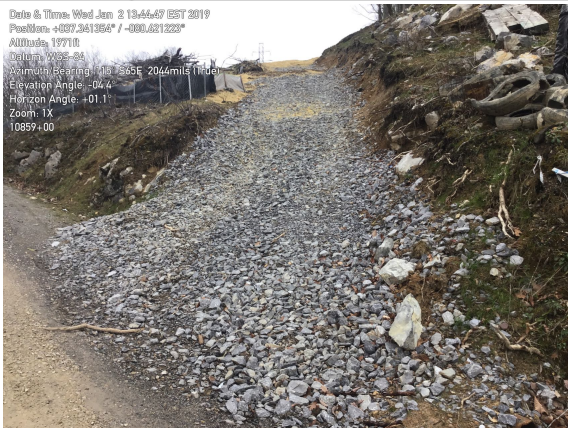
GPS Location	37.3194092674641, -80.6577526421375	GPS Location	37.3194119700796, -80.6577364636265		
Description	See photo for GPS location and station number. 50 foot buffer in place with ECDs required.	Description	See photo for GPS location and station number. RCE at Kow Camp Road.

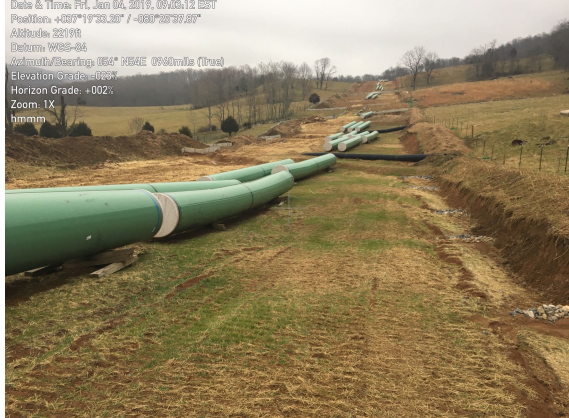
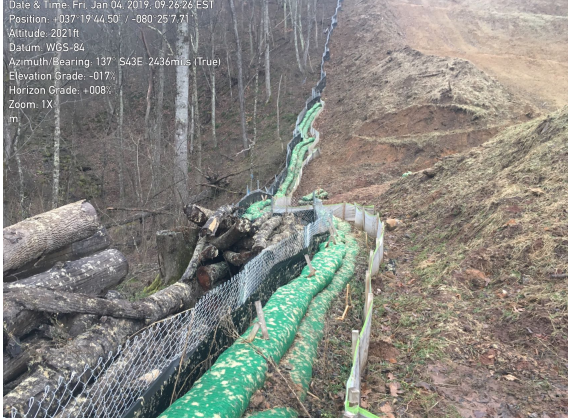
GPS Location	37.2427848168064, -80.4290842172507	GPS Location	37.2429346014161, -80.4293733929102		
Description	Row conditions @ MP 218	Description	Row conditions and ECD's @ MP 218.5		
<p>Date &amp; Time: Fri, Jan 04, 2019, 10:04:10 EST Position: +037°19'45.90" / -080°24'44.55" Altitude: 2200ft Datum: WGS-84 Azimuth/Bearing: 174° 504E 2193mils (True) Elevation/Grade: -052% Horizon Grade: +012% Zoom: 1X 1156</p>

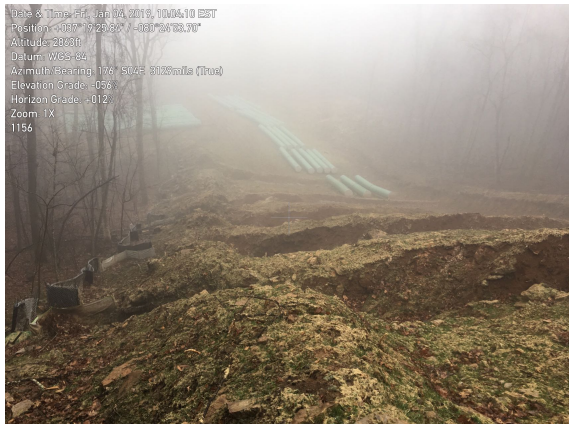
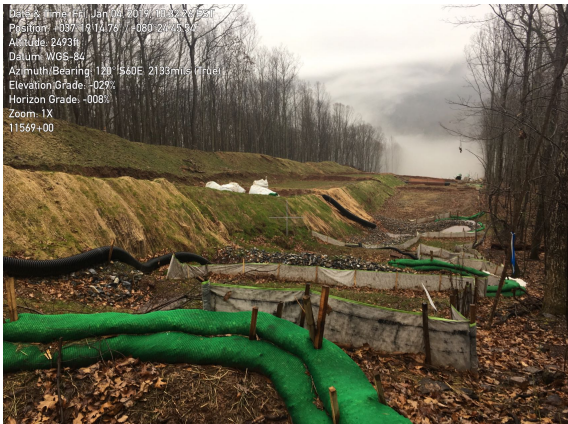
GPS Location	37.2430328373213, -80.4294093512748	GPS Location	37.2429940291096, -80.4293604009602		
Description	Row conditions and ECD's @ MP 219	Description	Row conditions and ECD's @ MP 219		
<p>Date &amp; Time: Fri, Jan 04, 2019, 10:31:32 EST Position: +037°19'45.90" / -080°24'44.55" Altitude: 2200ft Datum: WGS-84 Azimuth/Bearing: 036° 556W 4196mils (True) Elevation/Grade: +105% Horizon Grade: +012% Zoom: 2X 11569+00</p>

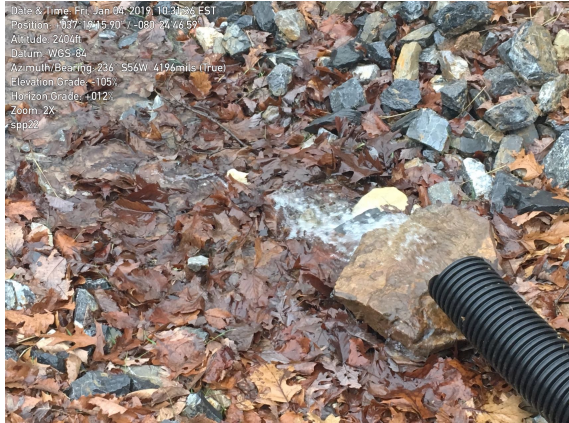
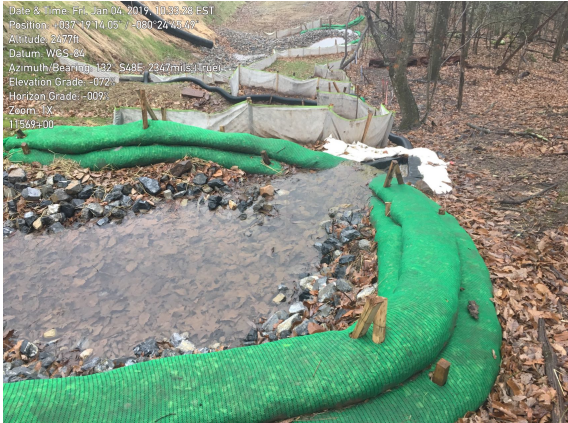
GPS Location	37.2429542150695, -80.4293155577783	GPS Location	37.2427289095123, -80.4293397814784		
Description	Clean water discharging off ROW @ s#pp22	Description	ECD's functioning properly @ MP 219.5

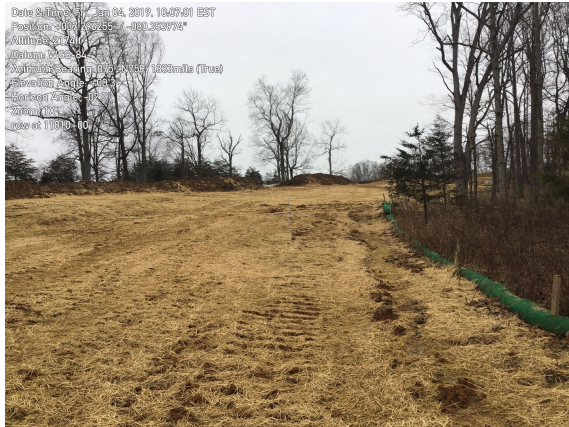
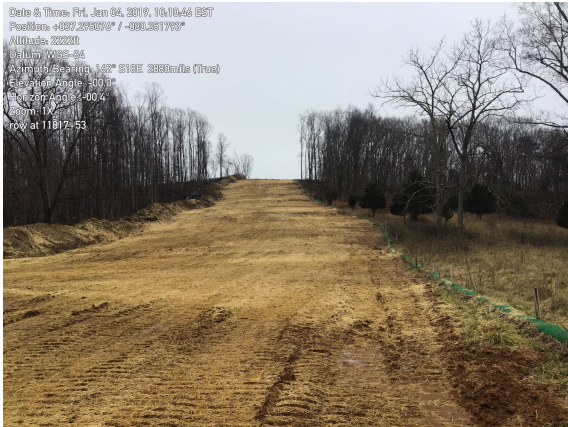
GPS Location	37.1360846562657, -80.3941228800271	GPS Location	37.1360846562657, -80.3941228800271		
Description	Temporary stabilization at 11810+00	Description	Temporary stabilization at 11817+53		
<p>Date &amp; Time: Fri, Jan 04, 2019, 10:41:12 EST Position: +037.265917° / -080.346736° Altitude: 2172ft Datum: WGS-84 Azimuth/Bearing: 120° S60E 213mils (True) Elevation Angle: +09.4° Horizon Angle: -00.4° Zoom: 2X permanent waterbar and level spreader 11863+00</p>

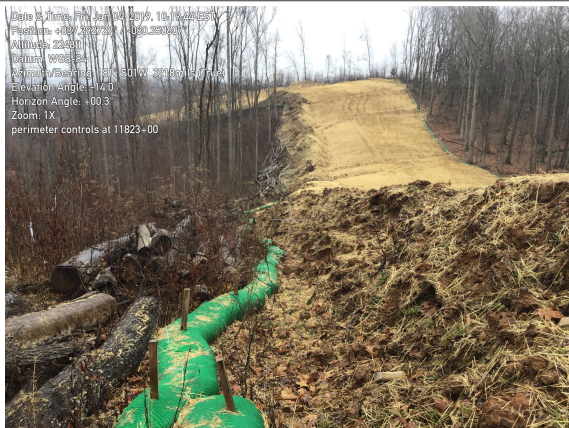
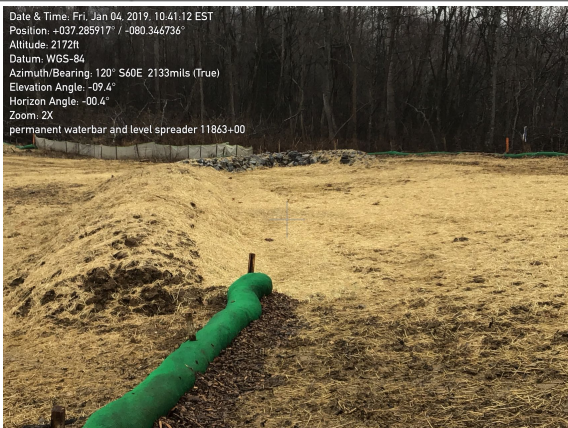
GPS Location	37.1360846562657, -80.3941228800271	GPS Location	37.1360846562657, -80.3941228800271		
Description	Perimeter controls at 11823+00	Description	Permanent waterbar and level spreader at 11863+00		
<p>Date &amp; Time: Fri, Jan 04, 2019, 11:15:16 EST Position: +037.265657° / -080.3941228° Altitude: 2037ft Datum: WGS-84 Azimuth/Bearing: 225° S25W 425mils (True) Elevation Angle: +01.5° Horizon Angle: +01.5° Zoom: 1X permanent waterbar and level spreader 11907+00</p>

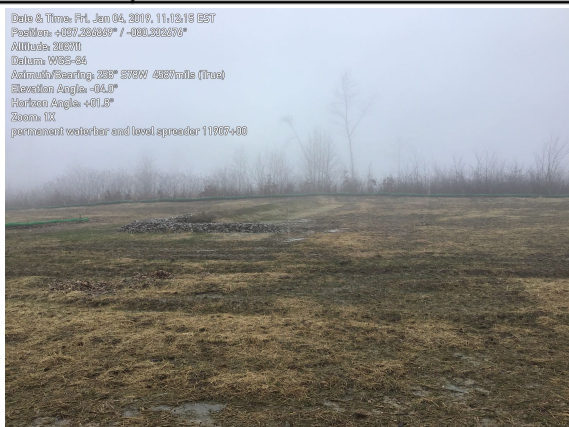
GPS Location	37.1361290972051, -80.3942011154601	GPS Location	37.1361215306366, -80.3942072242342		
Description	Permanent waterbar and level spreader at 11907+00	Description	Logging activity at 11918 causing rutting within final stabilization

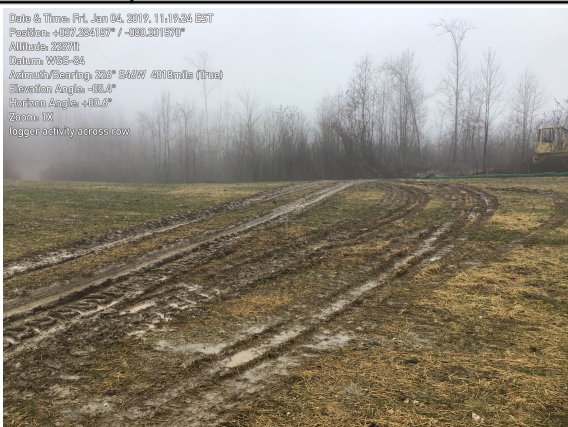
<p>Date &amp; Time: Fri, Jan 04, 2019, 11:19:24 EST Position: +037.264187° / -080.3942072° Altitude: 2237ft Datum: WGS-84 Azimuth/Bearing: 225° S25W 401mils (True) Elevation Angle: +01.5° Horizon Angle: +01.5° Zoom: 1X logging activity across row</p>
