Visual Site Inspection Report

Project Name	H-600 Pipeline Spread G	AFE	124300137	Spread	H-600 Pipeline Spread G
Contractor	Precision			Report #	12952
Inspector	Len Kruizenga			Date/Time	1/14/2019 8:40 AM
Permit #	TBD	Inspection Type	VA SWPP	Station Begin	10311+28
State	WV	Inspection Area	Full	Station End	10310+84
County	Monroe	Ground	Frozen	Temperature (°F)	30.00
Municipality	N/A	Weather	Cloudy	Rain Gauge (in)	0.00
GPS Location	37.3958897683752, -80.7932302305229			Rain Accumulation Time (days)	1.00

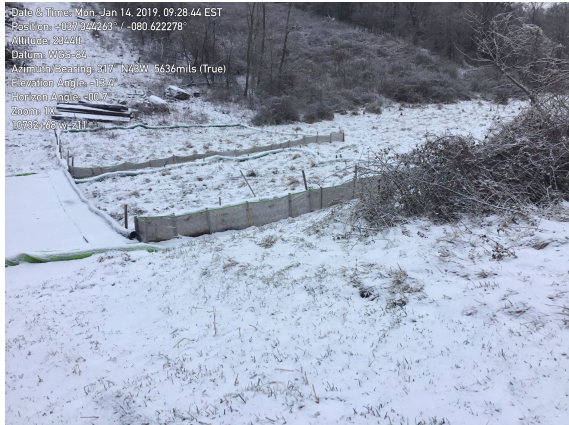
<p>Date & Time: Mon, Jan 14, 2019, 09:45:30 EST Position: +037.34377° / -080.643913° Altitude: 2024ft Datum: WGS-84 Azimuth/Bearing: 139.8° S18W 4944mils (True) Elevation Angle: +11.2° Horizon Angle: +0.0° Zoom: 1X 10713+13 S-G33</p>

GPS Location	37.3339001337826, -80.7501667929335		GPS Location	37.3339001337826, -80.7501667929335	
Description	10732+68 W-Z11 ECDs in good condition		Description	10713+13 S-G33 ECDs in good condition	
<p>Date & Time: Mon, Jan 14, 2019, 10:43:30 EST Position: +037.350241° / -080.658404° Altitude: 2041ft Datum: WGS-84 Azimuth/Bearing: 140.0° W45° 133mils (True) Elevation Angle: +21.6° Horizon Angle: +0.4° Zoom: 1X 10679+36 S-G30</p>

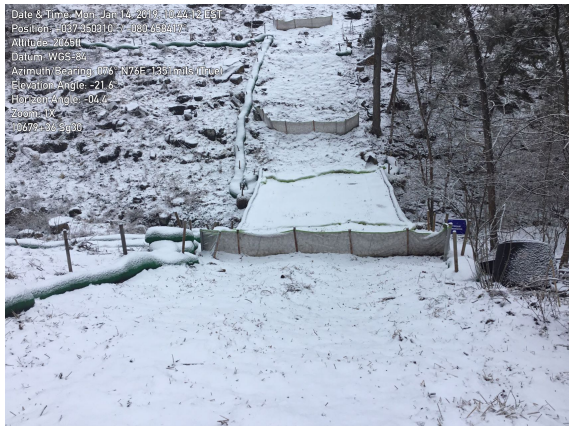
<p>Date & Time: Mon, Jan 14, 2019, 10:43:30 EST Position: +037.350241° / -080.658404° Altitude: 2041ft Datum: WGS-84 Azimuth/Bearing: 140.0° W45° 133mils (True) Elevation Angle: +21.6° Horizon Angle: +0.4° Zoom: 1X 10679+36 S-G30</p>

GPS Location	37.3339001337826, -80.7501667929335		GPS Location	37.3338999104612, -80.7501671586036	
Description	10679+36 S-G30 ECDs in good condition		Description	10679+00 ECDs in good condition	
<p>Date & Time: Mon, Jan 14, 2019, 10:54:55 EST Position: +037.349404° / -080.653530° Altitude: 2052ft Datum: WGS-84 Azimuth/Bearing: 136.5° S18W 3520mils (True) Elevation Angle: +27.5° Horizon Angle: -01.3° Zoom: 1X 10695+00</p>

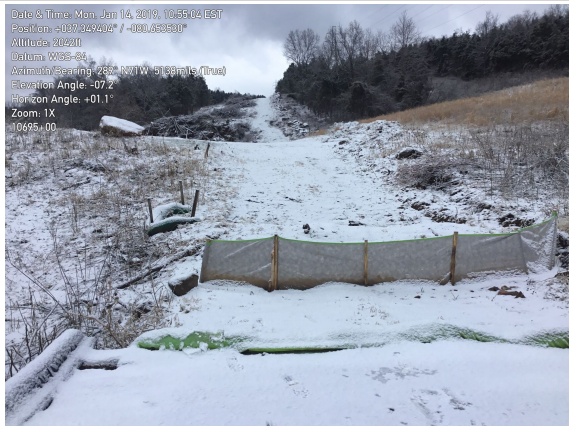
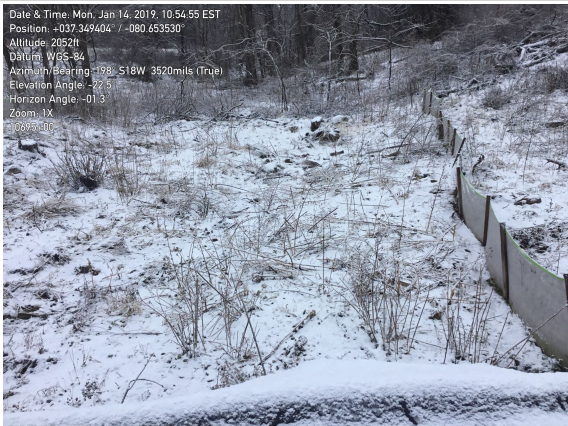
<p>Date & Time: Mon, Jan 14, 2019, 10:54:55 EST Position: +037.349404° / -080.653530° Altitude: 2052ft Datum: WGS-84 Azimuth/Bearing: 136.5° S18W 3520mils (True) Elevation Angle: +27.5° Horizon Angle: -01.3° Zoom: 1X 10695+00</p>

GPS Location	37.333904656788, -80.7501650311949		GPS Location	37.3339932271719, -80.7500871475934	
Description	10695+00 ECDs in good condition		Description	10695+00 ECDs in good condition

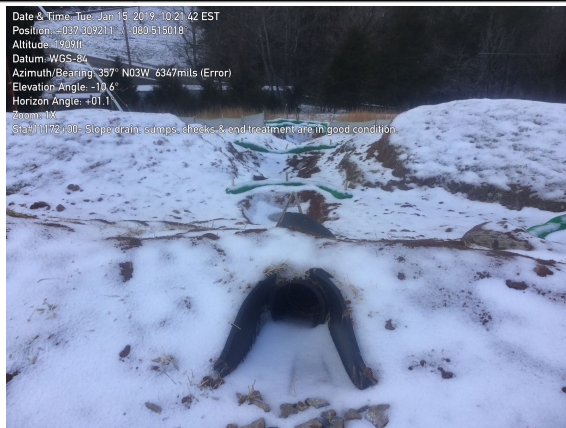
Description	Sta#11195+30- SSF fabric is detached from chain link fence.	Description	Sta#11172+00- Slope drain, sumps, checks & end treatment are in good condition.

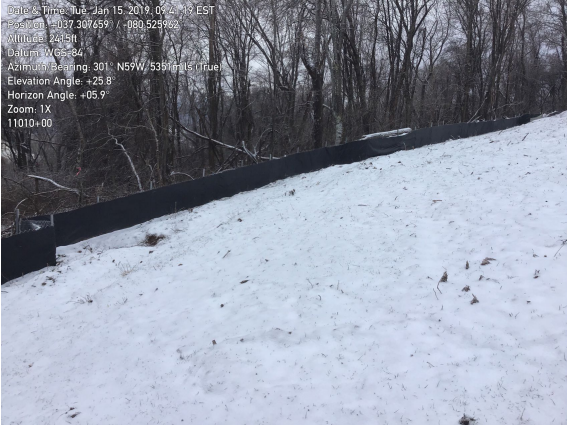
GPS Location	37.2061463514744, -80.3939147903751	GPS Location	37.206049809423, -80.3942687593498		
Description	See photo for station number and GPS location. Stream S-RR5 has sensitive resource buffer in place.	Description	See photo for station number and GPS location. Reinforce silt fence in place.

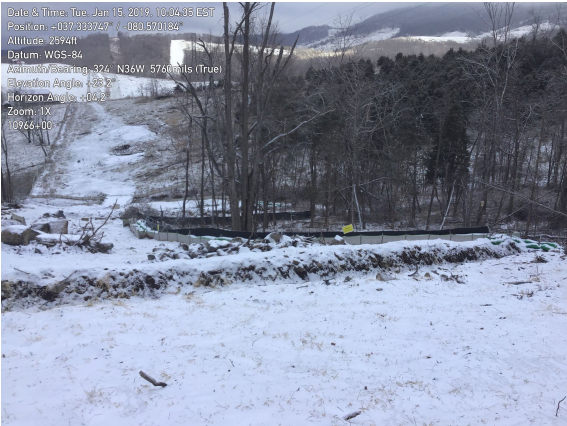
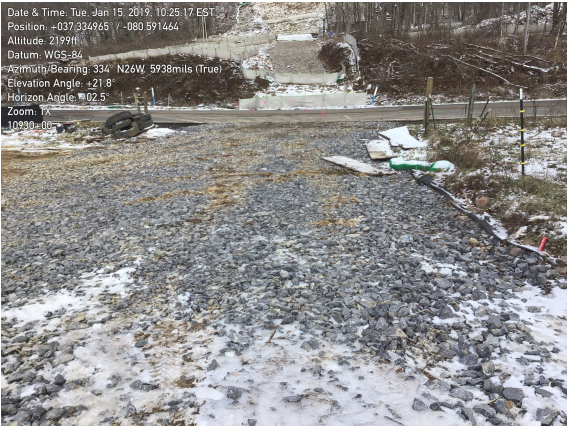
GPS Location	37.2061656229544, -80.3939028550688	GPS Location	37.2061316873448, -80.3941921977832		
Description	See photo for station number and GPS location. Triple barrier ECDs in place. Priority one silt fence, reinforced silt fence, and triple stack 18" CFS.	Description	See photo for station number and GPS location. RCE in place at Doe Creek Road crossing.

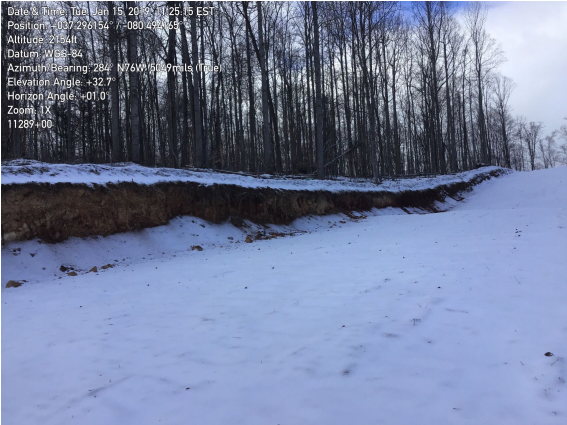
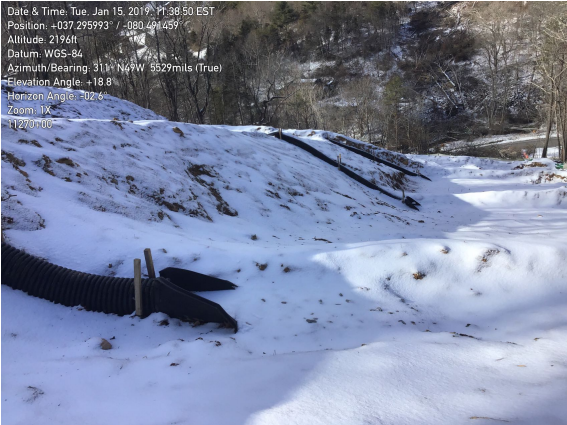
GPS Location	37.2061134700626, -80.3942131106924	GPS Location	37.2062130226169, -80.3939058725539		
Description	See photo for station number and GPS location. Clean water diversion berm in place along cut bank.	Description	See photo for station number and GPS location. Slope drains in place with rock inlets and outlets at two-tone.

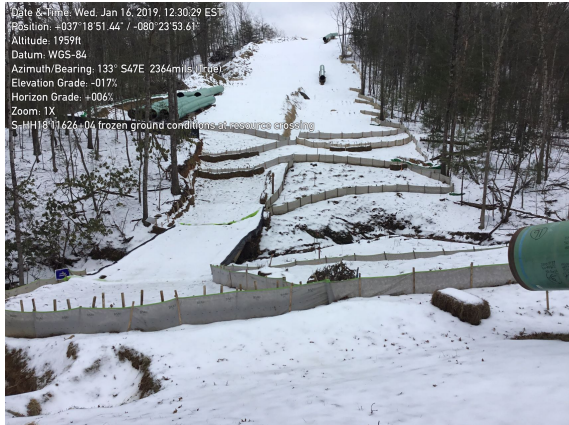
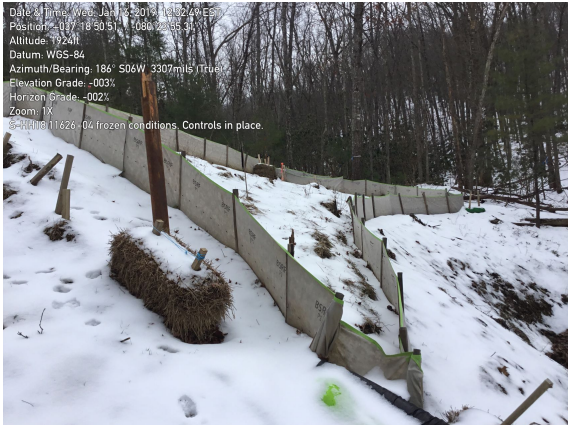
</div></div>		<div><div><div>Date & Time: Wed, Jan 16, 2019, 12:32:44 EST Position: +037°18'50.51" / -080°23'55.31" Altitude: 1924ft Datum: WGS-84 Azimuth/Bearing: 186° S06W 3307mils (True) Elevation Grade: -003% Horizon Grade: -002% Zoom: 1X S-HH18 11626-04 frozen conditions. Controls in place.</div>

</div></div>			
GPS Location	37.1329902, -80.39442642		GPS Location	37.1329902, -80.39442642	
Description	Correct coordinates on photo. S-HH18 crossing stable.		Description	Correct coordinates on photo. No issues with controls located. All appear functional.

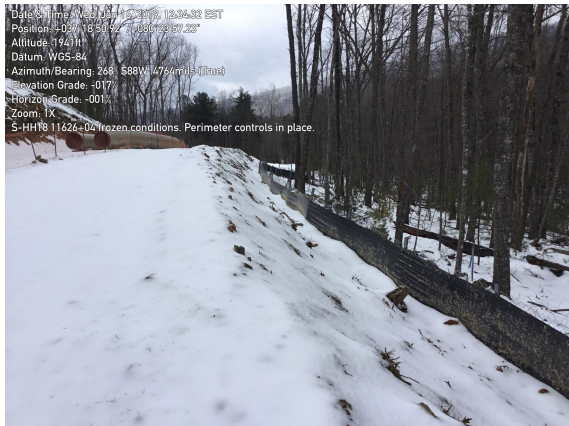
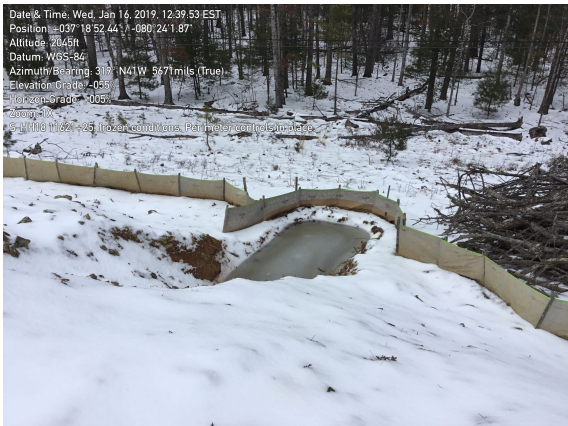
</div></div>		<div><div><div>Date & Time: Wed, Jan 16, 2019, 12:39:53 EST Position: +037°18'52.441" / -080°24'1.07" Altitude: 2045ft Datum: WGS-84 Azimuth/Bearing: 313° N41W 5471mils (True) Elevation Grade: -05% Horizon Grade: -005% Zoom: 1X S-HH18 11626-04 frozen conditions. Perimeter controls in place.</div>

</div></div>			
GPS Location	37.1331219468612, -80.3942869976912		GPS Location	37.1331040514979, -80.3944660351429	
Description	Correct coordinates on photo. Perimeter controls in place.		Description	Correct coordinates on photo. Perimeter controls in place.	
Insert image here		Insert image here

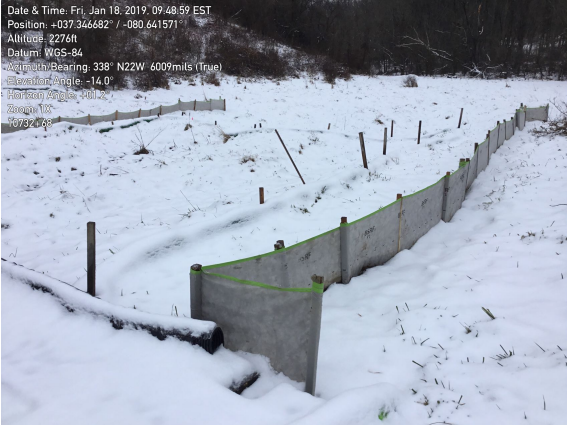
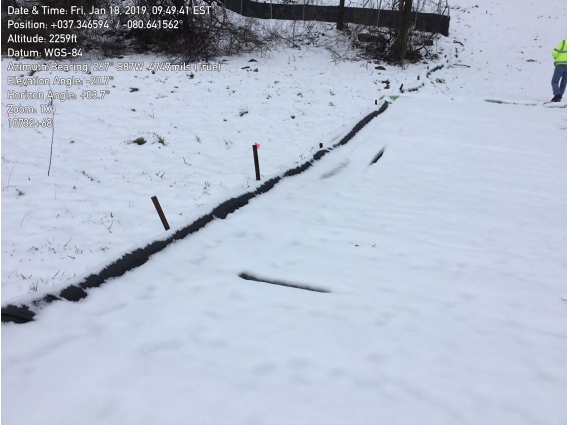
GPS Location	37.333906135046, -80.7501749793696	GPS Location	37.3339047540059, -80.7501798381014		
Description	10732+68 ECDs in good condition	Description	10732+00 ECDs in good condition

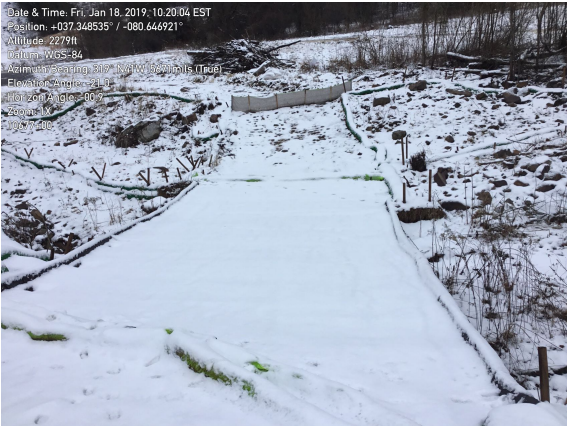
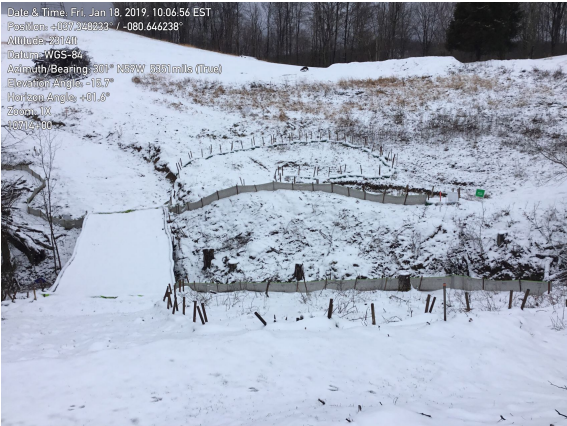
GPS Location	37.3339764782599, -80.7501122916084	GPS Location	37.3339764782599, -80.7501122916084		
Description	10677+00 ECDs in good condition	Description	10714+00 ECDs in good condition		
<p>Insert image here</p>

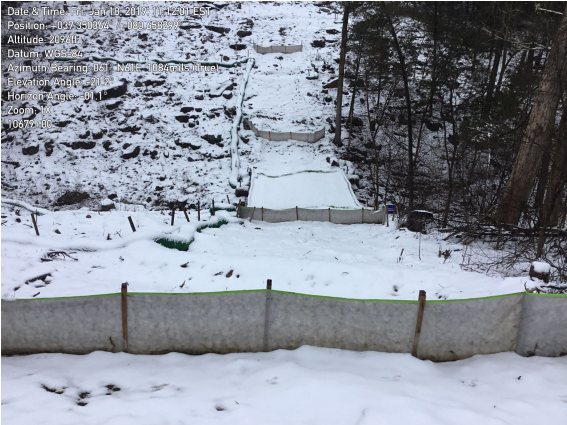
GPS Location		GPS Location	37.3339109892428, -80.7501776113228		
Description		Description	10679+00 ECDs in good condition
