Visual Site Inspection Report

Project Name	H-600 Pipeline Spread G	AFE	124300137	Spread	H-600 Pipeline Spread G
Contractor	Precision			Report #	13409
Inspector	Len Kruizenga			Date/Time	1/28/2019 7:06 AM
Permit #	TBD	Inspection Type	VA SWPP	Station Begin	11670+00
State	WV	Inspection Area	Full	Station End	11788+43
County	Monroe	Ground	Frozen	Temperature (°F)	30.00
Municipality	N/A	Weather	Cloudy	Rain Gauge (in)	0.00
GPS Location	37.2962808050563, -80.3611486405883			Rain Accumulation Time (days)	2.00

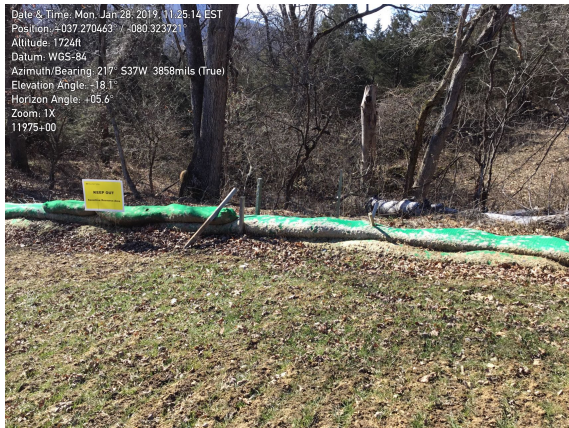
GPS Location	37.2958148131494, -80.3606097680334	GPS Location	37.2957706824292, -80.3608137835565		
Description	ECDs around karst feature 11975+00	Description	ECDs for karst protection 11950+00		
<p>Date & Time: Mon Jan 28 2019 13:42:01 EST Position: +037.268066 / -080.316639 Altitude: 1692ft Datum: WGS-84 Azimuth/Bearing: 118° S44E 204mils (True) Elevation Angle: -11.0 Horizon Angle: -01.7 Zoom: 1X 12002+00</p>

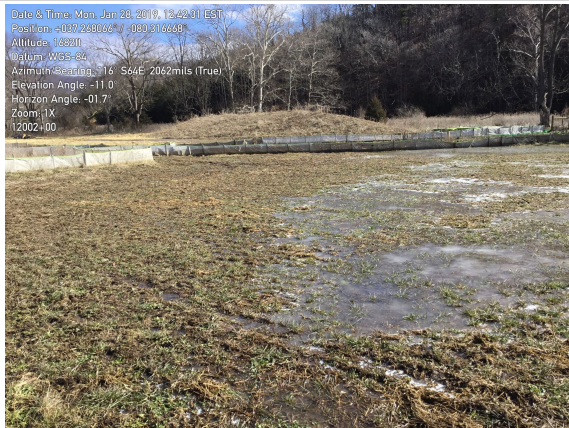
GPS Location	37.2957957443197, -80.3608630691472	GPS Location	37.2956368653451, -80.3609010391686		
Description	Wetland 12002+00	Description	11979+00 ECDs protecting karst feature

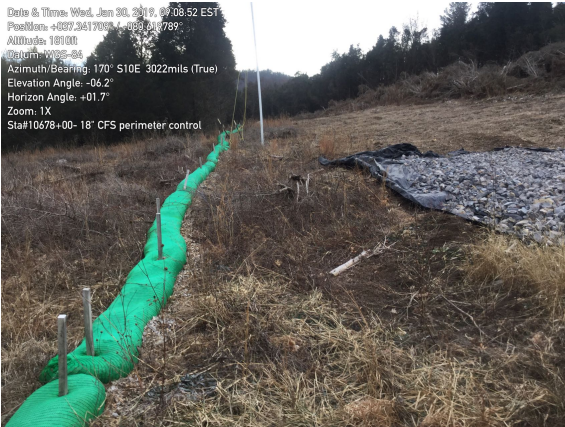
A/E	124300137	Date/Time	1/30/2019 7:02 AM	Report #	13479
Pictures					
<p>Date & Time: Wed, Jan 30, 2019, 09:08:52 EST Position: +037.361700° / -080.65789° Altitude: 1810ft Datum: WGS-84 Azimuth/Bearing: 170° S10E 3022mils (True) Elevation Angle: -06.2° Horizon Angle: +01.7° Zoom: 1X Sta#10670+00- 18" CFS perimeter control</p>

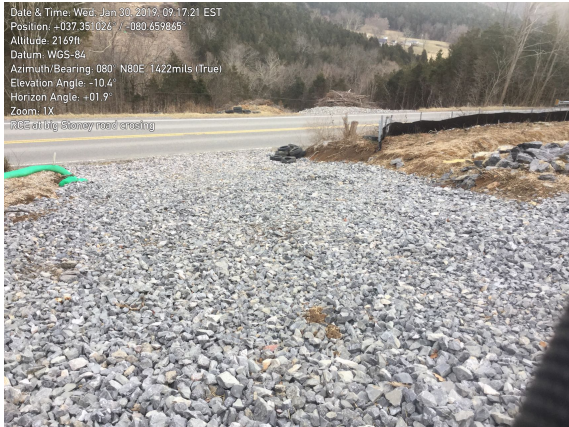
<p>Date & Time: Wed, Jan 30, 2019, 09:17:21 EST Position: +037.351024° / -080.659865° Altitude: 2169ft Datum: WGS-84 Azimuth/Bearing: 080° N80E 1422mils (True) Elevation Angle: -10.4° Horizon Angle: +01.9° Zoom: 1X RCE at Big Stoney Creek road crossing</p>

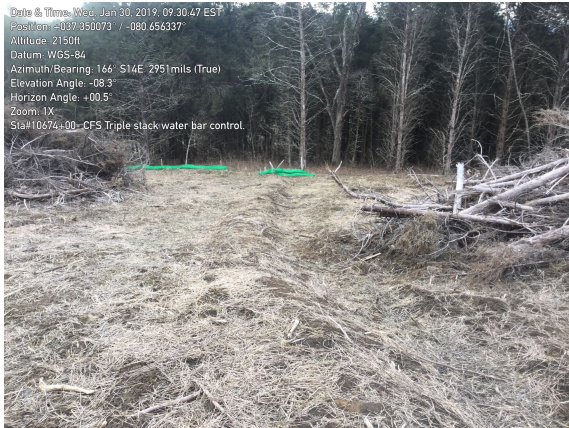
<p>Date & Time: Wed, Jan 30, 2019, 09:30:47 EST Position: +037.350073° / -080.656337° Altitude: 2150ft Datum: WGS-84 Azimuth/Bearing: 166° S14E 2951mils (True) Elevation Angle: -08.3° Horizon Angle: +00.5° Zoom: 1X Sta#10674+00- CFS Triple stack water bar control.</p>

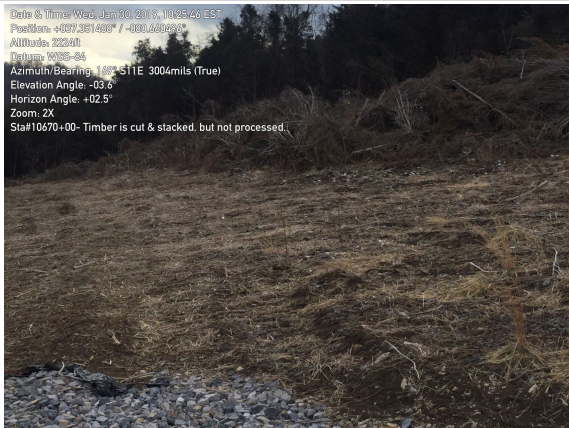
<p>Date & Time: Wed, Jan 30, 2019, 10:25:44 EST Position: +037.351488° / -080.650454° Altitude: 2224ft Datum: WGS-84 Azimuth/Bearing: 149° S11E 3004mils (True) Elevation Angle: -03.6° Horizon Angle: +02.5° Zoom: 2X Sta#10670+00- Timber is cut & stacked, but not processed.</p>

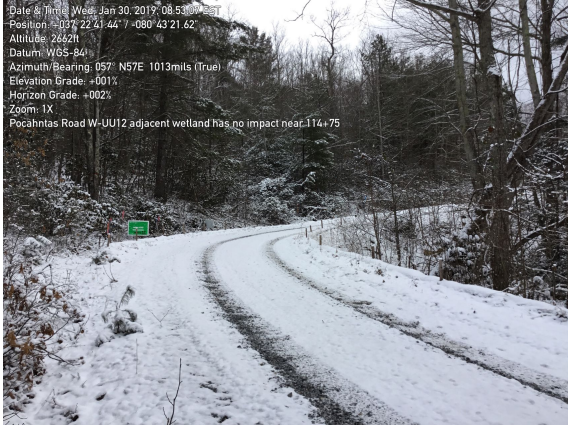
<p>Date & Time: Wed Jan 30, 2019, 08:53:00 EST Position: +037° 22' 41.44" / -080° 43' 21.62" Altitude: 2642ft Datum: WGS-84 Azimuth/Bearing: 857° N57E 1013mils (True) Elevation Grade: +001% Horizon Grade: +002% Zoom: 1X Pocahontas Road W-U12 adjacent wetland has no impact near 114+75</p>

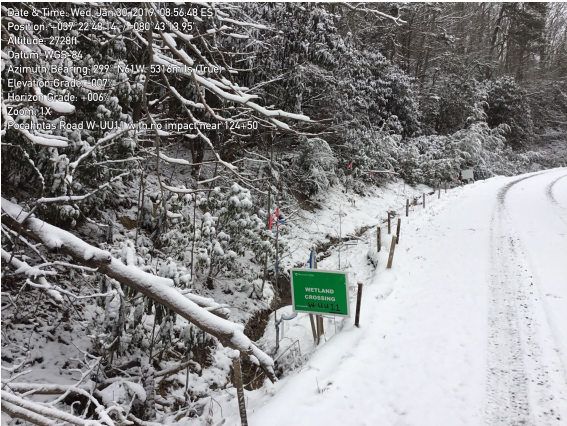
<p>Date & Time: Wed Jan 30, 2019, 09:05:49 EST Position: +037° 22' 50.02" / -080° 43' 19.86" Altitude: 2728ft Datum: WGS-84 Azimuth/Bearing: 092° N92W 531mils (True) Elevation Grade: +007% Horizon Grade: +006% Zoom: 1X Pocahontas Road W-U12 shows no impact near 124+50</p>

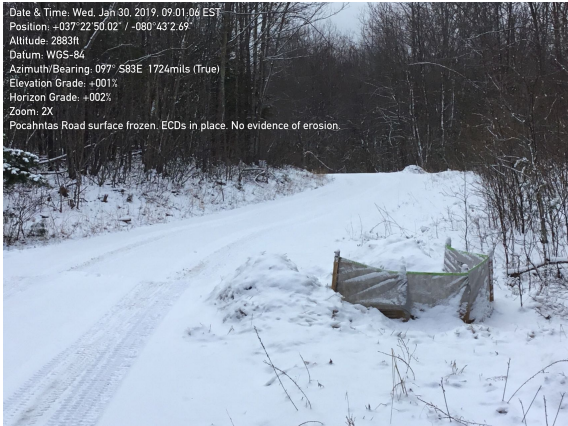
<p>Date & Time: Wed Jan 30, 2019, 09:01:06 EST Position: +037° 22' 50.02" / -080° 43' 2.69" Altitude: 2883ft Datum: WGS-84 Azimuth/Bearing: 097° S83E 1724mils (True) Elevation Grade: +001% Horizon Grade: +002% Zoom: 2X Pocahontas Road surface frozen. ECDs in place. No evidence of erosion.</p>

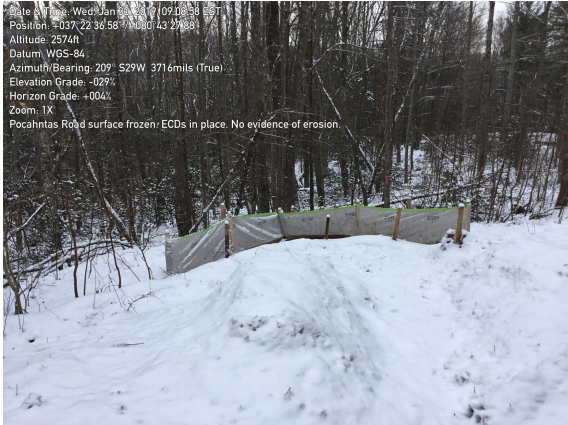
<p>Date & Time: Wed Jan 30, 2019, 09:08:38 EST Position: +037° 22' 36.56" / -080° 43' 27.68" Altitude: 2574ft Datum: WGS-84 Azimuth/Bearing: 209° S29W 3716mils (True) Elevation Grade: +029% Horizon Grade: +004% Zoom: 1X Pocahontas Road surface frozen; ECDs in place. No evidence of erosion.</p>

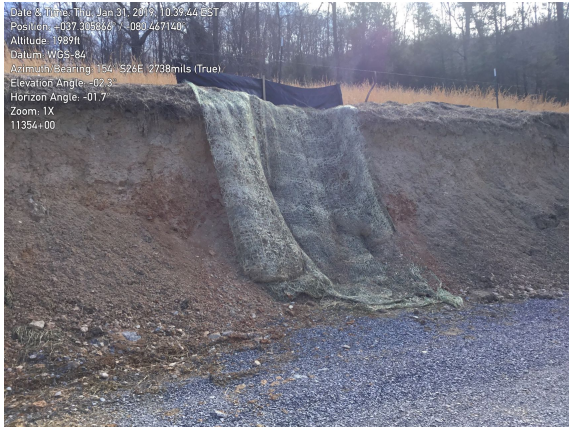
<p>Date & Time: Thu, Jan 31, 2019, 10:39:44 EST Position: +037.3193649, -80.3675426 Altitude: 1969ft Datum: WGS-84 Azimuth/Bearing: 154° S28E 2738mils (True) Elevation Angle: -02.3° Horizon Angle: -01.7° Zoom: 1X 11354+00</p>

GPS Location	37.2961029410709, -80.367559539229	GPS Location	37.2961095208649, -80.3675258439782		
Description	Mat bridge 11451+00	Description	Erosion control blanket needing additional pinning 11354+00		
<p>Date & Time: Thu, Jan 31, 2019, 10:22:07 EST Position: +037.3093281, -80.3675325 Altitude: 1921ft Datum: WGS-84 Azimuth/Bearing: 312° N48W 5547mils (True) Elevation Angle: -24.4° Horizon Angle: -01.8° Zoom: 1X 11372+00</p>

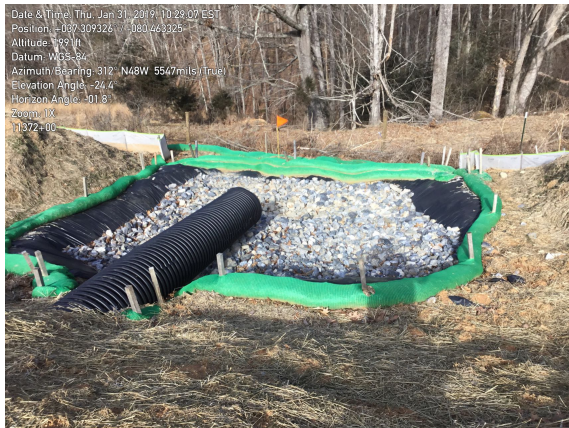
GPS Location	37.2961240634669, -80.3675113432858	GPS Location	37.2961189924155, -80.3675004468116		
Description	Plunge pool in good condition 11372+00	Description	11451+00 ECDs in good condition		
<p>Date & Time: Thu, Jan 31, 2019, 10:34:55 EST Position: +037.3076201, -80.3676730 Altitude: 1948ft Datum: WGS-84 Azimuth/Bearing: 151° S29E 2684mils (True) Elevation Angle: -12.2° Horizon Angle: -01.5° Zoom: 1X 11360+00</p>

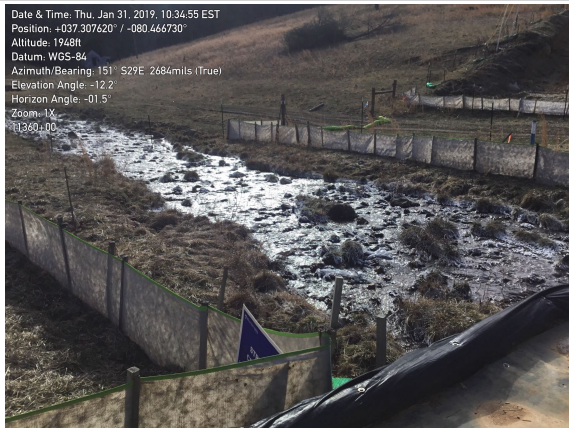
GPS Location	37.2960583912556, -80.367377232835	GPS Location	37.2960859258075, -80.3674989380691		
Description	11360+00 stream, ECDs in good condition	Description	11360+00 ECDs in good condition

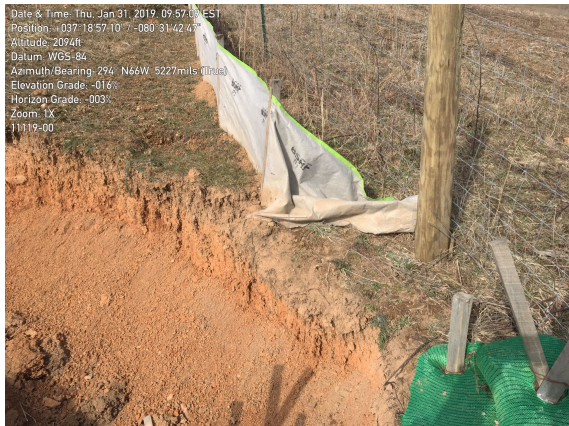
GPS Location	37.2959694173534, -80.36096666694704	GPS Location	37.2959694173534, -80.36096666694704		
Description	Broken P1 ECD @ 11119+00	Description	ROW conditions and ECD's @ MP 209		
<p>Date & Time: Thu, Jan 31, 2019, 12:20:05 EST Position: +037°17'50.88" / -080°28'30.82" Altitude: 2254ft Datum: WGS-84 Azimuth/Bearing: 316° N64W 5618mils (True) Elevation Grade: +051% Horizon Grade: +006% Zoom: 1X 11310-49</p>
