Visual Site Inspection Report

Project Name	H-600 Pipeline Spread H	AFE	124300138	Spread	H-600 Pipeline Spread H
Contractor	Precision			Report #	10867
Inspector	Glenn Mike Renfro			Date/Time	11/13/2018 2:21 PM
Permit #	TBD	Inspection Type	VA SWPP	Station Begin	13415+00
State	VA	Inspection Area	Full	Station End	13670+00
County	Franklin	Ground	Muddy	Temperature (°F)	51.00
Municipality	N/A	Weather	Light Rain	Rain Gauge (in)	3.10
GPS Location	36.9718382819526, -79.8701016884193			Rain Accumulation Time (days)	4.00

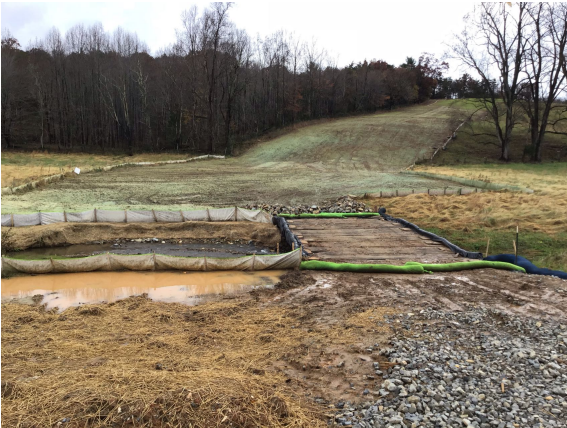
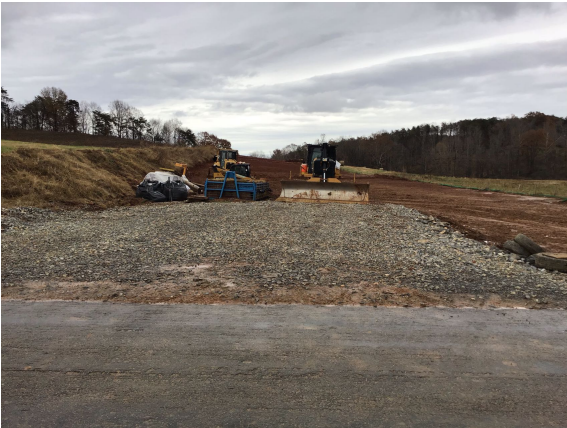
GPS Location	36.9718252800266, -79.8701091896824	GPS Location	36.9717685506092, -79.869999121949		
Description	Roadside ditch on CIS Cahas Mt #2 in good condition.	Description	Grow in on CIS of 13437+00

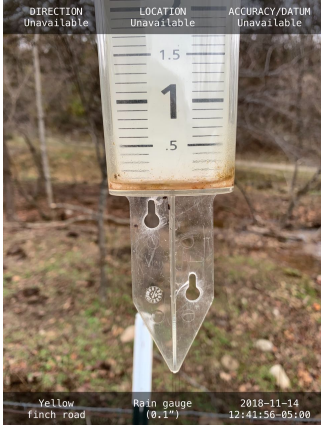
<p>DIRECTION Unavailable LOCATION Unavailable ACCURACY/DATUM Unavailable</p> <p>1.5 1 .5</p> <p>Yellow Finch Rd Rain gauge (0.1") 2018-11-14 12:41:56-05:00</p>

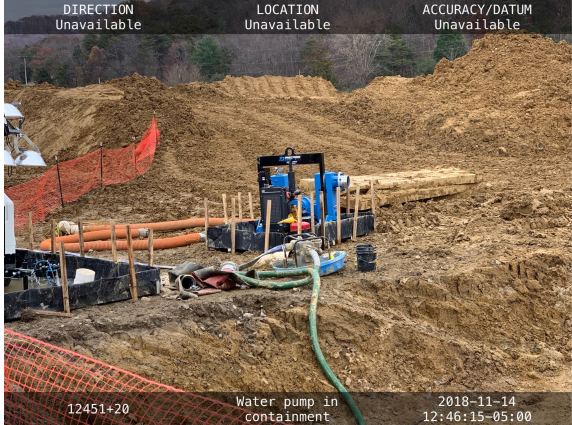
<p>DIRECTION Unavailable LOCATION Unavailable ACCURACY/DATUM Unavailable</p> <p>12451+20 Water pump in containment 2018-11-14 12:46:15-05:00</p>			
GPS Location	37.3314791480297, -79.9582705153469	GPS Location	37.3315421641651, -79.958461699795		
Description	Yellow Finch Rd_111418 rain gauge (0.1").	Description	12451+20_111418 Water pump in containment.

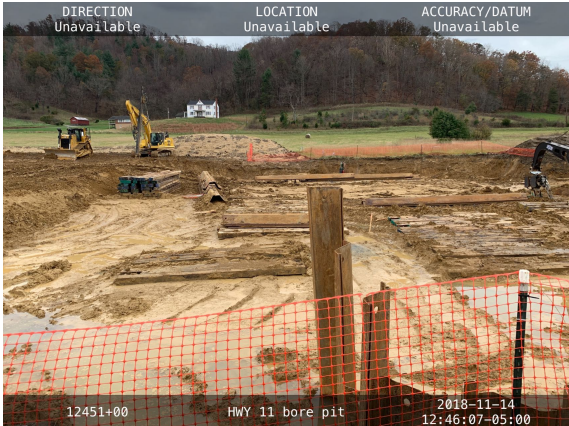
<p>DIRECTION Unavailable LOCATION Unavailable ACCURACY/DATUM Unavailable</p> <p>12451+00 HWY 11 bore pit 2018-11-14 12:46:07-05:00</p>

Description	12451+00_111418 HWY 11 bore pit.	Description	12866+58_111418 Environmental crew topsoiling work space. Looking SW. See picture for GPS data.

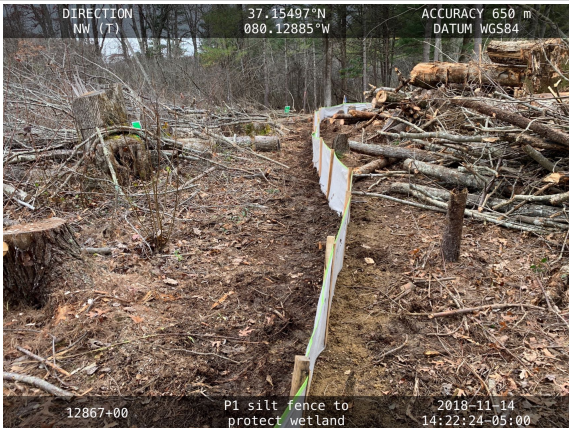
<p>DIRECTION NW (T) 37.15497°N 080.12885°W ACCURACY 650 m DATUM WGS84</p> <p>12867+00 P1 silt fence to protect wetland 2018-11-14 14:22:24-05:00</p>

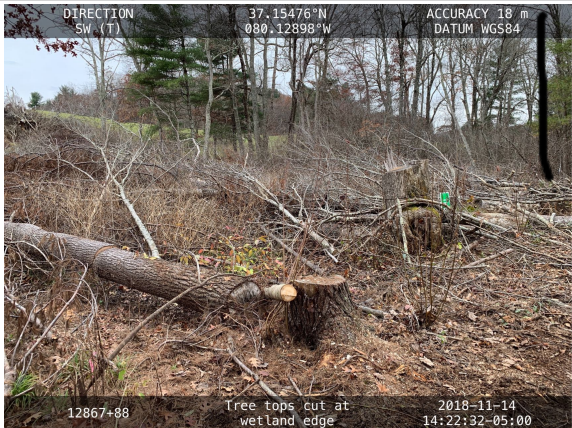
<p>DIRECTION SW (T) 37.15476°N 080.12898°W ACCURACY 18 m DATUM WGS84</p> <p>12867+88 Tree tops cut at wetland edge 2018-11-14 14:22:32-05:00</p>			
GPS Location	37.3315421641651, -79.958461699795	GPS Location	37.3315421641651, -79.958461699795		
Description	12867+00_111418 P1 Silt fence installed across ROW to prevent damage or disturbances to the wetland. Looking NW. See picture for GPS data	Description	12867+88_111418 Tree tops from fallen tread that were left to keep from disturbing wetland. Looking SW. See picture for GPS data.

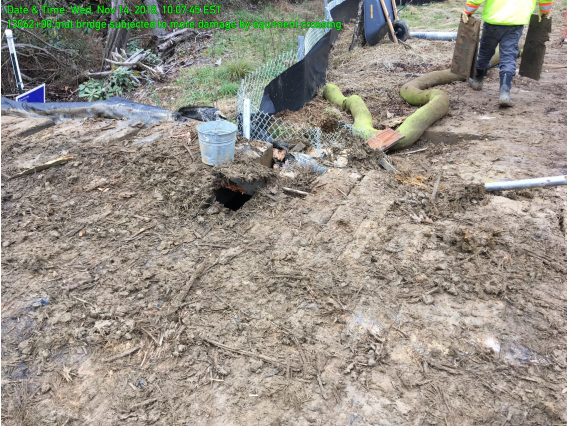
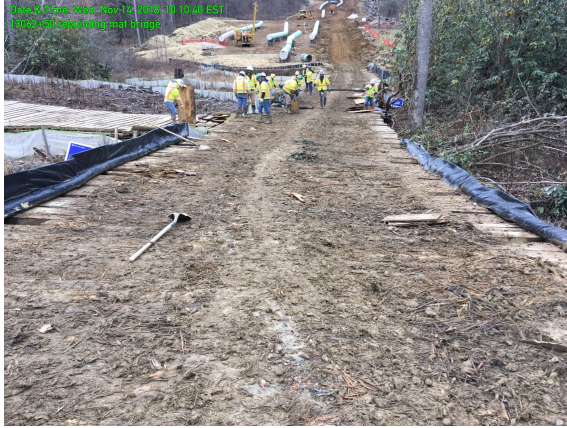
GPS Location	37.2937659386664, -80.0229072985743	GPS Location	37.2938263742601, -80.0228468981385		
Description	Equipment crossing the mat bridge at 13062+00 caused bore damage to mats. S-G26 and S-G27	Description	The environmental crew began repairing bridges immediately after the damage occurred. No impacts were made to either stream.

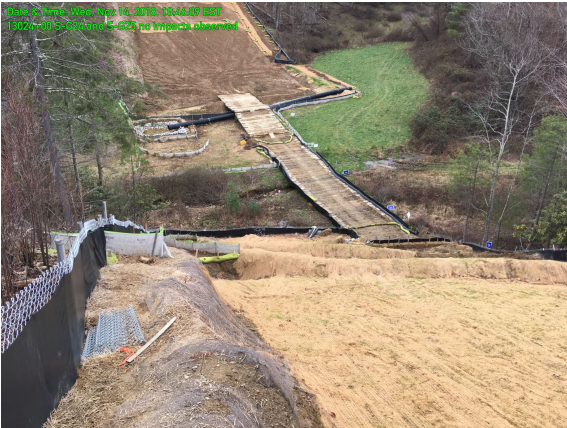
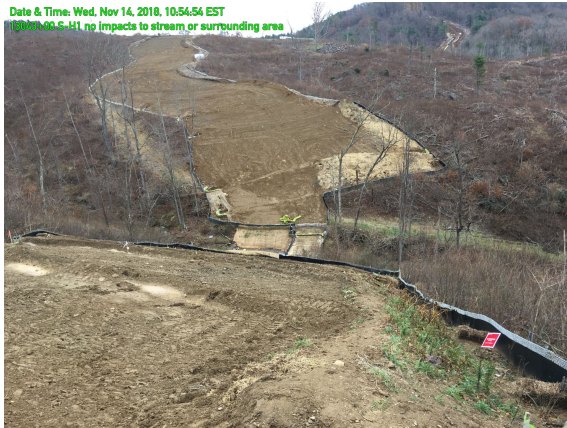
GPS Location	37.2938599856918, -80.0228864607215	GPS Location	37.2938619908066, -80.0228717224094		
Description	No impacts were observed and all ECD's were in good shape. S-G24 and S-G25	Description	Waterbars and ECD's were all in place and no impacts were observed. S-H1

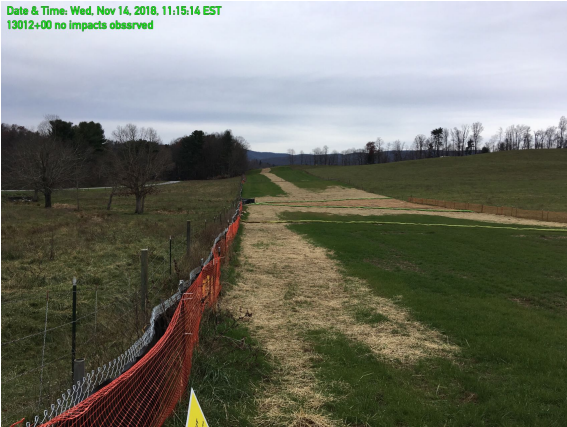
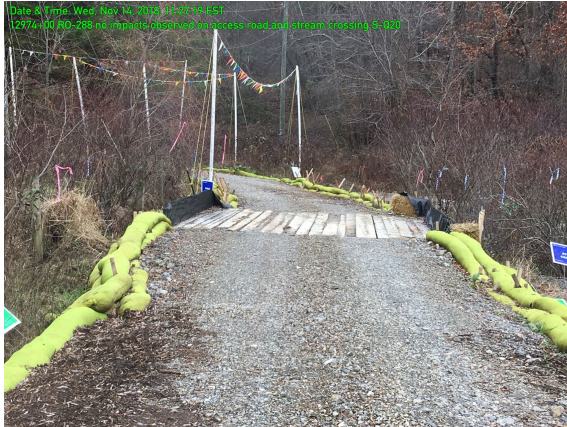
GPS Location	37.2937070578684, -80.0227940921486	GPS Location	37.2937076026921, -80.0228019711375		
Description	Area is well stabilized and no issues or impacts were observed. CIS of Blue Ridge Parkway.	Description	ECD's were in good shape and no impacts were observed. RO-288

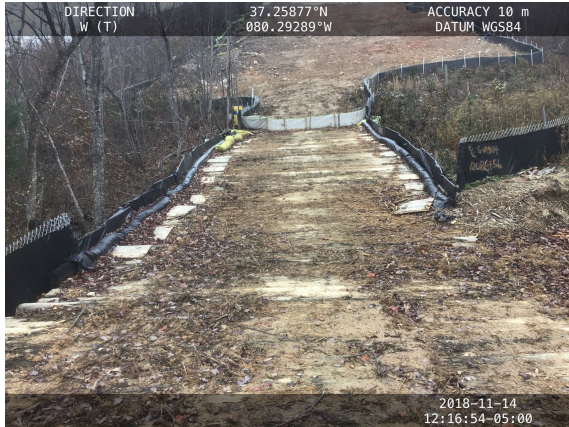
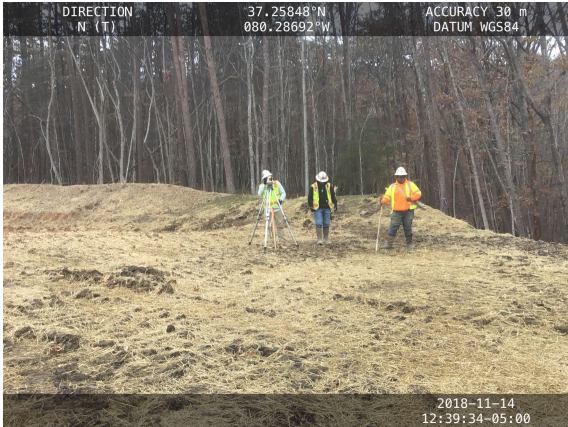
GPS Location	37.2582230251629, -80.2902856842431		GPS Location	37.2581271781002, -80.2859320399168	
Description	No issues at stream S-MM14 with the bridge or ECDs.		Description	The engineer for PPL was marking ditch in preparation for the blasting crew between Half Acre Rock Road and Flatwoods Road today.

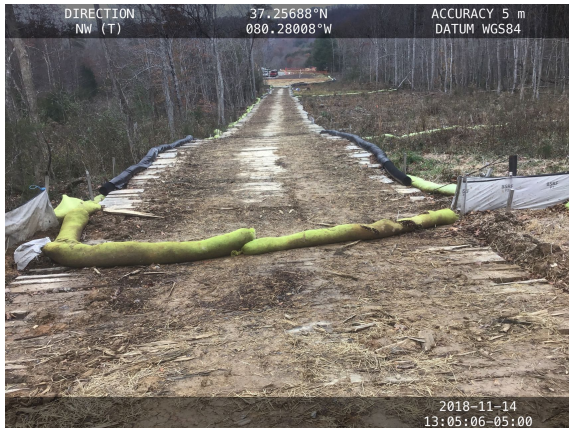
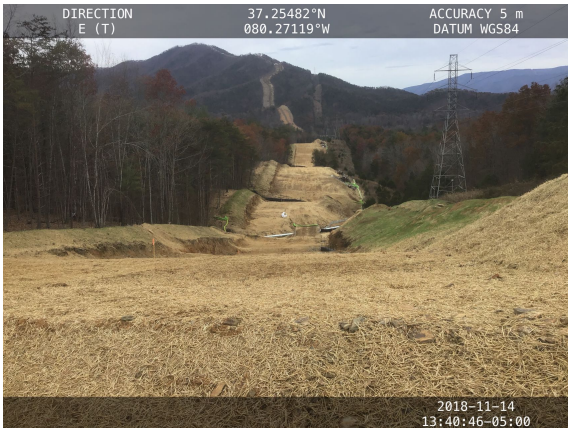
GPS Location	37.2559413873006, -80.2758963034305		GPS Location	37.2559563070883, -80.2760013286772	
Description	Bridge and ECDs functioning properly @ S-MM31 except for one CFS length across the entry to the bridge @		Description	The environmental crew stabilized ROW from access road MVP-MN-273 and Bradshaw Road on 11/11.

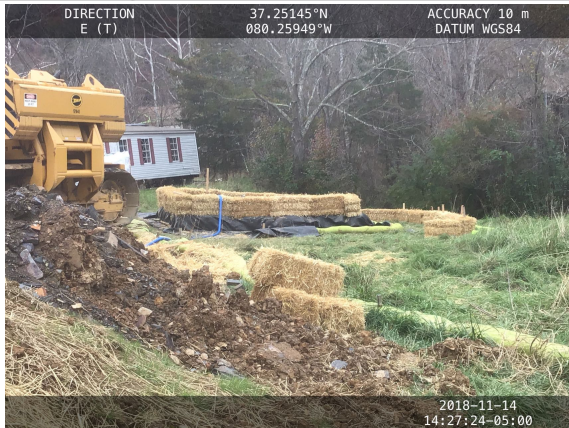
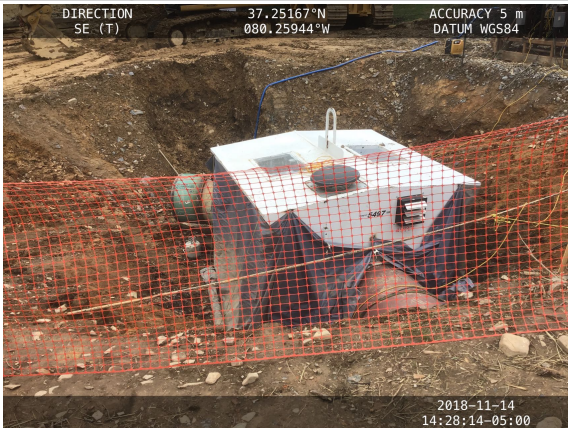
GPS Location	37.2519607795749, -80.260310154483		GPS Location	37.2519378969793, -80.2603283432128	
Description	The environmental crew built a dewatering structure @ station 12191+75, ~MP 230.7~, for the bore crew on GAS of Bradshaw Road.		Description	The bore crew finished welding the fitting onto the bore pipe on the GAS of Bradshaw Road @ station 12191+25, ~MP 230.7~.

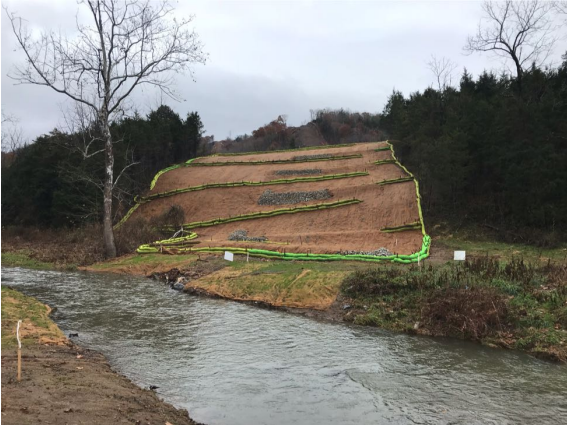
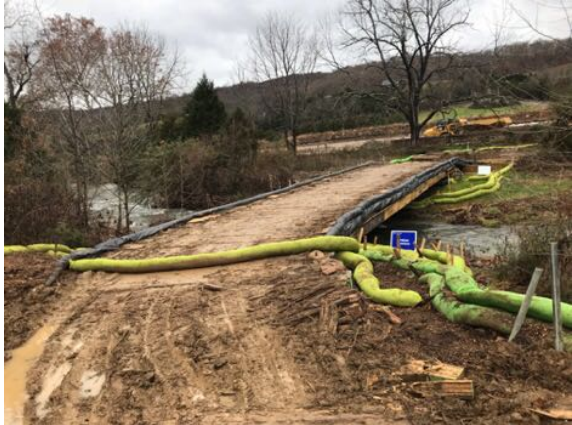
GPS Location	37.2357477061797, -80.2296856977792	GPS Location	37.2357278268951, -80.2296873457284		
Description	Right of way between station (12009+00 to 12011+55).	Description	Photo of bridge over stream G36 on access road MVP-MN-268.01.

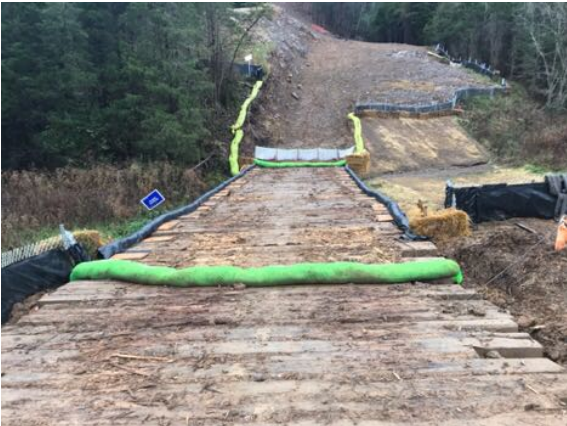
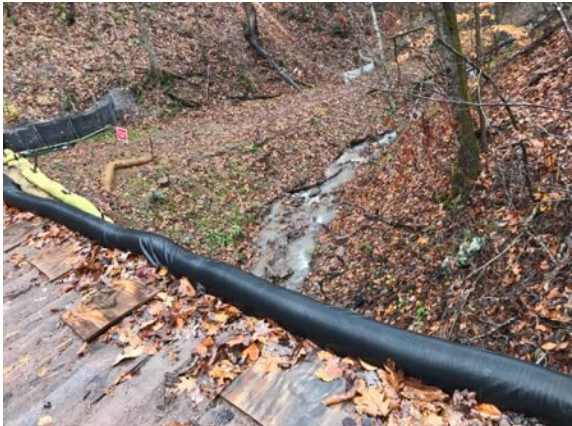
GPS Location	37.2357464908038, -80.22962417461	GPS Location	37.2357439458992, -80.2296293366874		
Description	Photo of bridge over stream G38.	Description	Photo of bridge over stream G39

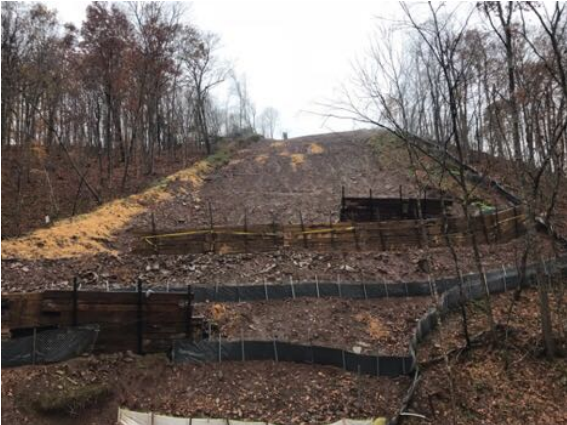
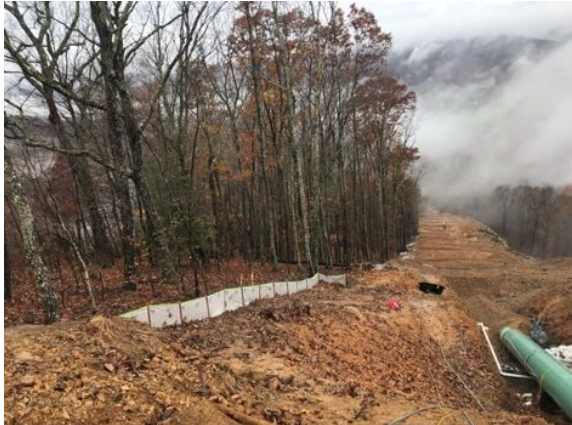
GPS Location	37.2356675751854, -80.2296448779108	GPS Location	37.2356164874856, -80.2296217438581		
Description	Photo of slope from 12030+00 to 12028+00 new mulch on the diversion berm.	Description	Photo of slope between 12052+00 to 12040+00.
