# Visual Site Inspection Report

<b>Project Name</b>	H-600 Pipeline Spread H	<b>AFE</b>	124300138	<b>Spread</b>	H-600 Pipeline Spread H
<b>Contractor</b>	Precision			<b>Report #</b>	11390
<b>Inspector</b>	Dawn McCullough			<b>Date/Time</b>	11/26/2018 9:52 PM
<b>Permit #</b>	TBD	<b>Inspection Type</b>	VA SWPP	<b>Station Begin</b>	13188+66
<b>State</b>	VA	<b>Inspection Area</b>	Partial	<b>Station End</b>	13315+79
<b>County</b>	Franklin	<b>Ground</b>	Damp	<b>Temperature (°F)</b>	60.00
<b>Municipality</b>	N/A	<b>Weather</b>	Sunny	<b>Rain Gauge (in)</b>	1.00
<b>GPS Location</b>	37.3255697731276, -80.0288225245476			<b>Rain Accumulation Time (days)</b>	1.00

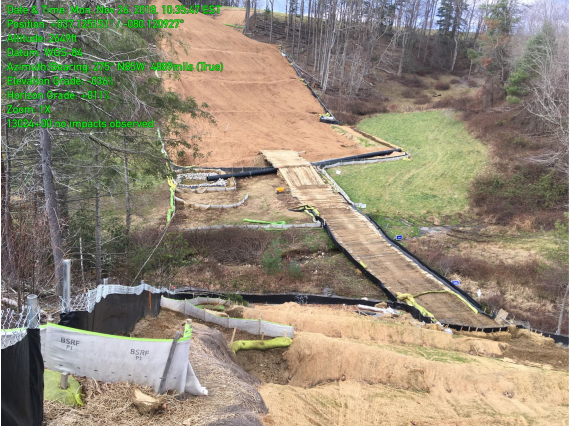
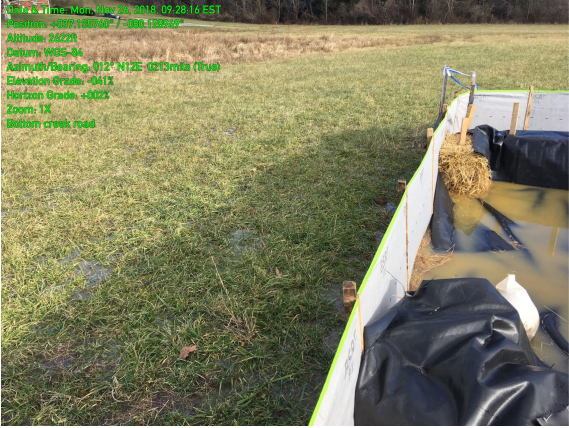
<b>GPS Location</b>	37.1550233382911, -80.1223825032178	<b>GPS Location</b>	37.1565077044879, -80.1292558004957	<b>Description</b>	No observed impacts in the area.
<b>Description</b>	No observed impacts in the area.	<b>Description</b>	Water expelled at the end of the dewatering structure was clean and clear.

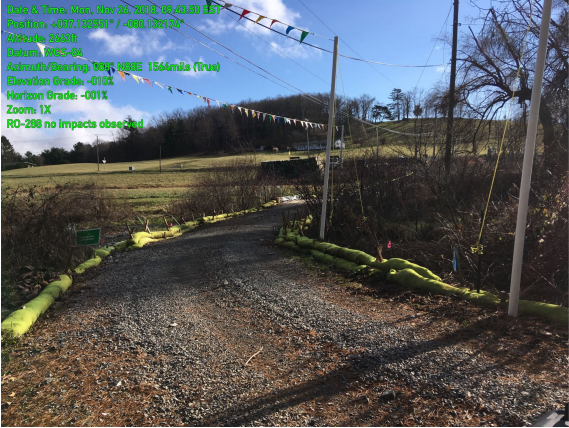
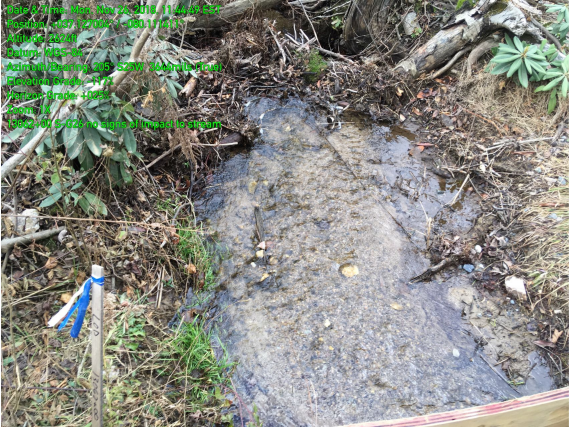
<b>GPS Location</b>	37.1258371090862, -80.1254419796915	<b>GPS Location</b>	37.1268260060224, -80.1118095685543	<b>Description</b>	No impacts in the area of RO-288. Both stream crossings were clear.
<b>Description</b>	No impacts in the area of RO-288. Both stream crossings were clear.	<b>Description</b>	S-G26 was not impacted by recent rain event.

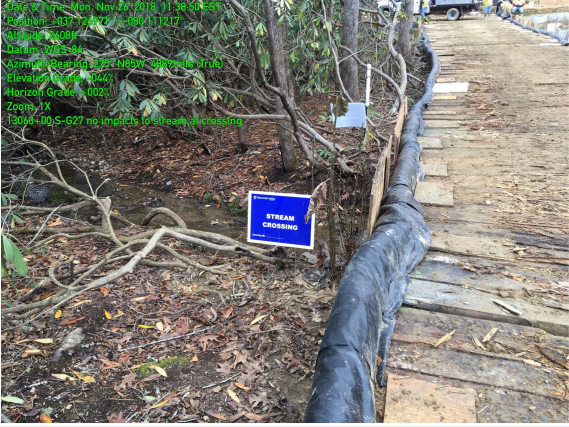
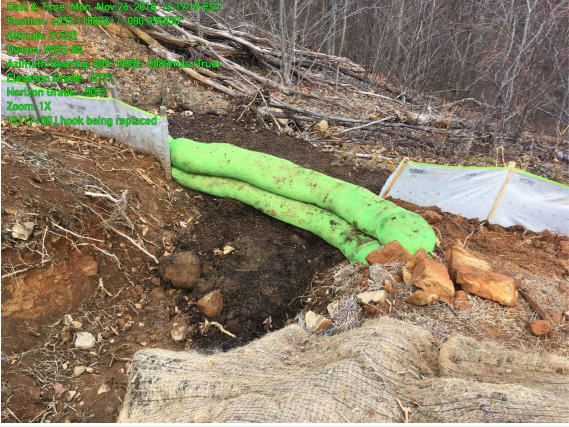
<b>GPS Location</b>	37.1267739544037, -80.1116084866972	<b>GPS Location</b>	37.1218911605301, -80.095811784342	<b>Description</b>	S-G27 showed no signs of impact from rain event.

<b>Description</b>	S-G27 showed no signs of impact from rain event.	<b>Description</b>	Environmental crew was replacing damaged j hook listed on the punch list.

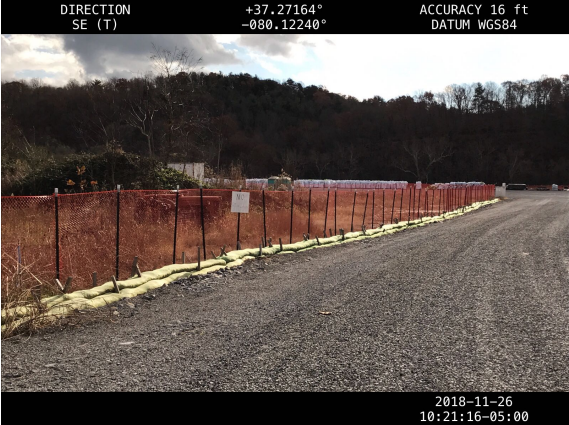
2018-11-26 10:21:16-05:00		<b>GPS Location</b> 37.0930804638538, -80.0252651610226  <b>Description</b> MVP-LY-049_112618 RCE in good condition. Looking S. See photo for gps data.	
DIRECTION E (T)      +37.27103° -080.12170°      ACCURACY 16 ft DATUM WGS84

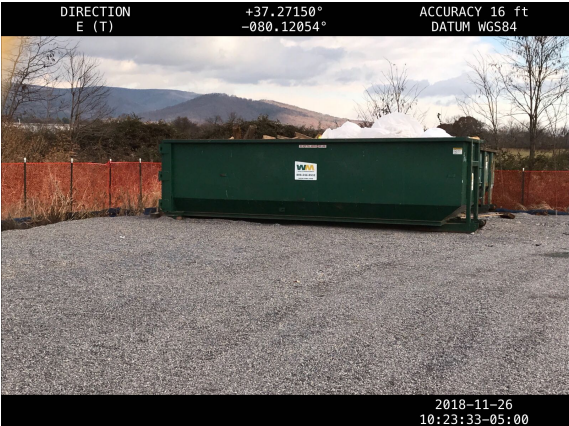
2018-11-26 10:23:33-05:00		<b>GPS Location</b> 37.0932764327499, -80.0251572859287  <b>Description</b> MVP-LY-049_112618 condition of ECD's and safety fence along driveway. Looking SE. See photo for gps data.	
<b>GPS Location</b> 37.0932764327499, -80.0251572859287  <b>Description</b> MVP-LY-049_112618 containment under porta toilets. Looking E. See photo for gps data.		<b>GPS Location</b> 37.0932764327499, -80.0251572859287  <b>Description</b> MVP-LY-049_112618 dumpster area clean and free of loose trash. Looking E. See photo for gps data.		DIRECTION SW (T)      +37.26937° -080.12261°      ACCURACY 16 ft DATUM WGS84

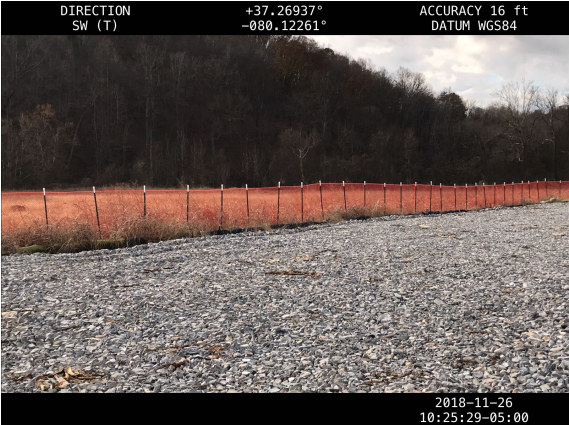
<b>GPS Location</b> 37.0932619320574, -80.0251746364683  <b>Description</b> MVP-LY-049_112618 condition of safety fence along south boundary. Looking SW. See photo for gps data.		DIRECTION SW (T)      +37.27042° -080.12468°      ACCURACY 16 ft DATUM WGS84

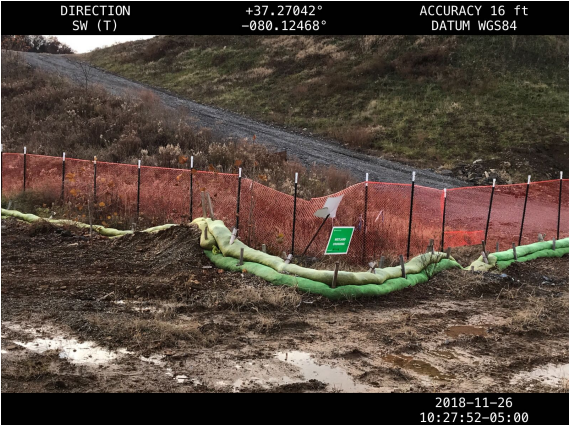
2018-11-26 10:27:52-05:00		<b>GPS Location</b> 37.0932619320574, -80.0251746364683  <b>Description</b> MVP-LY-049_112618 W-CV21B condition of ECD's. Looking SW. See photo for gps data.

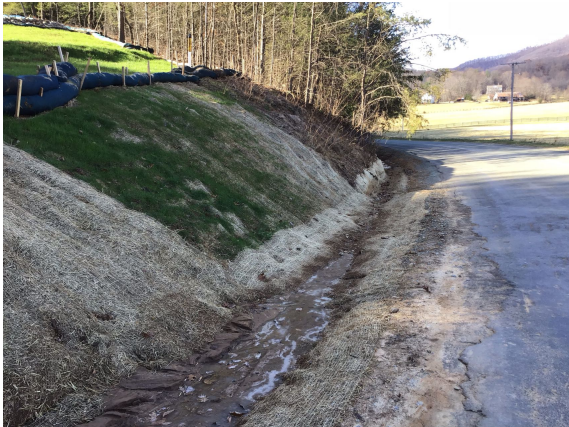
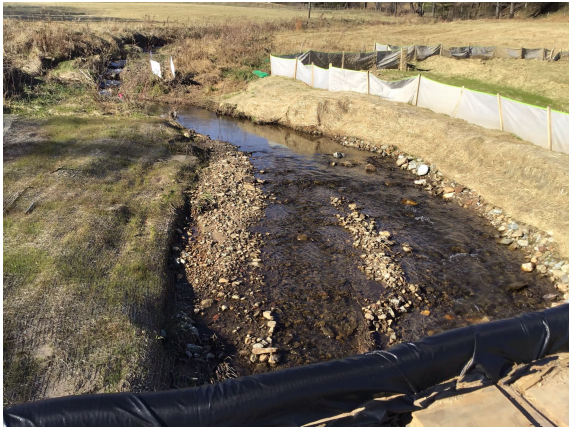
GPS Location		37.0894501777711, -79.9652872794121		GPS Location		37.0890795719224, -79.9654902891069	
Description		Roadside ditch along the side of Cahas Mt Rd in good condition.		Description		Stream crossing S-IJ10 at 13498+00 stabilized and in good condition.

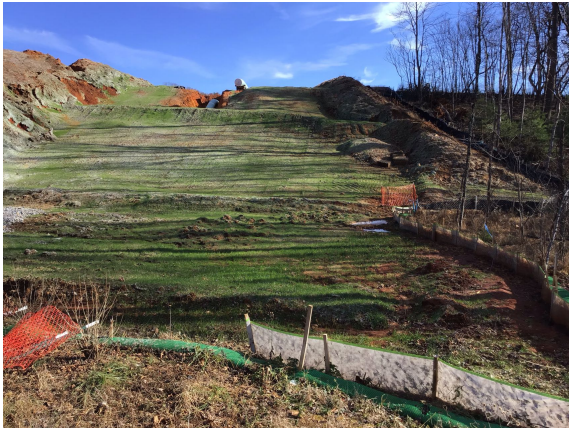
GPS Location		37.0893543726179, -79.9653839227557		GPS Location		37.0889541367414, -79.9655211345106	
Description		RCE at Cahas Mt #1 in good condition.		Description		Temporary stabilization in good condition at kickoff (13415+00)

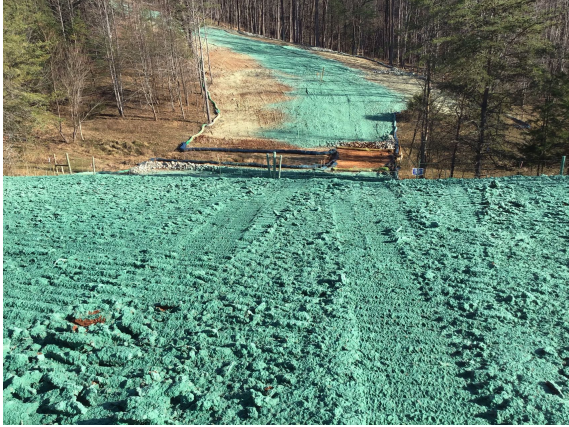
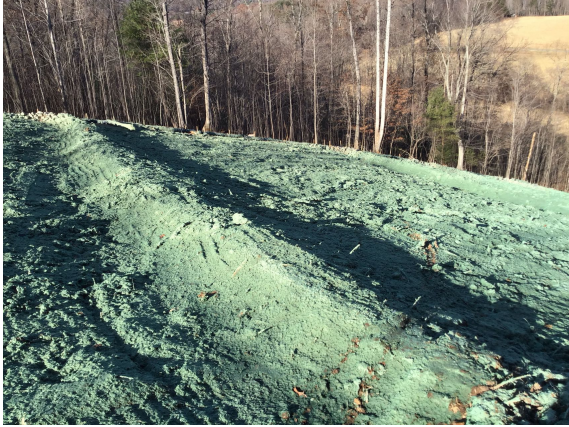
GPS Location		37.0891774725514, -79.9658254814148		GPS Location		37.0890941564339, -79.9661190156638	
Description		Final clean up and reclamation completed near stream crossing S-II6 at 13579+93		Description		Permanent waterbars and end treatment installed and reclamation completed at 13630+00

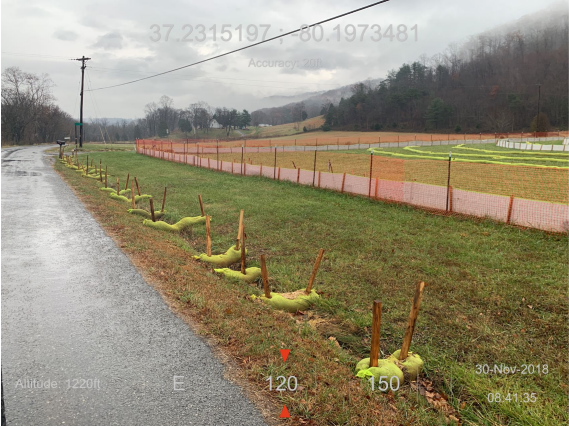
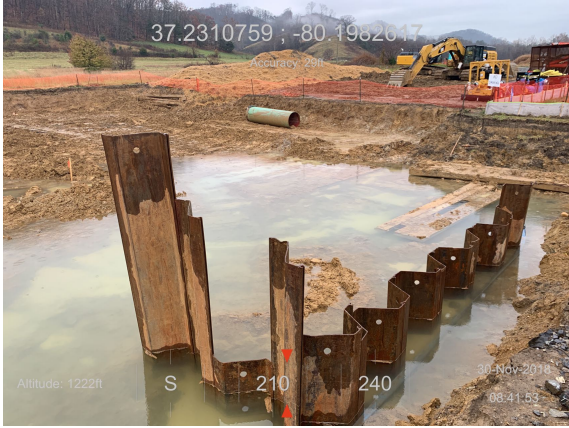
<b>GPS Location</b>	37.2355891128008, -80.2294235204499	<b>GPS Location</b>	37.2355891128008, -80.2294235204499		
<b>Description</b>	12451+00_113018 Checks in drainage ditch to filter water. Looking SE. See picture for GPS data.	<b>Description</b>	12451+00_113018 Sheet pilings in bore pit. Looking SW. See picture for GPS data

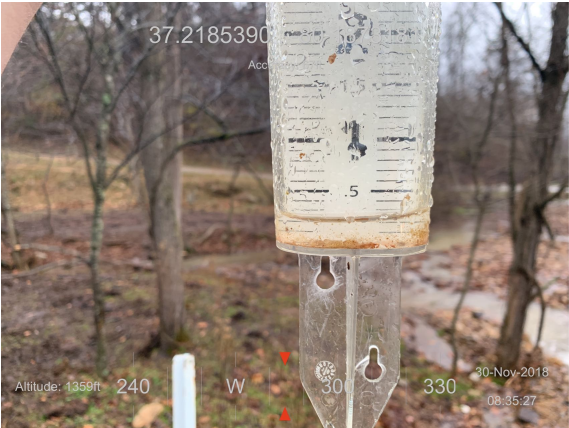
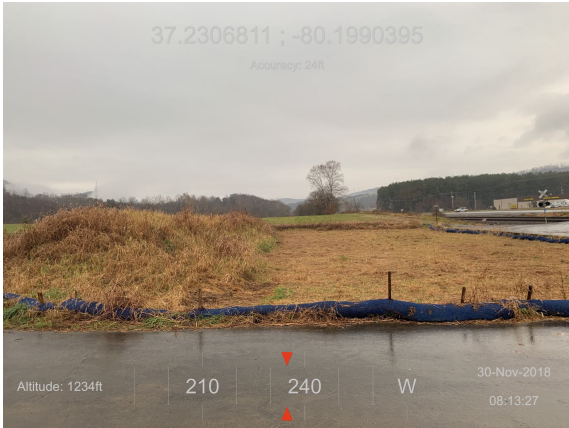
<b>GPS Location</b>	37.2355891128008, -80.2294235204499	<b>GPS Location</b>	37.2355891128008, -80.2294235204499		
<b>Description</b>	Yellow Finch Rd_113018 Rain Gauge (.3") Looking W. See picture for GPS data.	<b>Description</b>	12451+20_113018 Stabilized disturbed variance. Looking SW. See picture for GPS data.

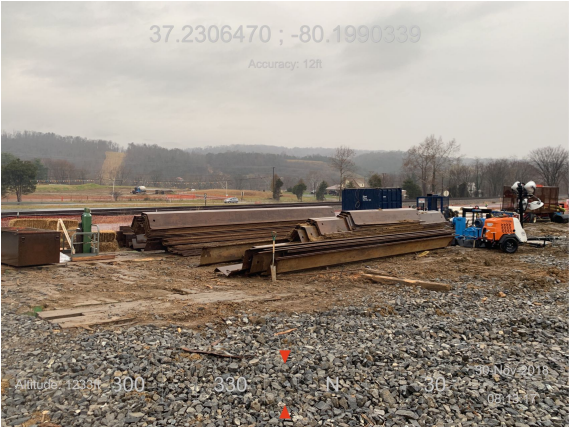
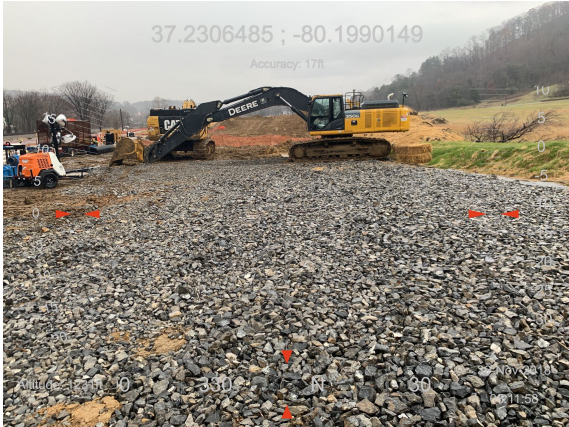
<b>GPS Location</b>	37.2355891128008, -80.2294235204499	<b>GPS Location</b>	37.2355891128008, -80.2294235204499		
<b>Description</b>	12451+00_113018 Sheet pilings stages for future use. Looking NE. See picture for GPS data.	<b>Description</b>	12451+20_113018 RCE. Looking N. See picture for GPS data.

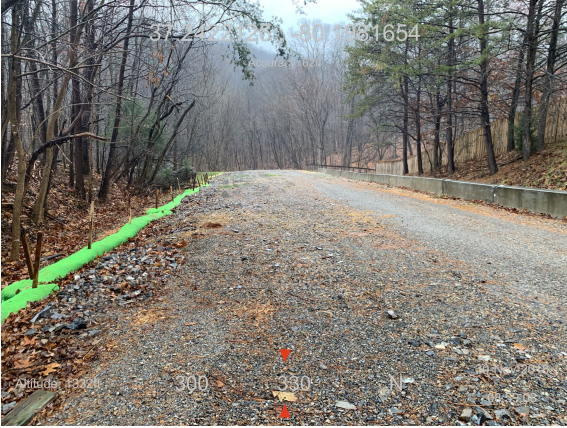
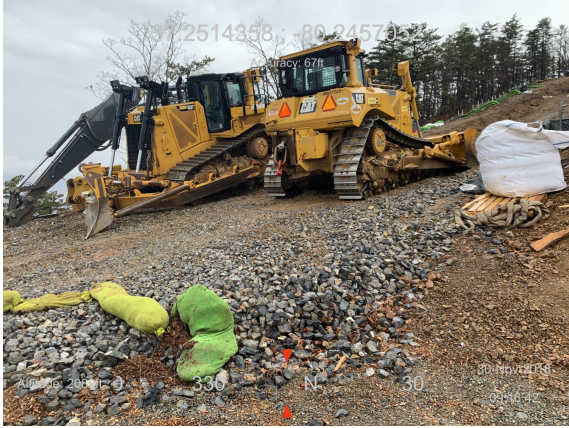
<b>GPS Location</b>	37.2375850135708, -80.2363447251427	<b>GPS Location</b>	37.2375906185423, -80.2363725598245		
<b>Description</b>	MVP-MLV-AR-27_113018 Access road 27 and perimeter controls. Looking NW. See picture for GPS data.	<b>Description</b>	12234+77_113018 Equipment staged in RCE. RCE needs maintenance. Looking N. See picture for GPS data.

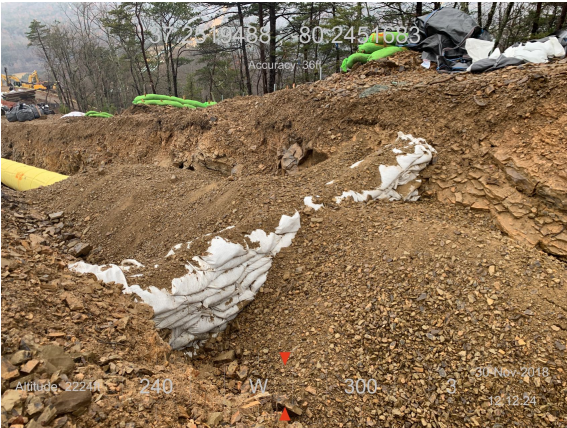
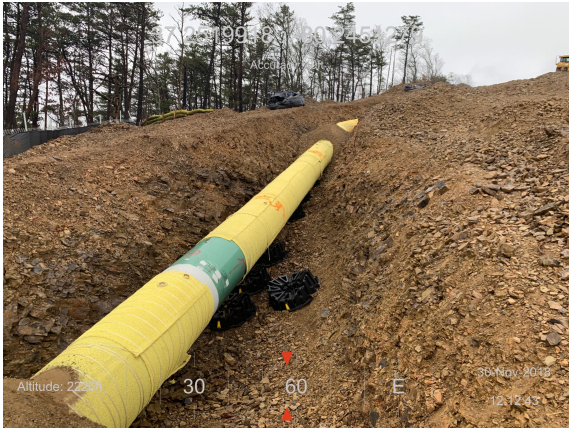
<b>GPS Location</b>	37.2375980828771, -80.2363444560592	<b>GPS Location</b>	37.2374696251731, -80.2362658908765		
<b>Description</b>	12236+71_113018 Trench breaker. Looking W. See picture for GPS data.	<b>Description</b>	12238+00_113018 Pipe in the ditch with soft trench plugs. Looking E. See picture for GPS data.

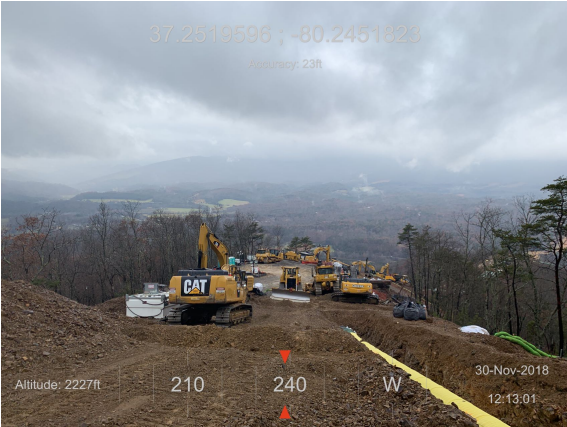
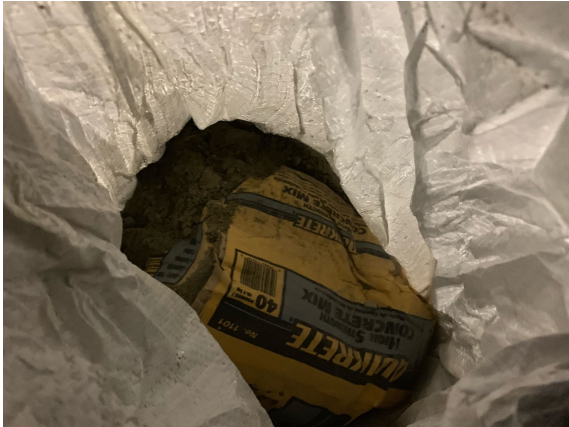
<b>Description</b>	12234+60 Equipment staged near access road. Looking W. See picture for GPS data.	<b>Description</b>	12234+40_113018 Sand bag filled with concrete for trench breakers.

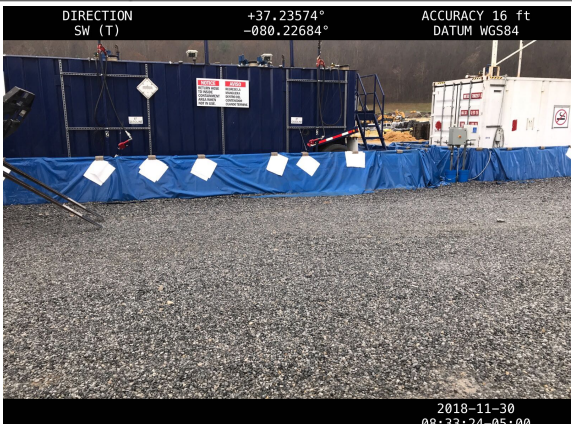
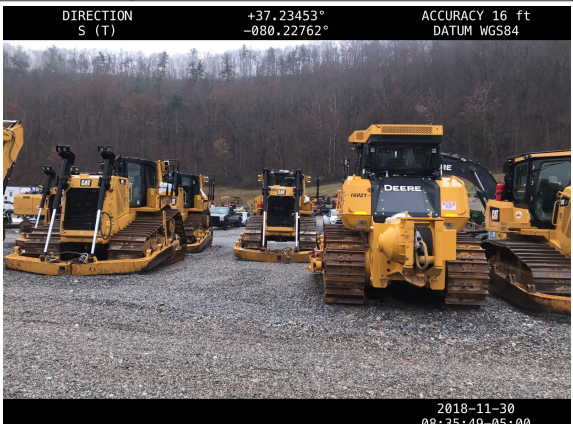
Description	MVP-PY-006_113018 no fluid deposits on the north side of the bulk fuel tanks. Looking SW. See photo for gps data.		Description	MVP-PY-006_113018 no fluid deposits around the parked equipment. Looking S. See photo for gps data.
