Visual Site Inspection Report

Project Name	H-600 Pipeline Spread H	AFE	124300138	Spread	H-600 Pipeline Spread H
Contractor	Precision			Report #	11972
Inspector	Glenn Mike Renfro			Date/Time	12/11/2018 10:48 AM
Permit #	TBD	Inspection Type	VA SWPP	Station Begin	13415+00
State	VA	Inspection Area	Full	Station End	13670+00
County	Franklin	Ground	Frozen	Temperature (°F)	31.00
Municipality	N/A	Weather	Sunny	Rain Gauge (in)	0.10
GPS Location	36.9718772713661, -79.8700529687872			Rain Accumulation Time (days)	6.00

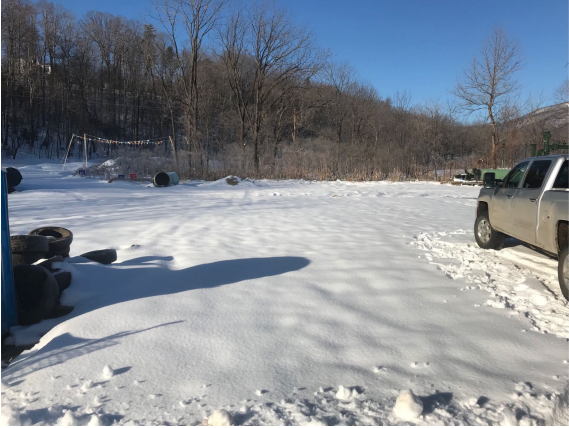
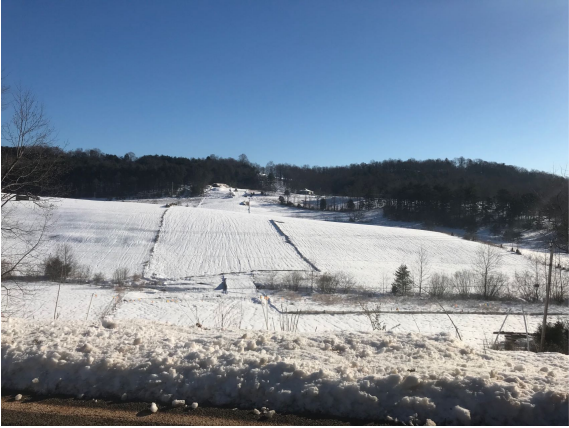
GPS Location	36.9720694190236, -79.8700141255556	GPS Location	36.9719381165104, -79.8700484913586		
Description	RCE on CIS of Leaning Oak	Description	RoW on the GAS of Bethlehem Rd

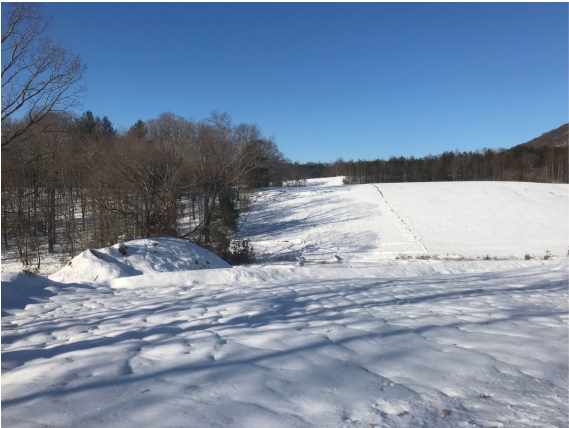
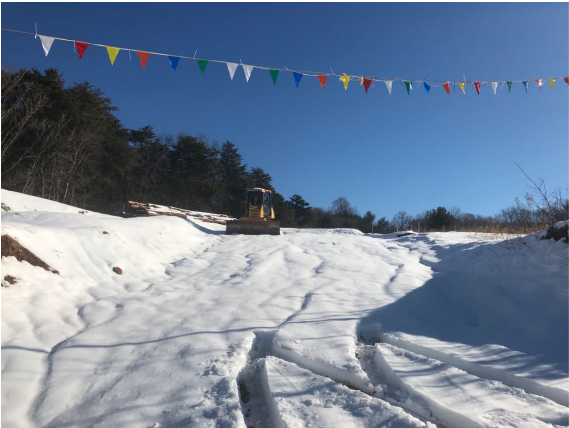
GPS Location	36.9719092827635, -79.8701163009553	GPS Location	36.9719092827635, -79.8701163009553		
Description	RoW on CIS of House Rock Rd	Description	RCE on the GAS of Monty Rd		
Insert image here		Insert image here			
GPS Location		GPS Location			
Description		Description

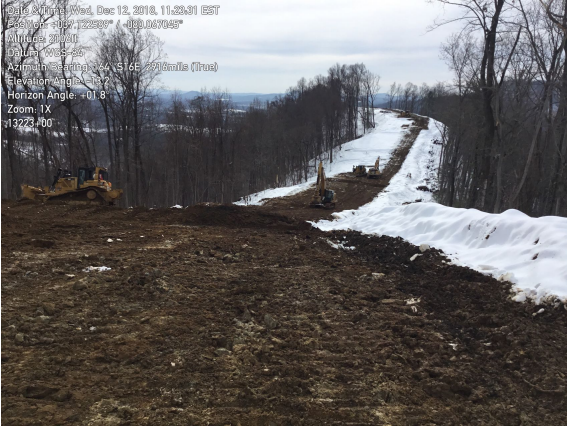
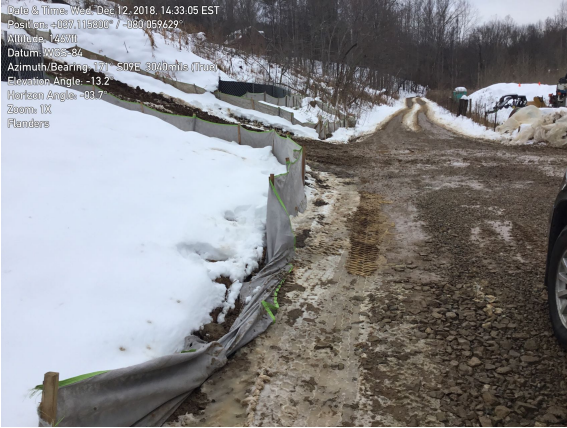
GPS Location	37.3254740926552, -80.028723840855	GPS Location	37.3256097548058, -80.0287777651847		
Description	Please see photo for coordinates. Sta. No. 13318+66, no off ROW impacts noted, ECDs functioning acceptably.	Description	Please see photo for coordinates. Sta. No. 13223+00,

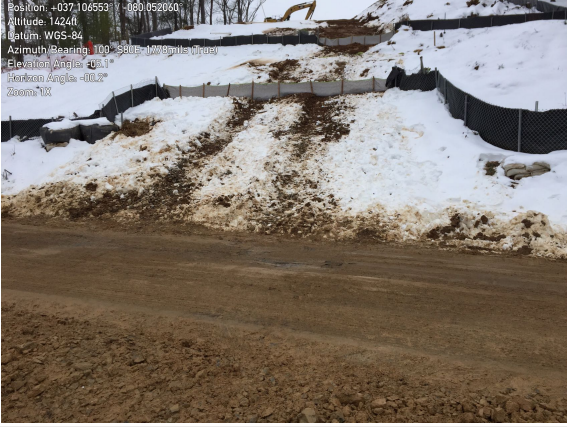
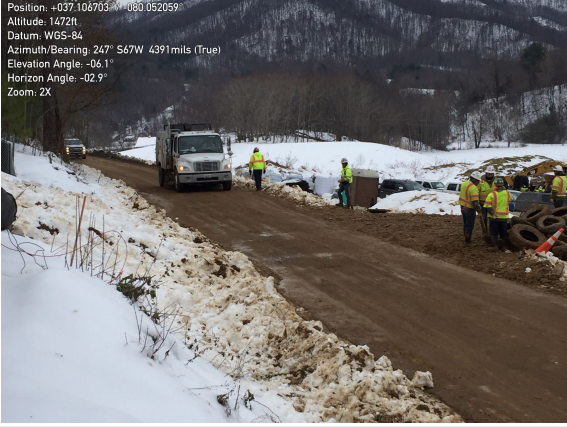
GPS Location	37.3256097548058, -80.0287777651847	GPS Location	37.3256097548058, -80.0287777651847		
Description	Please see photo for coordinates. Sta. No. 13315+70, Wade's Gap Road crossing and RCE.	Description	Please see photo for coordinates. Sta. No. 13315+70, Wade's Gap Road crossing, sweeper truck actively cleaning road.

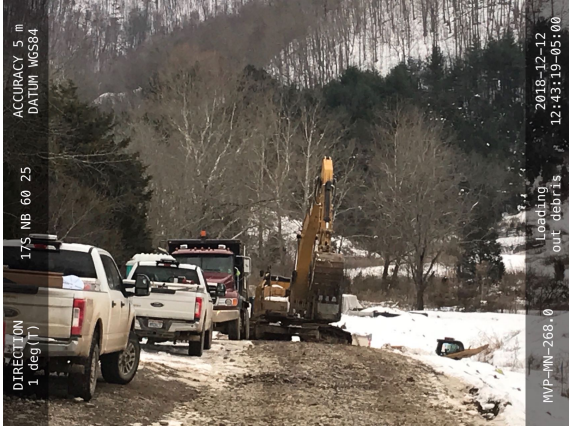
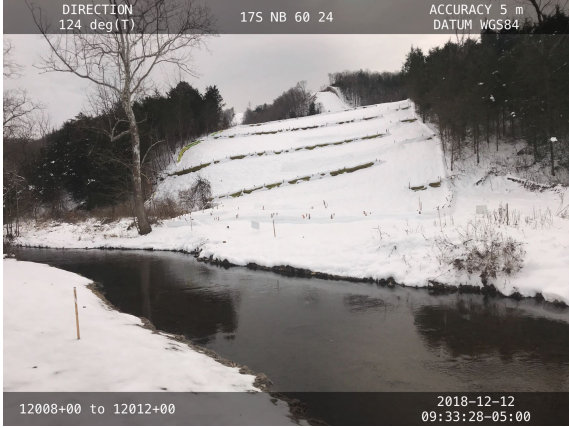
GPS Location	37.2705517569904, -80.3141959850493	GPS Location	37.2705517569904, -80.3141959850493		
Description	Photo shows the contractor loading out debris from ATWS-473.	Description	Photo shows the ROW from 12008+00 to 12012+00.

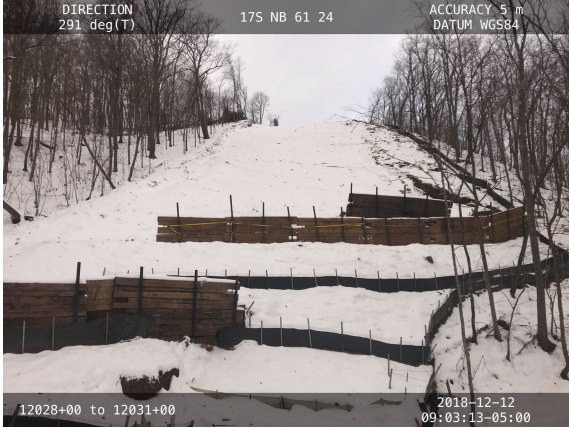
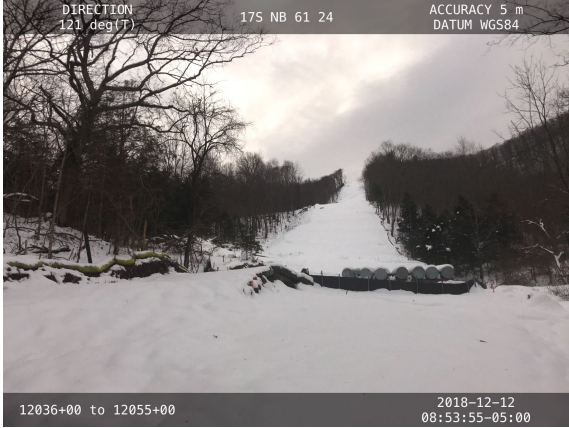
GPS Location	37.27053880695, -80.3141527344289	GPS Location	37.2705843206842, -80.3141744435581		
Description	Photo shows the ROW from 12028+00 to 12031+00.	Description	Photo shows the ROW from 12036+00 to 12054+00.

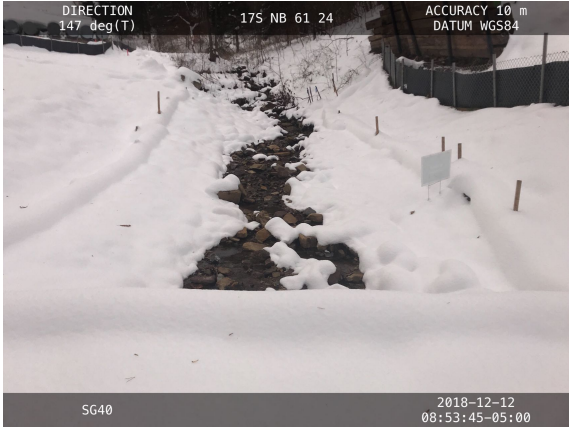
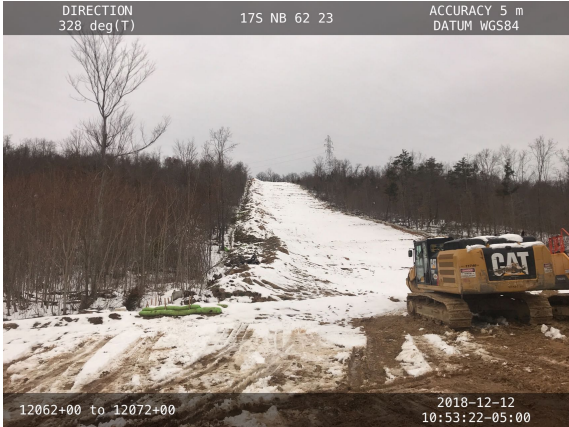
GPS Location	37.2705843206842, -80.3141744435581	GPS Location	37.2705843206842, -80.3141744435581		
Description	Photo shows stream SG40.	Description	Photo shows the ROW from 12062+00 to 12072+00.

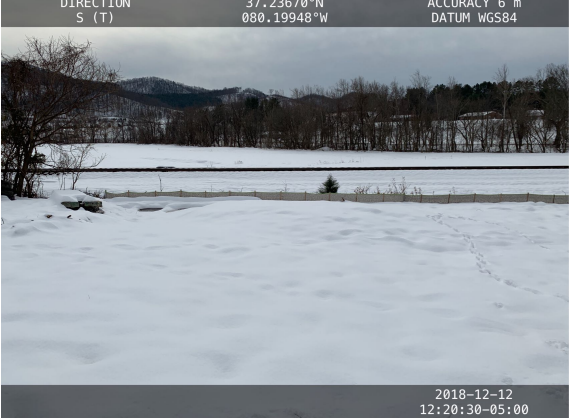
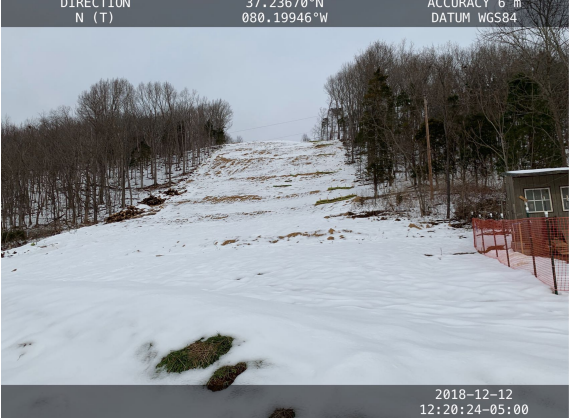
2018-12-12 12:20:24-05:00			
GPS Location	37.3314007299627, -79.9581992668225	GPS Location	37.3314316962905, -79.9582971951437		
Description	12421+68_121218 ROW covered in snow. Looking S. See picture for GPS data.	Description	12416+65_121218 Stabilized hill side covered in snow. Looking N. See picture for GPS data.		
DIRECTION NE (T) 37.25894°N ACCURACY 76 m 080.22953°W DATUM WGS84   2018-12-12 10:39:01-05:00		DIRECTION Unavailable LOCATION Unavailable ACCURACY/DATUM Unavailable

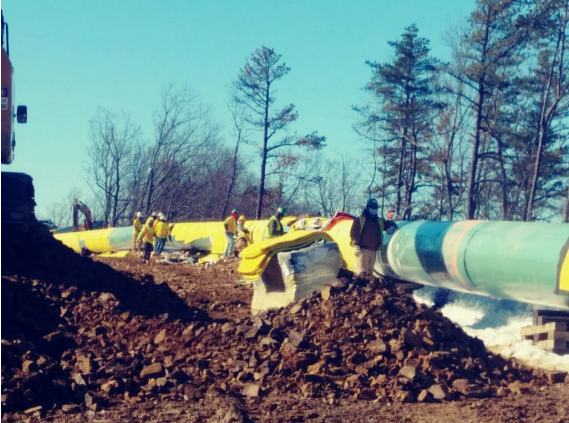
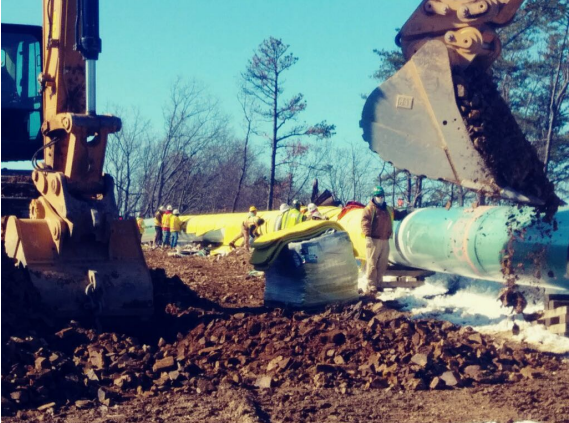
GPS Location	37.3314153077467, -79.9581942934479	GPS Location	37.331361300385, -79.9581371577235		
Description	12274+00_121218 Crew installing Rock shield to the 64 joint section.	Description	12274+00_121218 Track hoes relaying ditch dirt.

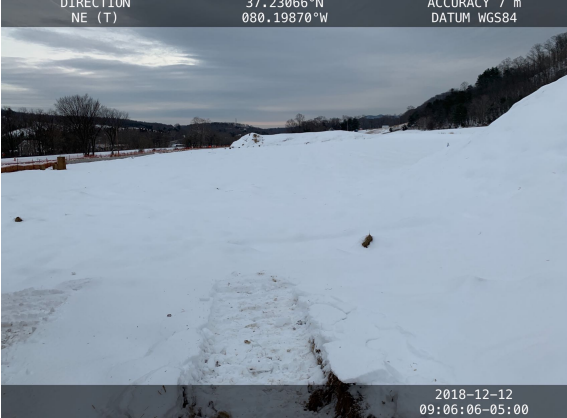
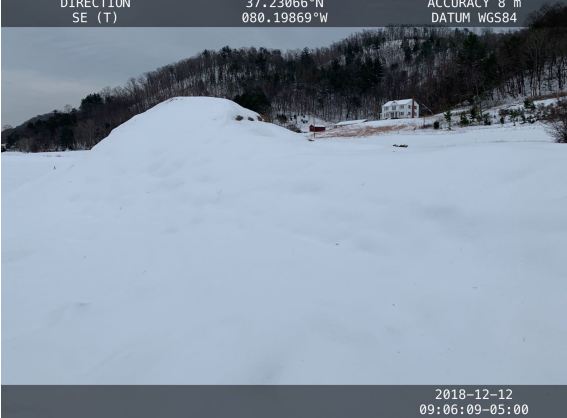
2018-12-12 09:06:09-05:00			
GPS Location	37.235637448852, -80.2295776879314		GPS Location	37.235637448852, -80.2295776879314	
Description	12451+00_121218 Stabilized RIW at Hwy 11 bore pit. Looking NE. See picture for GPS data.		Description	12451+00_121218 Top soil pile covered in snow. Looking SE. See picture for GPS data.	
DIRECTION NE (T) 37.23083°N ACCURACY 6 m 080.19878°W DATUM WGS84

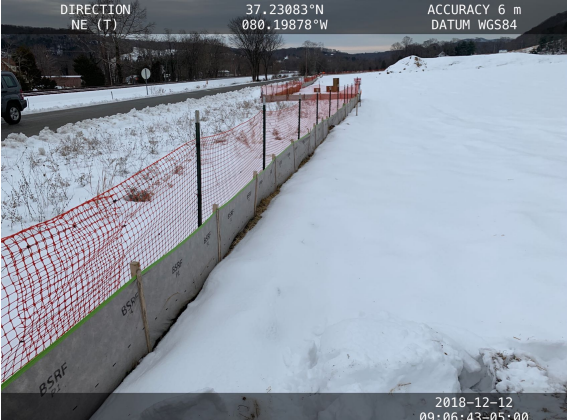
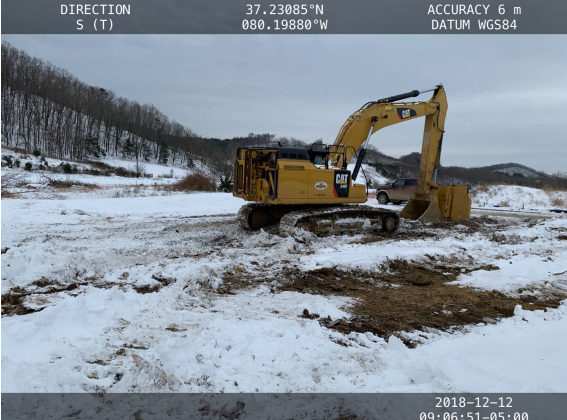
2018-12-12 09:06:51-05:00			
GPS Location	37.2356376899674, -80.2295770320741		GPS Location	37.2356367912703, -80.2295794766171	
Description	12451+00_121218 P1 Silt fence perimeter controls. Looking NE. See picture for GPS data.		Description	12451+00_121218 Track hoe waiting to be loaded out. Looking S. See picture for GPS data.

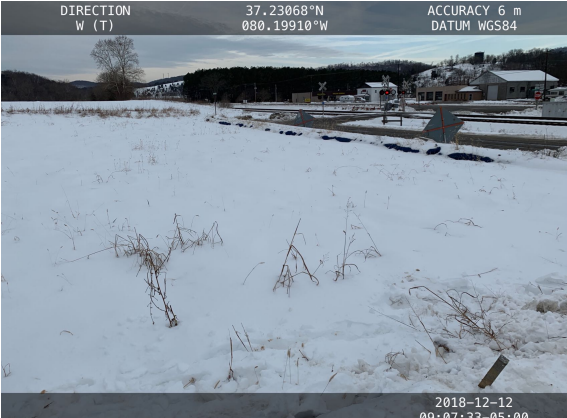
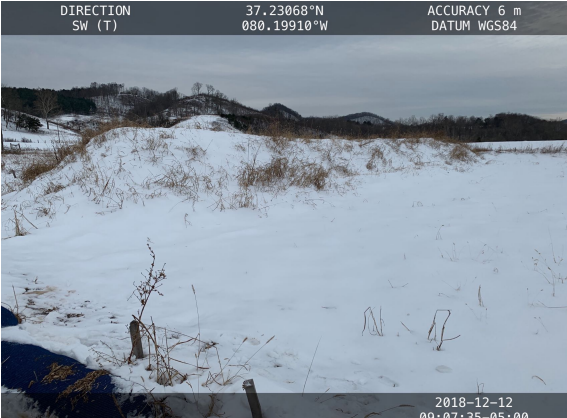
2018-12-12 09:07:35-05:00			
GPS Location	37.2356376899674, -80.2295770320741		GPS Location	37.2356376899674, -80.2295770320741	
Description	12451+00_121218 stabilized variance area and CFS covered in snow. Looking W. See picture for GPS data.		Description	12451+00_121218 Top soil pile in variance area covered in snow. Looking SW. See picture for GPS data

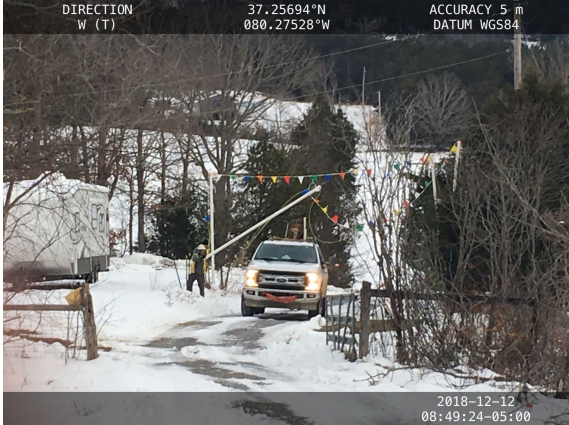
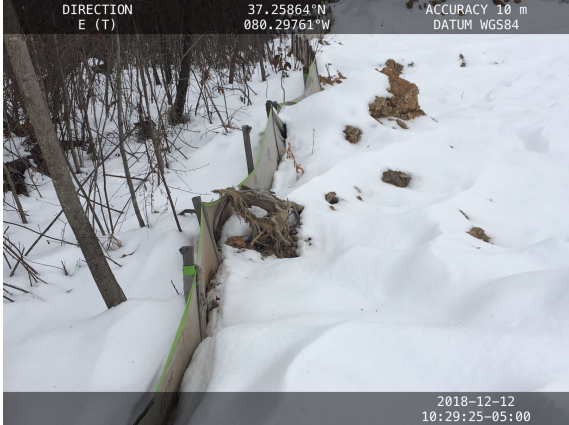
<p>DIRECTION E (T) 37.25864°N 080.29761°W ACCURACY 10 m DATUM WGS84</p> <p>2018-12-12 10:29:25-05:00</p>			
GPS Location	37.2582070995469, -80.2890082821998		GPS Location	37.2583612427462, -80.2888567373904	
Description	Laborers from the environmental crew were taking down goal posts in various locations throughout this inspection area.		Description	A large dirt clods is against the P1 silt fence @ station 12073+50, ~MP 228.5~, and needs to be pulled back off the fence.

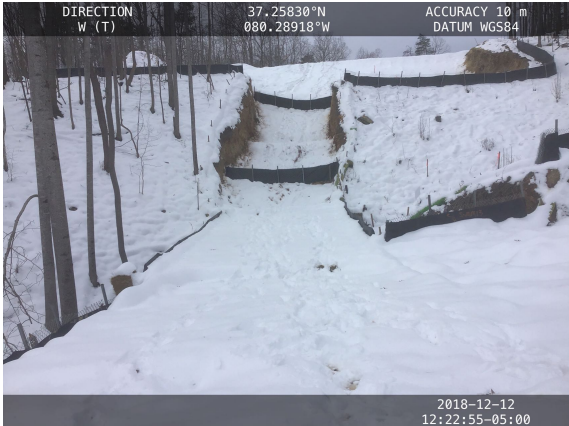
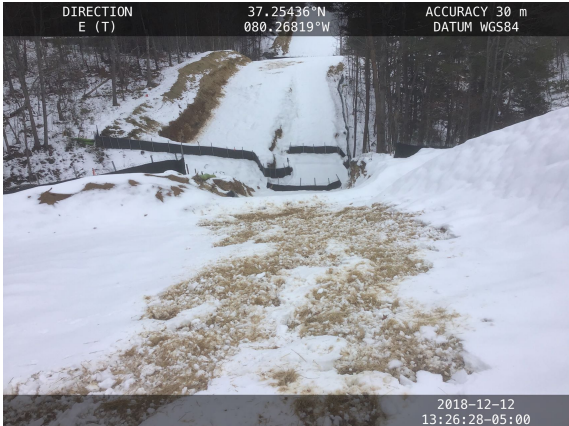
Description	The bridge over stream S-MM13 is covered in snow and showing no runoff yet.		Description	No apparent issues at stream S-C25 as the bridge is completely covered in snow with very little runoff occurring today.

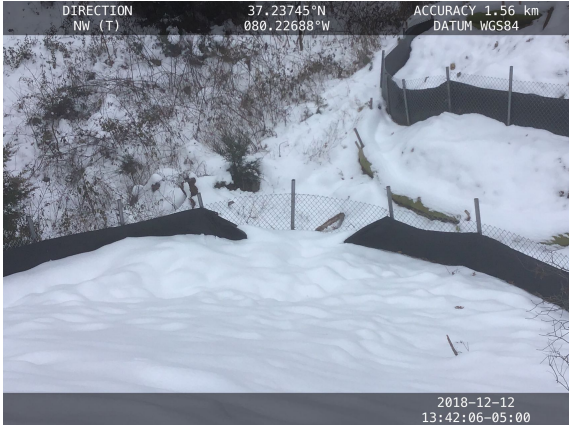
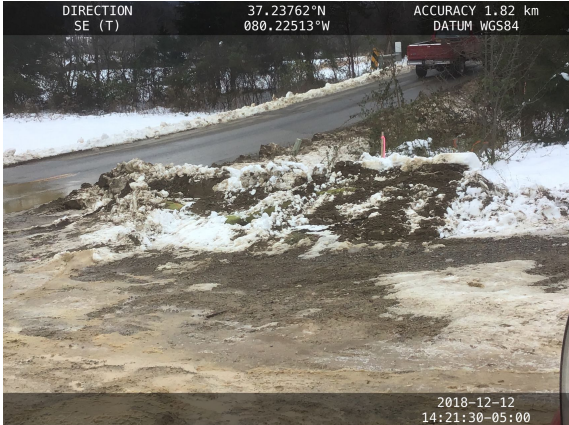
<p>DIRECTION SE (T) 37.23762°N 080.22513°W ACCURACY 1.82 km DATUM WGS84</p> <p>2018-12-12 14:21:30-05:00</p>			
GPS Location	37.2544509172787, -80.2693124861273		GPS Location	37.2521467986194, -80.2584408652391	
Description	Super silt fence fabric is damaged at station 12158+50, ~MP 230.1~, and needs to be reattached to the chain link.		Description	Dirt and gravel has been pushed over the CFS next to access road MVP-MN-274 by the homeowner that shares the driveway.

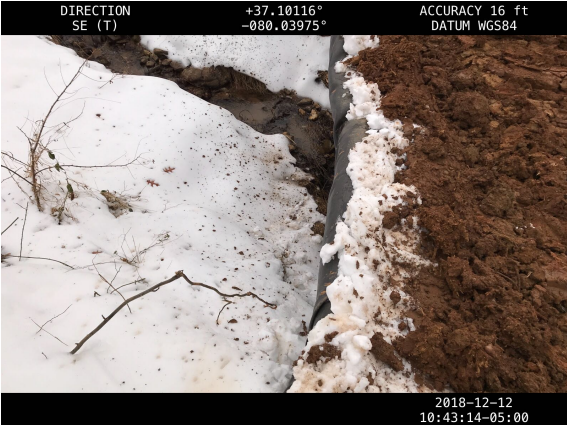
GPS Location	37.0925625041473, -80.0254631415755		GPS Location	37.0925625041473, -80.0254631415755	
Description	13358+64_121218 S-RR11 spoil on bridge and side bumpers full. Looking SE. See photo for gps data.		Description	13358+64_121218 S-RR11 dirt clods falling onto low bank. Looking SE. See photo for gps data.

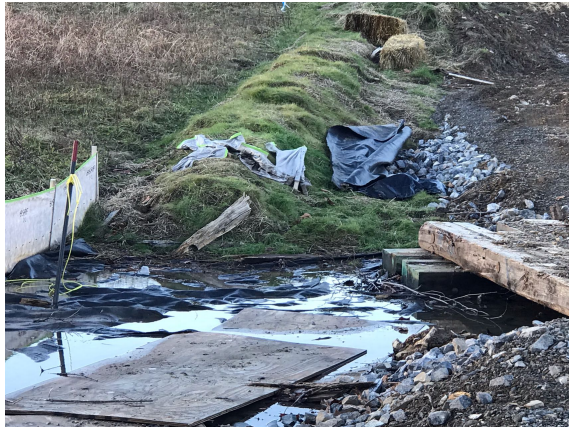
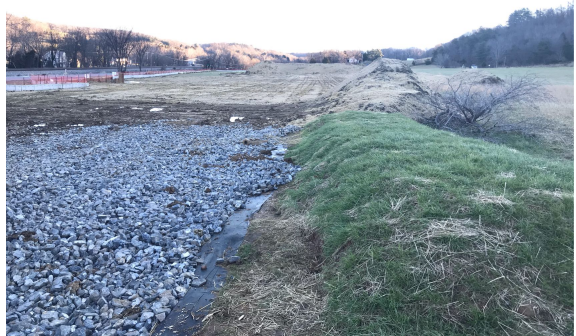
GPS Location	37.2356402920906, -80.2296277788283	GPS Location	37.2357622487817, -80.22961897783		
Description	Housekeeping items on the south side of Lafayette Road 12442+00	Description	12452+00 spruce vegetation on recently winterized right of way. RCE in good condition.

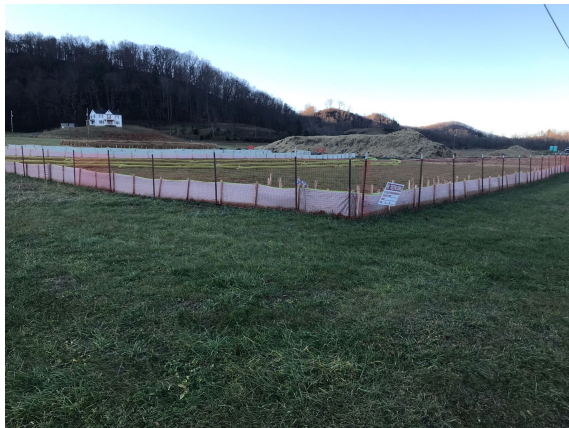
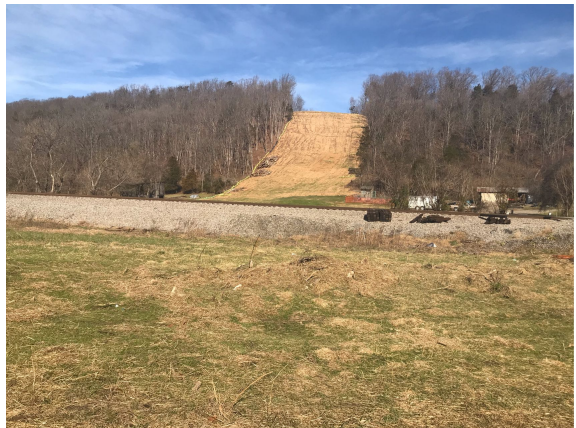
GPS Location	37.2357198363517, -80.2295804210754	GPS Location	37.2351779044021, -80.2295927424731		
Description	12451+00 priority one silt fencing in good condition and functioning properly on the south side of Cove Hollow Road.	Description	Station 12430+00 hillside has been mulched and some vegetation is starting to develop from temporary seeding.

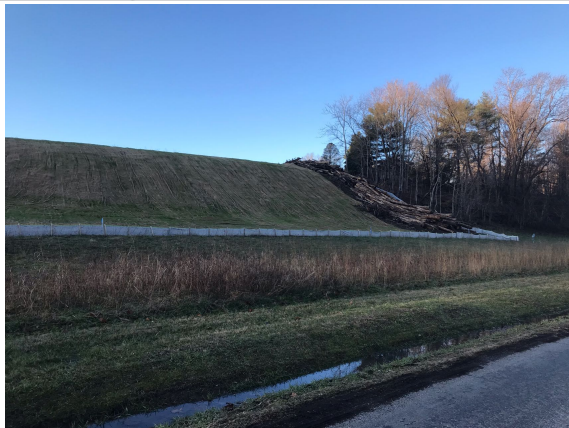
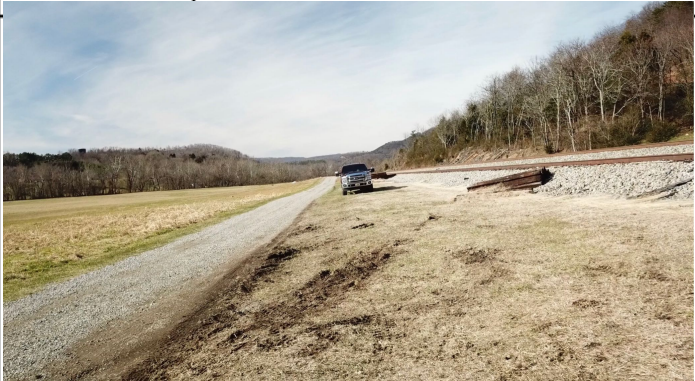
GPS Location	37.2357288468976, -80.2295613941552	GPS Location	37.235714094748, -80.2294790000471		
Description	Station 12445+00 ECD's and winter stabilization taking hold on slope south of Lafayette Road.	Description	Station 12431+00 foreign pipeline construction project traffic has damaged the road shoulder and surrounding area along MVP-MN-279.

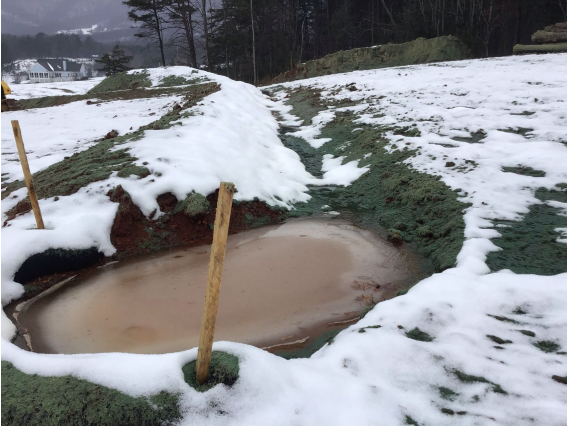
GPS Location	36.9718154682779, -79.8700514523626	GPS Location	36.9718521959888, -79.8701030899036		
Description	Functional plunge pool and waterbar near 13676+25	Description	ECD's in good condition on slope CIS of Cahas Mt #2

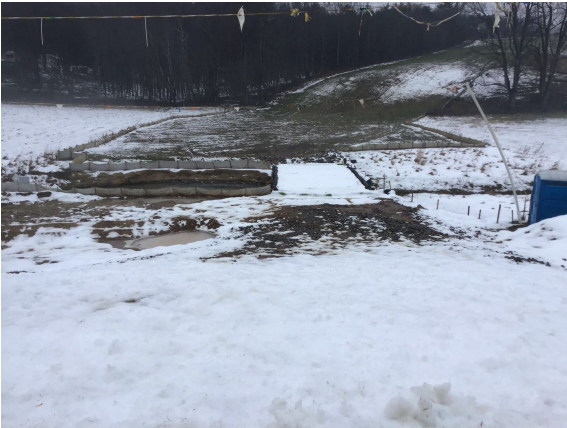
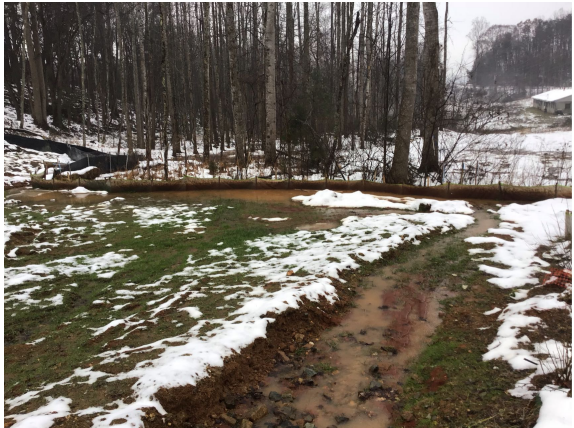
GPS Location	36.9719177484857, -79.8700279556959	GPS Location	36.9719177484857, -79.8700279556959		
Description	RoW on GAS is Cahas Mt #2	Description	Super silt fence and P1 silt fence is good condition at kickoff.

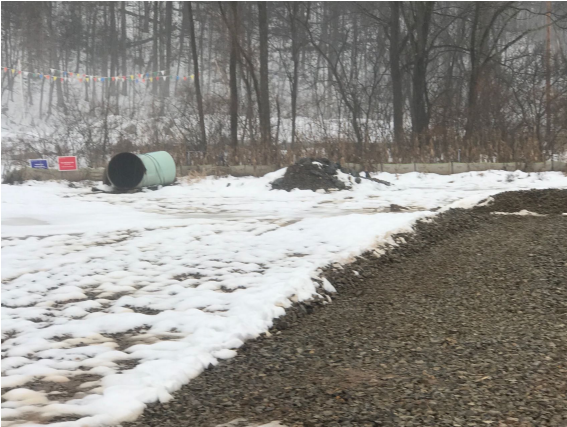
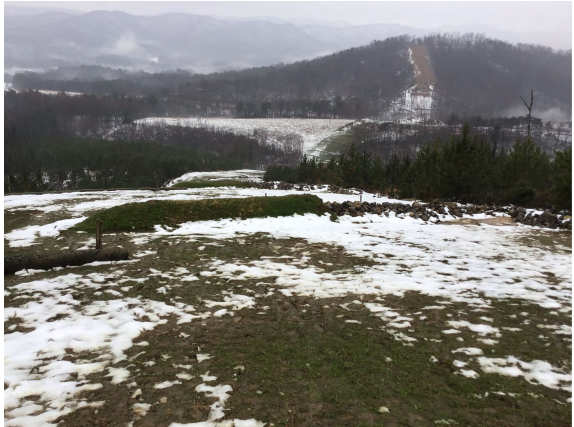
GPS Location	36.9719177484857, -79.8700279556959	GPS Location	36.9719177484857, -79.8700279556959		
Description	RCE at Leaning Oak in good condition	Description	Permanent waterbar and end treatment in good condition on CIS of 13437+00
