Visual Site Inspection Report

Project Name	H-600 Pipeline Spread H	AFE	124300138	Spread	H-600 Pipeline Spread H
Contractor	Precision			Report #	12294
Inspector	Dustin Lyons			Date/Time	12/18/2018 3:21 PM
Permit #	TBD	Inspection Type	VA SWPP	Station Begin	12005+00
State	VA	Inspection Area	Partial	Station End	12372+00
County	Montgomery	Ground	Damp	Temperature (°F)	45.00
Municipality	N/A	Weather	Sunny	Rain Gauge (in)	0.00
GPS Location	37.0698564829035, -80.6152265500649			Rain Accumulation Time (days)	1.00

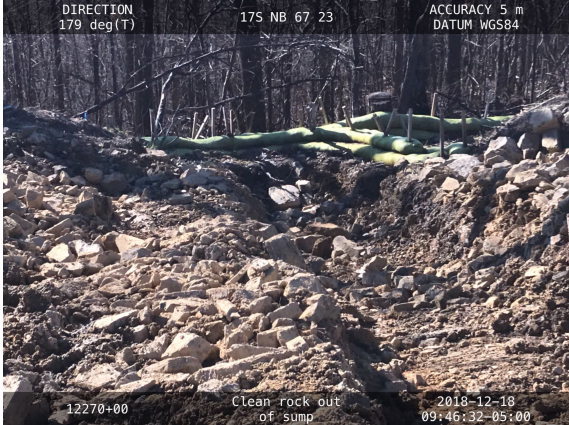
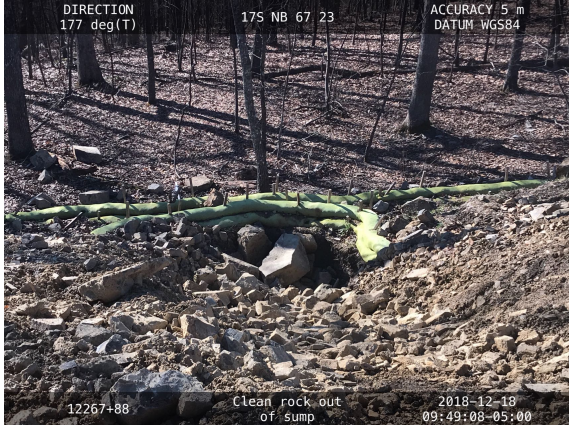
GPS Location	37.0698447024685, -80.6151612622791		GPS Location	37.0698629748372, -80.6151452740152	
Description	Photo shows the sump at 12270+00. Rock needs to be removed from the sump.		Description	Photo shows the sump at 12267+88. Rock needs to be removed from the sump.

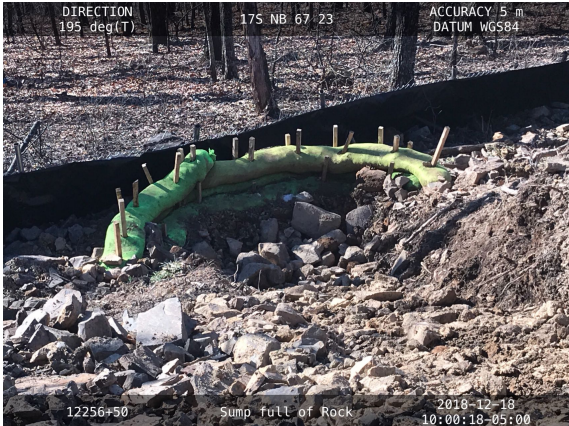
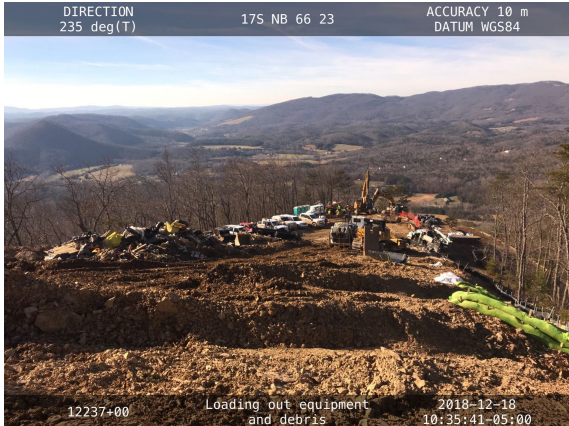
GPS Location	37.0698059304031, -80.6152921357012		GPS Location	37.0698059304031, -80.6152921357012	
Description	Photo shows the sump at 12256+50. Rock needs to be removed from the sump.		Description	Photo shows the contractor removing debris and loading out equipment near station number 12235+00.

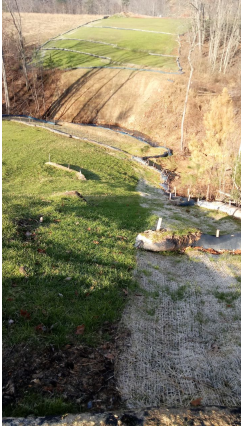
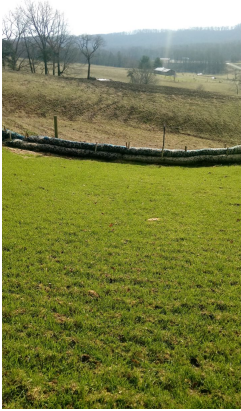
GPS Location	36.9720667368145, -79.8701221682875	GPS Location	36.9718435100389, -79.8701055507029		
Description	Controls in good condition at Stream S-IJ4	Description	Triple stacked CFS in good condition at 13506+00

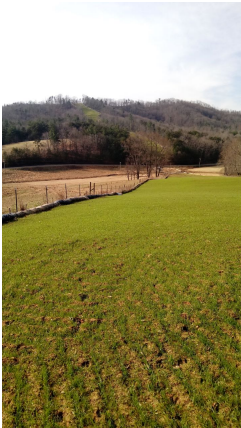
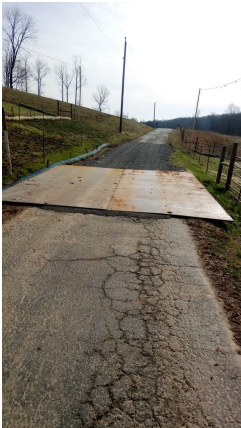
GPS Location	36.9720013579698, -79.8699849565326	GPS Location	36.9719580235304, -79.8700005468725		
Description	Perimeter ECD's and grow in at 13500+00.	Description	Private drive at 13525+99 free of mud and debris.		
Insert image here		Insert image here			
GPS Location		GPS Location			
Description		Description

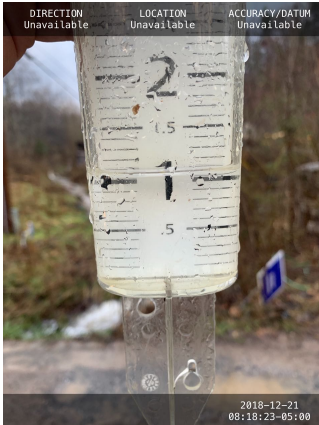
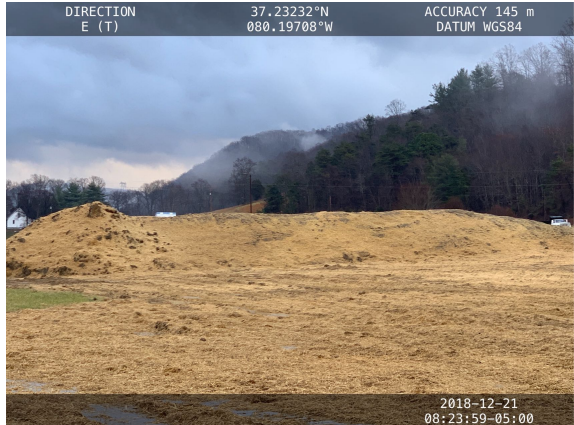
GPS Location	37.33127122218, -79.9580620962058		GPS Location	37.33127122218, -79.9580620962058	
Description	Yellow finch road_122118 Rain gauge (1.1") total for the day was 1.6".		Description	12451+00_122118 Stabilized topsoil pile. Looking W. See picture for GPS data.

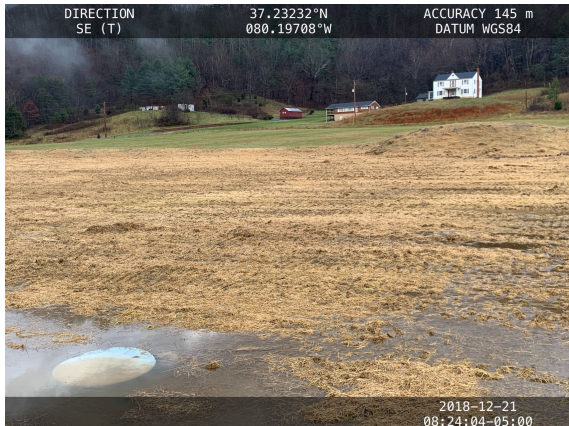
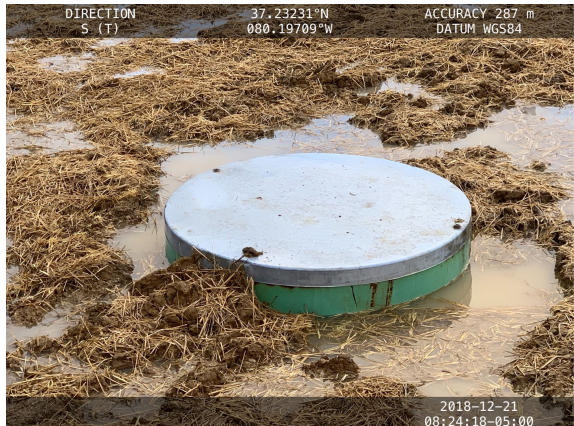
GPS Location	37.3313914452814, -79.9581399316132		GPS Location	37.3314153131105, -79.9581607238729	
Description	12451+00_122118 Stabilized ROW. Looking SE. See picture for GPS data.		Description	12451+00_122118 Pipe protecting the well point system left in place. Looking S. See picture for GPS data.

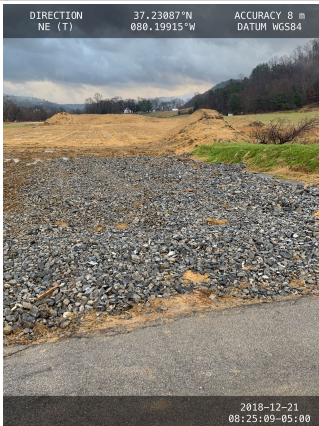
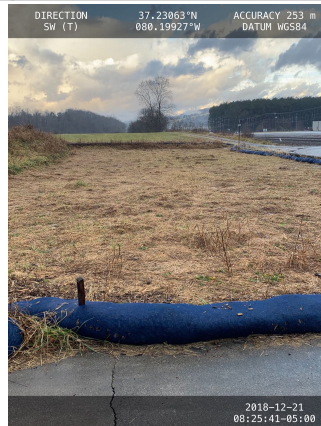
GPS Location	37.3313739688042, -79.9581122915438		GPS Location	37.3313600870005, -79.9581466079423	
Description	12451+00_122118 RCE. Looking NE. See picture for GPS data.		Description	12451+00_122118 Stabilized area disturbed in the variance. Looking SW. See picture for GPS data.

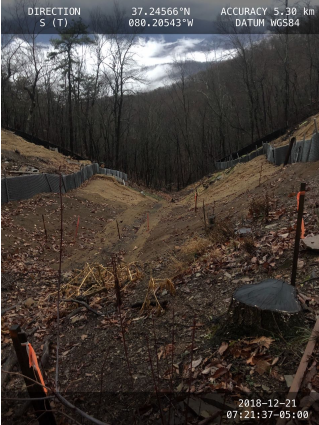
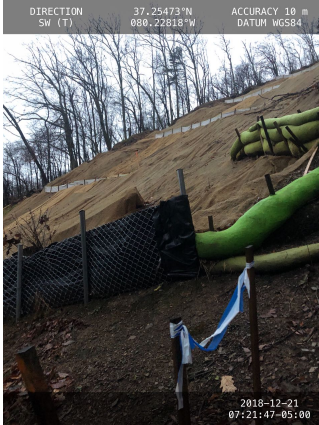
GPS Location	37.3313160761782, -79.9582395670451	GPS Location	37.3313160761782, -79.9582395670451		
Description	12291+64_122118 Drainage feature. Looking S. See picture for GPS data.	Description	12291+40_122118 Stabilized steep slope. Looking SW. See picture for GPS data.

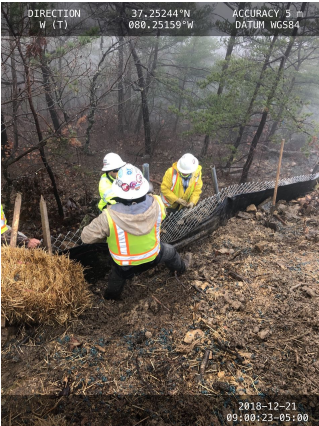
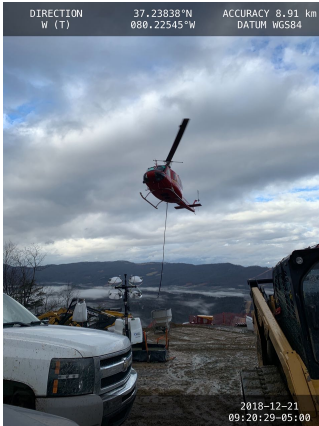
GPS Location	37.3314234987803, -79.9582557458468	GPS Location	37.3313160761782, -79.9582395670451		
Description	12215+00_122118 Crew repairing SSF. Looking W. See picture for GPS data.	Description	12234+50_122118 Helicopter loading up with earth guard. Looking W. See picture for GPS data.

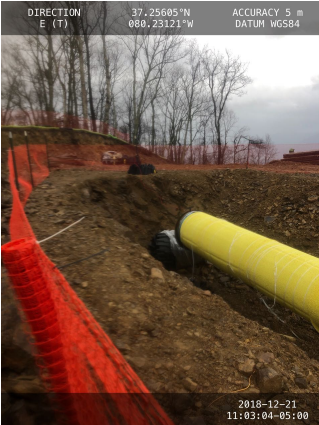
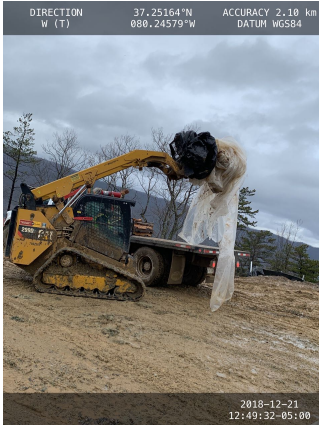
GPS Location	37.3314056261759, -79.9581274422784	GPS Location	37.3314041753671, -79.9581792153015		
Description	12279+60_122118 Safety fence around the open ditch. Looking E. See picture for GPS data.	Description	12234+50_122118 Environmental crew loading trash to haul off of the ROW. Looking W. See picture for GPS data.

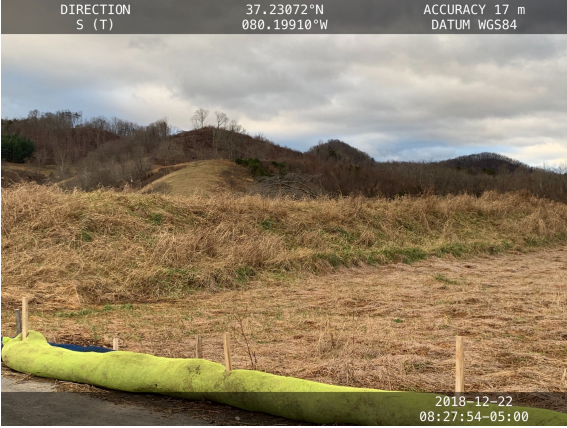
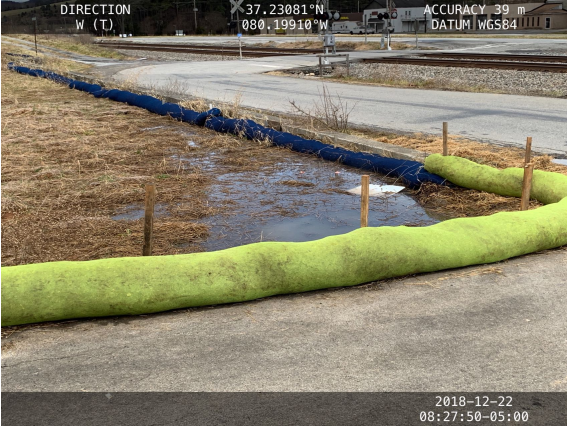
GPS Location	37.3313998018821, -79.9583185452457	GPS Location	37.3313995356636, -79.9583152647745		
Description	12451+00_122218 Stabilized topsoil pile in disturbed variance. Looking S. See picture for GPS data.	Description	12451+00_122218 CFS that was replaced due to damage. Looking W. See picture for GPS data.

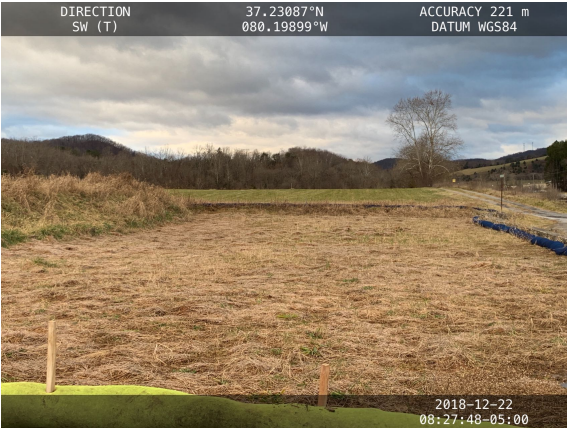
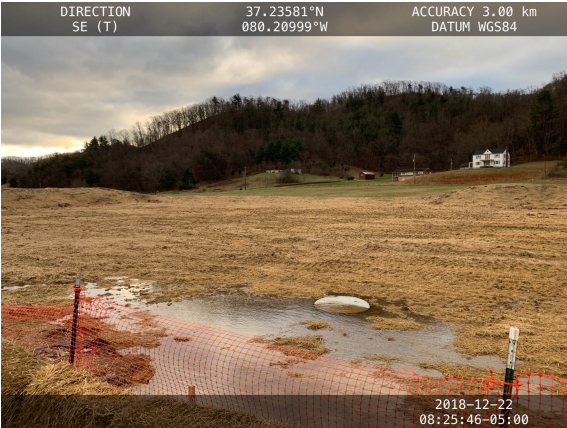
GPS Location	37.3314615308842, -79.9582977279095	GPS Location	37.3314352008302, -79.9583308435488		
Description	12451+00_122218 Stabilized disturbed variance. Looking SW. See picture for GPS data.	Description	12451+00_122218 Stabilized ROW. Looking SE. See picture for GPS data.

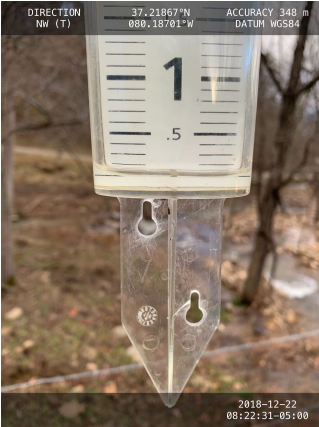
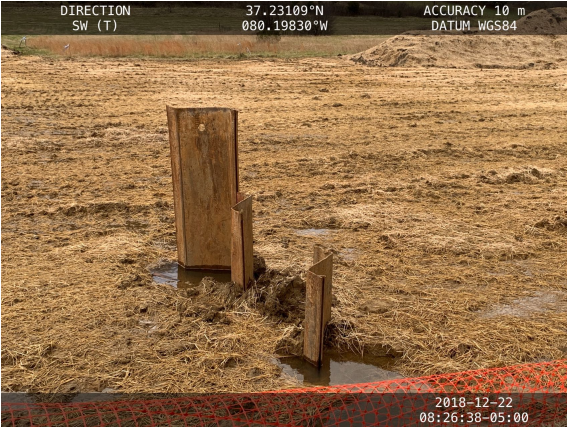
GPS Location	37.3315098926992, -79.958146086457	GPS Location	37.3315288705485, -79.9582757049287		
Description	Yellow Finch road_122218 Rain gauge totals. (.2"). Looking NW. See picture for GPS data.	Description	12451+00_122218 Sheet pilings left during stabilization. Looking SW. See picture for GPS data.

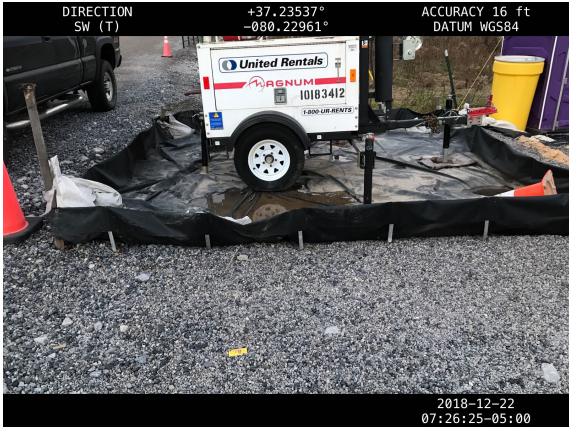
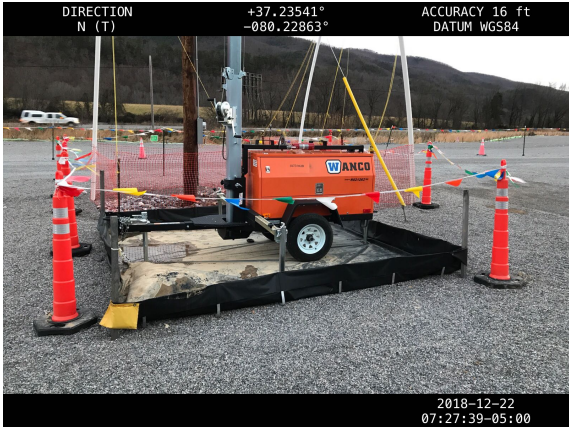
GPS Location	37.2351470304865, -80.2120841230346		GPS Location	37.2351470304865, -80.2120841230346	
Description	MVP-PY-006_122218 condition of containment under light plant. Looking SW. See photo for gps data.		Description	MVP-PY-006_122218 condition of containment under light plant. Looking N. See photo for gps data.

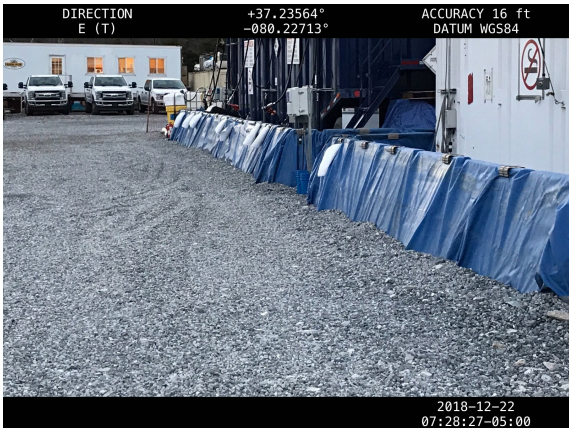
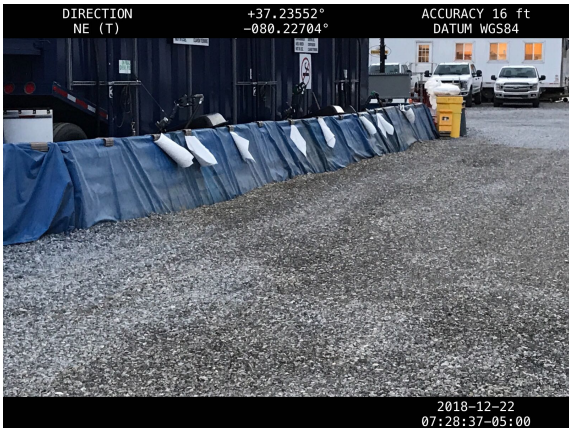
GPS Location	37.2351470304865, -80.2120841230346		GPS Location	37.2355652740572, -80.2296081651749	
Description	MVP-PY-006_122218 no fluid deposits on the north side of the bulk fuel tanks. Looking E. See photo for gaps data.		Description	MVP-PY-006_122218 no fluid deposits on the south side of the bulk fuel tanks. Looking NE. See photo for gps data.

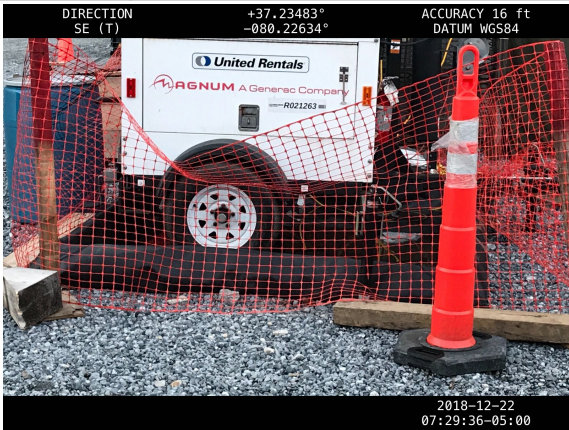
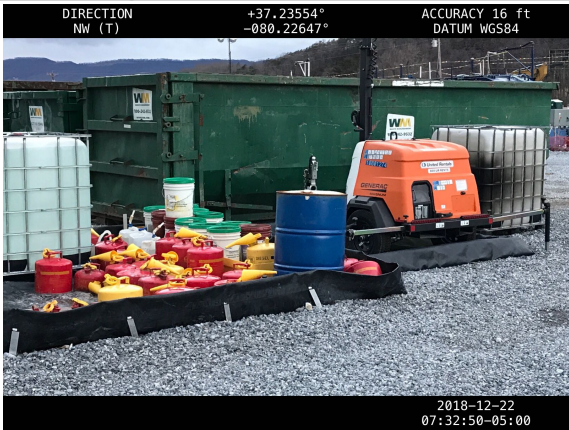
GPS Location	37.2355652740572, -80.2296081651749		GPS Location	37.2355652740572, -80.2296081651749	
Description	MVP-PY-006_122218 condition of containment under light plant. Looking SE. See photo for gps data.		Description	MVP-PY-006_122218 containment under for supplies. Looking NW. See photo for gps data.
