Visual Site Inspection Report

Project Name	H-600 Pipeline Spread H	AFE	124300138	Spread	H-600 Pipeline Spread H
Contractor	Precision			Report #	11770
Inspector	Glenn Mike Renfro			Date/Time	12/5/2018 3:09 PM
Permit #	TBD	Inspection Type	VA SWPP	Station Begin	13415+00
State	VA	Inspection Area	Full	Station End	136+70
County	Franklin	Ground	Damp	Temperature (°F)	37.00
Municipality	N/A	Weather	Cloudy	Rain Gauge (in)	0.40
GPS Location	37.0893035363751, -79.9607256800681			Rain Accumulation Time (days)	6.00

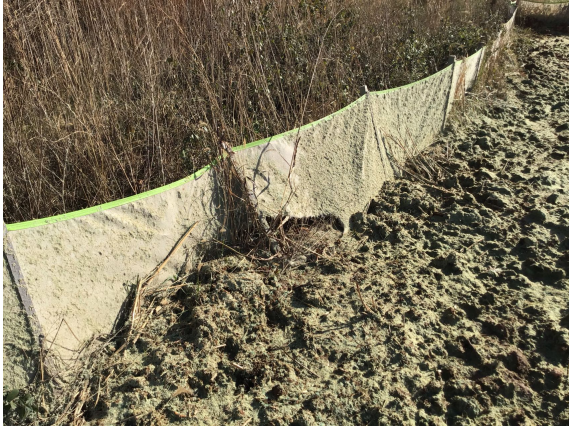
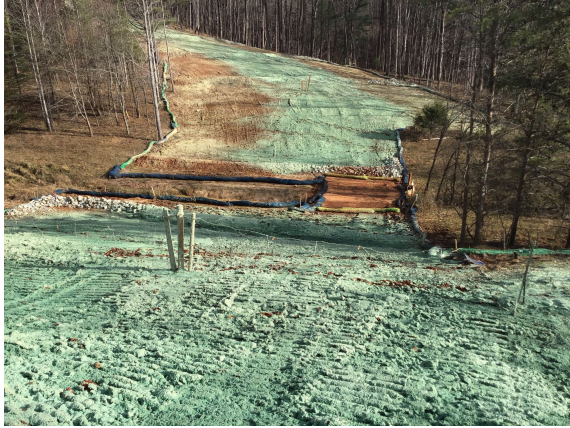
GPS Location	37.0892697153958, -79.9608168751746	GPS Location	37.089374614914, -79.9607376661896		
Description	P1 silt fence in need of repair at delineated stream on the CIS of Monty Rd	Description	Stabilization completed and resource buffer in good condition at S-II6

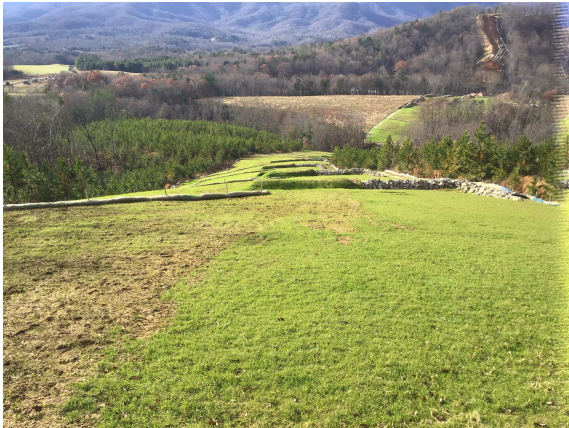
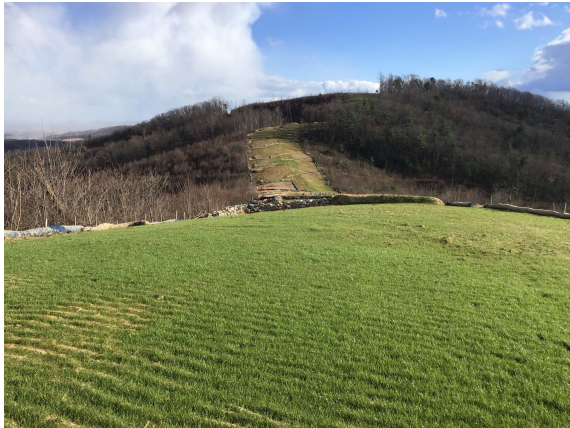
GPS Location	37.089374614914, -79.9607376661896	GPS Location	37.089374614914, -79.9607376661896		
Description	Grow in and permanent waterbars in good condition on the CIS of 13437+00	Description	Grow in and permanent waterbars in good condition of the GAS at 13437+00

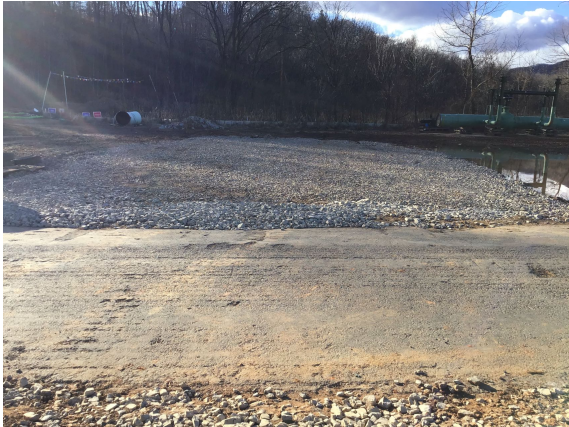
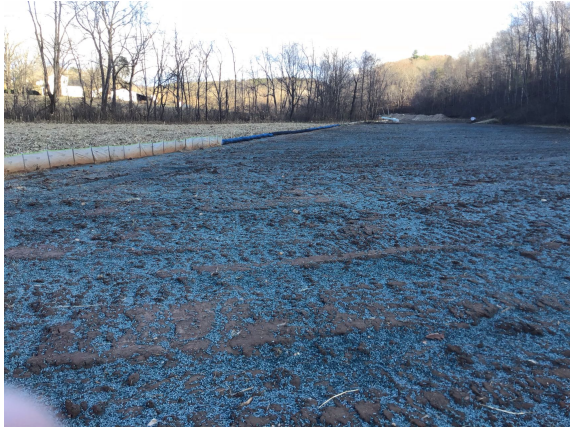
GPS Location	37.089374614914, -79.9607376661896	GPS Location	37.089374614914, -79.9607376661896		
Description	RCE on the CIS of Leaning Oak in good condition.	Description	Stabilization completed and perimeter ECD's in good condition at approximately 13635+00

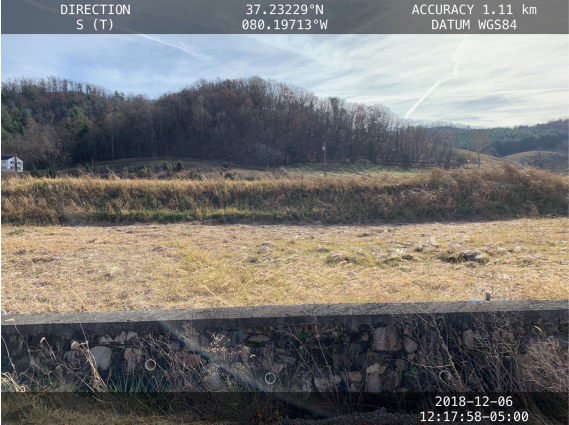
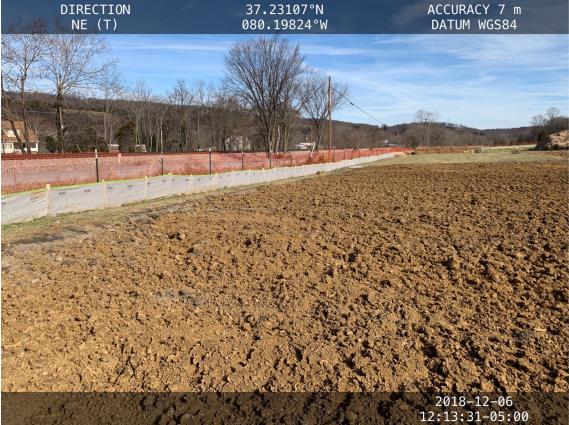
2018-12-06 12:13:31-05:00			
GPS Location	37.2356579196676, -80.2296004960249	GPS Location	37.2356579196676, -80.2296004960249		
Description	12451+00_120618 Disturbed variance stabilized. Looking S. See picture for GPS data.	Description	12451+00_120618 P1 Silt fence and safety fence down the road side perimeter. Looking NE. See picture for GPS data.		
DIRECTION SE (T) 37.23241°N ACCURACY 65 m 080.19682°W DATUM WGS84

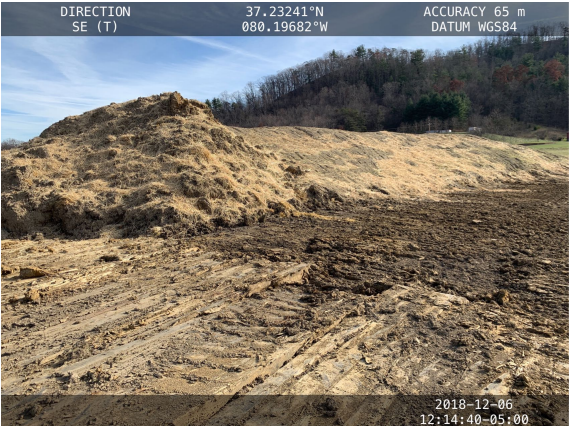
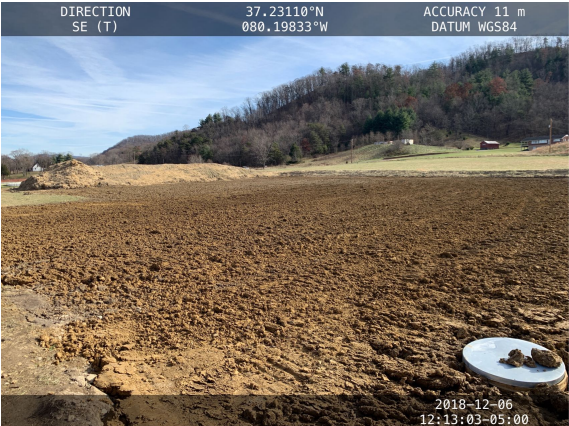
2018-12-06 12:13:03-05:00			
GPS Location	37.2356579196676, -80.2296004960249	GPS Location	37.2356579196676, -80.2296004960249		
Description	12451+20_120618 Stabilized topsoil pile. Looking SE. See picture for GPS data.	Description	12451+20_120618 Area where the crew has rough cleaned up the ROW. Looking SE. See picture for GPS data.

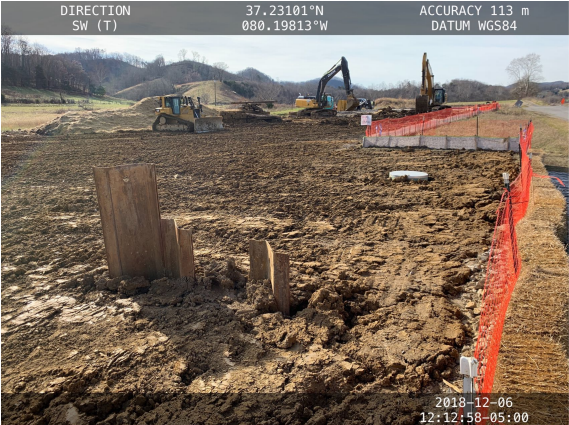
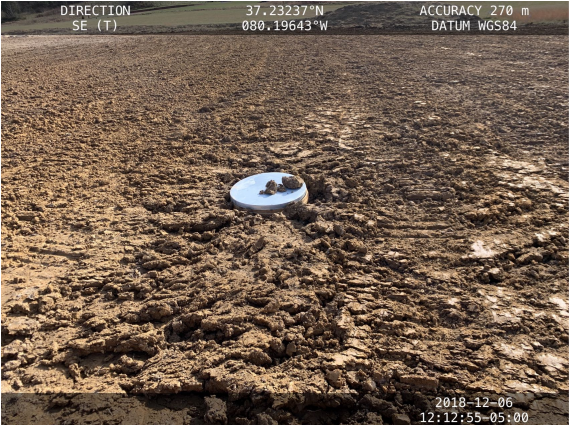
2018-12-06 12:12:55-05:00			
GPS Location	37.2355162965968, -80.2295153348921	GPS Location	37.2356064067685, -80.2295661191191		
Description	12451+00_120618 HWY 11 bore pit after it was back filled. Looking SW. See picture for GPS data.	Description	12451+00_120618 Piece of pipe and night cap covering well system. Looking SE. See picture for GPS data.

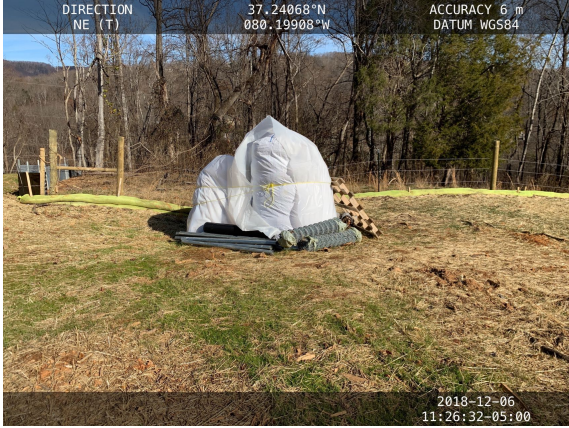
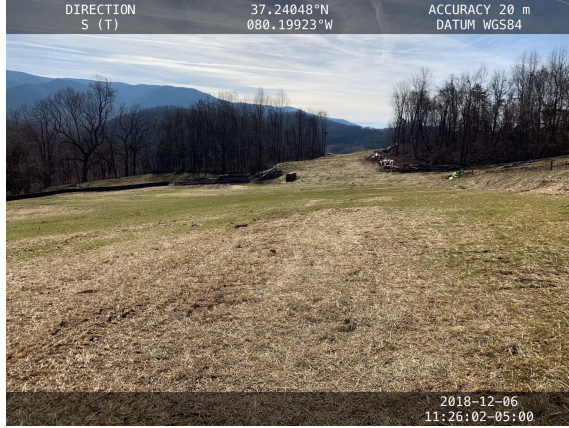
GPS Location	37.2356541964372, -80.229588414444	GPS Location	37.2356541964372, -80.229588414444		
Description	12409+03_120618 Materials staged Incase of emergency during the winter. Looking NE. See picture for GPS data.	Description	12405+00_120618 Stabilized ROW. Looking S. See picture for GPS data.

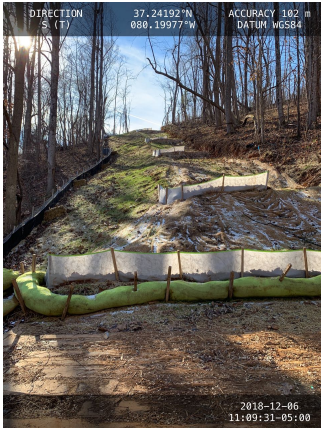
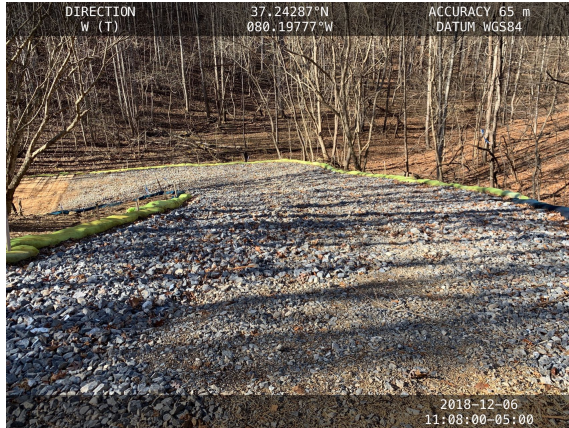
GPS Location	37.2356457520574, -80.2298253274855	GPS Location	37.235333835792, -80.2294591136429		
Description	MVP-MLV-AR-27_120618 Access road heading up the hill. Looking S. See picture for GPS data	Description	MVP-MLV-AR-27_120618 RCE. Looking W. See picture for GPS data.

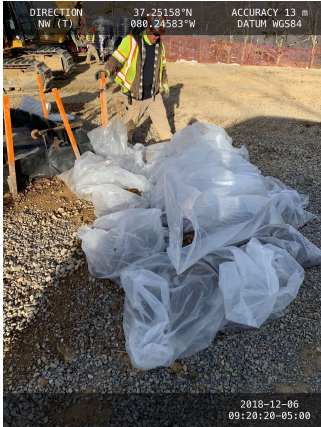
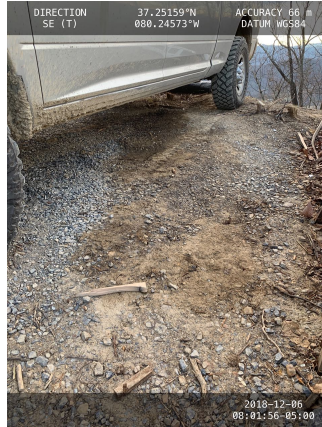
GPS Location	37.235333835792, -80.2294591136429	GPS Location	37.235333835792, -80.2294591136429		
Description	12234+59_120618 Bags with sediment after a spill clean up. Looking NW. See picture for GPS data.	Description	12234+59_120618 Diesel spill where the trucks park. Looking SE. See picture for GPS data.

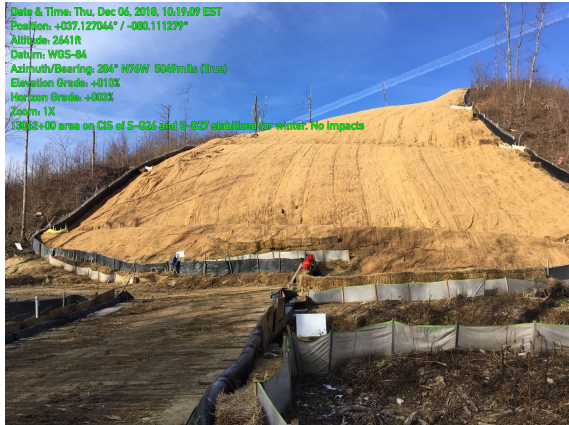
A/E	124300138	Date/Time	12/6/2018 2:34 PM	Report #	11822
Pictures					
<p>Date & Time: Thu, Dec 06, 2018, 10:19:09 EST Position: +037.127044° / -080.111279° Altitude: 2641ft Datum: WGS-84 Azimuth/Bearing: 204° N76W 504ft/mile (True) Elevation Grade: +010% Horizon Grade: +003% Zoom: 1X 13052+00 area on C15 of S-026 and S-027 stabilized for winter. No impacts</p>

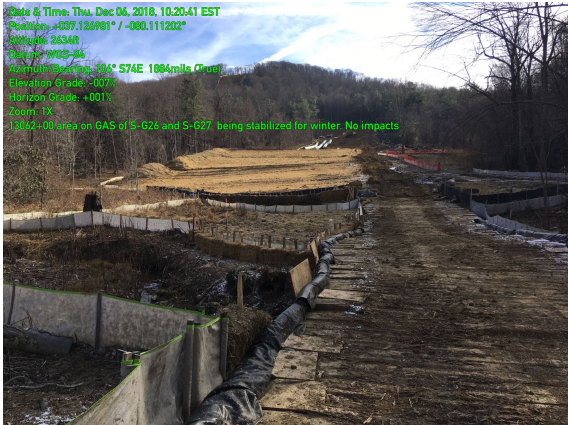
<p>Date & Time: Thu, Dec 06, 2018, 10:20:41 EST Position: +037.126981° / -080.111202° Altitude: 2634ft Datum: WGS-84 Azimuth/Bearing: 102° S74E 1884ft/mile (True) Elevation Grade: +000% Horizon Grade: +001% Zoom: 1X 13052+00 area on G45 of S-026 and S-027 being stabilized for winter. No impacts</p>

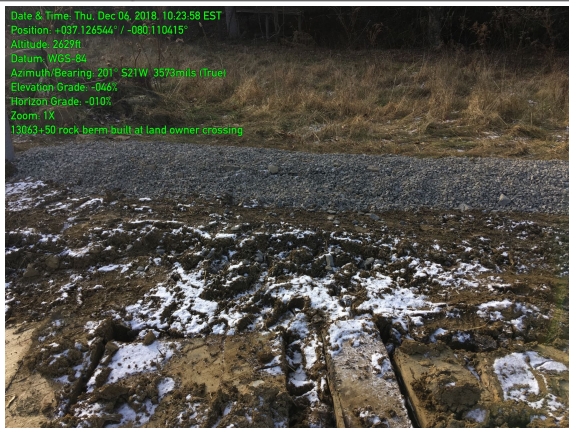
GPS Location	37.118369294365, -80.0951237977297		GPS Location	37.1183542488489, -80.095108626485	
Description	No impacts observed in area		Description	No impacts observed in area.	
<p>Date & Time: Thu, Dec 06, 2018, 10:23:58 EST Position: +037.126544° / -080.110415° Altitude: 2629ft Datum: WGS-84 Azimuth/Bearing: 201° S21W 3593ft/mile (True) Elevation Grade: +04% Horizon Grade: +010% Zoom: 1X 13063+00 rock berm built at land owner crossing</p>

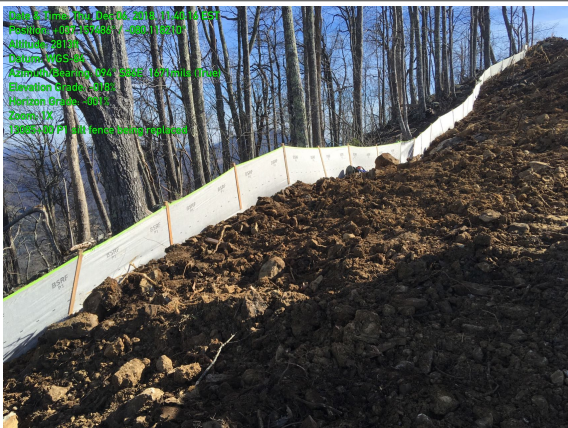
<p>Date & Time: Thu, Dec 06, 2018, 10:24:01 EST Position: +037.126544° / -080.110415° Altitude: 2629ft Datum: WGS-84 Azimuth/Bearing: 201° S21W 3593ft/mile (True) Elevation Grade: +04% Horizon Grade: +010% Zoom: 1X 13063+00 P1 silt fence being replaced</p>

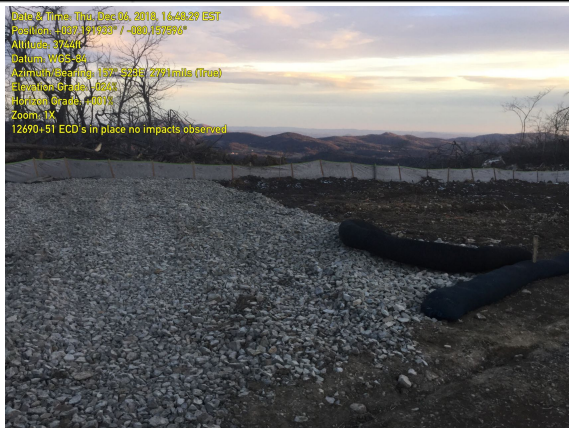
GPS Location	37.1183542488489, -80.095108626485		GPS Location	37.1183542488489, -80.095108626485	
Description	12" CFS replaced with rock berms where landowner crosses ROW.		Description	Damaged P1 silt fence being replaced along edge of ROW.	
<p>Date & Time: Thu, Dec 06, 2018, 16:48:37 EST Position: +037.127033° / -080.157596° Altitude: 3724ft Datum: WGS-84 Azimuth/Bearing: 102° S74E 1884ft/mile (True) Elevation Grade: +001% Horizon Grade: +014% Zoom: 1X 12690+51 ECD's in place no impacts observed</p>

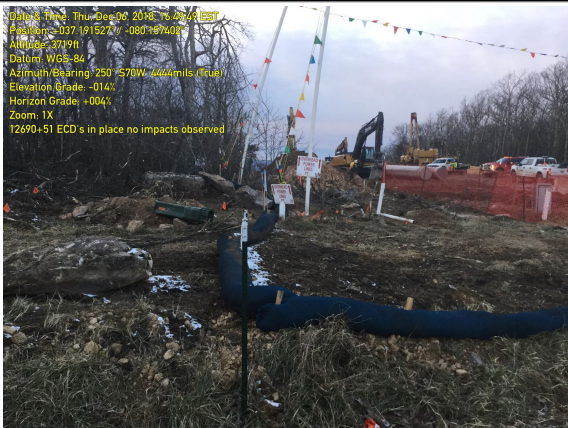
<p>Date & Time: Thu, Dec 06, 2018, 16:49:44 EST Position: +037.151527° / -080.167400° Altitude: 3719ft Datum: WGS-84 Azimuth/Bearing: 125° S78W 1444ft/mile (True) Elevation Grade: +014% Horizon Grade: +004% Zoom: 1X 12690+51 ECD's in place no impacts observed</p>

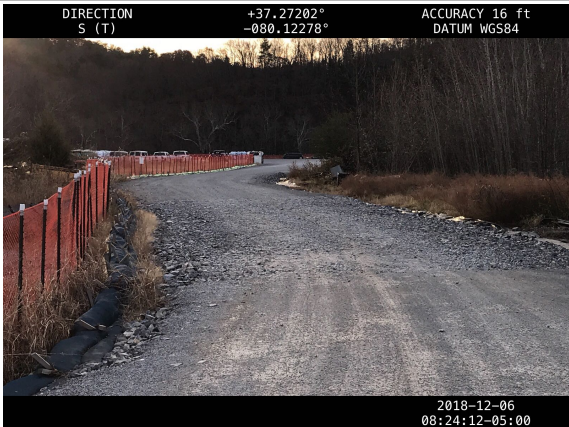
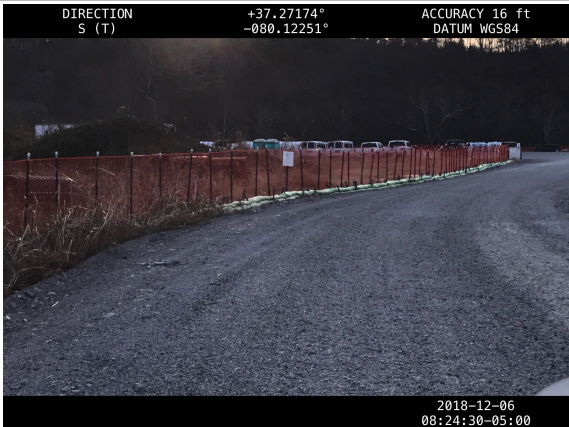
GPS Location	37.2702649282639, -80.1235019043834	GPS Location	37.2702670237397, -80.1235009823741		
Description	MVP-LY-049_120618 rock approach in good condition. Looking S. See photo for gps data.	Description	MVP-LY-049_120618 condition of safety fence and compost filter sock good. Looking S. See photo for gps data.

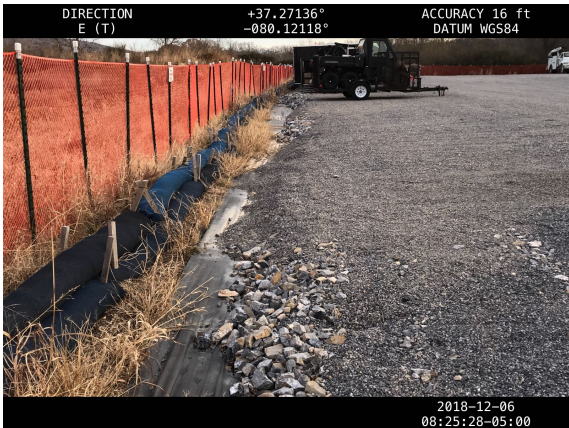
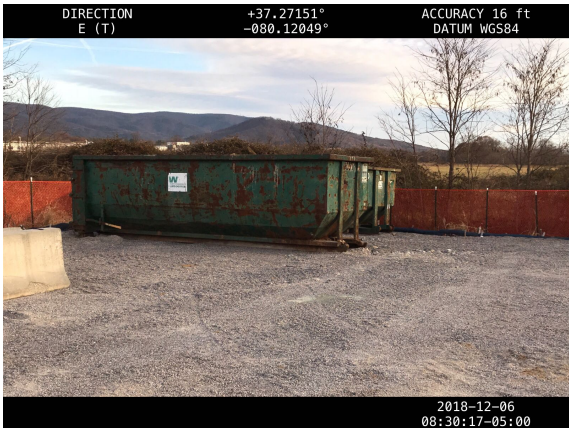
GPS Location	37.2702670237397, -80.1235009823741	GPS Location	37.2702670237397, -80.1235009823741		
Description	MVP-LY-049_120618 condition of safety fence and compost filter sock on the north boundary. Looking E. See photo for gps data.	Description	MVP-LY-049_120618 dumpster area clean and free of loose trash. Looking E. See photo for gps data.

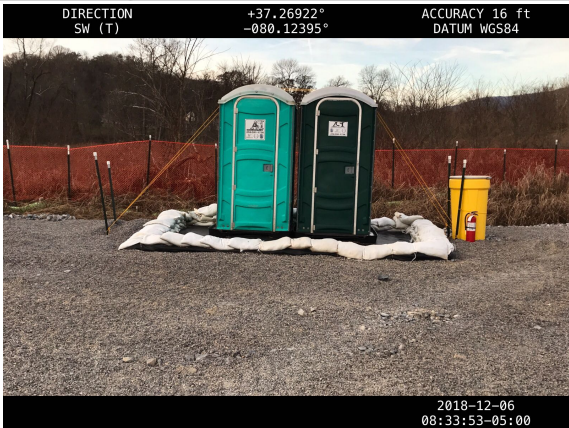
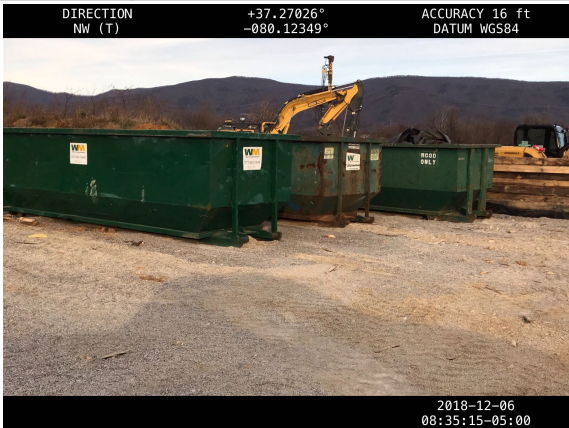
GPS Location	37.2702670237397, -80.1235009823741	GPS Location	37.2702670237397, -80.1235009823741		
Description	MVP-LY-049_120618 condition of containment under porta toilets. Looking SW. See photo for gps data.	Description	MVP-LY-049_120618 dumpster clean and free of loose trash. Looking NW. See photo for gps data.

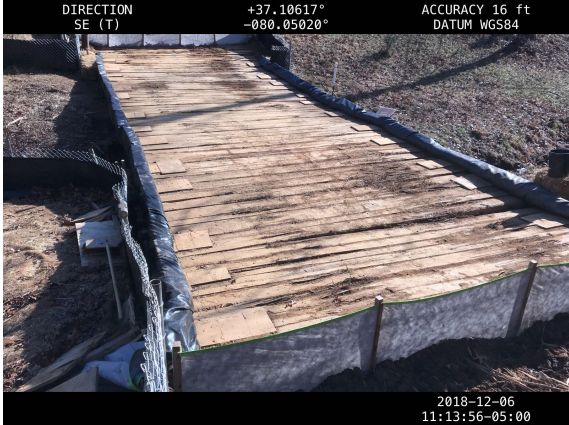
GPS Location	37.0932496106598, -80.0300510600955	GPS Location	37.0932496106598, -80.0300510600955		
Description	13321+47_120618 S-GH15 timber mat bridge clean and closed. Looking SE. See photo for gps data.	Description	13325+30_120618 S-GH14 timber mat bridge clean and closed. Looking E. See photo for gps data.

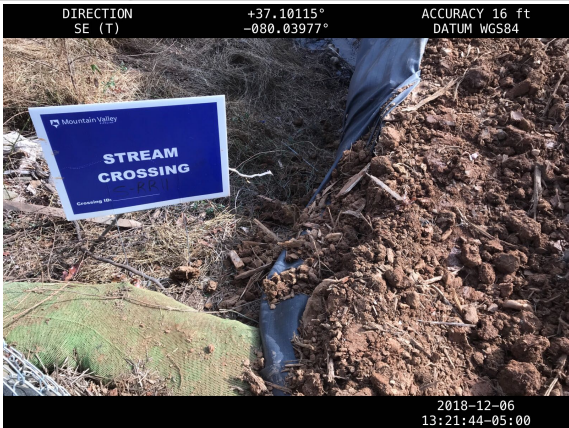
GPS Location	37.0932517480451, -80.0300409179926	GPS Location	37.0932517480451, -80.0300409179926		
Description	13348+46_120618 S-RR08 bridge bumpers knocked off bridge. No impact to feature. Looking NW. See photo for gps data.	Description	13352+23_120618 S-RR09 bridge bumpers knocked off bridge. No impact to feature. Looking SE. See photo for gps data.

GPS Location	37.0932517480451, -80.0300409179926	GPS Location	37.0932517480451, -80.0300409179926		
Description	13358+64_120618 S-RR11 side bumpers knocked off bridge. No impact to channel. Looking SE. See photo for gps data.	Description	13358+64_120618 S-RR11 pipe pillow in fracture channel. Looking SE. See photo for gps data.
