Visual Site Inspection Report

Project Name	H-600 Pipeline Spread H	AFE	124300138	Spread	H-600 Pipeline Spread H
Contractor	Precision			Report #	12597
Inspector	Glenn Mike Renfro			Date/Time	1/3/2019 2:11 PM
Permit #	TBD	Inspection Type	VA SWPP	Station Begin	13415+00
State	VA	Inspection Area	Full	Station End	13670+00
County	Franklin	Ground	Wet	Temperature (°F)	54.00
Municipality	N/A	Weather	Light Rain	Rain Gauge (in)	2.25
GPS Location	36.9720863923775, -79.8699340783803			Rain Accumulation Time (days)	6.00

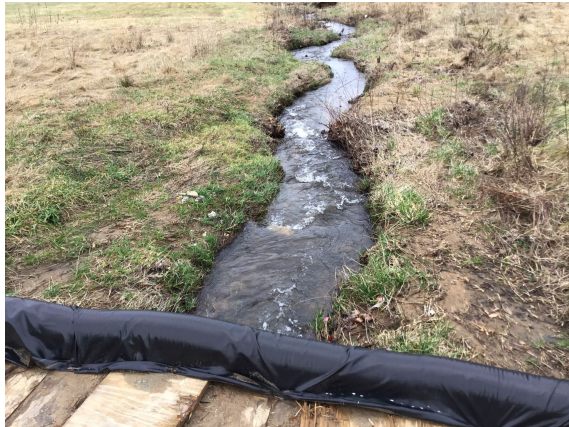
GPS Location	36.972031659307, -79.8702624200903	GPS Location	36.9716337696062, -79.8700190708785		
Description	Stream S-IJ10 flowing free and clear of any sediment.	Description	Slope on CIS of Cahas Mt #2 permanent stabilization in good condition.

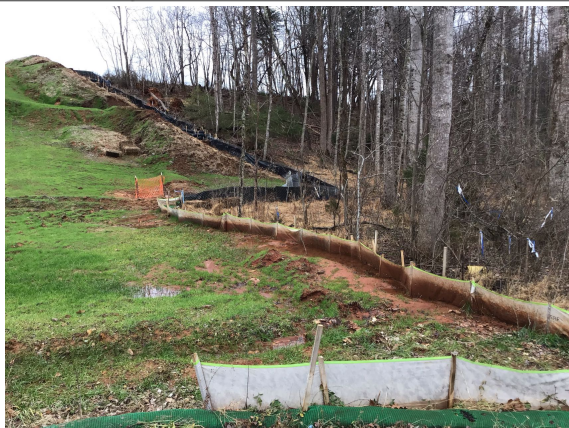
GPS Location	36.9717394654052, -79.8699645046889	GPS Location	36.9719275972219, -79.8702136986701		
Description	perimeter ECD's in good condition at kickoff 13415+00	Description	Perimeter ECD's in good condition near 13626+00

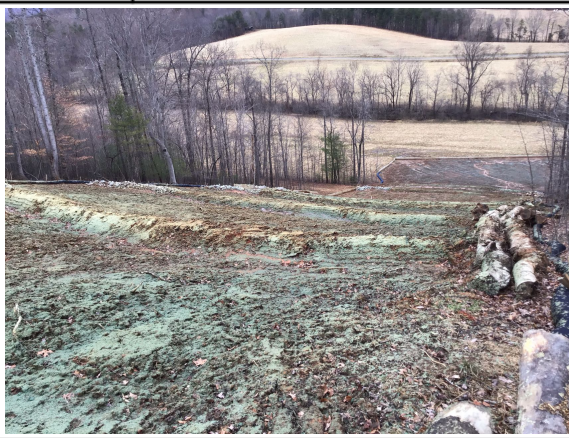
Insert image here			
GPS Location	36.972016319667, -79.8701251019536	GPS Location			
Description	Permanent waterbars and end treatments in acceptable condition at 13630+00.	Description

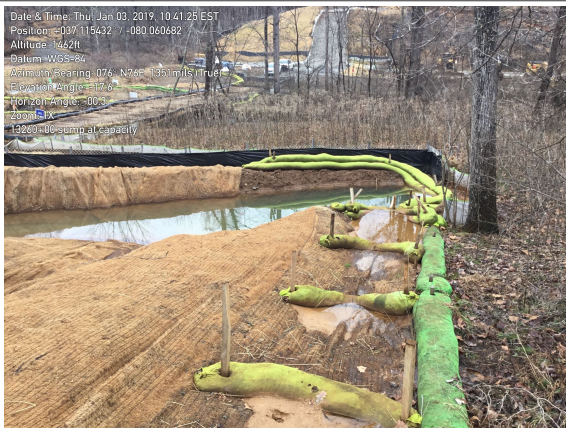
</div>		<div><p>Date & Time: Thu Jan 03, 2019, 10:41:25 EST Position: +037.115432 / -80.028082 Altitude: 142ft Datum: WGS-84 Azimuth/Bearing: 074.874E 131mils (True) Elevation Angle: -27.6 Horizon Angle: -00.3 Zoom: 1X 13260+00 sump at capacity</p>

GPS Location	37.3254318908205, -80.0287175831199		GPS Location	37.3254725011413, -80.0287691318244	
Description	Please see photo for coordinates. Sta. No. 13252+00, sediment laden water bypassed outlet protection, sediment within LOD.		Description	Please see photo for coordinates. Sta. No. 13260+00, sump at capacity, CWD steadily flowing water, P1 at outlet needs repair.	
<div><p>Date & Time: Thu Jan 03, 2019, 13:04:04 EST Position: +037.106603 / -80.028593 Altitude: 1370ft Datum: WGS-84 Azimuth/Bearing: 233.553W 414mils (True) Elevation Angle: -10.1 Horizon Angle: -00.4 Zoom: 1X GAS S-GH7, waterbar ponding</p>

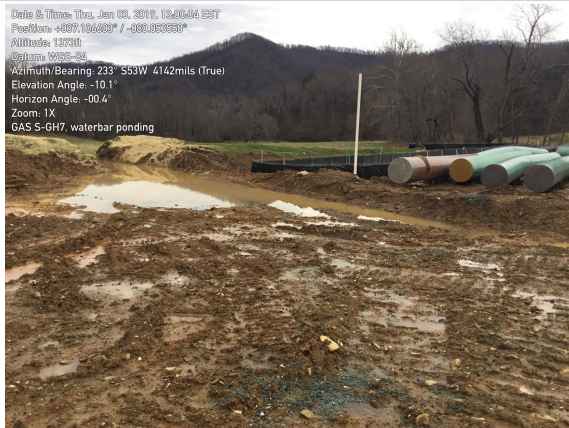
Description	Please see photo for coordinates. Sta. No. 13310+00, waterbar and sump ponding, berm low in travel lane.		Description	Please see photo for coordinates. Sta. No. 13315+70, CFS buried on rock pile.

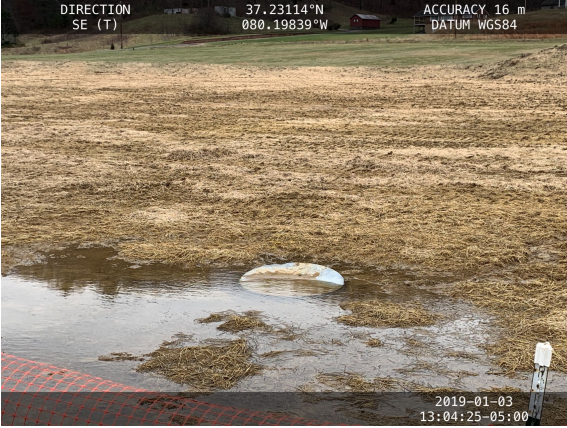
GPS Location	37.3314212447624, -79.9580696458209		GPS Location	37.3313829729552, -79.9580380297532	
Description	12451+00_010319 Night cap covering the well point system. Looking SE. See picture for GPS data.		Description	12451+00_010319 Sheet pilings for the bore pit. Looking SW. See picture for GPS data.

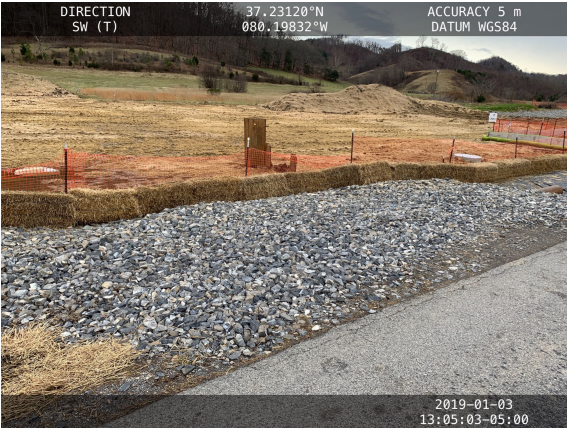
GPS Location	37.3313596302425, -79.9580199772176		GPS Location	37.3313689247673, -79.9580273971848	
Description	12451+00_010319 RCE. Looking SW. See picture for GPS data.		Description	12451+00_010319 Stabilized top soil pile. Looking SW. See picture for GPS data.

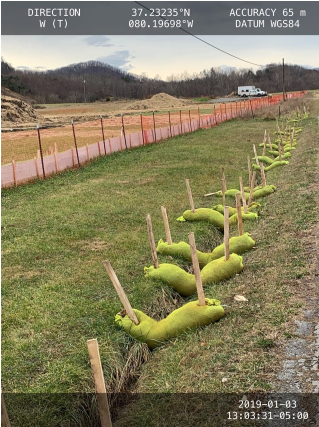
GPS Location	37.331369804525, -79.9580168769191		GPS Location	37.3313627210398, -79.958015740613	
Description	12451+00_010319 Checks in ditch from dewatering activity. Looking W. See picture for GPS w.		Description	Yellow finch road_010319 Rain gauge totals (.2") Looking NW. See picture for GPS data.
