Visual Site Inspection Report

Project Name	H-600 Pipeline Spread H	AFE	124300138	Spread	H-600 Pipeline Spread H
Contractor	Precision			Report #	13233
Inspector	Dawn McCullough			Date/Time	1/21/2019 8:52 PM
Permit #	TBD	Inspection Type	VA SWPP	Station Begin	13188+66
State	VA	Inspection Area	Partial	Station End	13315+18
County	Franklin	Ground	Frozen	Temperature (°F)	27.00
Municipality	N/A	Weather	Below Freezing Tem	Rain Gauge (in)	0.80
GPS Location	37.0916088712241, -80.051420237472			Rain Accumulation Time (days)	1.00

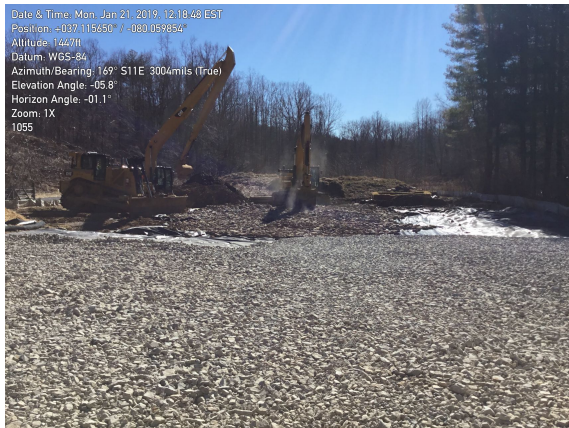
GPS Location	37.1157543501231, -80.059905974269	GPS Location	37.1157543501231, -80.059905974269		
Description	Please see photo for coordinates. MVP-AR-29, access road maintained, no environmental issues observed.	Description	Please see photo for coordinates. S-II/4, ECDs functioning acceptably at stream crossing.		
<p>Date & Time: Mon Jan 21, 2019, 12:18:48 EST Position: -037.115650 / -080.059854 Altitude: 1467ft Datum: WGS-84 Azimuth/Bearing: 169° S11E 3004mils (True) Elevation Angle: -05.8° Horizon Angle: -01.1° Zoom: 1X 1055</p>

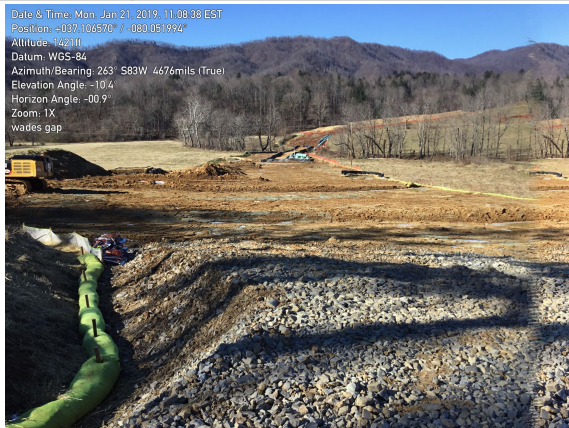
GPS Location	37.1157543501231, -80.059905974269	GPS Location	37.1156772366139, -80.0599286054075		
Description	Please see photo for coordinates. ATWS-1055, geotech and rocking additional workspace.	Description	Please see photo for coordinates. Flanders Road, rock construction entrance and road maintained.		
<p>Date & Time: Mon Jan 21, 2019, 11:08:38 EST Position: -037.106570 / -080.051934 Altitude: 1421ft Datum: WGS-84 Azimuth/Bearing: 263° S83W 4476mils (True) Elevation Angle: -10.4° Horizon Angle: -00.9° Zoom: 1X wades gap</p>

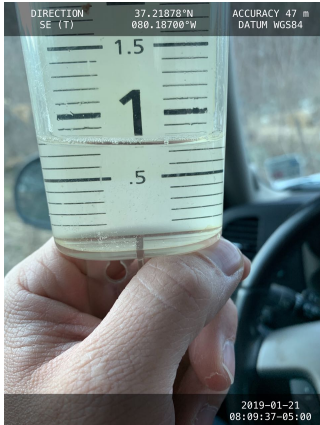
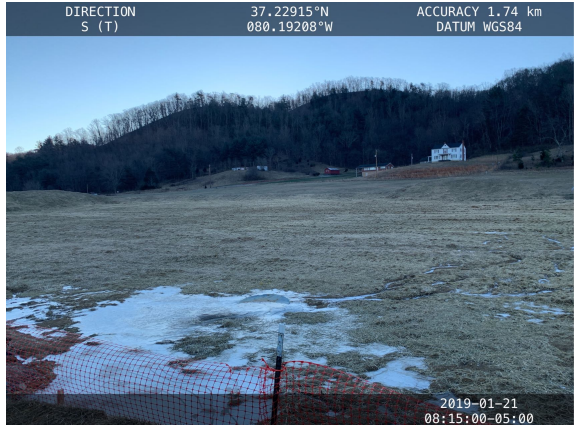
GPS Location	37.2545676030628, -80.1745526632228		GPS Location	37.2545676375548, -80.1745525302447	
Description	YellowFinchRoad_012119 Rain gauge totals after thawing out the ice. Looking SE. See picture for GPS data.		Description	12451+00_012119 Stabilized ROW. Looking S. See picture for GPS data.

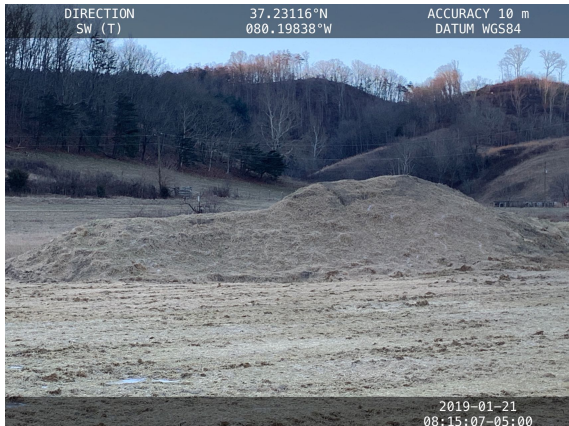
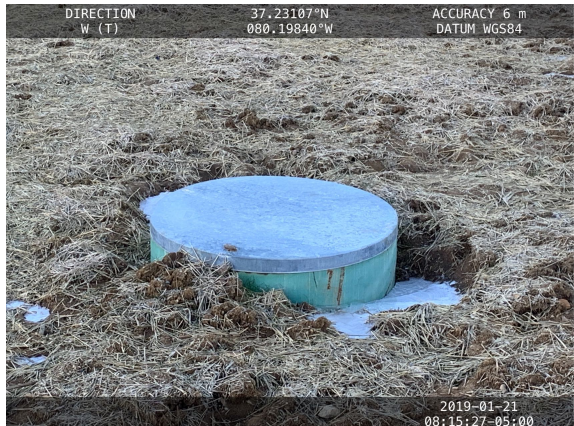
GPS Location	37.2545874216555, -80.1745343784131		GPS Location	37.2545669137179, -80.1745542769357	
Description	12451+20_012119 Stabilized topsoil pile. Looking SW. See picture for GPS data.		Description	12451+00_012119 End cap and pipe protecting the well point system. Looking W. See picture for GPS data.

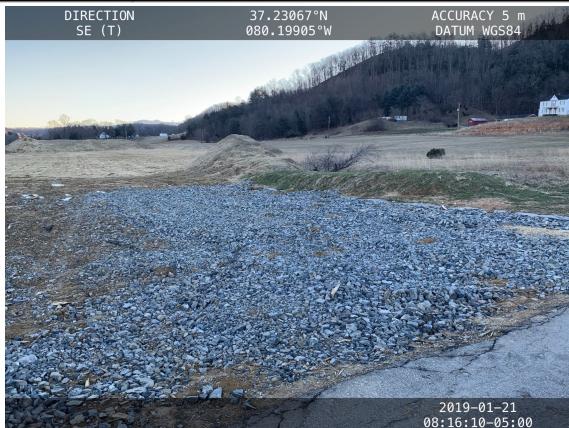
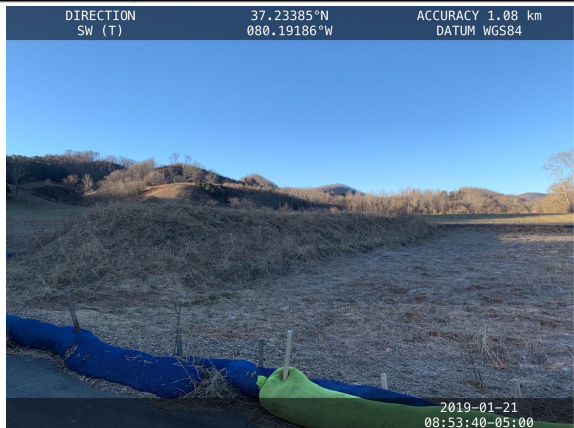
GPS Location	37.2545643398564, -80.174566020377		GPS Location	37.2545669137179, -80.1745542769357	
Description	12452+50_012119 RCE. Looking SE. See picture for GPS data.		Description	12453+00_012119 Stabilized topsoil in the disturbed variance. Looking SW. See picture for GPS data.

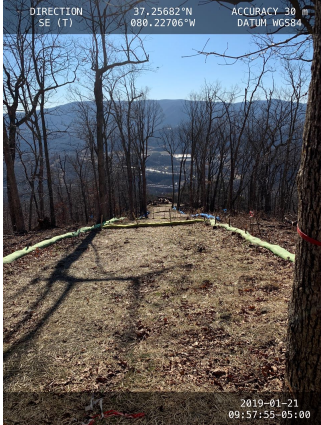
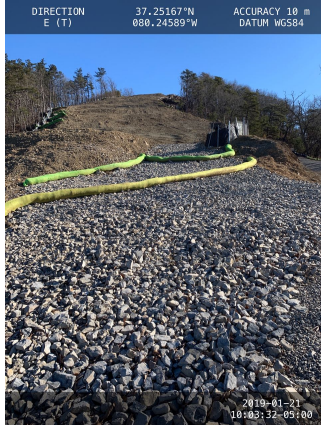
GPS Location	37.2311023742731, -80.1983536535916	GPS Location	37.2311023742731, -80.1983536535916		
Description	MBP-MN-276.03_012119 Stabilized travel lane down to the ROW. Looking SE. See picture for GPS data.	Description	12234+77_013119 RCE. LOOKING E. See picture for GPS data.

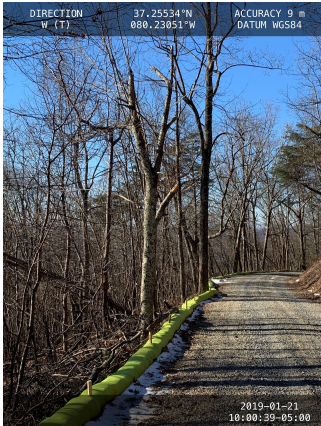
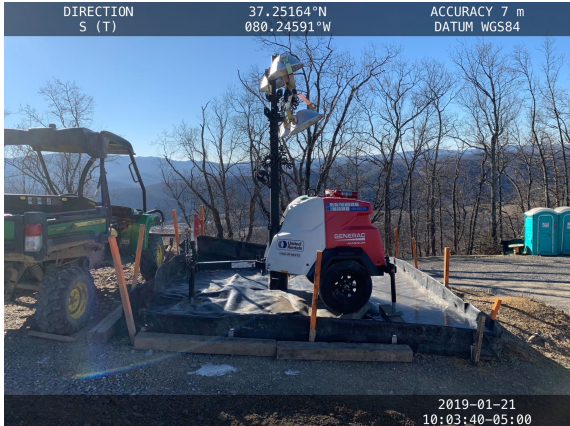
GPS Location	37.2311023742731, -80.1983536535916	GPS Location	37.2311023742731, -80.1983536535916		
Description	MVP-MN-276.03_012119 CFS along road side. Looking W. See picture for GPS data.	Description	12234+60_012119 light plant in containment. Looking S. See picture for GPS data.

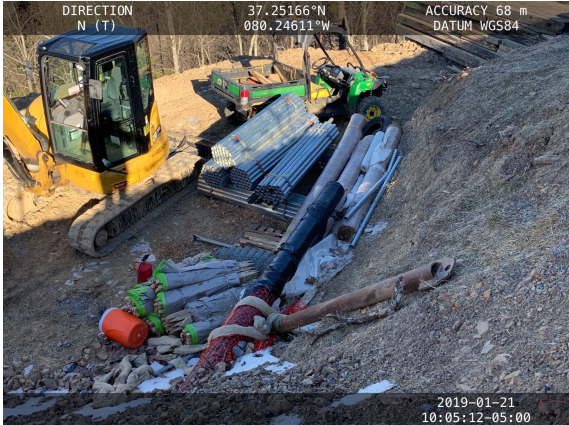
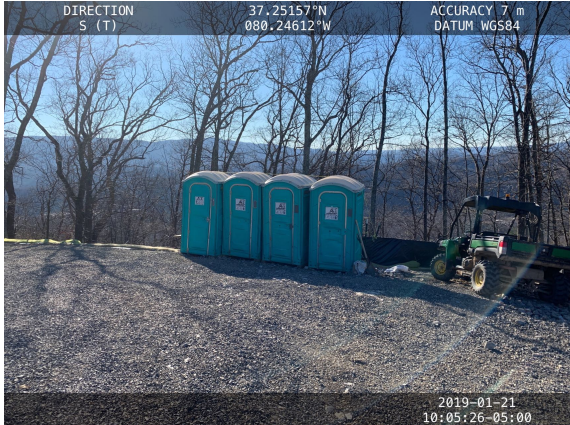
GPS Location	37.2310969841533, -80.198522389837	GPS Location	37.2309964069393, -80.1983780737664		
Description	12234+50_012119 Materials staged Incase of emergency. Looking N. See picture for GPS data.	Description	12234+50_012119 Port-O-Potties. Looking S. See picture for GPS data.

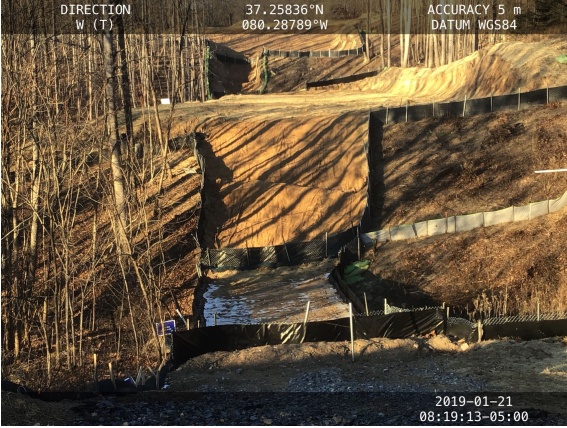
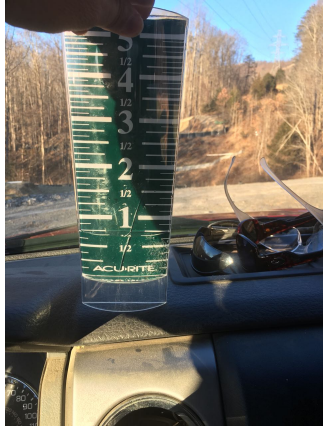
GPS Location	37.2584149288361, -80.2877187263968	GPS Location	37.2583896993075, -80.2875456400963		
Description	Stream S-MM11, station 12101+57, facing west.	Description	There was 0.75 inches of rain in the rain gauge at Half Acre Rock Road after thawing it out inside my vehicle.

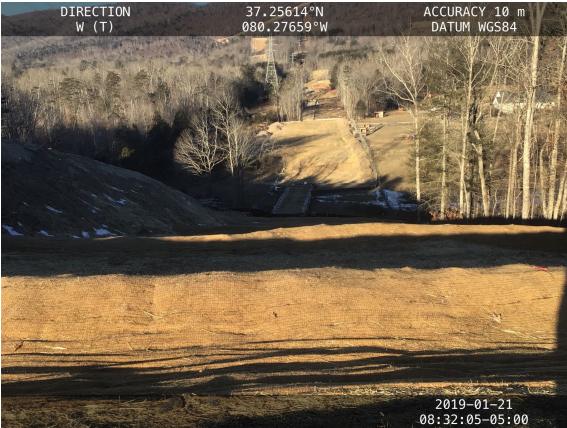
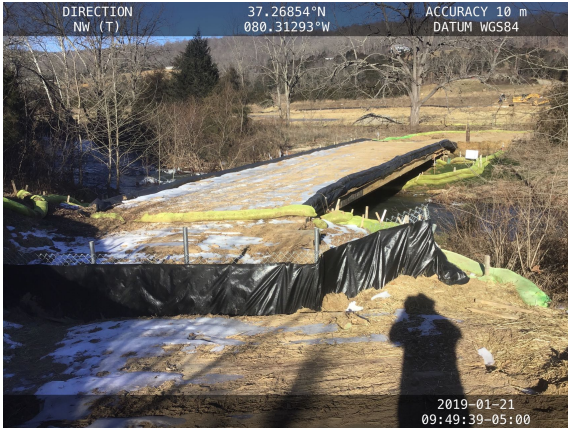
GPS Location	37.2561470372949, -80.2762723994258	GPS Location	37.268715156277, -80.3132989537719		
Description	Station 12137+00, facing west.	Description	Stream S-G36 on the access road MVP-MN-268.01, facing northwest.

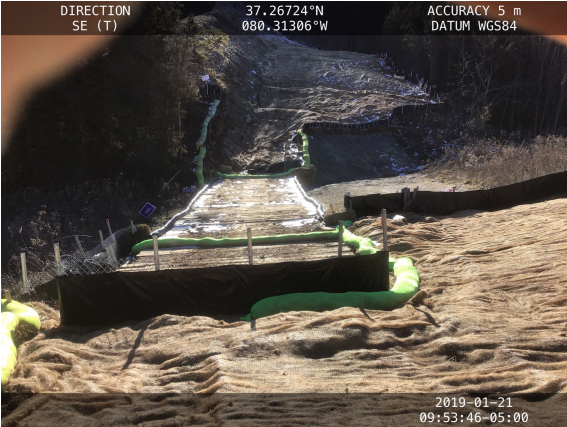
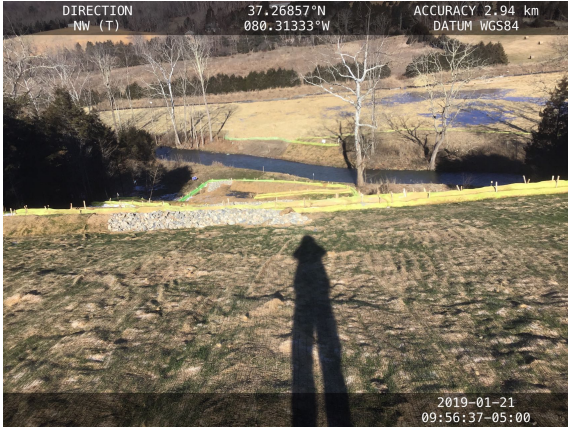
GPS Location	37.2672688169752, -80.3130859696123	GPS Location	37.2679959051658, -80.3137324658039		
Description	Stream S-G38, station 12015+84, facing southeast.	Description	Station 12012+00, facing northwest back toward stream S-G-36.

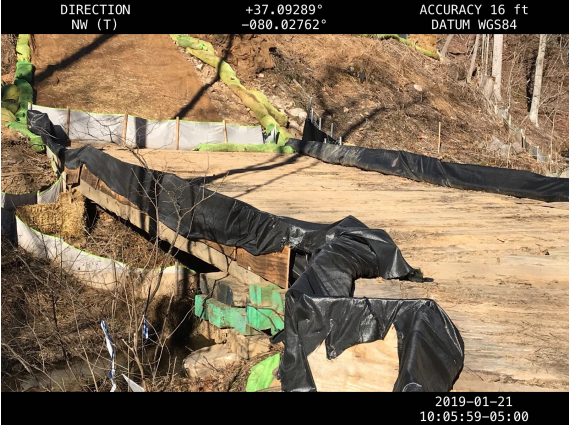
GPS Location	37.0924794394868, -80.027060899958	GPS Location	37.0924794394868, -80.027060899958		
Description	13413+24_012119 W-IJ1 timber mats over feature. Looking N. See photo for gps data.	Description	13413+05_012119 S-IJ1 timber mats over feature. Looking NW. See photos for gps data.

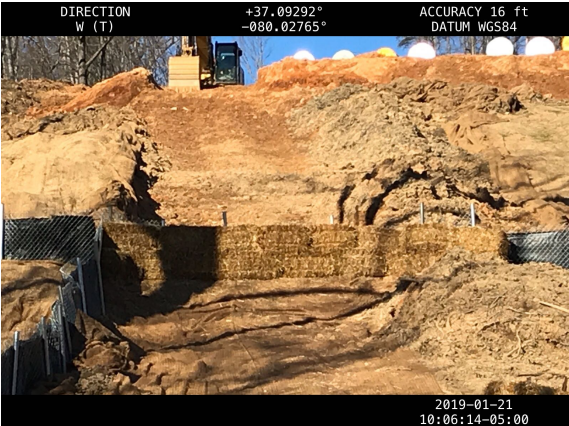
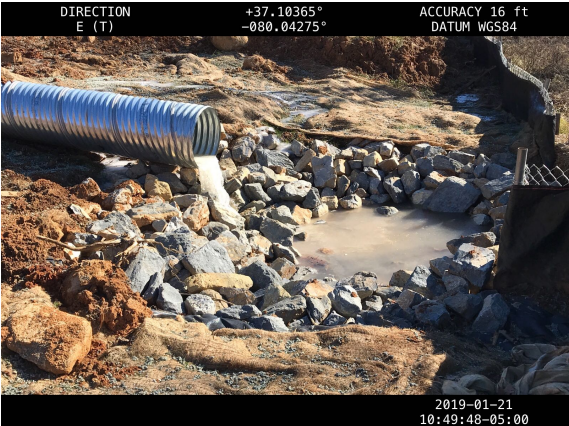
GPS Location	37.0924794394868, -80.027060899958	GPS Location	37.0924794394868, -80.027060899958		
Description	13413+00_012119 super silt re-enforced with straw bales. Looking W. See photo for gps data.	Description	13345+00_012119 condition of plunge pool. Looking E. See photo for gps data.

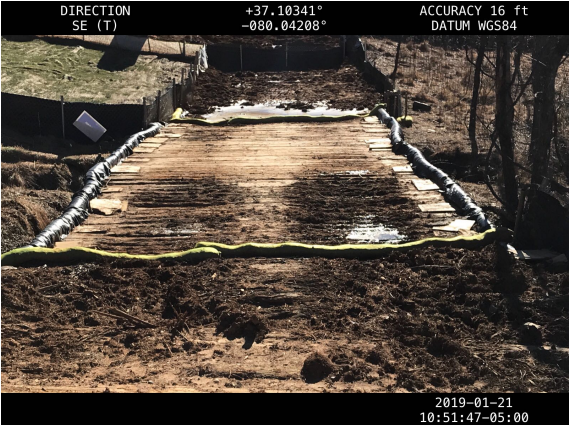
GPS Location	37.0924794394868, -80.027060899958	GPS Location	37.0924794394868, -80.027060899958		
Description	13348+00_012119 condition of plunge pool. Looking SE. See photo for gps data.	Description	13348+46_012119 S-RR11 condition of mat bridge. Looking SE. See photo for gps data.

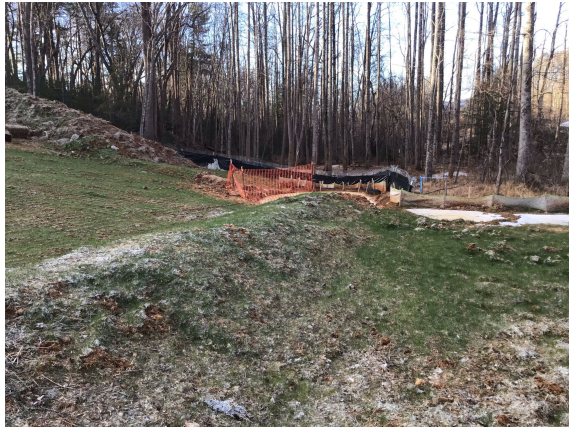
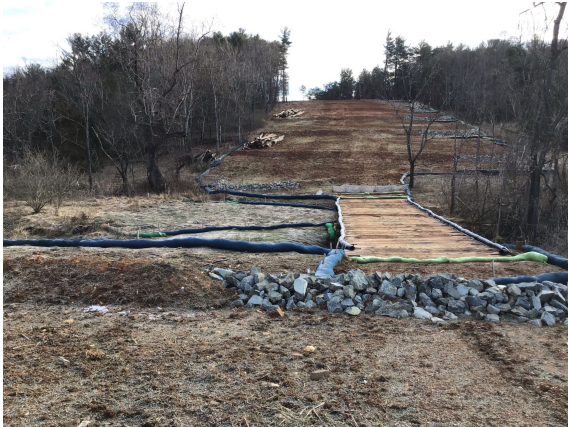
GPS Location	37.0893234433952, -79.9607664999365		GPS Location	37.0893237786713, -79.9606740475446	
Description	Temporary waterbar and end treatment functioning properly at approximately 13415+00.		Description	ECD's in place and in compliance at stream crossings S-I11 and S-I12.

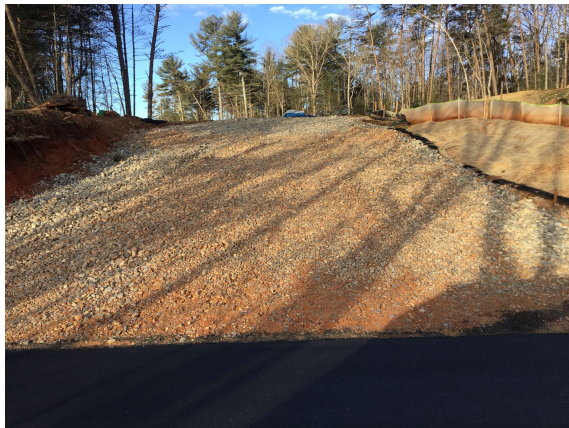
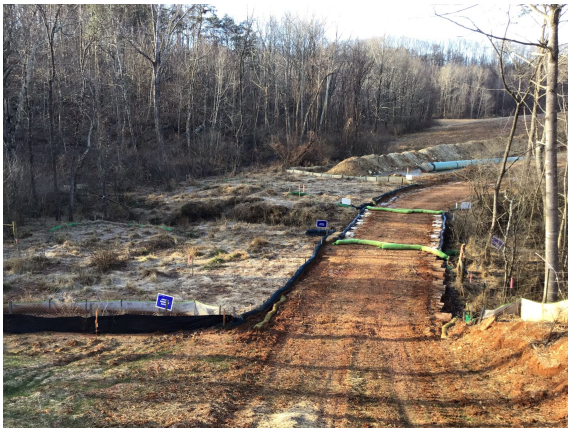
GPS Location	37.0893237786713, -79.9606740475446		GPS Location	37.0893237786713, -79.9606740475446	
Description	RCE on the CIS of Bethlehem in acceptable condition.		Description	All ECD's in place and in compliance at stream crossing S-GH3.

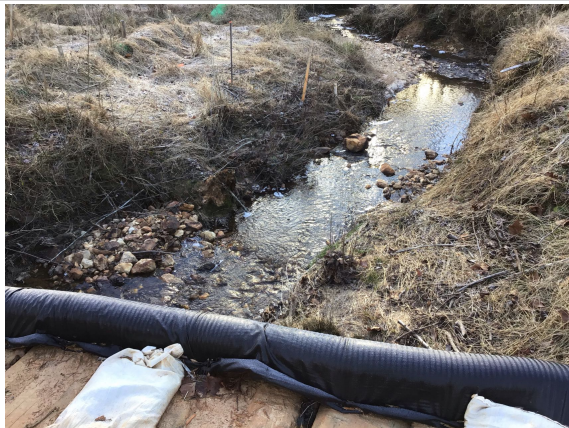
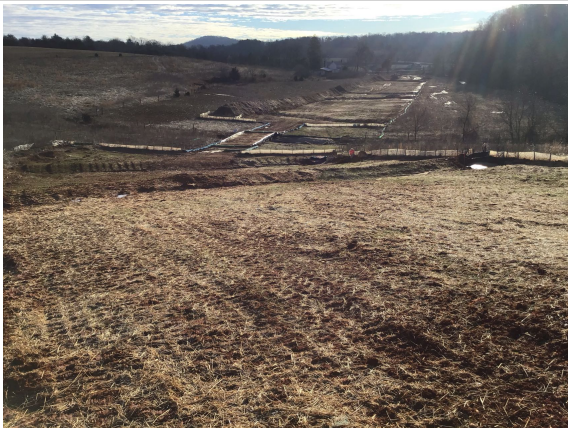
GPS Location	37.0893548755321, -79.9607164599746		GPS Location	37.0893548755321, -79.9607164599746	
Description	Stream S-GH3 flowing free and clear of any sediment.		Description	RoW erosion controls in place and functioning properly on the GAS of 13665+00

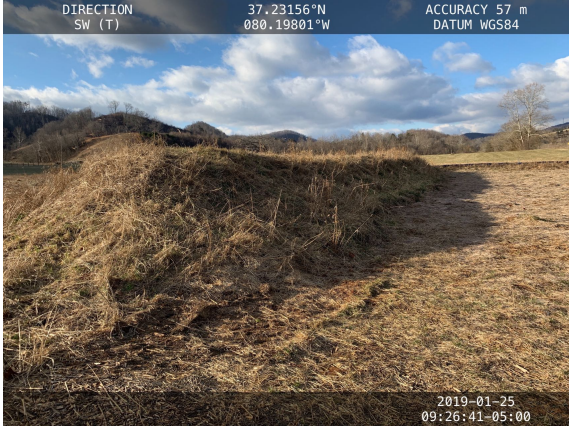
GPS Location	37.2355328066594, -80.2296681321264	GPS Location	37.2355328066594, -80.2296681321264		
Description	12453+00_012519 Stabilized topsoil on variance. Looking SW. See picture for GPS data.	Description	12452+60_012519 P1 perimeter controls. Looking W. See picture for GPS data.

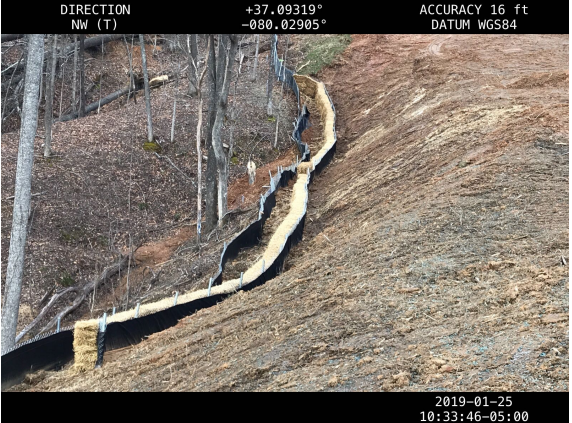
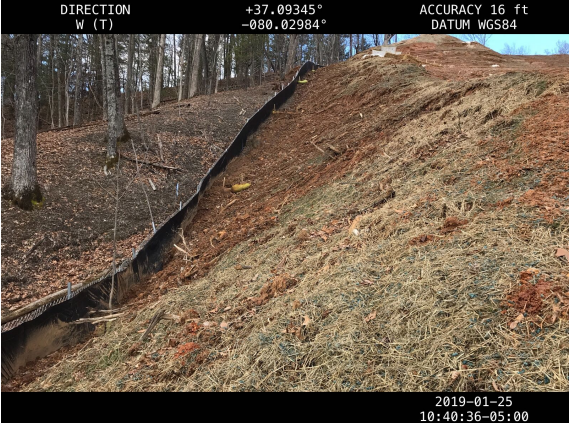
<p>DIRECTION W (T) +37.09345° -080.02984° ACCURACY 16 ft DATUM WGS84</p> <p>2019-01-25 10:40:36-05:00</p>		
GPS Location	37.1039409377026, -80.0433607679606			GPS Location	37.1039329329851, -80.0433774479479
Description	13408+00_012519 slope holding in place. Looking NW. See photo for gps data.			Description	13408+00_012519 topsoil pile becoming unstable. Looking W. See photo for gps data.

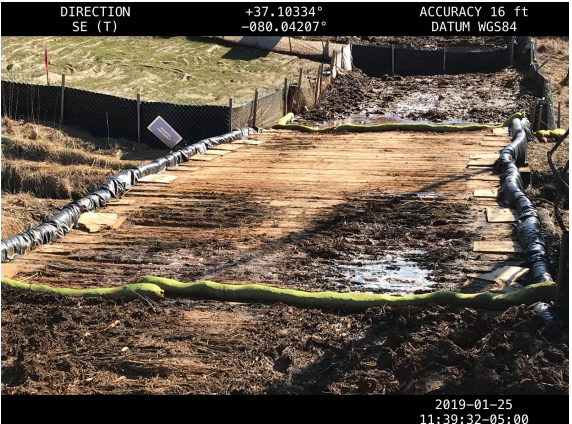
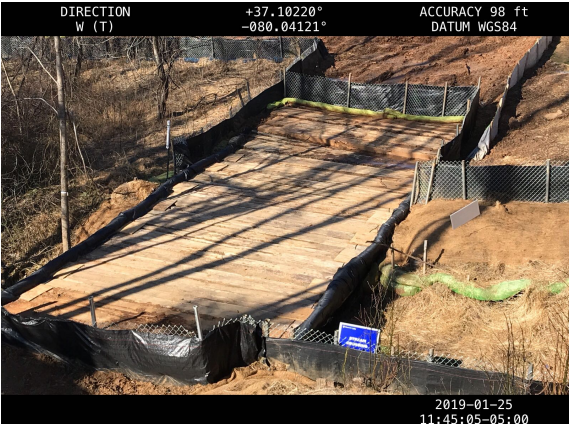
Description	13348+46_012519 S-RR08 timber mat bridge clean and closed. Looking SE. See photo for gps data.			Description	13352+23_012519 S-RR09 timber mar bridge cleaned and closed. Looking W. See photo for gps data.

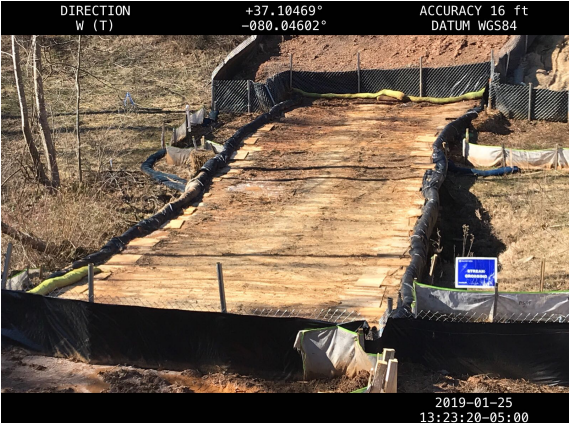
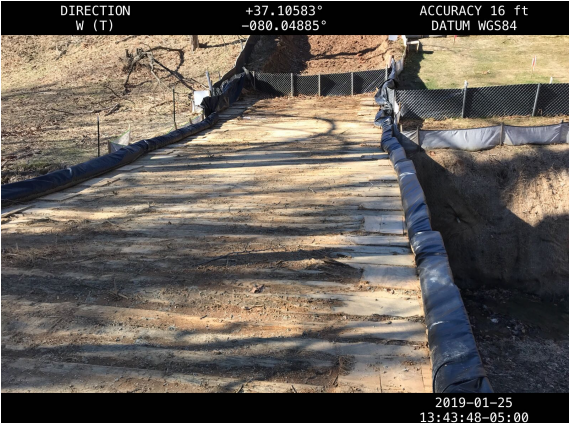
<p>DIRECTION W (T) +37.10583° -080.04885° ACCURACY 16 ft DATUM WGS84</p> <p>2019-01-25 13:43:48-05:00</p>		
GPS Location	37.1039329329851, -80.0433774479479			GPS Location	37.1039329329851, -80.0433774479479
Description	13334+17_012519 S-GH11 timber mat bridge clean and closed. Looking W. See photo for gps data.			Description	13325+30_012519 S-GH14 timber mat bridge clean and closed. Looking W. See photo for gps data.
