# Visual Site Inspection Report

<b>Project Name</b>	H-600 Pipeline Spread H	<b>AFE</b>	124300138	<b>Spread</b>	H-600 Pipeline Spread H
<b>Contractor</b>	Precision			<b>Report #</b>	15147
<b>Inspector</b>	Glenn Mike Renfro			<b>Date/Time</b>	3/25/2019 2:22 PM
<b>Permit #</b>	TBD	<b>Inspection Type</b>	VA SWPP	<b>Station Begin</b>	13416+00
<b>State</b>	VA	<b>Inspection Area</b>	Full	<b>Station End</b>	13670+00
<b>County</b>	Franklin	<b>Ground</b>	Wet	<b>Temperature (°F)</b>	67.00
<b>Municipality</b>	N/A	<b>Weather</b>	Cloudy	<b>Rain Gauge (in)</b>	0.10
				<b>Rain Accumulation Time (days)</b>	6.00

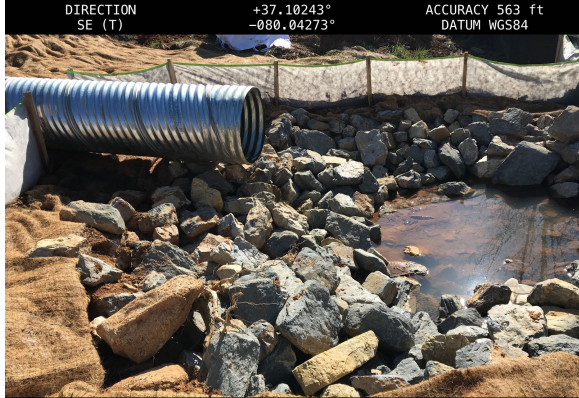
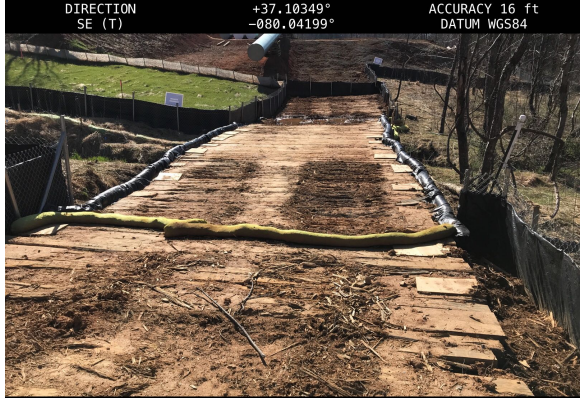
GPS Location	37.27	Field Station#	13345+00	GPS Location	37.27	Field Station#	13348+46
Description	13345+00_032819 condition of plunge pool. Looking SE. See photo for gps data.			Description	13348+46_032819 S-RR08 mat bridge clean and closed. Looking SE. See photo for gps data.

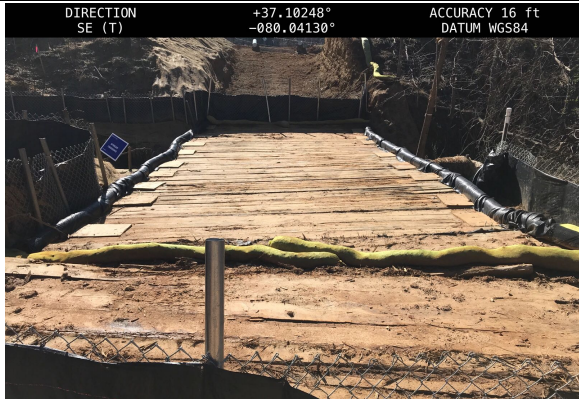
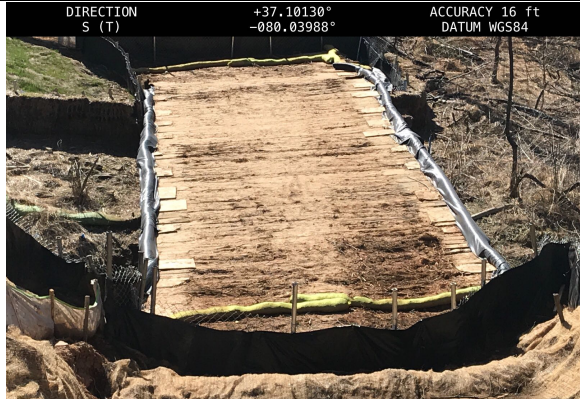
GPS Location	37.27	Field Station#	13352+23	GPS Location	37.27	Field Station#	13358+64
Description	13352+23_032819 S-RR09 mat bridge clean and closed. Looking SE. See photo for gps data.			Description	13358+64_032819 S-RR11 mat bridge clean and closed. Looking SE. See photo for gps data.

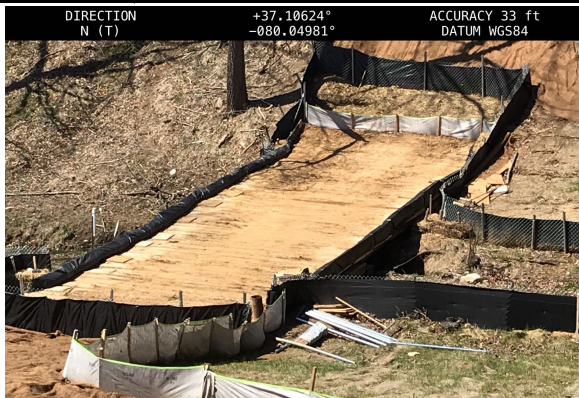
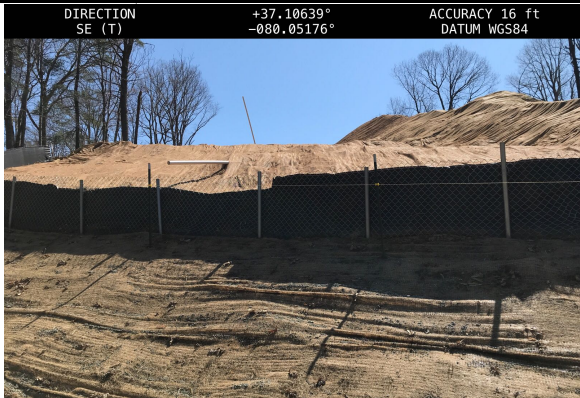
GPS Location	37.27	Field Station#	13321+47	GPS Location	37.27	Field Station#	13317+02
Description	13321+47_032819 S-GH15 mat bridge clean and closed. Extra supplies by bridge. Looking NW. See photo for gps data.			Description	13317+02_032819 erosion control blanket on slope. Looking SE. See photo for gps data.

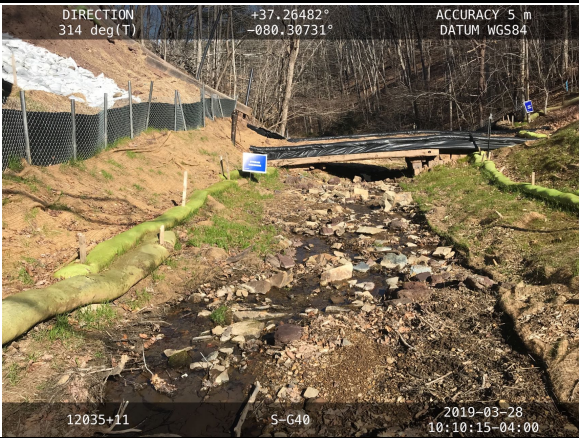
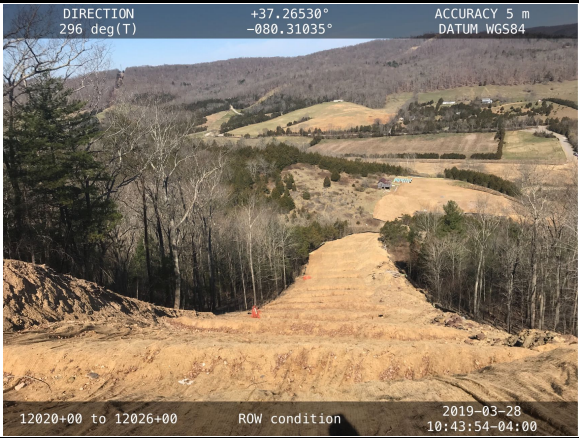
GPS Location	37.27	Field Station#	12035+11	GPS Location	37.27	Field Station#	12026+00
Description	See photo for gps data. Photo shows the condition of stream S-G40 at about 12035+11.			Description	See photo for gps data. Photo shows the general condition of the ROW from about 12020+00 to 12026+00.		
<div>DIRECTION 229 deg(T)</div> <div>+37.26710° -080.31288°</div> <div>ACCURACY 5 m DATUM WGS84</div>

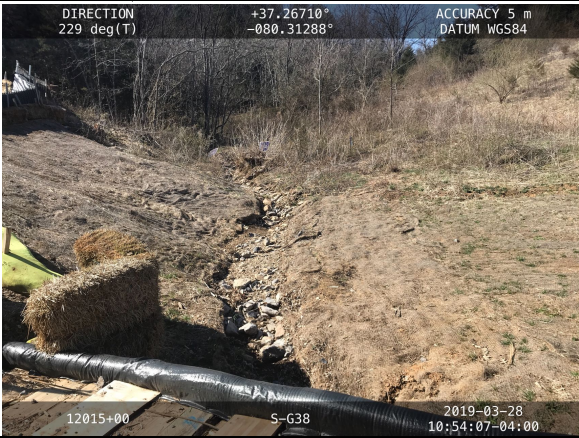
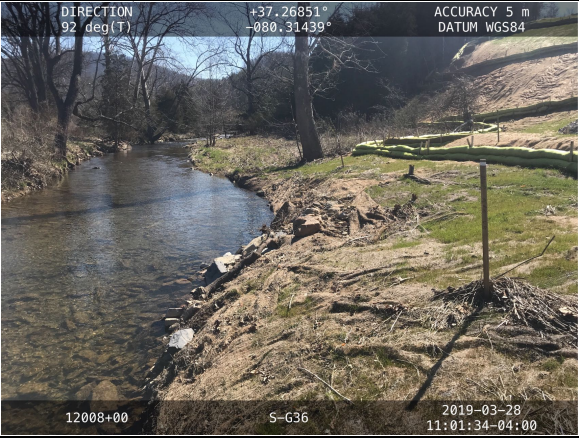
<div>12008+00</div> <div>S-G36</div> <div>2019-03-28 11:01:34-04:00</div>				
GPS Location	37.27	Field Station#	12015+00	GPS Location	37.27	Field Station#	12008+79
Description	See photo for gps data. Photo shows the general condition of stream S-G38 at about 12015+00.			Description	See photo for gps data. Photo shows the stream bank on the southeast side of stream S-G36.

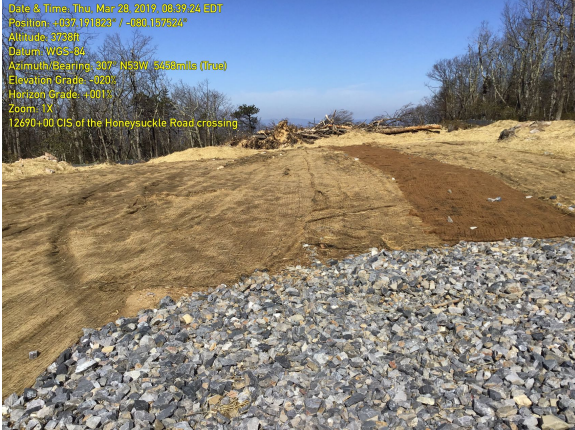
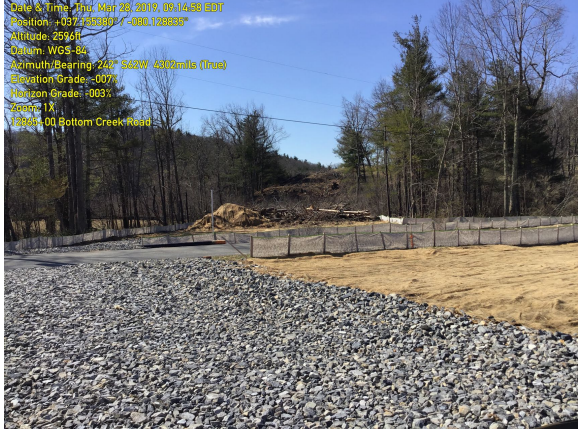
</div>				
<b>GPS Location</b>	37.19	<b>Field Station#</b>	12690+00		<b>GPS Location</b>	37.15	<b>Field Station#</b>	12865+00
<b>Description</b>	No issues or impacts found at Honeysuckle road.				<b>Description</b>	Bottom Creek Road was in good condition throughout the work area. No issues.

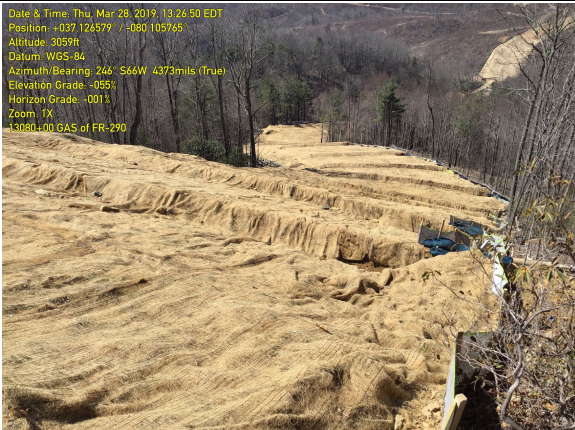
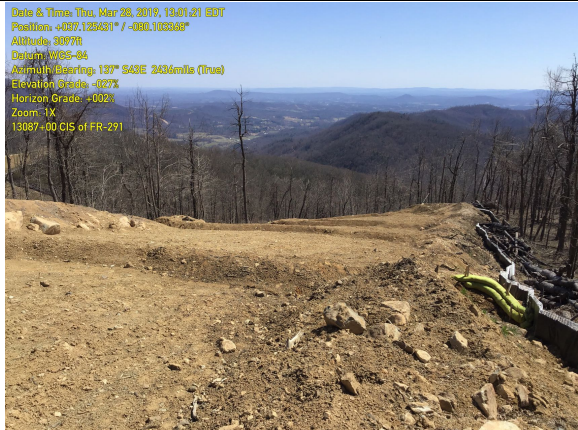
</div>				
<b>GPS Location</b>	37.12	<b>Field Station#</b>	13080+00		<b>GPS Location</b>	37.12	<b>Field Station#</b>	13087+00
<b>Description</b>	ROW stabilized with Curlex. No issues or impacts observed.				<b>Description</b>	ROW stabilized with EarthGuard continues to resist erosion. No issues or impacts found throughout the area.		
<div><p>Date &amp; Time: Thu, Mar 28, 2019, 13:46:05 EDT Position: +037.126043° / -080.107152° Altitude: 2782ft Datum: WGS-84 Azimuth/Bearing: 273° N87W 4853mils (True) Elevation Grade: +040% Horizon Grade: +004% Zoom: 1X 13074+00 GAS of FR-290</p>

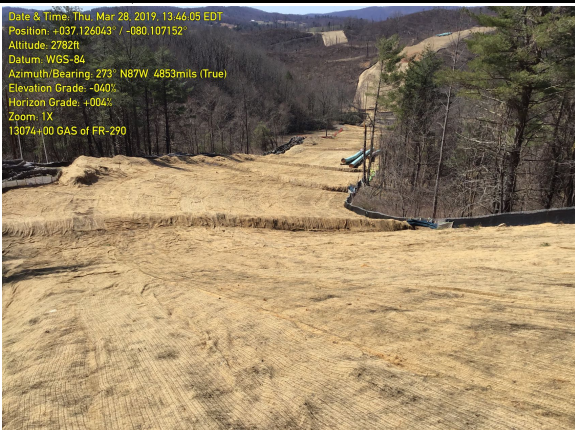
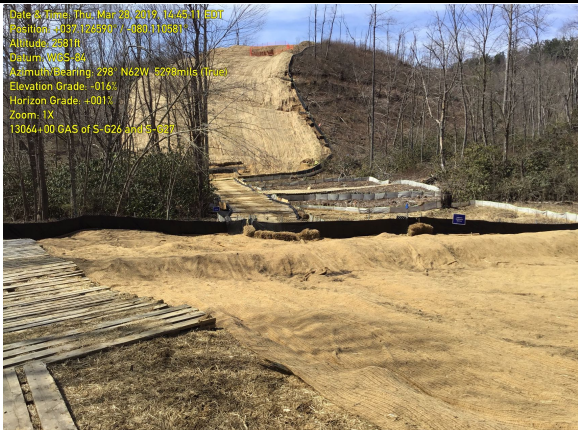
<b>GPS Location</b>	37.12	<b>Field Station#</b>	13074+00		<b>GPS Location</b>	37.12	<b>Field Station#</b>	13064+00
<b>Description</b>	All ECD's, BMP's, and stabilized ROW remain within compliance.				<b>Description</b>	S-G26 and S-G27 showed no signs of impact.

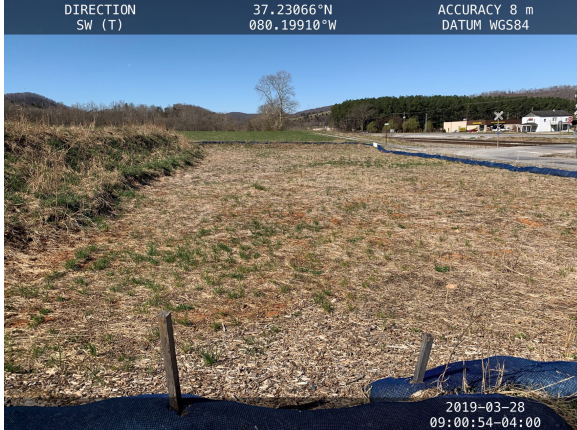
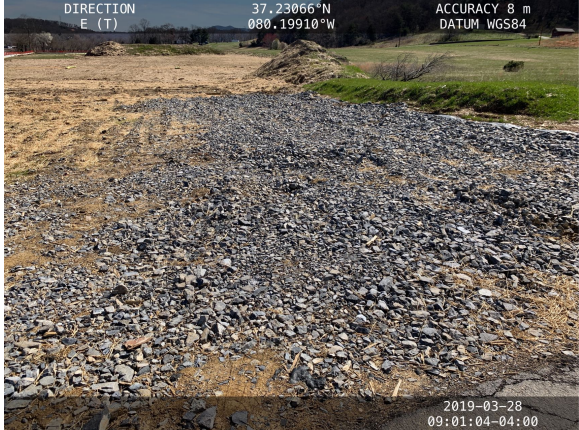
<div>2019-03-28 09:01:04-04:00</div>					
GPS Location 37.25		Field Station# 12448+41		GPS Location 37.25		Field Station# 12448+12	
Description		Stabilized disturbed variance. Looking SW. See picture for GPS data.		Description		RCE. Looking E. See picture for GPS data.	
<div>DIRECTION NE (T)</div> <div>37.23066°N 080.19847°W</div> <div>ACCURACY 45 m DATUM WGS84</div>

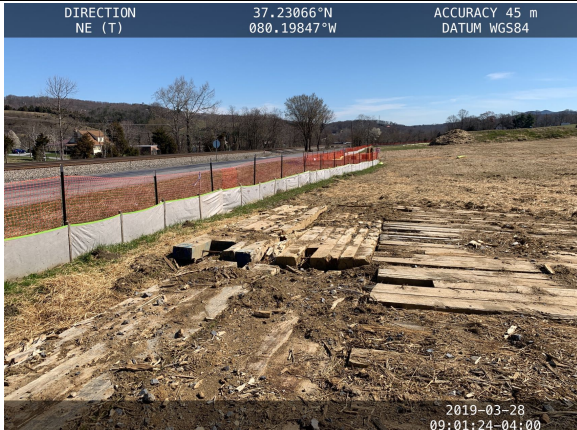
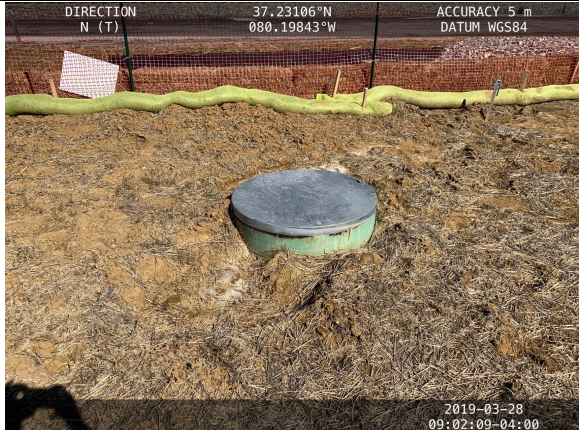
<div>2019-03-28 09:02:09-04:00</div>					
GPS Location 37.25		Field Station# 12447+60		GPS Location 37.25		Field Station# 12446+50

Description		P1 Perimeter controls. Looking NE. See picture for GPS data.		Description		End cap on well point system. Looking N. See picture for GPS data.	
<div>DIRECTION S (T)</div> <div>37.23112°N 080.19837°W</div> <div>ACCURACY 5 m DATUM WGS84</div>   <div>2019-03-28 09:02:25-04:00</div>		<div>DIRECTION Unavailable</div> <div>LOCATION Unavailable</div> <div>ACCURACY/DATUM Unavailable</div>

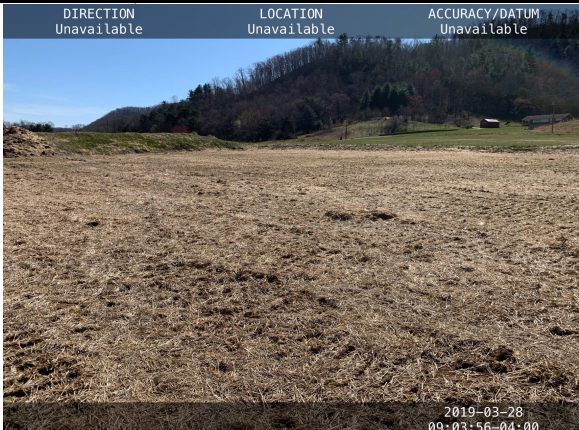
<div>2019-03-28 09:03:56-04:00</div>					
GPS Location 37.25		Field Station# 12447+00		GPS Location 37.25		Field Station# 12447+00	
Description		Stabilized channel where rain water was crossing the ROW. Looking S. See picture for GPS data.		Description		Stabilized ROW.

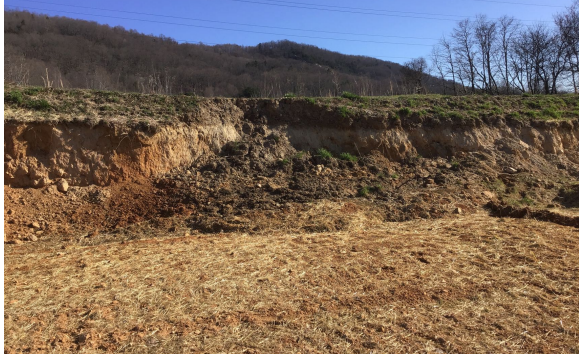
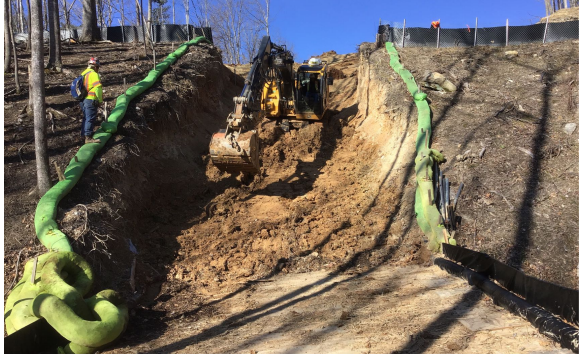
<div>2019-03-28 09:35:34-04:00</div>				
GPS Location	37.25	Field Station#	12089+00	GPS Location	37.25	Field Station#	12098+00
Description	The cut bank has eroded resulting in damage to the clean water diversion berm.			Description	An operator maintained the travel lane above stream S-MM13 on his way through to other work in the area.		
<div>DIRECTION SE (T)</div> <div>37.25744°N 080.28209°W</div> <div>ACCURACY 10 m DATUM WGS84</div>

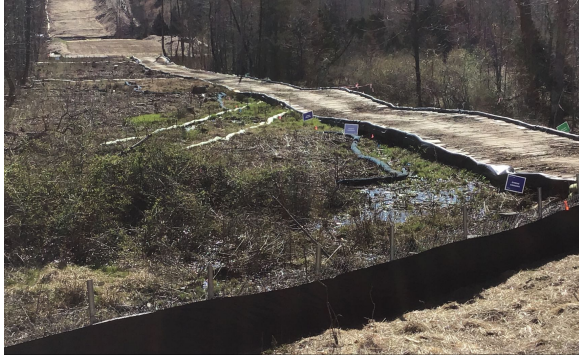
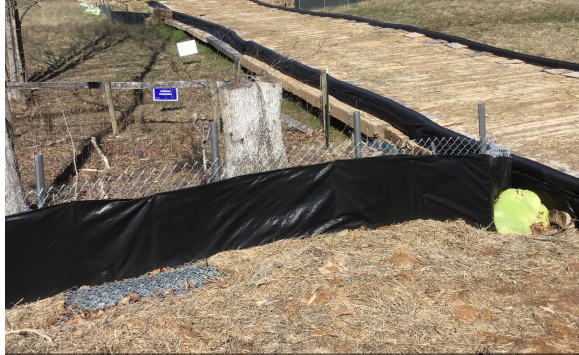
GPS Location	37.25	Field Station#	12120+50	GPS Location	37.25	Field Station#	12133+00
Description	ECDs are all intact and functioning as needed through the series of streams and wetlands on the going away side of Flatwoods Road.			Description	PL item #1987 (MBP action item) has been completed. Fabric was reattached to chain link on SSF.		
<div>DIRECTION N (T)</div> <div>37.25462°N 080.26937°W</div> <div>ACCURACY 5 m DATUM WGS84</div>

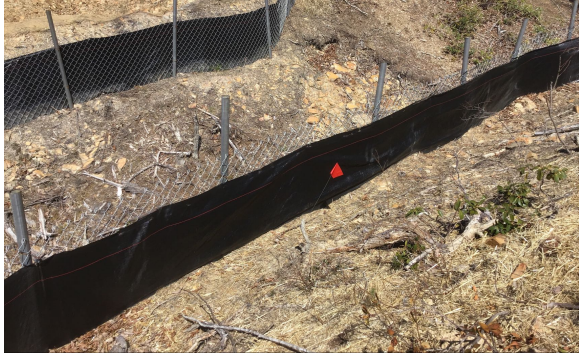
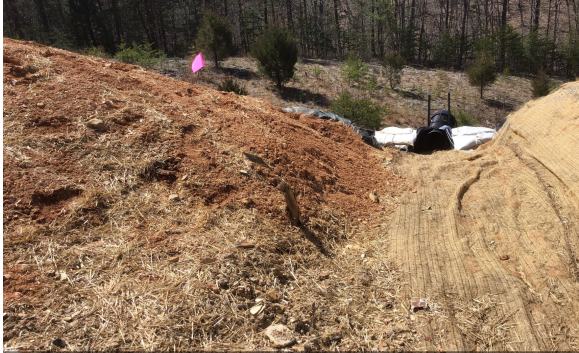
<div>2019-03-28 12:27:21-04:00</div>				
GPS Location	37.25	Field Station#	12158+75	GPS Location	37.25	Field Station#	12170+00
Description	PL item #1985 (MBP action item) has been completed. Fabric was reattached to the chain link on SSF.			Description	The end of the stockpile next to the fill slope drain inlet needs to be stabilized.
