Visual Site Inspection Report

Project Name	H-600 Pipeline Spread G	AFE	124300137	Spread	H-600 Pipeline Spread G
Contractor	Precision			Report #	19161
Inspector	Len Kruizenga			Date/Time	6/24/2019 7:38 AM
Permit #	TBD	Inspection Type	VA SWPP	Station Begin	11788+00
State	VA	Inspection Area	Full	Station End	12001+00
County	Montgomery	Ground	Dry	Temperature (°F)	83.00
Municipality	N/A	Weather	Sunny	Rain Gauge (in)	0.00
				Rain Accumulation Time (days)	3.00

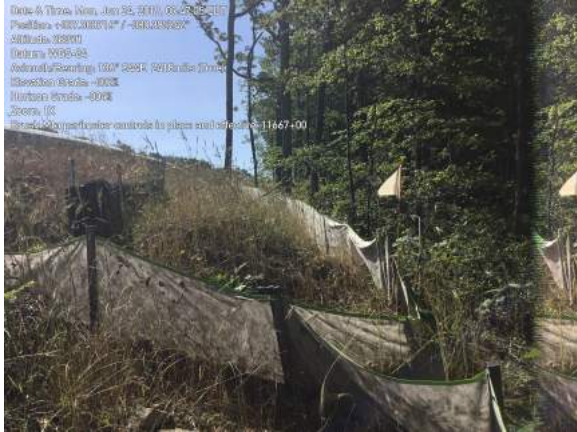
GPS Location	37.29	Field Station#	11667+00	GPS Location	37.29	Field Station#	11661+50
Description	Perimeter controls are in place and effective.			Description	Slope breakers, end treatments and perimeter controls are effective.

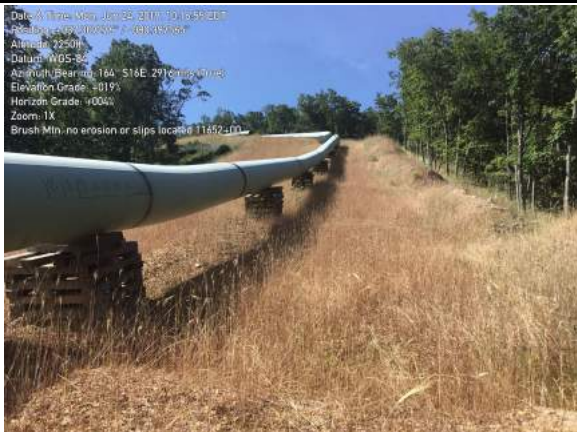
GPS Location	37.29	Field Station#	11652+00	GPS Location	37.29	Field Station#	11630+00
Description	No erosion or slips located.			Description	ROW surface is currently stable with no sediment migration noted.

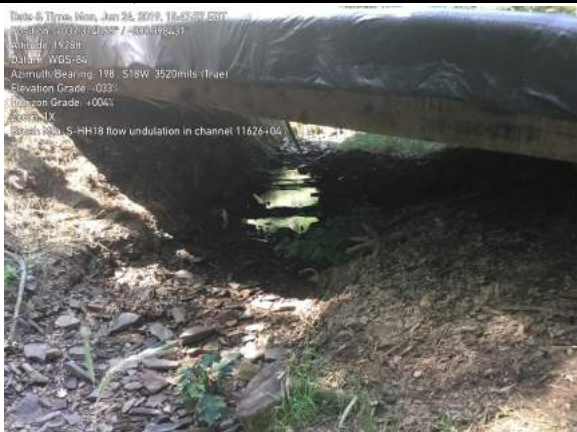
GPS Location	37.29	Field Station#	11626+04	GPS Location	37.29	Field Station#	11618+50
Description	Resource crossings are stable with no impact identified.			Description	Perimeter controls are in place and functional.

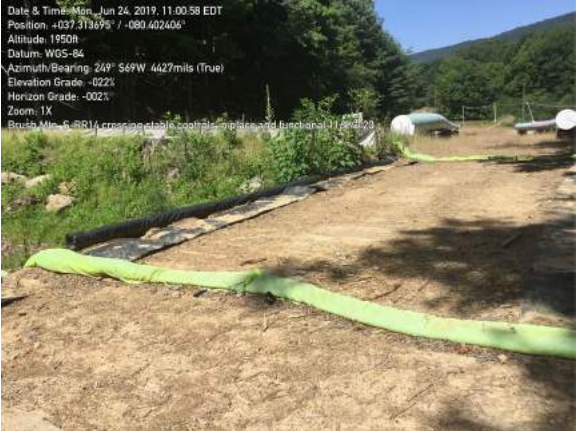
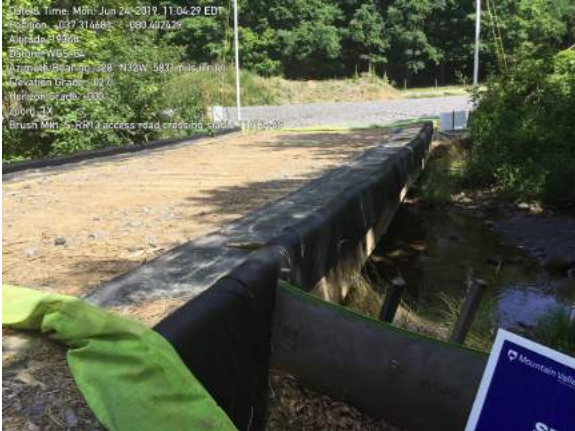
GPS Location	37.29	Field Station#	11614+20	GPS Location	37.29
Description	Equipment bridges are in good condition. Resource crossings are stable.		Description	Equipment bridges are in good condition with no impact to streams noted.

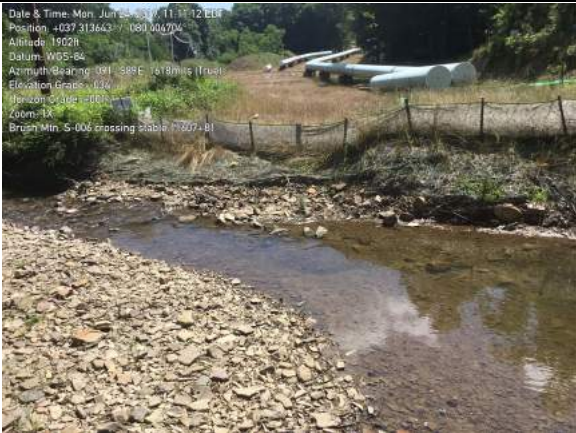
<div style="text-align: center; height: 100px;">Insert image here</div>			
GPS Location	37.29	Field Station#	11607+81	GPS Location	
Description	Craig Creek crossing is stable.		Description		
<div style="text-align: center; height: 150px;">Insert image here</div>			<div style="text-align: center; height: 150px;">Insert image here</div>		
GPS Location		Field Station#		GPS Location	
Description			Description

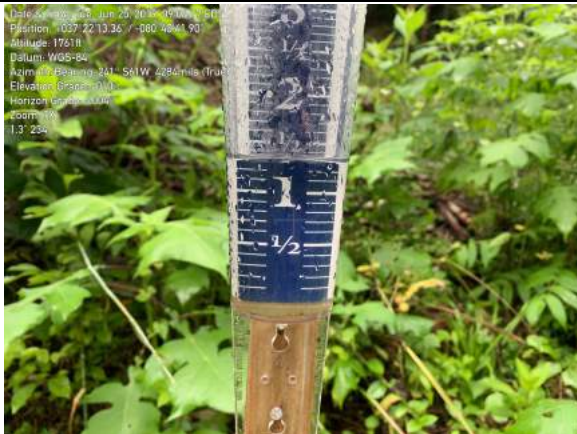
GPS Location		37.29	Field Station#		2+34		GPS Location		37.29	Field Station#		10696+00	
Description		1.3" of rain recorded @ AR 234						Description		1.1" of rain collected @ Buffalo Anklets

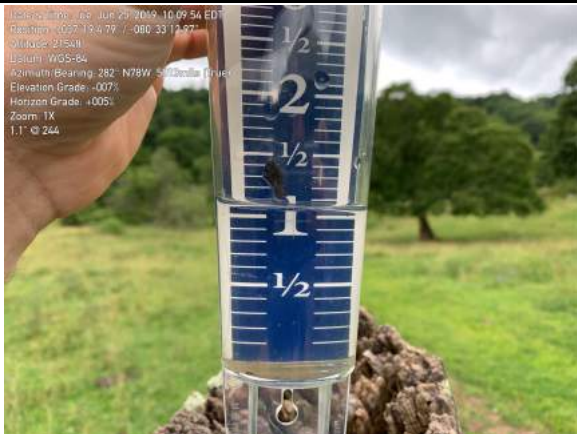
GPS Location		37.29	Field Station#		2+44		GPS Location		37.29	Field Station#		+28	
Description		1.1" and f rain collected @ 244						Description		ECD's and row conditions @ LDY 28

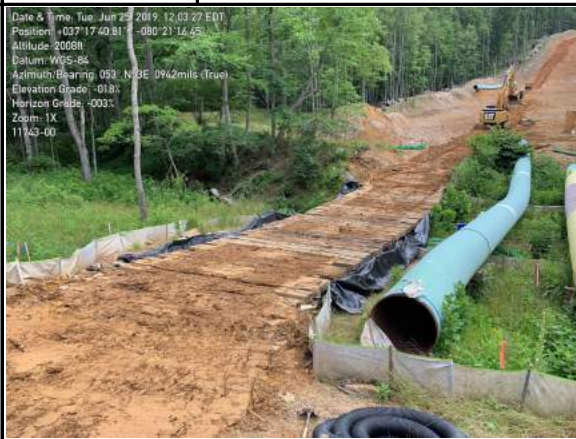
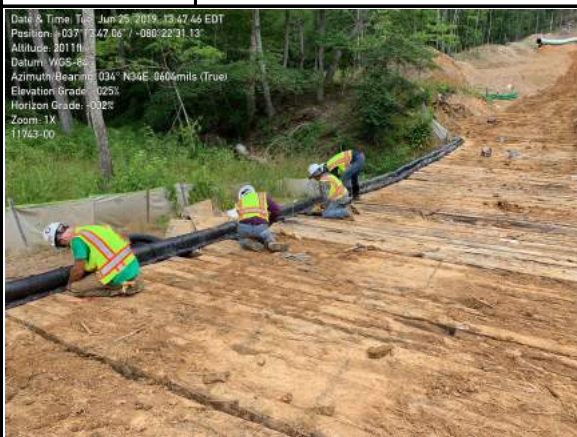
GPS Location		37.29	Field Station#		11743+00		
Description		Crews replacing geotech for the bridge crossing on S-lj52					
<div><div><div>Date & Time: Tue Jun 25 2019 13:47:46 EDT Position: +037 21 47.66 / -080 22 31.13 Altitude: 2011ft Datum: WGS-84 Azimuth/Bearing: 034° 134E, 060mils (True) Elevation Grade: -025% Horizon Grade: -032% Zoom: 1X 11743-00</div><div>

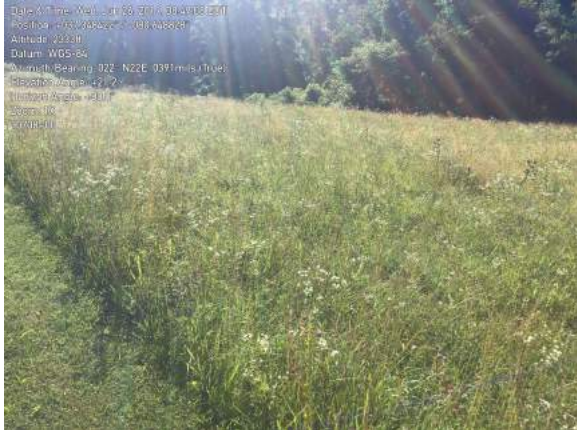
GPS Location	37.31	Field Station#	10708+00	GPS Location	37.31	Field Station#	10708+00
Description	See photo for GPS location. ROW stabilized with natural vegetation.			Description	See photo for GPS location. Sediment build up along CFS.

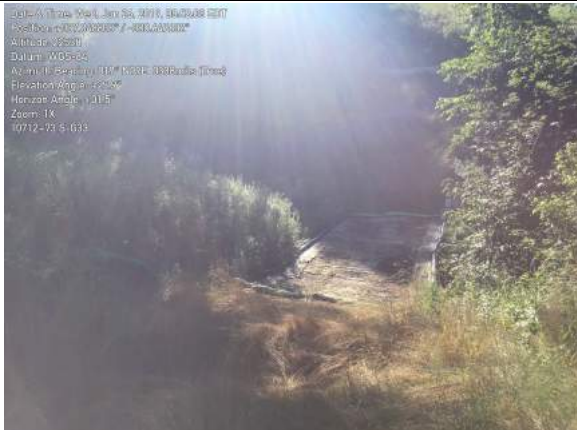
GPS Location	37.31	Field Station#	10712+73	GPS Location	37.31	Field Station#	10696+00
Description	See photo for GPS location. Sensitive resource buffer in place at stream S-G33.			Description	See photo for GPS location. RCE in place buffalo anklets road.

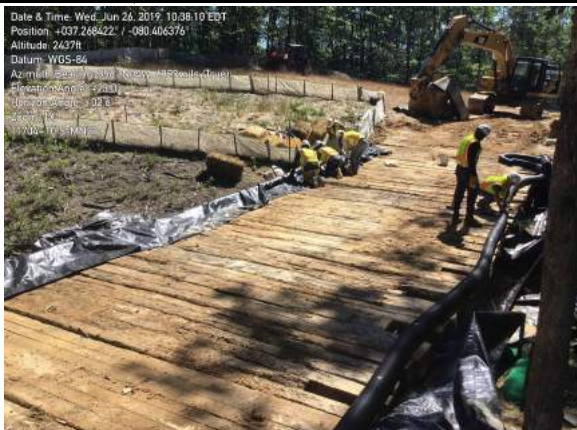
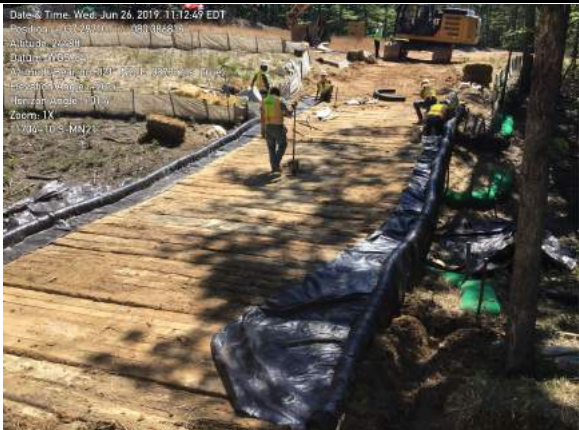
GPS Location	37.31	Field Station#	11704+10	GPS Location	37.31	Field Station#	1104+10
Description	See photo for GPS location. Environmental crew installing side rails.			Description	See photo for GPS location. Environmental crew installing side rails.

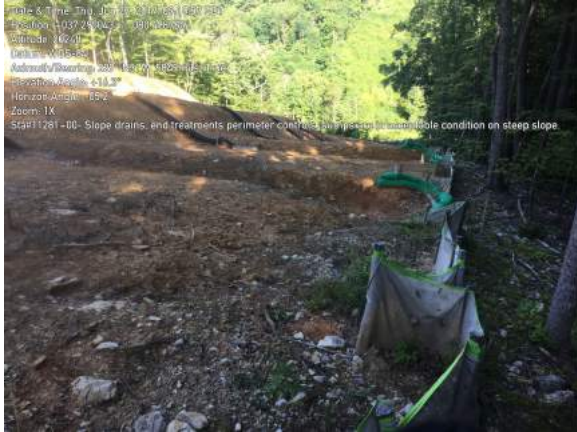
GPS Location	37.29	Field Station#	11281+00	GPS Location	37.30	Field Station#	11281+00
Description	Perimeter controls, End treatments, slope drains& sumps are in acceptable condition on steep slope.			Description	Stream ECD's, signage, buffers , Equipment bridge are in acceptable condition

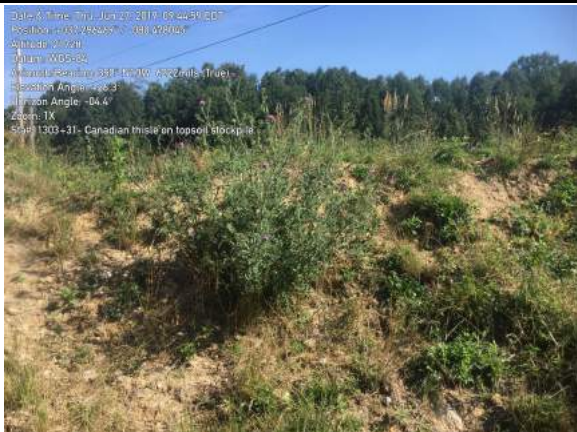
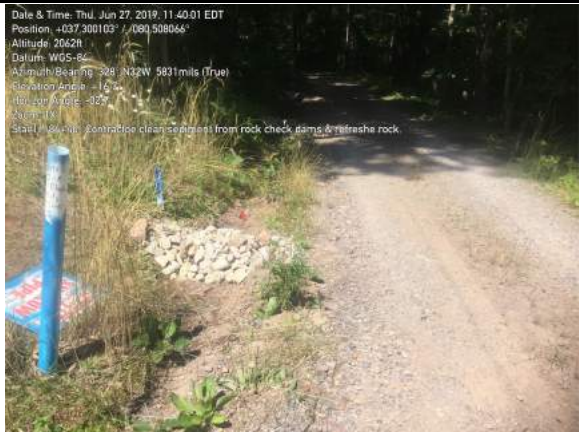
GPS Location	37.29	Field Station#	11303+31	GPS Location	37.30	Field Station#	11184+40
Description	Canadian thistles on topsoil stock piles, Landowner has complained.			Description	Rock check dams have been cleaned out& rock refreshed.		
<p>Date & Time: Thu, Jun 27, 2019, 11:54:26 EDT Position: +037.310413° / -080.515208° Altitude: 1724ft Datum: WGS-84 Azimuth/Bearing: 316° N42W 583mils (True) Elevation Angle: +16.6° Horizon Angle: -02.1° Zoom: 1X Stn#11172+70- CFS under cut check has been repaired.</p>

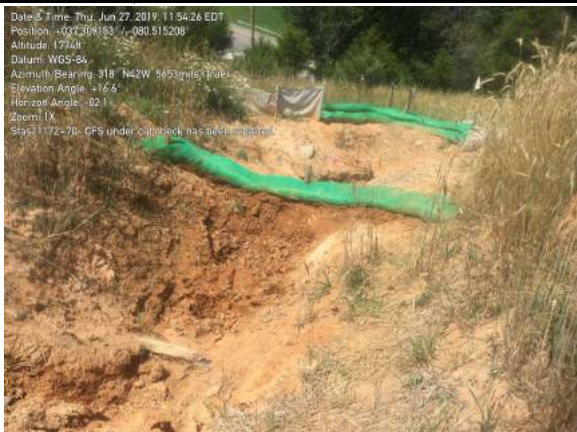
GPS Location	37.30	Field Station#	11172+70	GPS Location	37.31	Field Station#	11169+00
Description	Under cut CFS check has been repaired.			Description	Removed sediment from the access rd, refreshed rock, installed waddle .

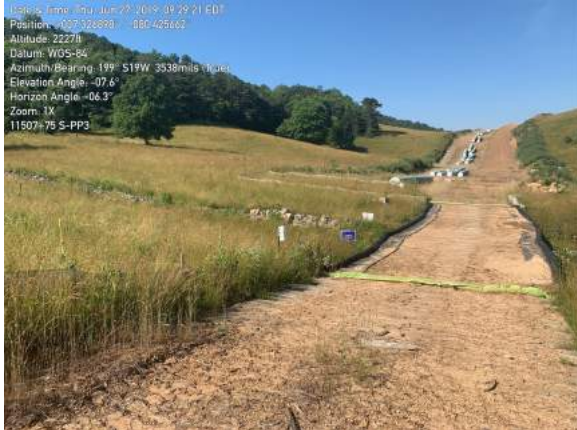
GPS Location	37.18	Field Station#	11507+75	GPS Location	37.18	Field Station#	11504+00
Description	See photo for GPS location. Sensitive resource buffer in place at stream S-PP3.			Description	See photo for GPS location. Plunge pool in place.

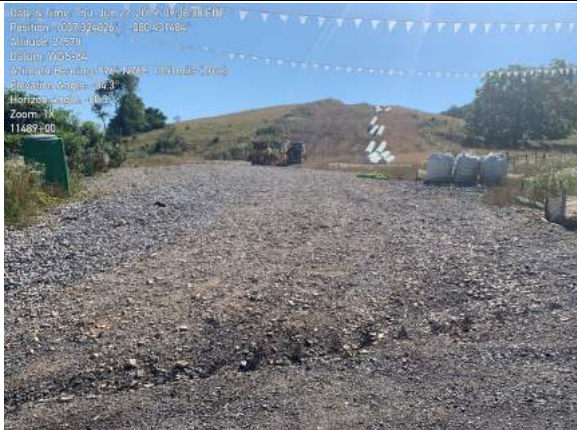
GPS Location	37.18	Field Station#	11489+00	GPS Location	37.18	Field Station#	11486+00
Description	See photo for GPS location. RCE in place at Stevers Gap Road.			Description	See photo for GPS location. Clean water diversion pipe and berm in place.

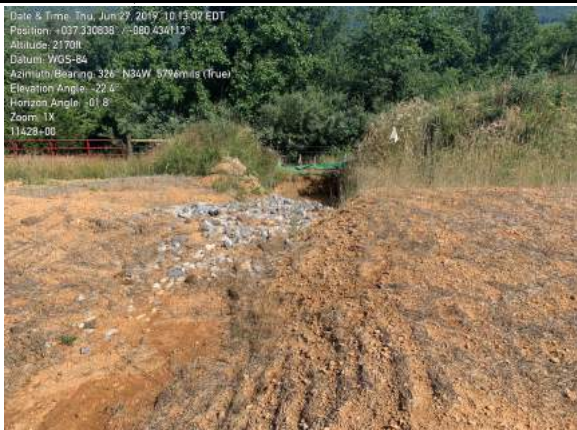
GPS Location	37.18	Field Station#	11428+00	GPS Location	37.18	Field Station#	11381+00
Description	See photo for GPS location. Rock lined channel in place over fill slope.			Description	See photo for GPS location. Triple barrier ECDs in place at off ROW karst feature.
