# Visual Site Inspection Report

<b>Project Name</b>	H-600 Pipeline Spread G	<b>AFE</b>	124300137	<b>Spread</b>	H-600 Pipeline Spread G
<b>Contractor</b>	Precision			<b>Report #</b>	19898
<b>Inspector</b>	Rob Robertson			<b>Date/Time</b>	7/8/2019 11:16 AM
<b>Permit #</b>	TBD	<b>Inspection Type</b>	VA SWPP	<b>Station Begin</b>	10458+91
<b>State</b>	VA	<b>Inspection Area</b>	Full	<b>Station End</b>	10459+03
<b>County</b>	Giles	<b>Ground</b>	Damp	<b>Temperature (°F)</b>	78.00
<b>Municipality</b>	N/A	<b>Weather</b>	Sunny	<b>Rain Gauge (in)</b>	0.10
				<b>Rain Accumulation Time (days)</b>	1.00

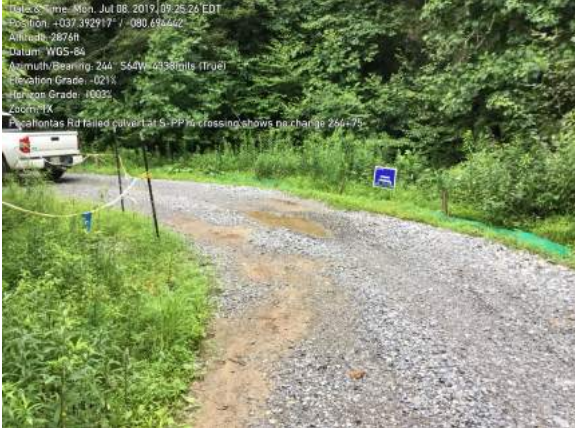
A/E	124300137	Date/Time	7/8/2019 11:16 AM	Report #	19898		
Pictures							
<p>Date &amp; Time: Mon, Jul 08, 2019, 09:25:26 EDT Position: +037.392917° / +090.693442° Altitude: 2676ft Datum: WGS-84 Azimuth/Bearing: 244° S44W 033mils (True) Elevation Grade: +021% Horizon Grade: +003% Zoom: 1X Pocahontas Rd failed culvert at S-PP14 crossing shows no change 264+75</p>

GPS Location	37.31	Field Station#	264+75	GPS Location	37.31	Field Station#	258+00
Description	No change at failed culvert S-PP14 crossing.			Description	ECD maintenance needed.		
<p>Date &amp; Time: Mon, Jul 08, 2019, 09:29:19 EDT Position: +037.390935° / +090.692972° Altitude: 2937ft Datum: WGS-84 Azimuth/Bearing: 093° N03E 000mils (True) Elevation Grade: +05% Horizon Grade: +002% Zoom: 1X Pocahontas Rd (weeds) (elevation grade) 258+00</p>

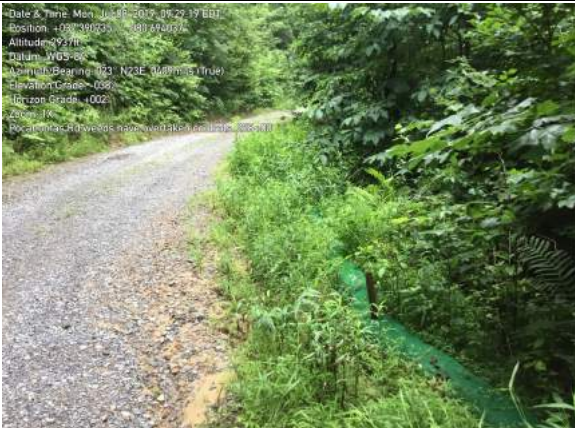
GPS Location	37.31	Field Station#	258+00	GPS Location	37.31	Field Station#	163+00
Description	Weeds are overtaking controls.			Description	ECD maintenance needed.		
<p>Date &amp; Time: Mon, Jul 08, 2019, 09:44:48 EDT Position: +037.382278° / +090.712122° Altitude: 2963ft Datum: WGS-84 Azimuth/Bearing: 085° N05E 1911mils (True) Elevation Grade: +009% Horizon Grade: +005% Zoom: 1X Pocahontas Rd failed culvert at the S-PP19 crossing shows no change 152+75</p>

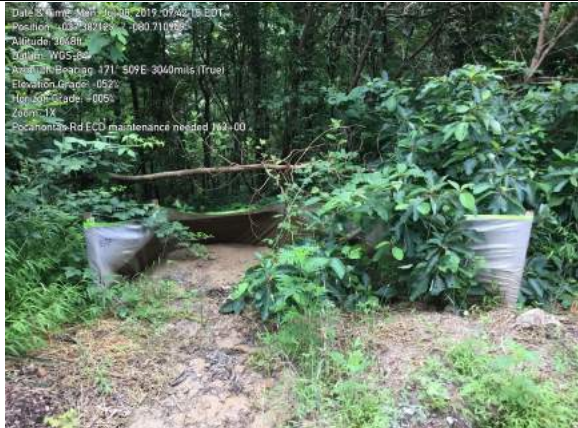
<p>Date &amp; Time: Mon, Jul 08, 2019, 09:42:18 EDT Position: +037.382183° / +090.711095° Altitude: 2968ft Datum: WGS-84 Azimuth/Bearing: 171° S09E 3040mils (True) Elevation Grade: +05% Horizon Grade: +005% Zoom: 1X Pocahontas Rd ECD maintenance needed 163+00</p>

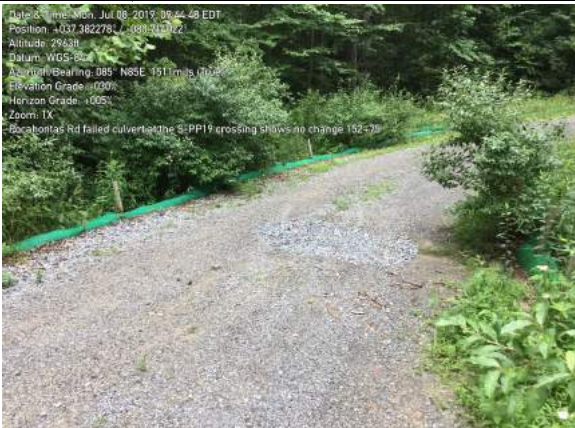
GPS Location	37.31	Field Station#	152+75	GPS Location	37.31	Field Station#	144+00
Description	No change at failed culvert.			Description	Runoff channeling on road surface in some spots.

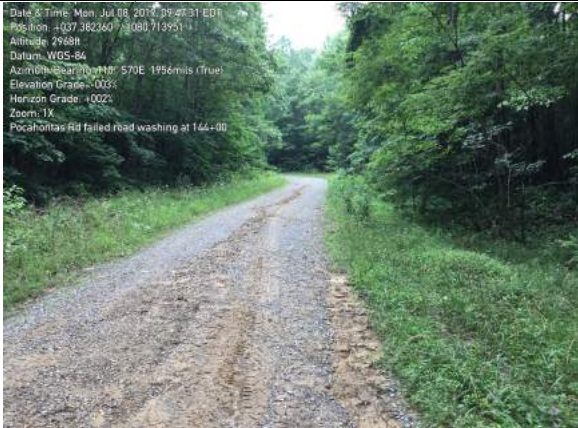
<p>Date &amp; Time: Mon, Jul 08, 2019, 09:47:31 EDT Position: +037.382360° / +090.713951° Altitude: 2968ft Datum: WGS-84 Azimuth/Bearing: 100° N10E 570E 1956mils (True) Elevation Grade: +003% Horizon Grade: +002% Zoom: 1X Pocahontas Rd failed road washing at 144+00</p>

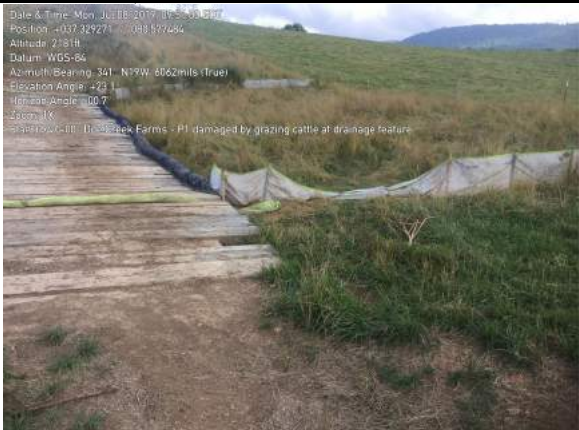
Description	Karst ECD's & signage are in acceptable condition.			Description	P1 at drainage feature, Doe Creek Farms - P1 damaged by grazing cattle.

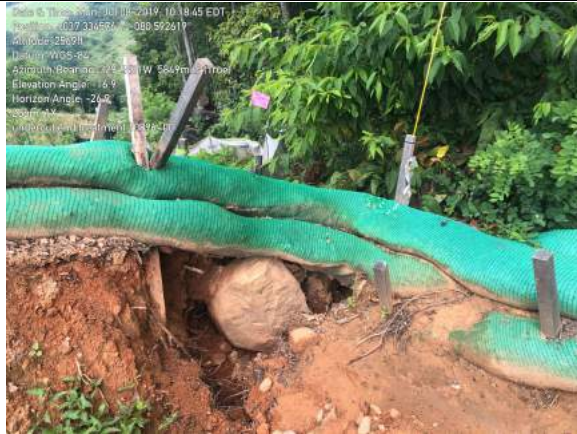
GPS Location	37.32	Field Station#	10883+00	GPS Location	37.32
Description	S-A32.			Description	Undercut end treatment resulting in sediment off RoW.

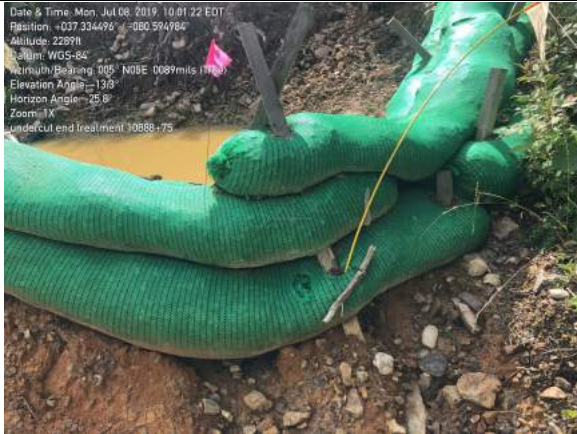
GPS Location	37.32	Field Station#	10896+00	GPS Location	37.32
Description	Sediment off RoW.			Description	Undercut end treatment.

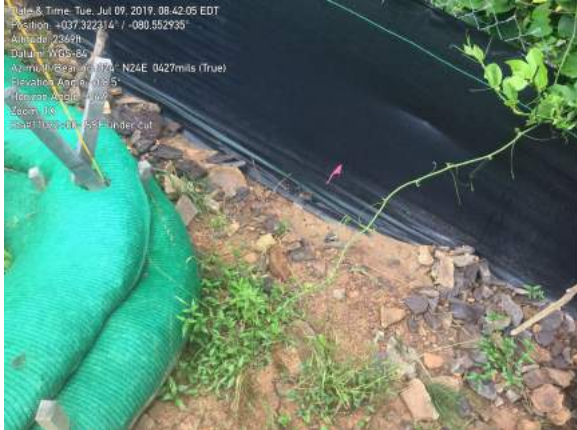
GPS Location	37.32	Field Station#	11022+00	GPS Location	37.31	Field Station#	11049+64
Description	SSF Under cut.			Description	P1 stream buffer down.

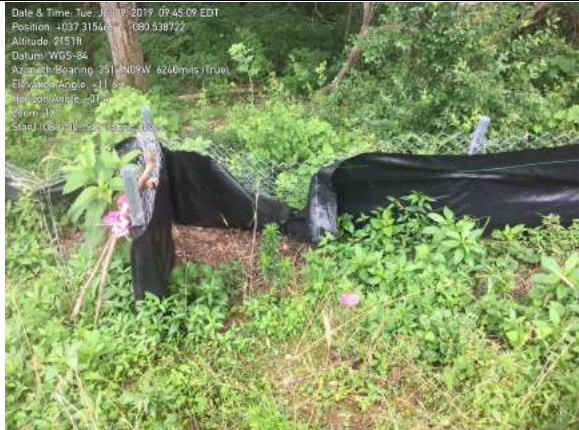
GPS Location	37.31	Field Station#	11057+00	GPS Location	37.31	Field Station#	11081+00
Description	Karst ECD's are in acceptable condition.			Description	SSF fabric down.

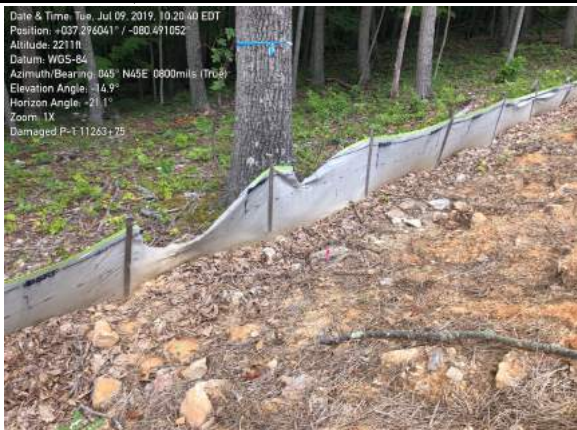
GPS Location	37.31	Field Station#	11263+75	GPS Location	37.30	Field Station#	11332+15
Description	Damaged P-1, recommended replacement.			Description	Undercut P-1, recommended replacement.

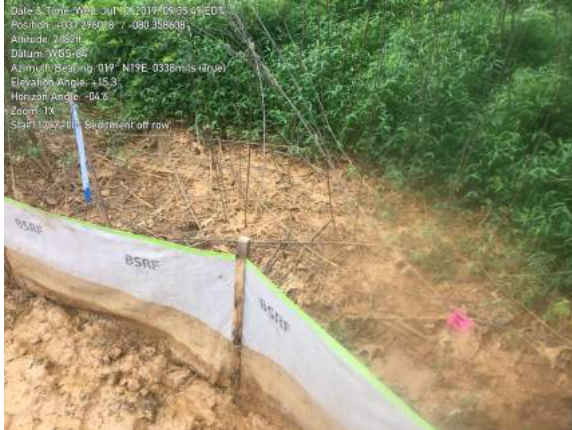
GPS Location		37.29		Field Station#		11797+00		GPS Location		37.29		Field Station#		11824+00	
Pic 1 Description		Sediment off row.						Pic 2 Description		Sediment has been removed from controls.

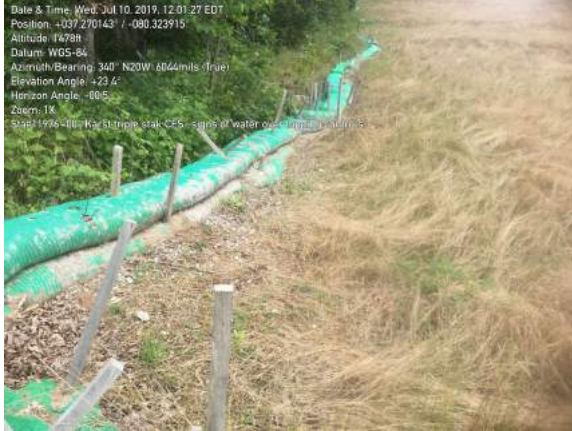
GPS Location		37.27		Field Station#		11976+00		GPS Location		37.26		Field Station#		12001+00	
Pic 5 Description		Karst Triple stack- There are signs of water over topping control and causing some rilling behind perimeter controls.						Pic 6 Description		Sta#12001+00- Wetland ECD's are in acceptable condition.

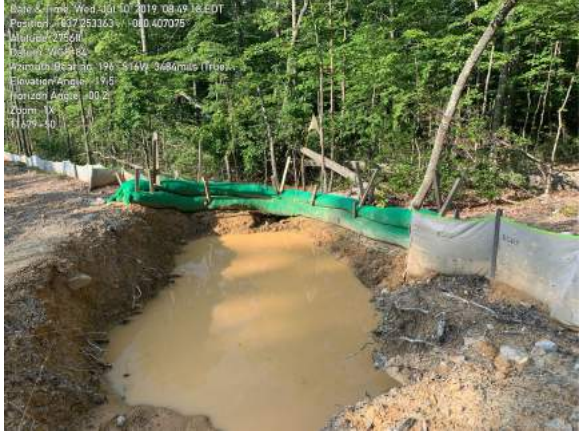
<p>Date &amp; Time: Wed, Jul 10, 2019, 08:49:18 EDT Position: +037.253263 / -080.407075 Altitude: 2625ft Datum: WGS-84 Azimuth Bearing: 194.51ftW / 368.4mils (True) Elevation Angle: 19.8 Horizon Angle: 0.0 Zoom: 1X 11679+50</p>				
GPS Location	37.18	Field Station#	11669+00	GPS Location	37.18	Field Station#	11679+50
Pic 1 Description	See photo for GPS location. Undermined priority one silt fence.			Pic 2 Description	See photo for GPS location. Undermined end treatment resulting in sediment outside the LOD.

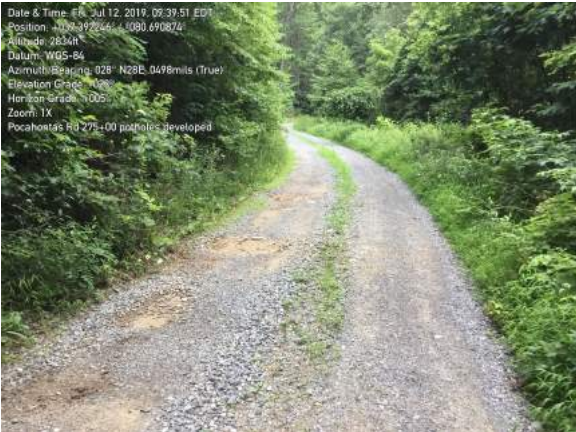
GPS Location	37.31	Field Station#	275+00	GPS Location	37.31	Field Station#	265+50
Pic 1 Description	Potholes developing in road surface.			Pic 2 Description	Potholes developing in road surface.

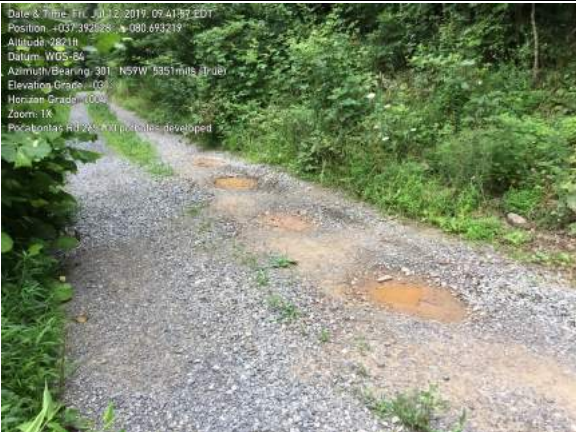
GPS Location	37.31	Field Station#	265+00	GPS Location	37.31	Field Station#	+1
Pic 3 Description	Potholes developing in road surface.			Pic 4 Description	ECDs are worn and in need of maintenance or replacement.

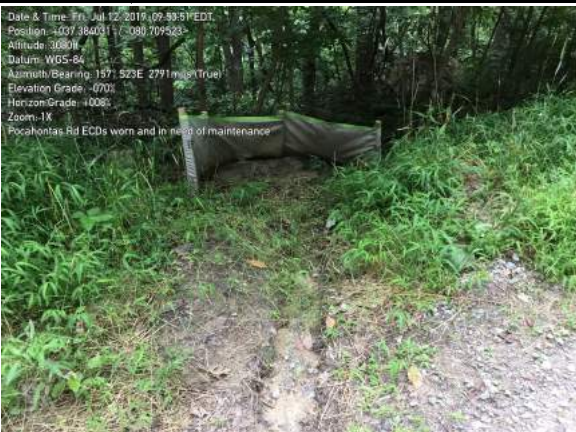
GPS Location	37.31	Field Station#	+2	GPS Location	37.31	Field Station#	+3
Pic 5 Description	ECDs are worn and in need of maintenance or replacement.			Pic 6 Description	ECDs are worn and in need of maintenance or replacement.

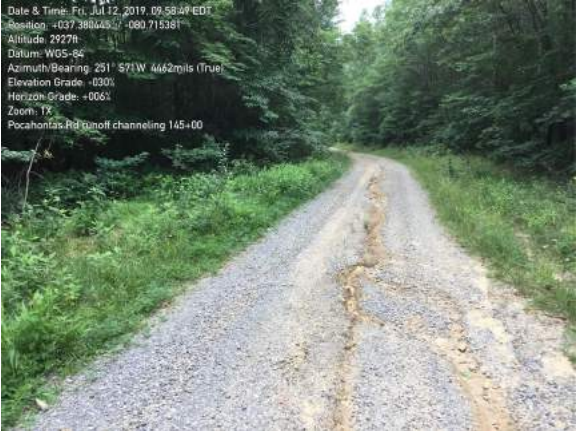
<small>Date &amp; Time: Fri Jul 12, 2019 10:09:38 EDT          Position: +037.388265 / -080.716929          Altitude: 2874ft          Datum: WGS-84          Azimuth/Bearing: 253° 57'0W 4458mils (True)          Elevation Grade: +028%          Horizon Grade: +008%          Zoom: 1X          Pocahontas Rd runoff channeling 140+00</small>
