Visual Site Inspection Report

Project Name	H-600 Pipeline Spread G	AFE	124300137	Spread	H-600 Pipeline Spread G
Contractor	Precision			Report #	20656
Inspector	Len Kruizenga			Date/Time	7/22/2019 7:27 AM
Permit #	TBD	Inspection Type	VA SWPP	Station Begin	11900+00
State	VA	Inspection Area	Full	Station End	12001+00
County	Giles	Ground	Wet	Temperature (°F)	80.00
Municipality	N/A	Weather	Light Rain	Rain Gauge (in)	1.10
				Rain Accumulation Time (days)	1.00

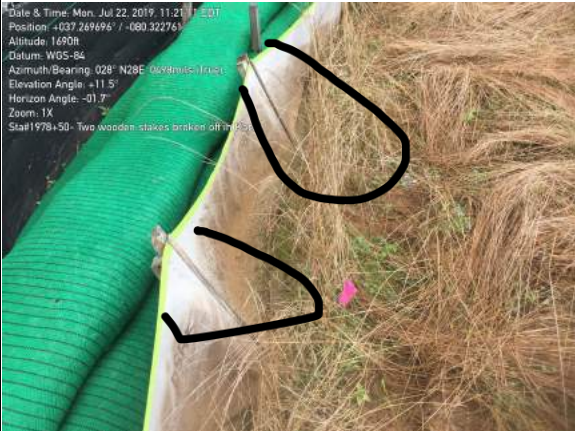
GPS Location	37.26	Field Station#	11978+50	GPS Location	37.26	Field Station#	12001+00
Pic 7 Description	Two wooden stakes broken off in Karst.			Pic 8 Description	Wetland ECD's have been reinstalled.

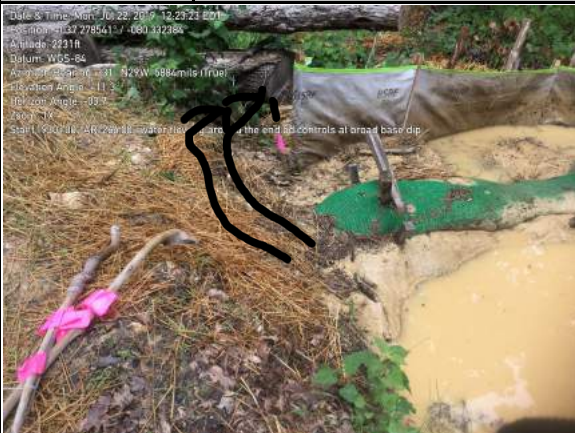
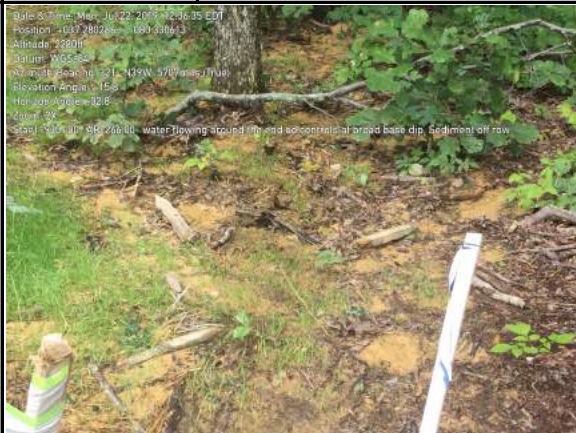
GPS Location	37.27	Field Station#	11930+00	GPS Location	37.28	Field Station#	11930+00
Pic 9 Description	AR-266.00- Water flowing around end of controls at broad base dip			Pic 10 Description	Top of AR- 266.00- Sediment by passing end of controls, sediment off row.

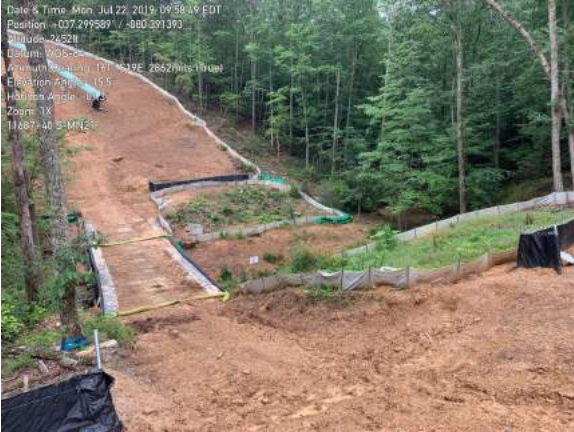
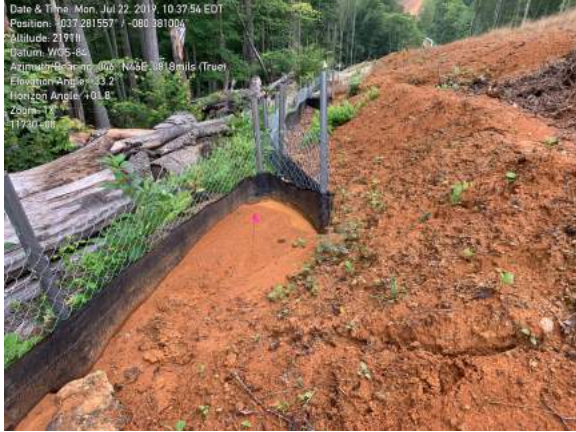
GPS Location	37.18	Field Station#	11687+40	GPS Location	37.18	Field Station#	11730+00
Pic 1 Description	See photo for GPS location. Sensitive resource buffer in place at stream S-MN21.			Pic 2 Description	See photo for GPS location. Sediment build up in SSF dissipator.

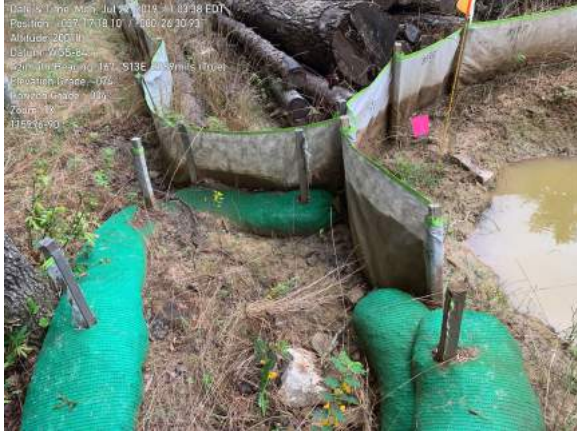
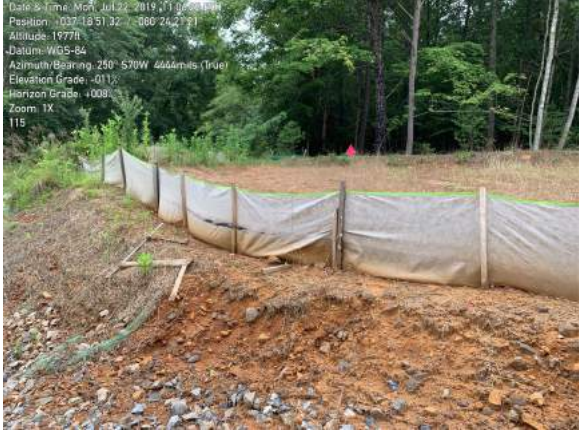
GPS Location		37.24	Field Station#		11534+00
Pic 3 Description		Undermined CFS

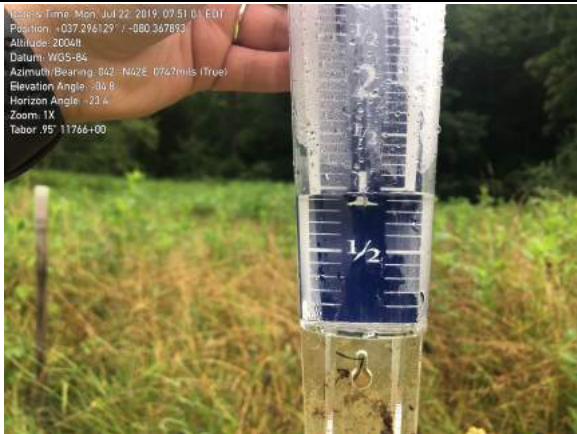
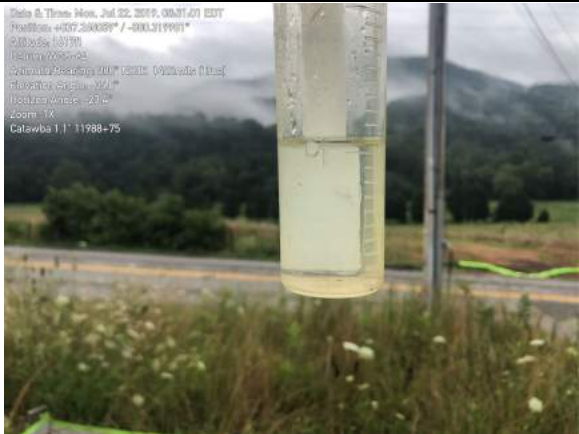
GPS Location	37.32	Field Station#	11766+00	GPS Location	37.32	Field Station#	11988+75
Pic 1 Description	Rain gauge Mt Tabor rd showing .95\".			Pic 2 Description	Catawba Rd rain gauge showing 1.1\".

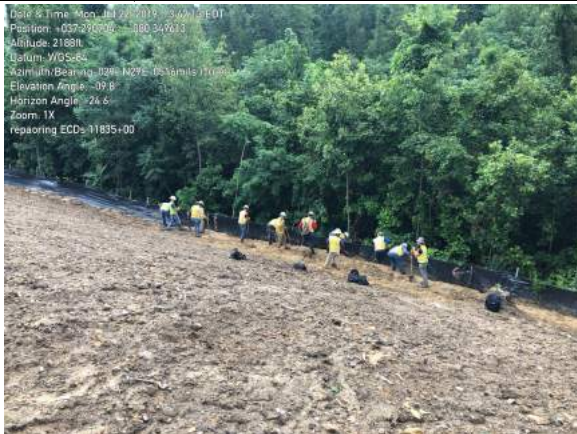
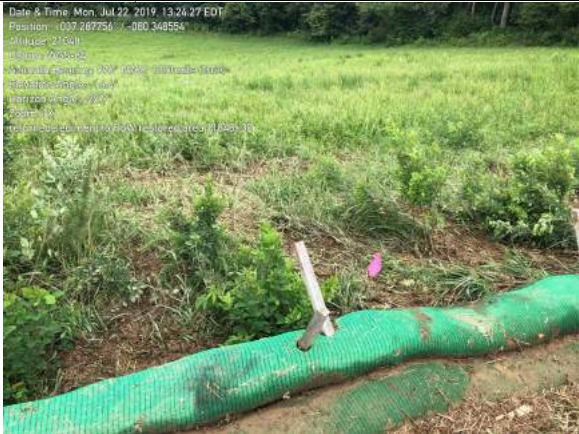
GPS Location	37.32	Field Station#	11835+00	GPS Location	37.32	Field Station#	11848+30
Pic 5 Description	Crews repairing ECDs.			Pic 6 Description	Sediment returned to RoW and off RoW area restored.

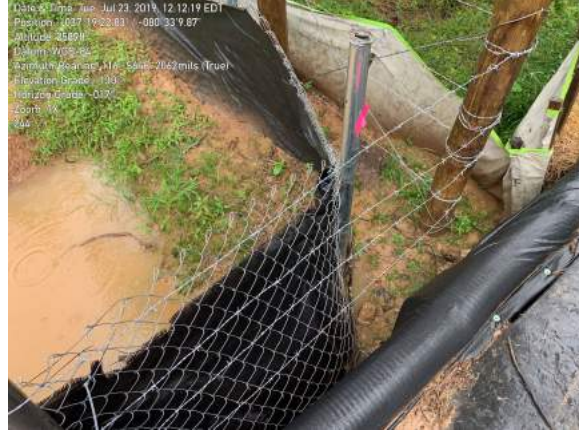
GPS Location		37.24		Field Station#		10854+00		GPS Location		37.24		Field Station#		11025+00	
Pic 3 Description		ECD's and row conditions										Pic 4 Description		SSF undermined

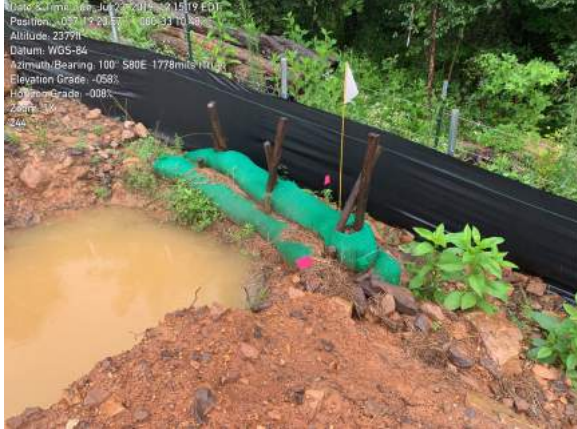
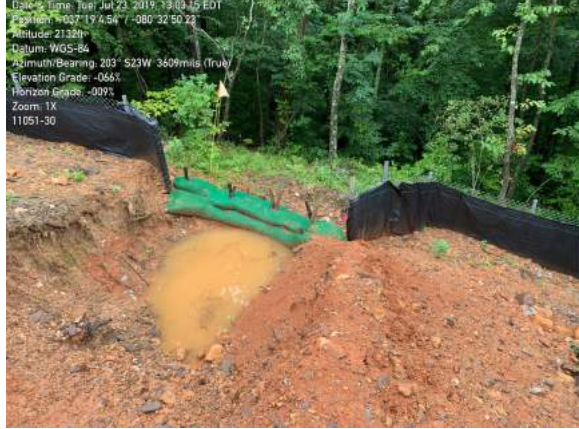
GPS Location		37.24		Field Station#		11025+00		GPS Location		37.24		Field Station#		11051+30	
Pic 5 Description		CFS end treatment undermined										Pic 6 Description		Add stabilization to end treatment

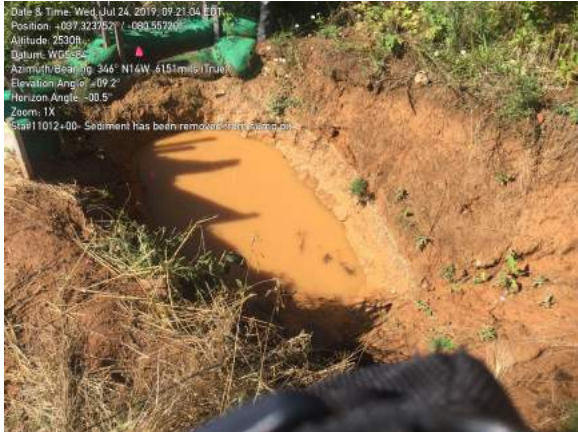
<p>Date & Time: Wed, Jul 24, 2019, 09:21:04 EDT Position: +037.323752° / -090.55790° Altitude: 2530ft Datum: WGS-84 Azimuth/Bearing: 344° N14W 615ftmils (True) Elevation Angle: -09.2° Horizon Angle: -00.5° Zoom: 1X Spot 11012+00- Sediment has been removed from sump pit.</p>

GPS Location	37.32	Field Station#	11016+00	GPS Location	37.32	Field Station#	11012+00
Pic 1 Description	Stream S-RR5- Equipment bridge, ECD's, signage, buffers are in acceptable condition.			Pic 2 Description	Sediment has been removed from sump pit.

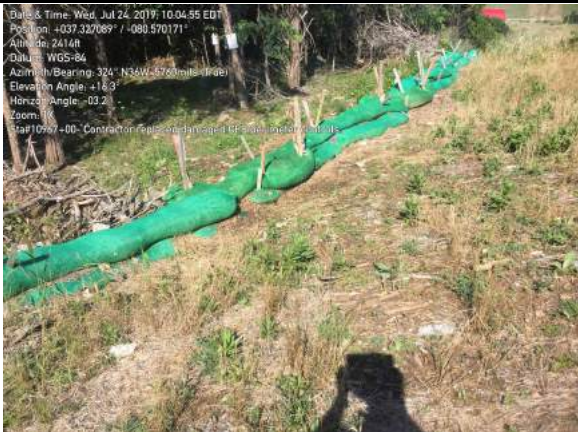
<p>Date & Time: Wed, Jul 24, 2019, 10:04:55 EDT Position: +037.323708° / -090.570171° Altitude: 2410ft Datum: WGS-84 Azimuth/Bearing: 324° N34W 570ftmils (True) Elevation Angle: +16.3° Horizon Angle: -03.2° Zoom: 1X Spot 10967+00- Contractor replaced damaged CFS perimeter controls.</p>

GPS Location	37.32	Field Station#	10977+00	GPS Location	37.32	Field Station#	10967+00
Pic 5 Description	Triple stack CFS perimeter controls are in acceptable condition.			Pic 6 Description	Contractor replaced damaged CFS perimeter controls.

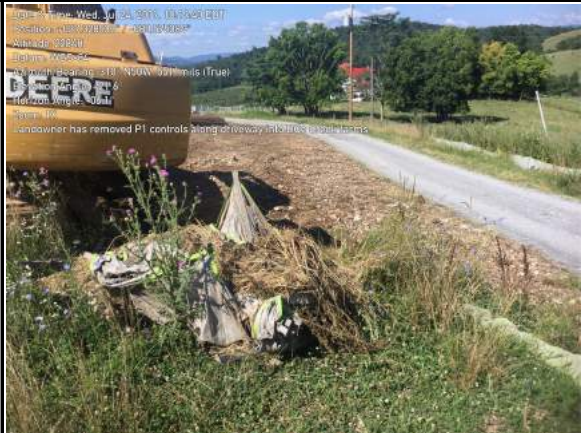
GPS Location	37.32	Field Station#	10965+00	GPS Location	37.32	Field Station#	10960+00
Pic 7 Description	Karst ECD's are in good condition.		Pic 8 Description	Doe Creek Farms- Landowner has removed P1 controls along driveway.

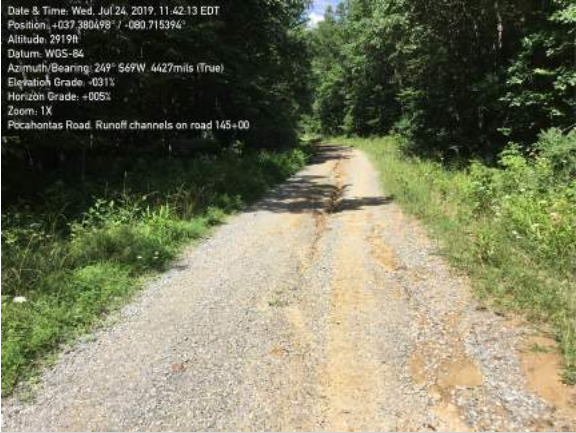
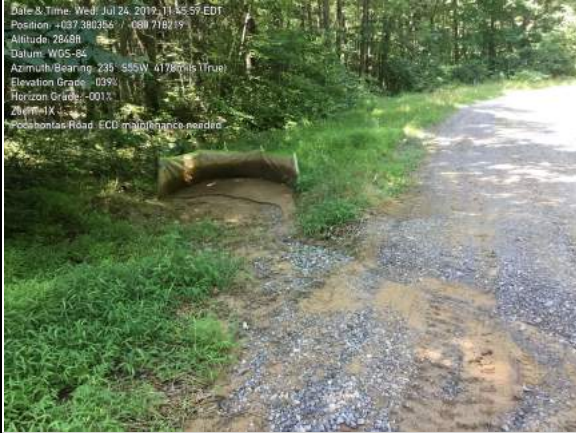
GPS Location 37.31		Field Station# 145+00		GPS Location 37.31	
Field Station# 143+00					
Pic 7 Description		Runoff is channeling in several areas.			
Pic 8 Description		ECD maintenance needed.

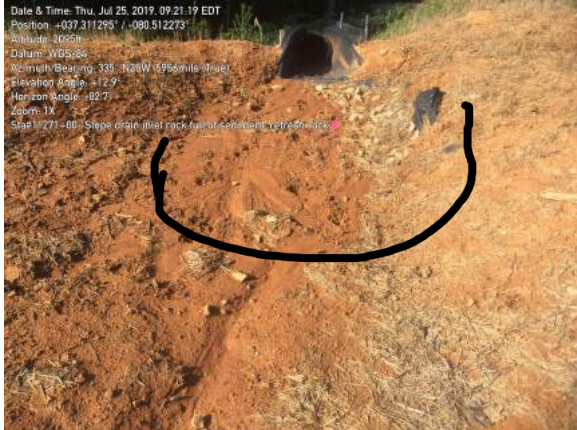
A/E	124300137	Date/Time	7/25/2019 7:43 AM	Report #	20863		
Pictures							
<p>Date & Time: Thu, Jul 25, 2019, 09:21:19 EDT Position: +037.311293° / -090.512273° Altitude: 2050ft Datum: WGS84 Azimuth/Bearing: 335° N28W 195mils.11ft Elevation Angle: +12.9° Horizon Angle: -82.7° Zoom: 1X Sta# 11271+00 - Slope drain inlet rock full of sediment, needs to be refreshed.</p>

GPS Location	37.29	Field Station#	11271+00	GPS Location	37.29	Field Station#	11277+00
Pic 1 Description	Slope drain inlet rock full of sediment, needs to be refreshed.			Pic 2 Description	Estimated sta#, Stakes fadded or none existent, Slope drain & CWD pipe & plunge pool are in acceptable condition.

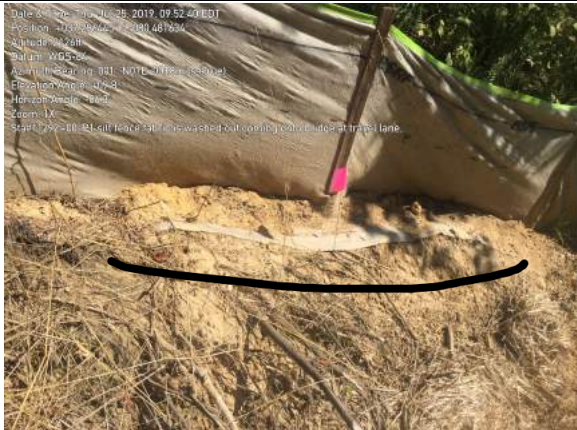
<p>Date & Time: Thu, Jul 25, 2019, 09:52:40 EDT Position: +037.296773° / -090.496308° Altitude: 2222ft Datum: WGS84 Azimuth/Bearing: 335° N28W 195mils.11ft Elevation Angle: +12.9° Horizon Angle: -82.7° Zoom: 1X Sta# 11292+00 - Silt fence washed out coming onto bridge at travel lane cut.</p>

GPS Location	37.29	Field Station#	11292+00	GPS Location	37.29	Field Station#	11298+00
Pic 3 Description	Stream- S- MM18- P1 silt fence fabric is washed out coming onto bridge at travel lane cut.			Pic 4 Description	P1 perimeter controls has a large hole.		
<p>Date & Time: Thu, Jul 25, 2019, 10:40:42 EDT Position: +037.309172° / -090.506689° Altitude: 2293ft Datum: WGS84 Azimuth/Bearing: 028° N28E 067mils.11ft Elevation Angle: +13.9° Horizon Angle: -93.6° Zoom: 1X Sta# 11300+10 - P1 perimeter controls has hole in it.</p>

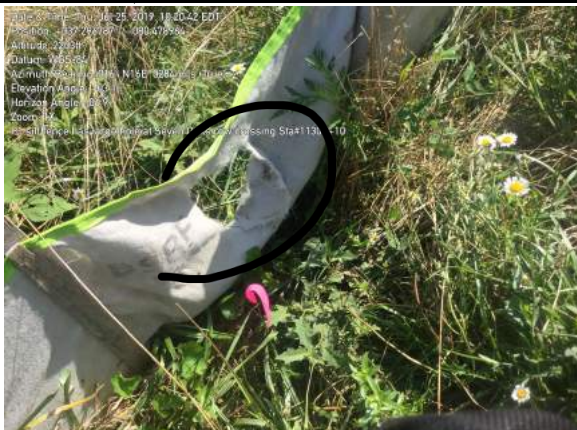
GPS Location	37.29	Field Station#	11300+10	GPS Location	37.29	Field Station#	11301+50
Pic 5 Description	P1 perimeter controls has hole in it.			Pic 6 Description	Sta#11301+00 & 11301+40 - 11301+50 - 11301+70 -P1 damaged, have large holes.

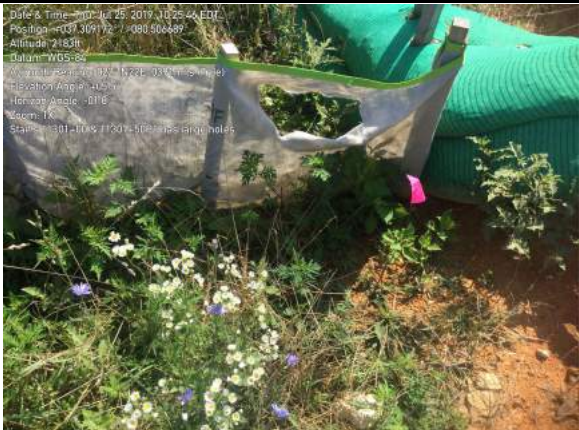
<p>Date & Time: Thu, Jul 25, 2019, 10:25:44 EDT Position: +037.309172° / -090.506689° Altitude: 2183ft Datum: WGS84 Azimuth/Bearing: 028° N28E 067mils.11ft Elevation Angle: +13.9° Horizon Angle: -93.6° Zoom: 1X Sta# 11301+00 & 11301+40 - 11301+50 - 11301+70 - P1 damaged, have large holes.</p>
