Re: Mountain Valley Pipeline, LLC
Docket No. CP16-10-000
Weekly Status Report No. 102

Docket No. CP16-10-000
Weekly Report No. 102
Report Period: 10/05/19- 10/11/19

**Re: Mountain Valley Pipeline Project (Permit No. WVR310667)
Response to Notice of Violation No. W19-09-028-JTL**

**Re: Mountain Valley Pipeline Project (Permit No. WVR310667)
Response to Notice of Violation No. W19-21-029-JTL**

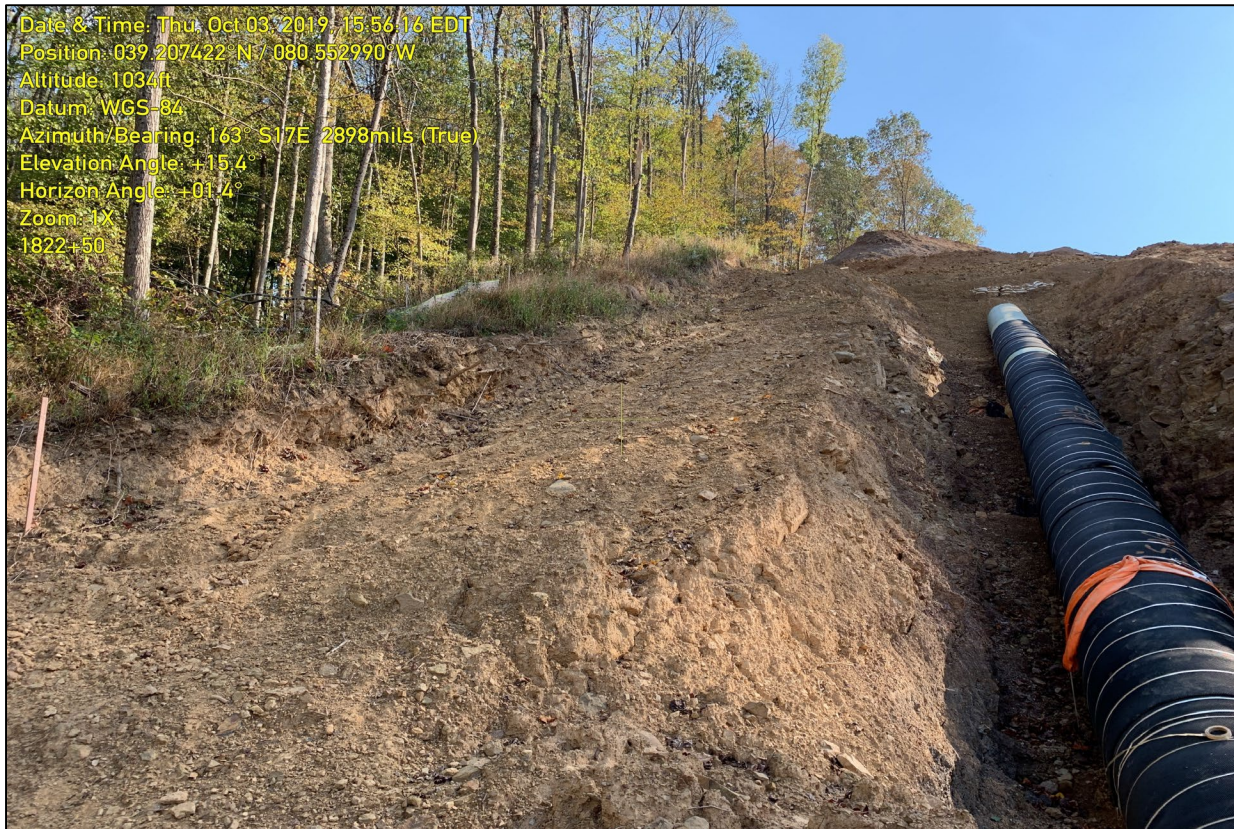
Photo 1: Photo illustrates the regraded slope near Station 1822+50. The area is still in active construction and will be stabilized once complete.

- Mountain Valley has regraded the hillside to address the erosion rills;
- Additional slope drains have been added to protect the fill slope;
- Compost filter sock (CFS) has been repaired or replaced to increase infiltration; and
- A clean water diversion has been installed to prevent onsite saturation.

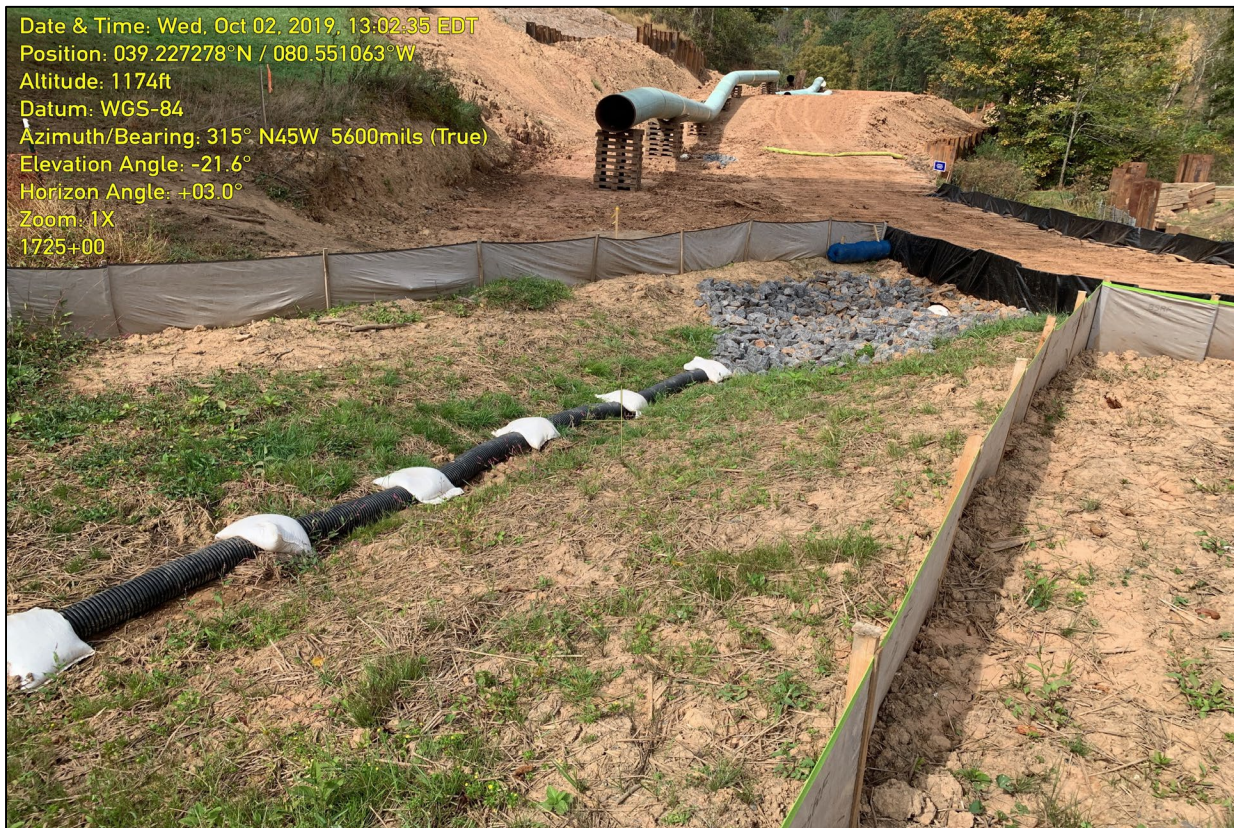
Photo 2: Photo illustrates the clean water diversion that was installed to contain the seep and prevent onsite saturation.

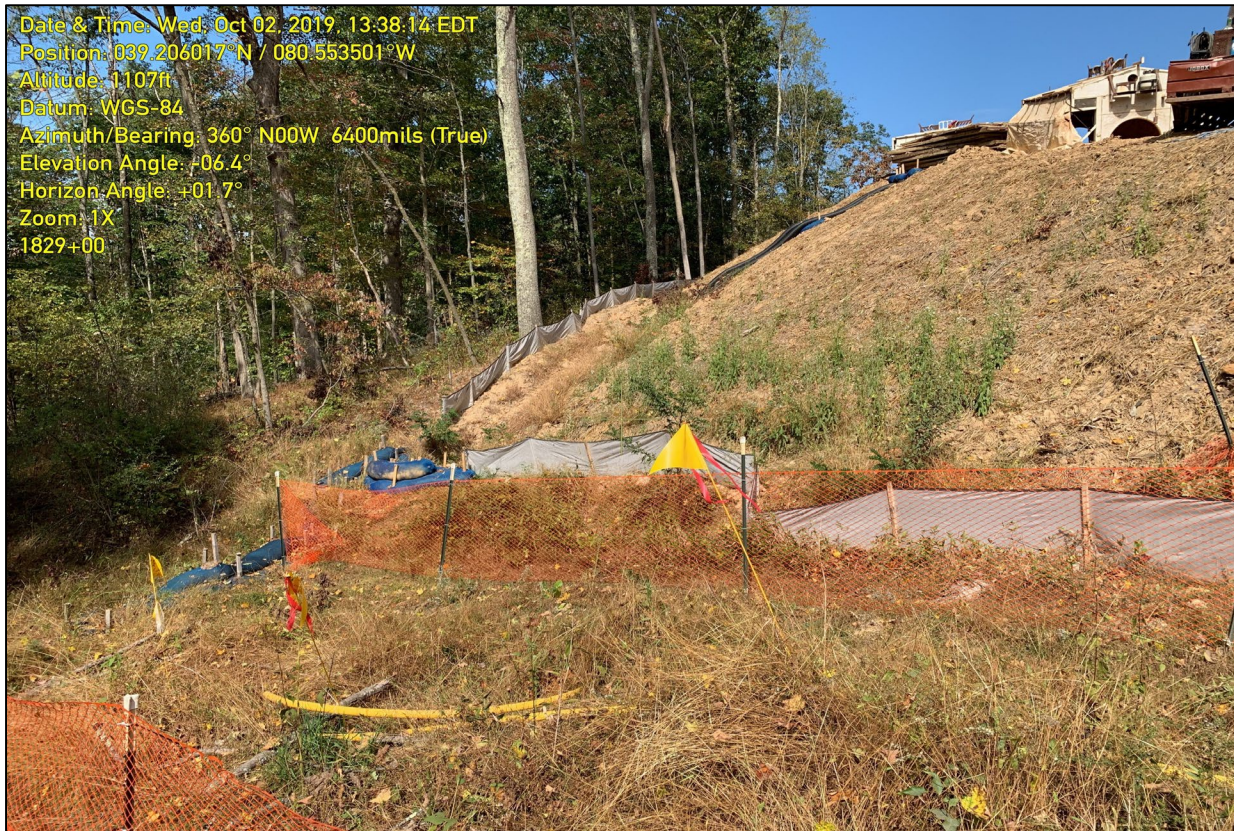
Photo 3: Photo illustrates additional ECDs that have been installed downslope of the inspection area.

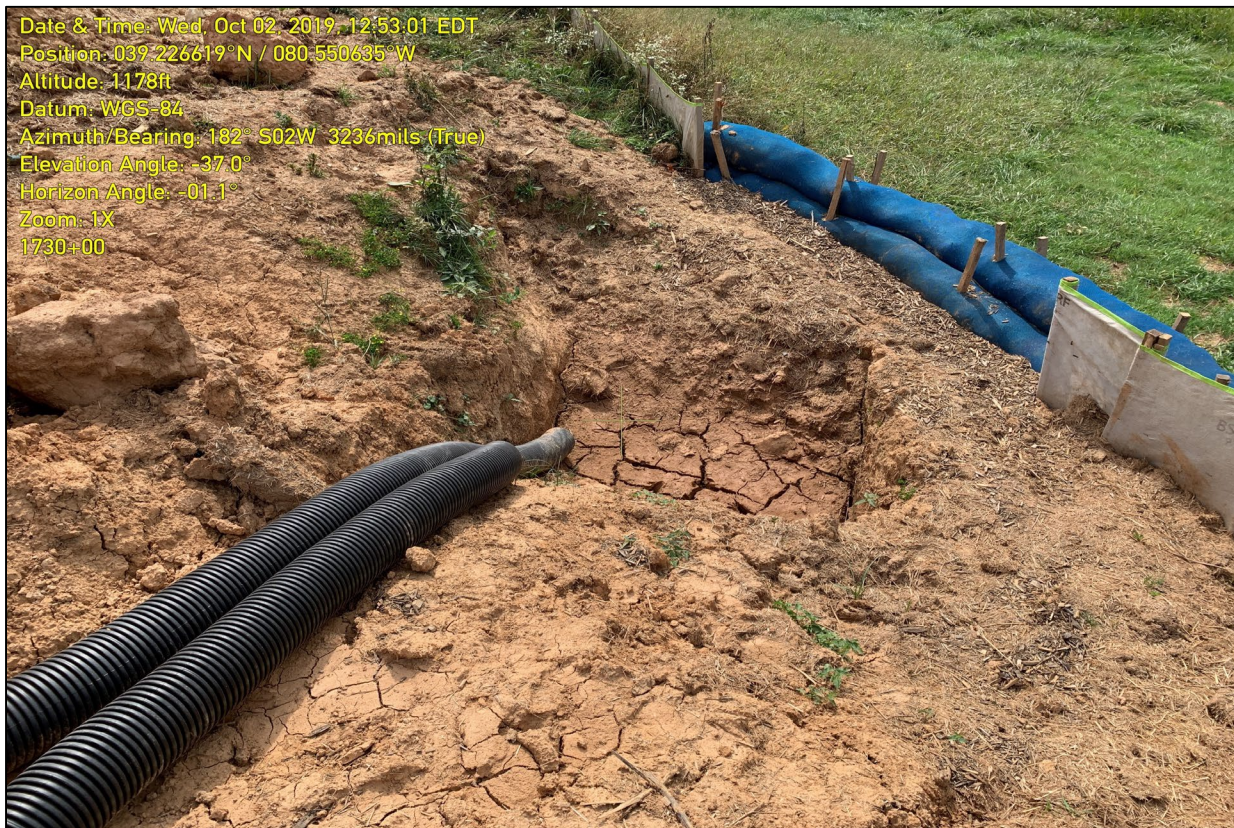
Photo 4: Photo illustrates the additional slope drain and triple stacked CFS that have been added near station 1730+00.

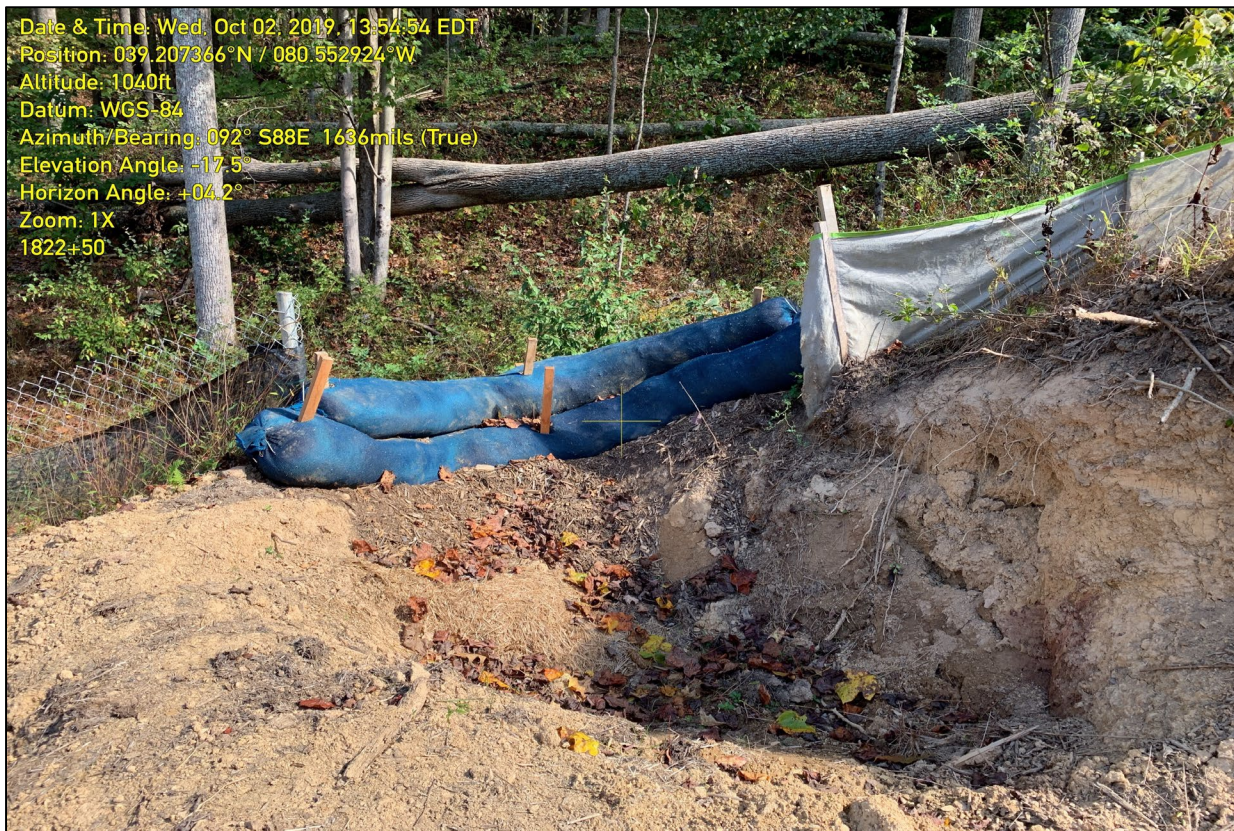
Photo 5: Photo illustrates repaired compost filter sock (CFS) that has been installed at the end of the waterbar in the inspection area.

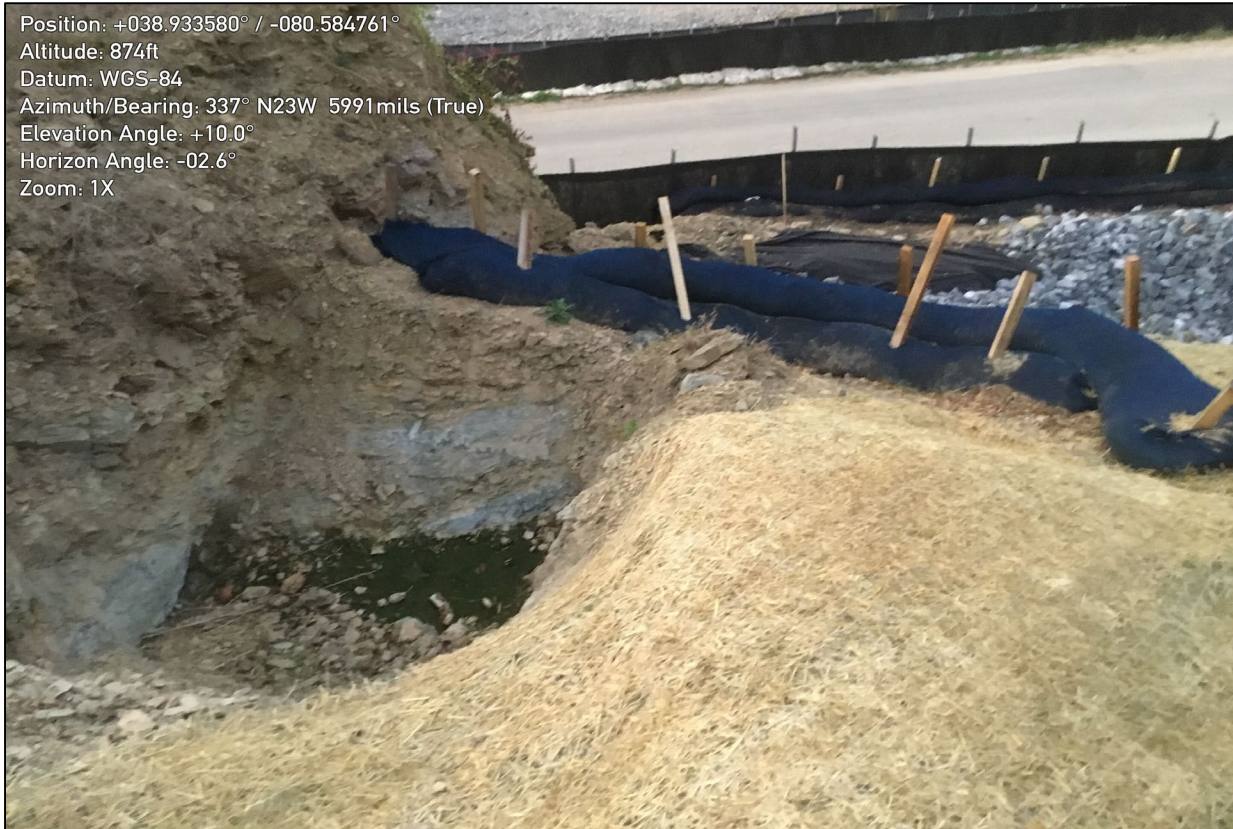
Photo 1: Photo illustrates the repaired and replaced controls upslope of CR 21. An additional row of compost filter sock (CFS), erosion control blanketing (ECB), and super silt fence (SSF) have been installed.

- Mountain Valley has reworked the hill side to remove erosion rills and installed erosion control blanketing (ECB) for stabilization;
- Supersilt fence (SSF) has been repaired and replaced within the inspection area;
- Additional rows of compost filter sock (CFS) have been incorporated within the inspection area;
- Additional gravel has been added to the rock construction entrance; and
- Gravel has been added to several sumps in the area to provide stabilization and promote filtration.

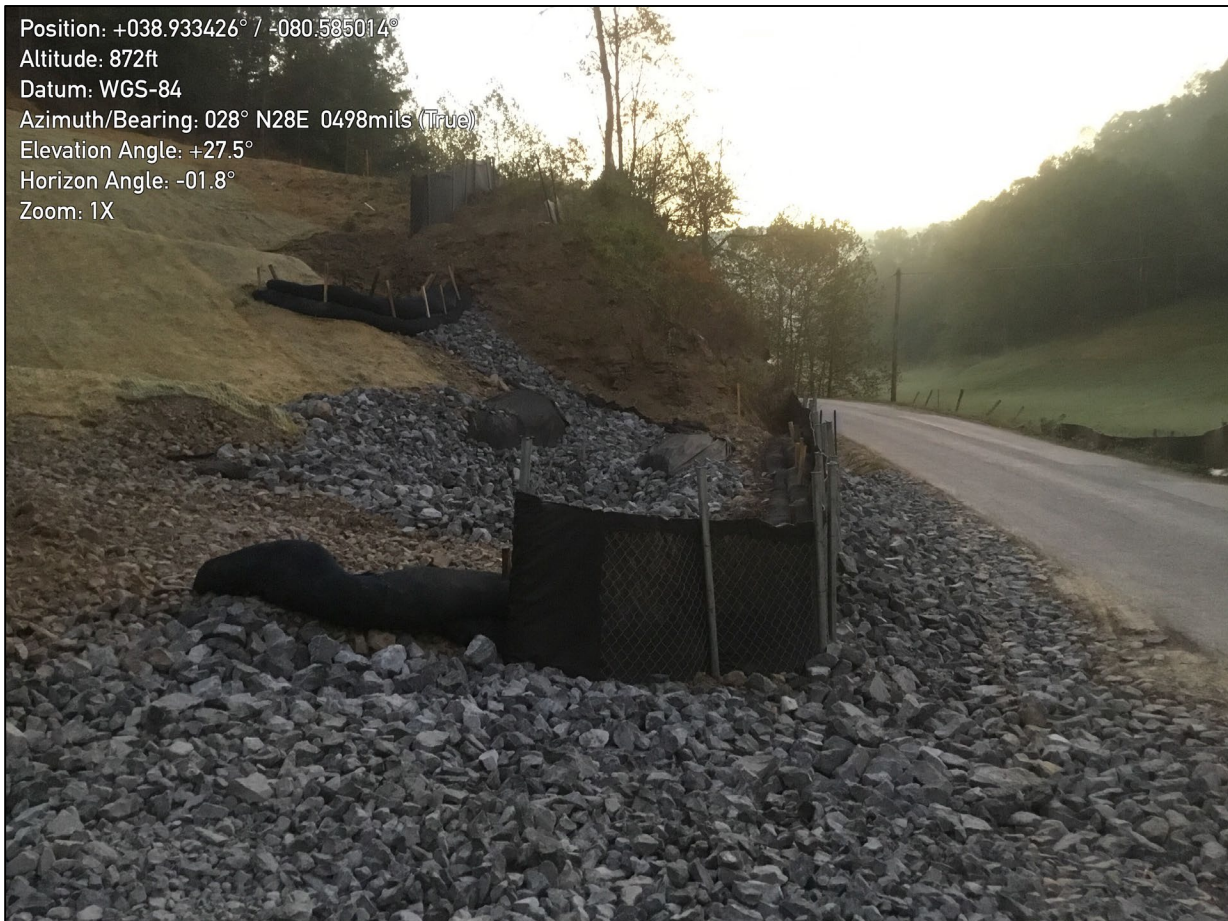
Photo 2: Photo illustrates the additional and upgraded controls near CR 21.

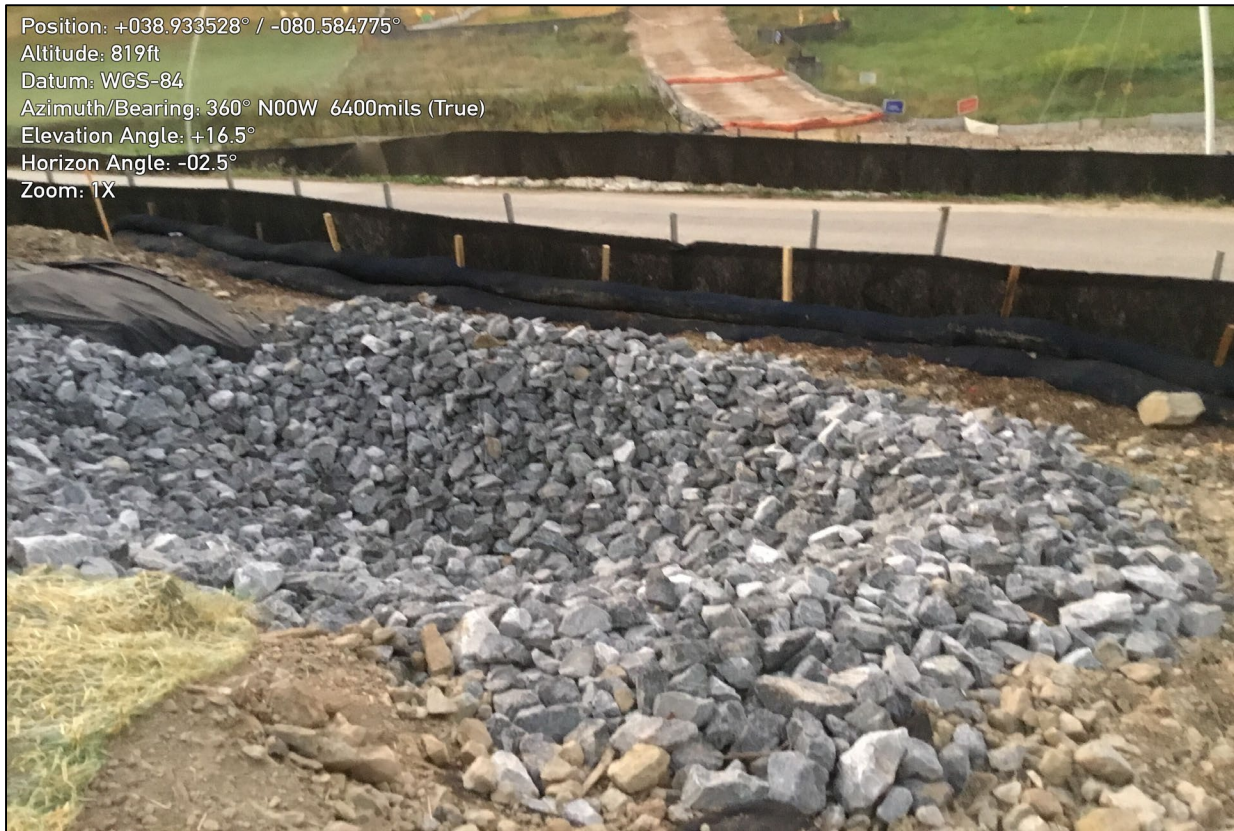
Photo 3: Photo illustrates the rock sump that has been installed near CR 21.

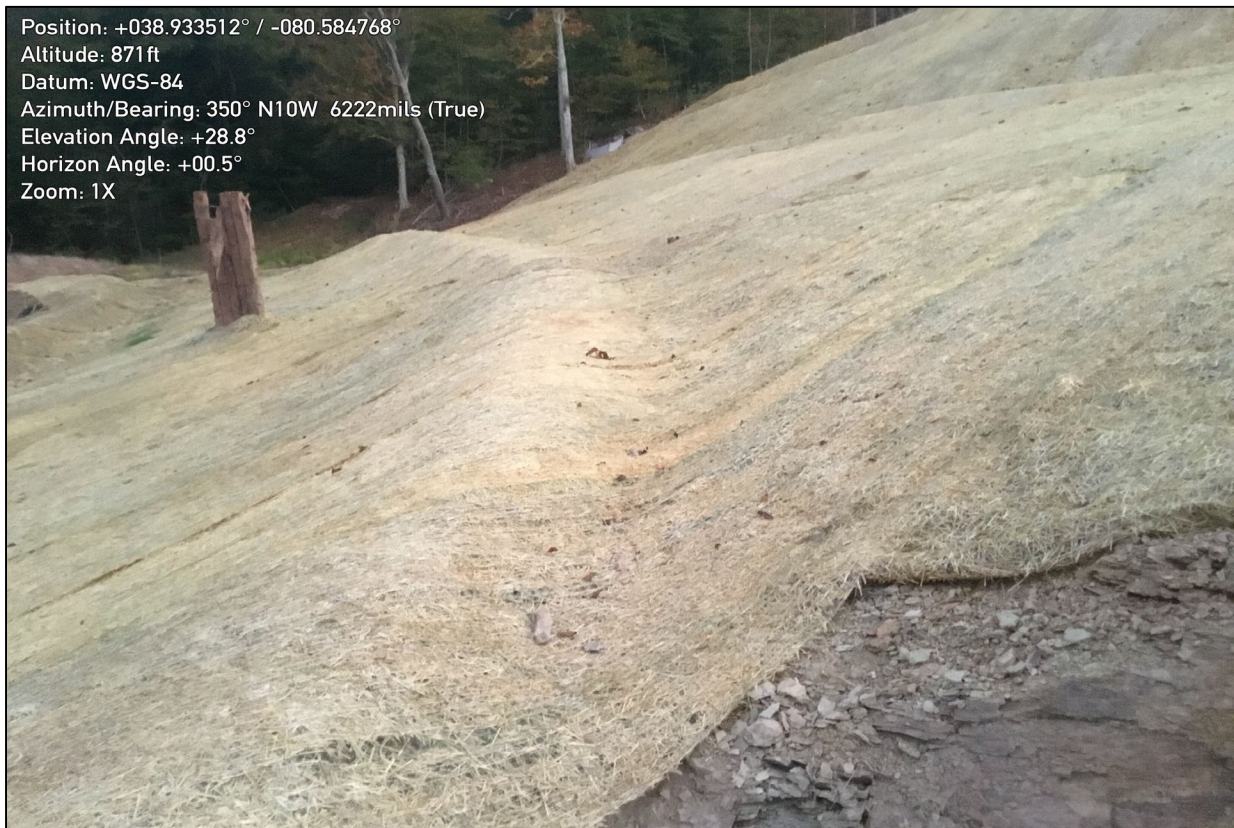
Photo 4: Photo illustrates the repaired waterbar and stabilized hillside, using ECB, located above CR 21.
