Visual Site Inspection Report

Project Name H-600 Pipeline Spread G		AFE 124300137	Spread H-600 Pipeline Spread
Contractor Precision		Report # 100007	
Inspector Jared Saunders		Date/Time 9/9/2019 4:28 PM	
Permit # TBD	Inspection Type VA SWPP	Station Begin	10650+00
State VA	Inspection Area Partial	Station End	10832+00
County Giles	Ground Dry	Temperature (°F)	86.00
Municipality N/A	Weather Sunny	Rain Gauge (in)	0.00
			Rain Accumulation Time (days) 1.00

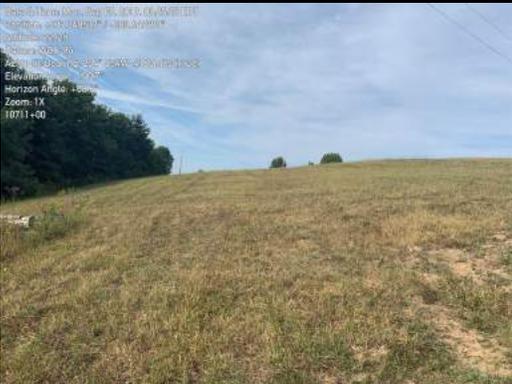
<p><small>Date & Time: Mon Sep 09 2019 09:26:56 EDT Position: (032.50455, -080.18310) Altitude: 2900ft Datum: WGS-84 Azimuth Bearing: 090° N90E 1600mils True Elevation Angle: -05.6° Horizon Angle: -06.0° Zoom: 1X 10711+00</small></p>		GPS Location	See photo for GPS location.	GPS Location	See photo for GPS location.
Field Station#	10712+50	Field Station#	10711+00	Pic 1 Desc.	Sensitive resource buffer in place at stream S-G33.	Pic 2 Desc.	ROW stabilized with natural vegetation.

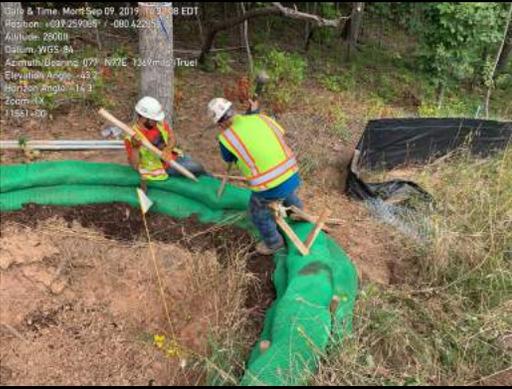
<p><small>Date & Time: Mon Sep 09 2019 10:31:08 EDT Position: (032.50455, -080.18310) Altitude: 2900ft Datum: WGS-84 Azimuth Bearing: 071° N71E 136Vmils True Elevation Angle: -05.7° Horizon Angle: -06.0° Zoom: 1X 11561+00</small></p>		GPS Location	See photo for GPS location.	GPS Location	See photo for GPS location.
Field Station#	10694+00	Field Station#	11561+00	Pic 5 Desc.	Priority one silt fence in travel damaged by third party.	Pic 6 Desc.	Environmental crew installing triple stack compost filter sock.

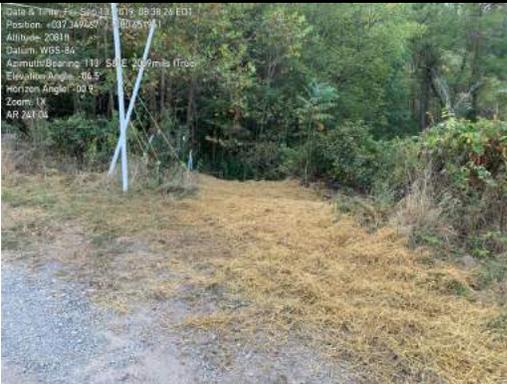
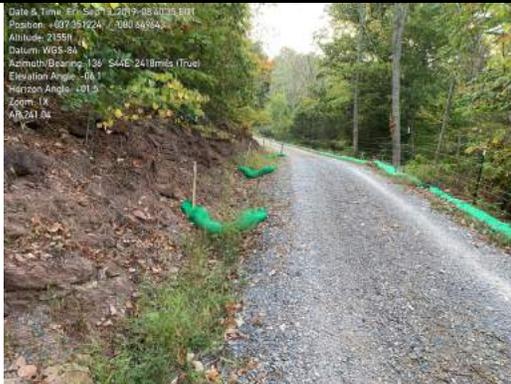
GPS Location	See photo for GPS location.		GPS Location	See photo for GPS location.	
Field Station#	12005+00		Field Station#	12005+00	
Pic 1 Desc.	Top soil spoil pile pushed outside the LOD by land owner recovered. Area of denuded soils stabilized with seed and mulch.		Pic 2 Desc.	Sock checks placed in bar ditch along access road.

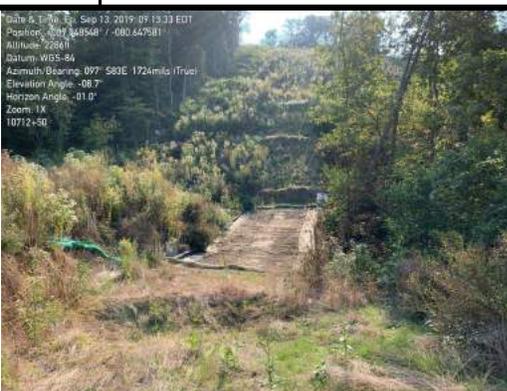
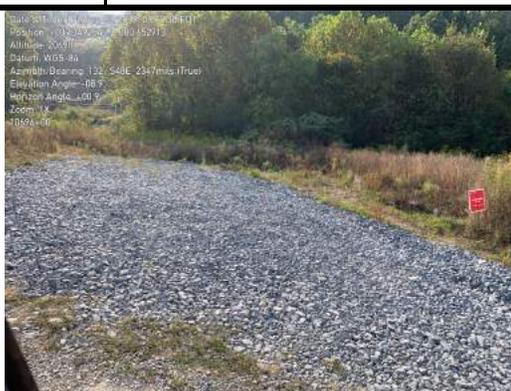
GPS Location	See photo for GPS location.		GPS Location	See photo for GPS location.	
Field Station#	10712+50		Field Station#	10696+00	
Pic 3 Desc.	Sensitive resource buffer in place at stream S-G33.		Pic 4 Desc.	RCE in place at Buffalo Anklets Road.

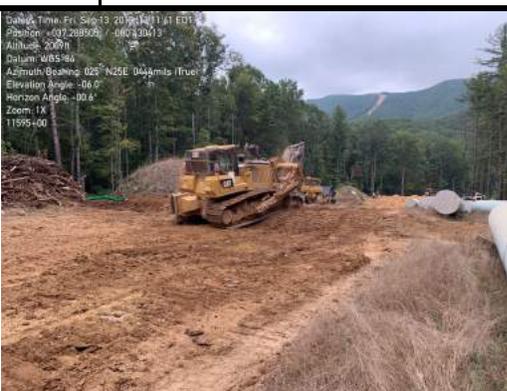
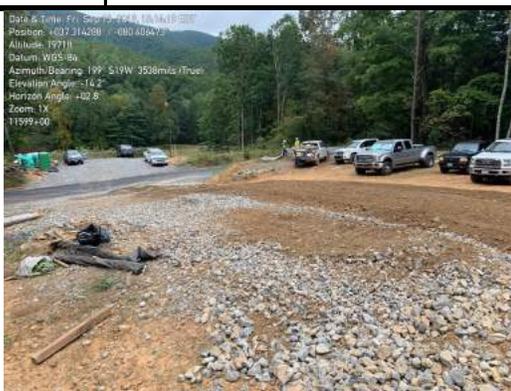
GPS Location	See photo for GPS location.		GPS Location	See photo for GPS location.	
Field Station#	11595+00		Field Station#	11599+00	
Pic 5 Desc.	Environmental crew tracking in waterbar that was re-installed at end of the day.		Pic 6 Desc.	Environmental crew capping portion of RCE with crush and run as a safety precaution due to water truck traffic.

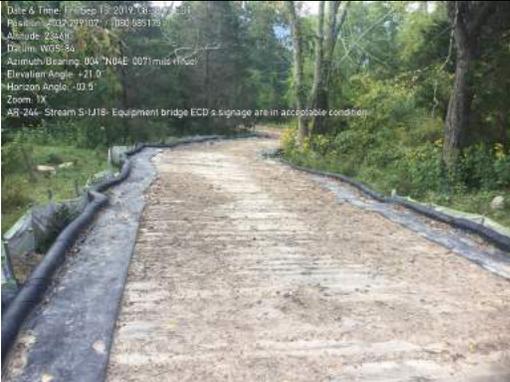
<p>Date & Time: Fri, Sep 13, 2019 7:39:05 EDT Position: -107.2297027, 43.04399178 Altitude: 2240ft Datum: WGS 84 Azimuth Bearing: 304.7184E 0071mils (FPO) Elevation Angle: +21.0 Horizon Angle: -03.5 Zoom: IX AR-244- Stream S-IJ18- Equipment bridge ECD's signage are in acceptable condition.</p>

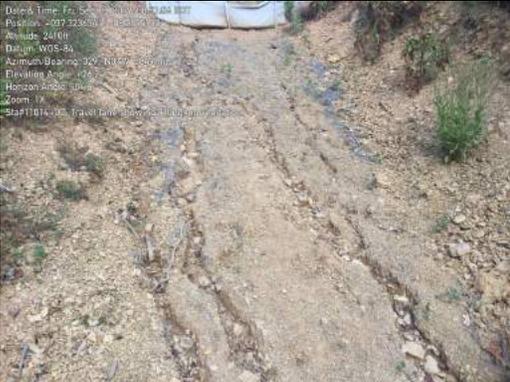
<p>Date & Time: Fri, Sep 13, 2019 7:39:05 EDT Position: -107.2326301, 43.04399178 Altitude: 2410ft Datum: WGS 84 Azimuth Bearing: 327.1124E 0000mils (FPO) Elevation Angle: +22.0 Horizon Angle: -04.0 Zoom: IX Star#11014-002- Travel lane shows rilling and no vegetation.</p>			
GPS Location		See photo GPS		GPS Location	
Field Station#		11022+00		Field Station#	
Pic 1 Desc.		AR-244- Stream S-IJ18- Equipment bridge, ECD's, sensitive resource signage are in acceptable condition.		Pic 2 Desc.	
				Travel lane has rilling, no vegetation

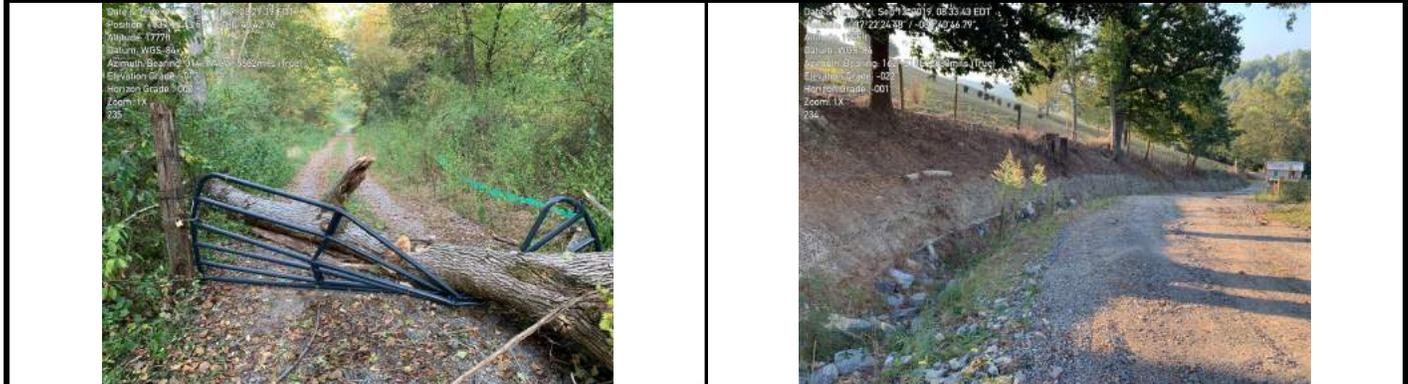
GPS Location	See picture above for GPS coordinates	GPS Location	See picture above for GPS coordinates
Field Station#	2+35	Field Station#	2+34
Pic 1 Desc.	Damaged gate for AR 235	Pic 2 Desc.	ECD's and row conditions AR 234

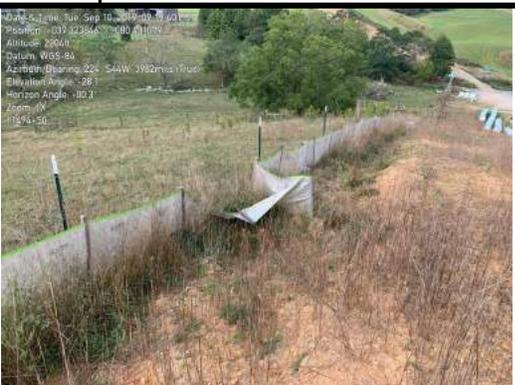
GPS Location	See photo for GPS location.		GPS Location	See photo for GPS location.	
Field Station#	11494+50		Field Station#	11489+00	
Pic 3 Desc.	Priority one silt fence with broken stake.		Pic 4 Desc.	RCE in place at Stevers Gap Road.

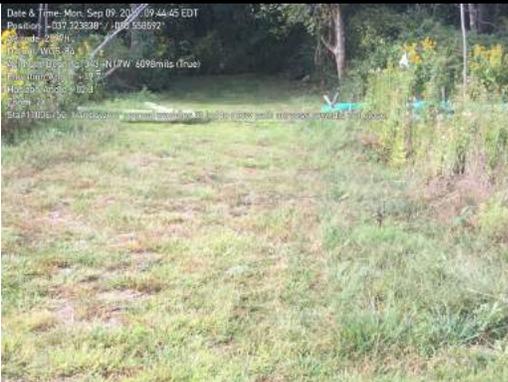
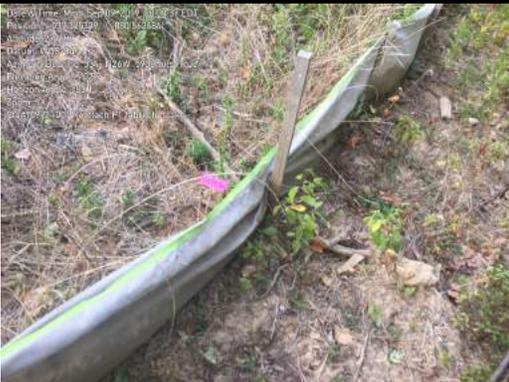
GPS Location	See photo GPS	GPS Location	See photo GPS		
Field Station#	11006+50	Field Station#	10992+00		
Pic 3 Desc.	Landowner opened waddles at lod to mow path, did not close waddles.	Pic 4 Desc.	Reattach P1 fabric ito wooden stake.

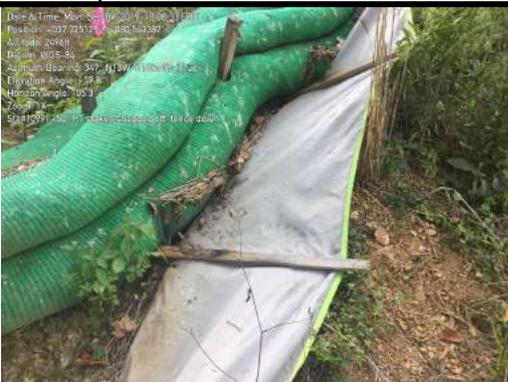
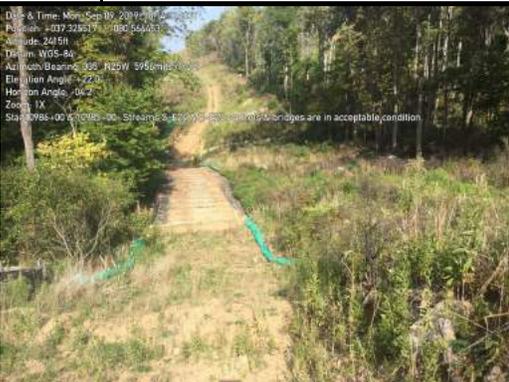
GPS Location	See photo GPS	GPS Location	See photo GPS		
Field Station#	10991+50	Field Station#	10986+00		
Pic 5 Desc.	Two P1 stakes snapped off, fence down.	Pic 6 Desc.	Streams S-E24 & S-E25 are in good condition.

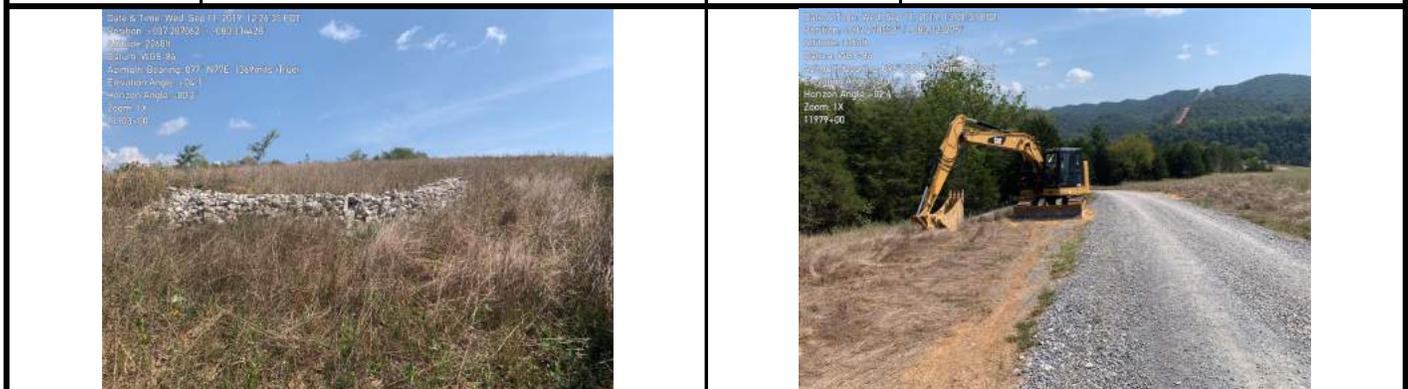
GPS Location	See photo for GPS location.	GPS Location	See photo for GPS location.
Field Station#	11903+00	Field Station#	11979+00
Pic 5 Desc.	Rock level spreader in place in restored area of ROW.	Pic 6 Desc.	314 trackhoe parked in karst no parking area. LEI notified.

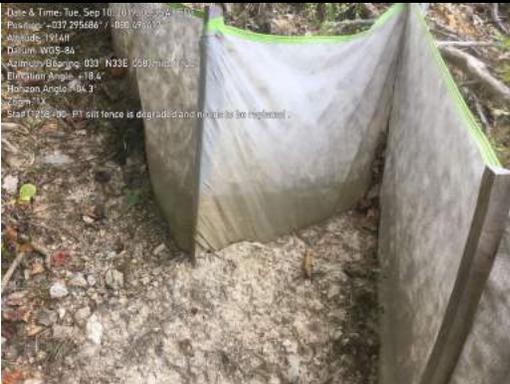
<p><small>Date & Time: Tue, Sep 10, 2019, 09:35:29 EDT Position: +037.295686 / +080.676132 Altitude: 2164ft Datum: WGS-84 Azimuth/Bearing: 033 N33E 059/mils (True) Elevation Angle: +18.4° Horizon Angle: -04.1° Zoom: IX Sta#11258+00- P1 silt fence is degraded and needs to be replaced.</small></p>

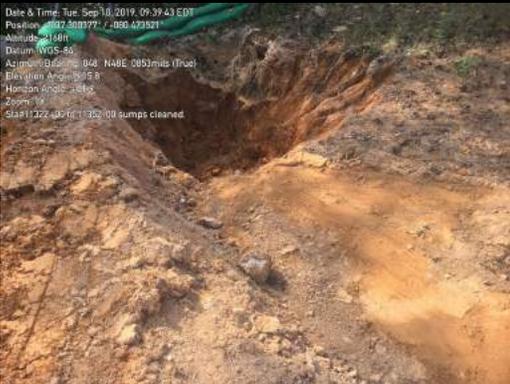
<p><small>Date & Time: Tue, Sep 10, 2019, 09:39:43 EDT Position: +037.300777 / +080.473321 Altitude: 2168ft Datum: WGS-84 Azimuth/Bearing: 046 N46E 083/mils (True) Elevation Angle: +19.8° Horizon Angle: -03.5° Zoom: IX Sta#11332+00- P1 sumps cleaned.</small></p>
GPS Location See photo GPS	GPS Location See photo GPS
Field Station# 11258+00	Field Station# 11332+00
Pic 1 Desc. P1 silt fence is degraded on steep slope & needs to be replaced ahead of winter stabilization.	Pic 2 Desc. Sumps cleaned

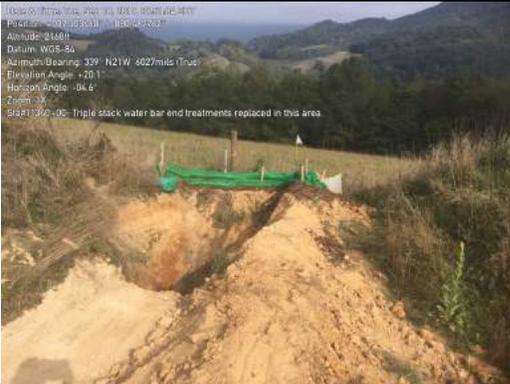
<p><small>Date & Time: Tue, Sep 10, 2019, 09:45:45 EDT Position: +037.302341 / +080.673322 Altitude: 2166ft Datum: WGS-84 Azimuth/Bearing: 329 N21W 662/mils (True) Elevation Angle: +20.1° Horizon Angle: -04.6° Zoom: IX Sta#11302+00- Triple stack water bar end treatments replaced in this area.</small></p>

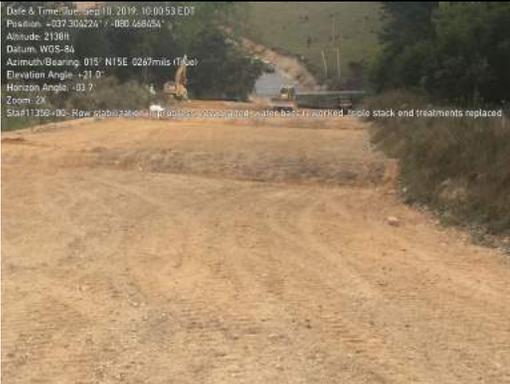
<p><small>Date & Time: Tue, Sep 10, 2019, 10:00:53 EDT Position: +037.304226 / +080.668054 Altitude: 2126ft Datum: WGS-84 Azimuth/Bearing: 015 N15E 026/mils (True) Elevation Angle: +21.3° Horizon Angle: -03.7° Zoom: IX Sta#11350+00- Row stabilization in progress, water bars reworked, triple stack end treatments replaced.</small></p>

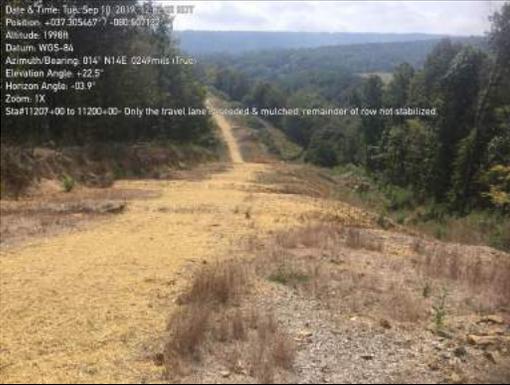
<p><small>Date & Time: Tue, Sep 10, 2019, 10:02:01 EDT Position: +037.303467 / +080.607037 Altitude: 1998ft Datum: WGS-84 Azimuth/Bearing: 014 N14E 024/mils (True) Elevation Angle: +22.5° Horizon Angle: -03.9° Zoom: IX Sta#11207+00 to 11200+00- Only the travel lane seeded & mulched; remainder of row not stabilized.</small></p>

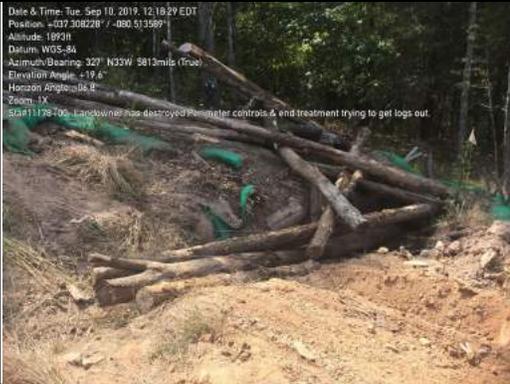
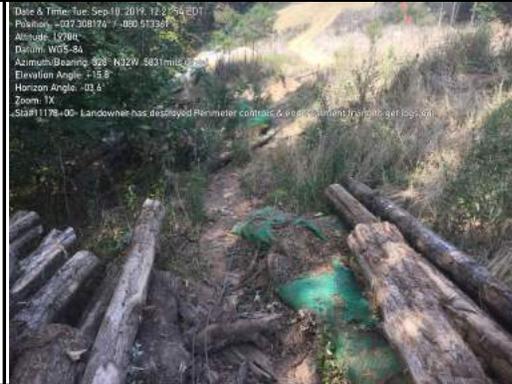
GPS Location	See photo GPS	GPS Location	See photo GPS
Field Station#	11177+00	Field Station#	11178+76
Pic 7 Desc.	Landowner has damaged CFS perimeter controls while removing logs.	Pic 8 Desc.	CFS damaged by landowner during log removal
