Visual Site Inspection Report

Project Name	H-600 Pipeline Spread H	AFE	124300138	Spread	H-600 Pipeline Spread H
Contractor	Precision			Report #	5243
Inspector	Pat Davis			Date/Time	10/28/2019 5:05 PM
Permit #	TBD	Inspection Type	VA SWPP	Station Begin	+0
State	VA	Inspection Area	Partial	Station End	+0
County	Montgomery	Ground	Wet	Temperature (°F)	69.00
Municipality	N/A	Weather	Sunny	Rain Gauge (in)	0.00
				Rain Accumulation Time (days)	0.00

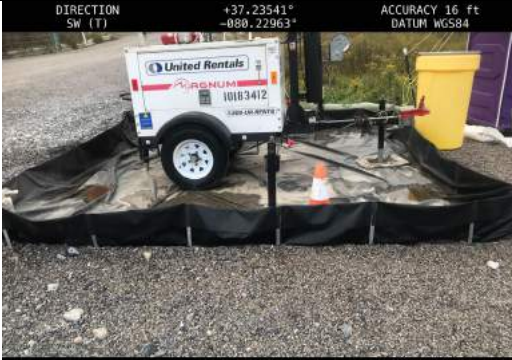
<p>DIRECTION SW (T) +37.23541° -080.22963° ACCURACY 16 ft DATUM WGS84</p> <p>MVP-PY-006_102819 Condition of containment 2019-10-28 08:33:49-04:00</p>

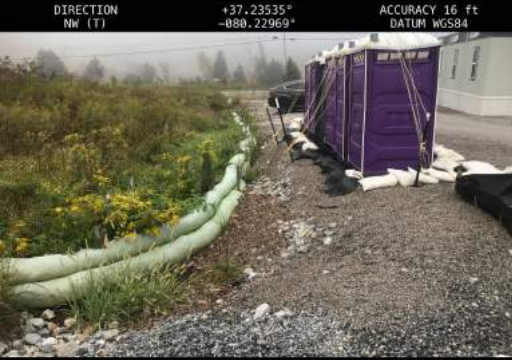
<p>DIRECTION NW (T) +37.23535° -080.22969° ACCURACY 16 ft DATUM WGS84</p> <p>MVP-PY-006_102819 Condition of CFS along West boundary 2019-10-28 08:34:04-04:00</p>			
GPS Location	MVP-PY-006 See photo for gps data		GPS Location	MVP-PY-006 See photo for gps data	
Field Station#	+0		Field Station#	+0	
Pic 1 Desc.	Condition of containment under light plant. Looking SW.		Pic 2 Desc.	Condition of compost filter sock along west boundary. Looking NW.

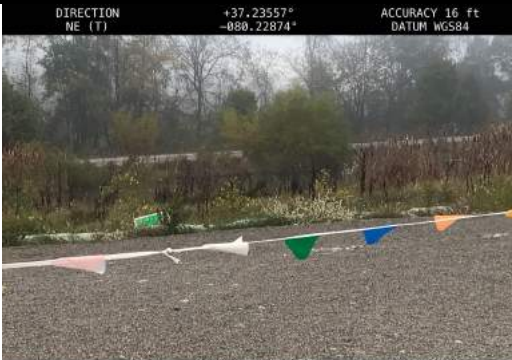
<p>DIRECTION NE (T) +37.23557° -080.22874° ACCURACY 16 ft DATUM WGS84</p> <p>MVP-PY-006_102819 Signage and buffer flagging for feature 2019-10-28 08:36:28-04:00</p>

GPS Location	MVP-PY-006 See photo for gps data		GPS Location	MVP-PY-006 See photo for gps data	
Field Station#	+0		Field Station#	+0	
Pic 3 Desc.	Signage and buffer flagging in place at off LOD feature. Looking NE.		Pic 4 Desc.	No loose trash around dumpsters. Looking E.

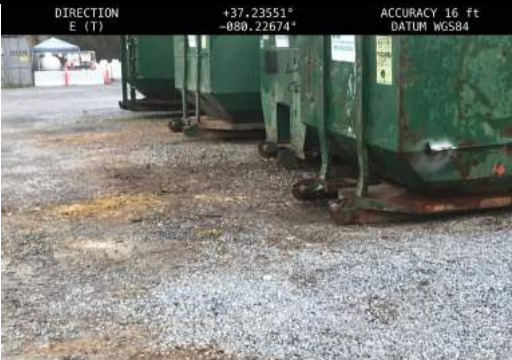
<p>DIRECTION E (T) +37.23551° -080.22674° ACCURACY 16 ft DATUM WGS84</p> <p>MVP-PY-006_102819 No loose trash around dumpsters 2019-10-28 08:38:17-04:00</p>

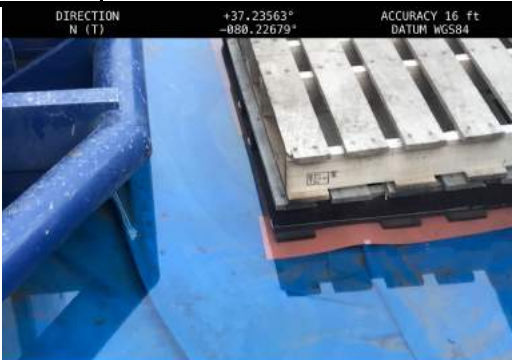
<p>DIRECTION N (T) +37.23563° -080.22679° ACCURACY 16 ft DATUM WGS84</p> <p>MVP-PY-006_102819 Condition of containment 2019-10-28 08:41:04-04:00</p>

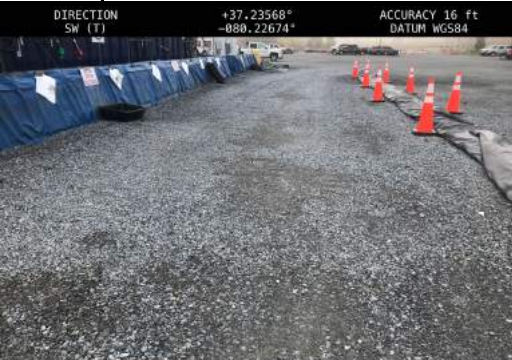
<p>DIRECTION SW (T) +37.23568° -080.22674° ACCURACY 16 ft DATUM WGS84</p> <p>MVP-PY-006_102819 No fluid deposits North of bulk tanks 2019-10-28 08:42:21-04:00</p>			
GPS Location	MVP-PY-006 See photo for gps data		GPS Location	MVP-PY-006 See photo for gps data	
Field Station#	+0		Field Station#	+0	
Pic 5 Desc.	Blue Bulk Fuel tanks containment holding stormwater, sheen observed. Looking N.		Pic 6 Desc.	No fluid deposits on the north side of bulk fuel tanks. Looking SW.

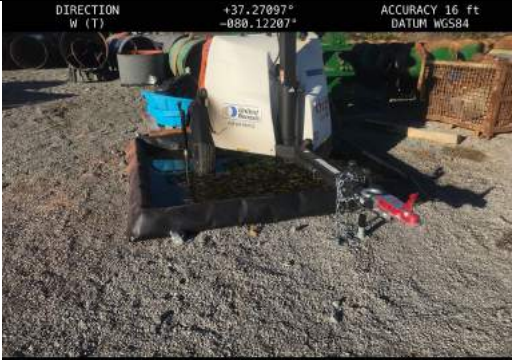
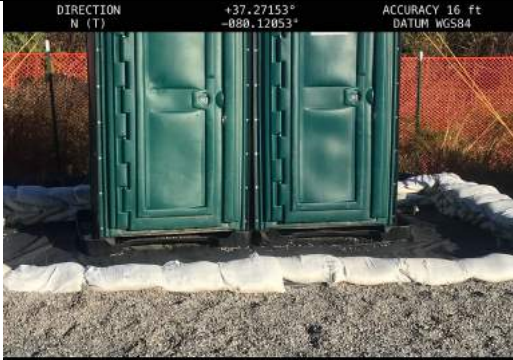
GPS Location	MVP-LY-049 See photo for gps data		GPS Location	MVP-LY-049 See photo for gps data	
Field Station#	+0		Field Station#	+0	
Pic 1 Desc.	Condition of containment under light plant. Looking W.		Pic 2 Desc.	Condition of trays and containment under toilets. Looking N.

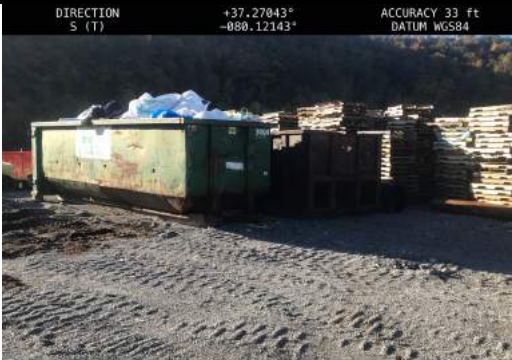
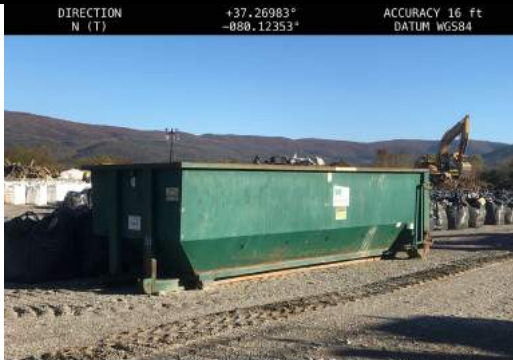
GPS Location	MVP-LY-049 See photo for gps data		GPS Location	MVP-LY-049 See photo for gps data	
Field Station#	+0		Field Station#	+0	
Pic 3 Desc.	No loose trash around FAB Area dumpsters. Looking S.		Pic 4 Desc.	No loose trash around West dumpster. Looking N.

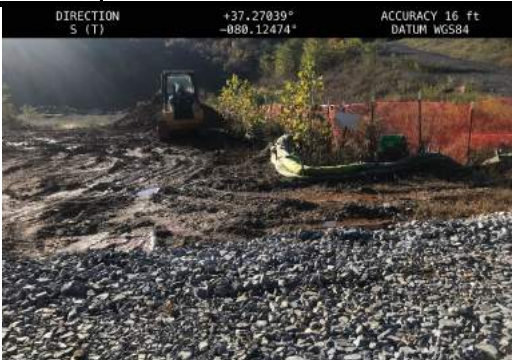
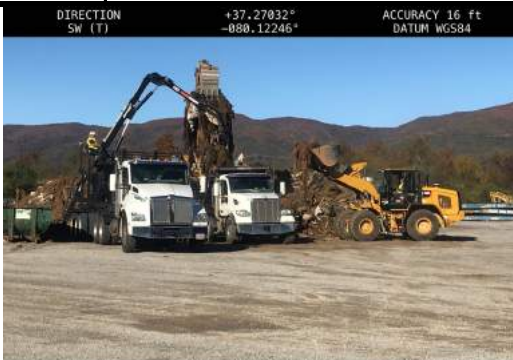
GPS Location	MVP-LY-049 See photo for gps data		GPS Location	MVP-LY-049 See photo for gps data	
Field Station#	+0		Field Station#	+0	
Pic 5 Desc.	Landowner parked equipment next to CFS and in 100 ft buffer of feature. No impact to CFS or feature. Looking S.		Pic 6 Desc.	Crew loading ROW debris on dump trucks to be hauled off site. Looking SW.

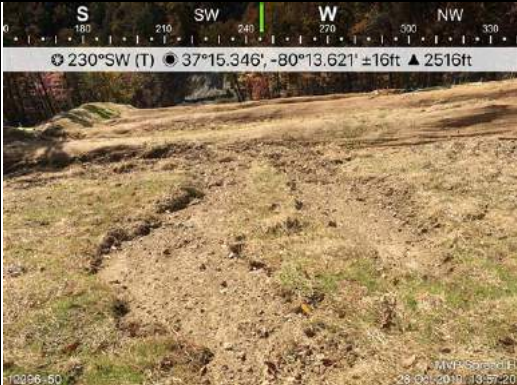
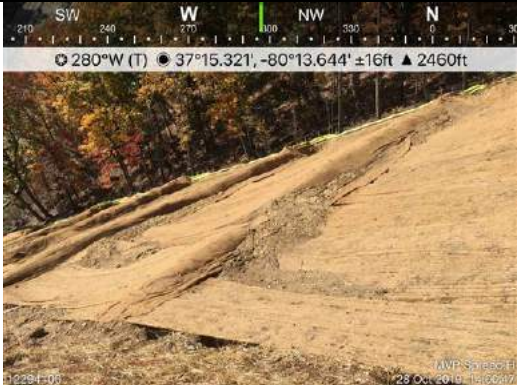
GPS Location	See Picture Watermark		GPS Location	See Picture Watermark	
Field Station#	12296+00		Field Station#	12294+00	
Pic 7 Desc.	Previous punchlist item for erosion remains to be addressed. ROW currently too wet for equipment.		Pic 8 Desc.	Previous punchlist item for erosion and waterbar failure remains to be addressed. ROW currently too wet or equipment.

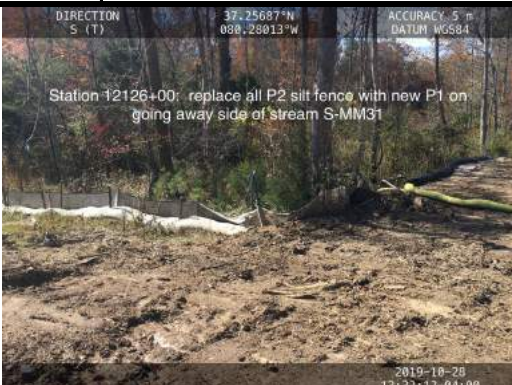
GPS Location	See photo		GPS Location	See photo	
Field Station#	12126+00		Field Station#	12179+50	
Pic 5 Desc.	The P2 silt fence on the GAS of stream S-MM31 is damaged and needs to be replaced.		Pic 6 Desc.	The P1 behind this end treatment is undermined and needs to be fixed per MBP action item.

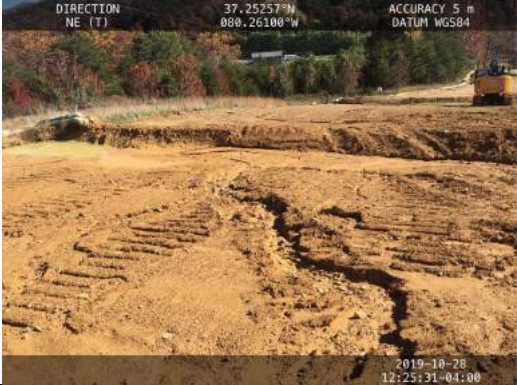
GPS Location	See photo	GPS Location			
Field Station#	12185+00	Field Station#			
Pic 7 Desc.	Waterbar accumulating sediment in the throat and needs maintenance on coming in side of AR 273.	Pic 8 Desc.			
Insert image here		Insert image here			
GPS Location		GPS Location			
Field Station#		Field Station#			
Pic 9 Desc.		Pic 10 Desc.			
Insert image here		Insert image here			
GPS Location		GPS Location			
Field Station#		Field Station#			
Pic 11 Desc.		Pic 12 Desc.

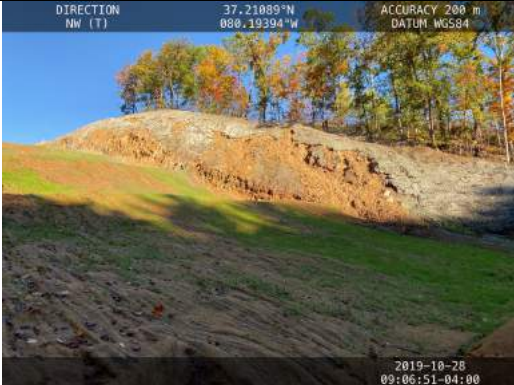
GPS Location	See picture for GPS data		GPS Location	See picture for GPS data	
Field Station#	12543+00		Field Station#	12533+00	
Pic 1 Desc.	Spoil pile erosion, hasn't gotten any bigger since before.		Pic 2 Desc.	Stabilized ROW with fill slope pipes.

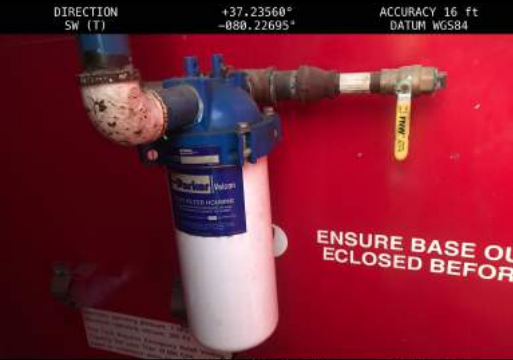
<p>DIRECTION SW (T) +37.23560° -080.22695° ACCURACY 16 ft DATUM WGS84</p> <p>MVP-PY-006_110119 Off Road Fuel unit no leaky fittings 2019-11-01 07:40:13-04:00</p>	
GPS Location	MVP-PY-006 See photo for gps data		GPS Location	MVP-PY-006 See photo for gps data	
Field Station#	+0		Field Station#	+0	
Pic 1 Desc.	Signage and buffer flagging in good condition at off LOD feature. Looking E.		Pic 2 Desc.	Off Road Fuel unit no leaky fittings. Looking SW.

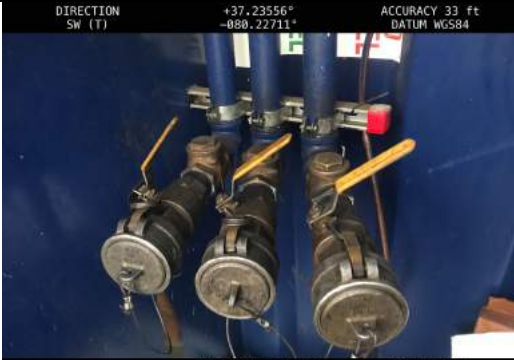
<p>DIRECTION SW (T) +37.23556° -080.22711° ACCURACY 33 ft DATUM WGS84</p> <p>MVP-PY-006_110119 Blue Bulk tanks no leaky fittings 2019-11-01 07:42:08-04:00</p>

GPS Location	MVP-PY-006 See photo for gps data		GPS Location	MVP-PY-006 See photo for gps data	
Field Station#	+0		Field Station#	+0	
Pic 3 Desc.	Blue Bulk Fuel tanks no leaky fittings. Looking SW.		Pic 4 Desc.	No loose trash around dumpsters. Looking E.

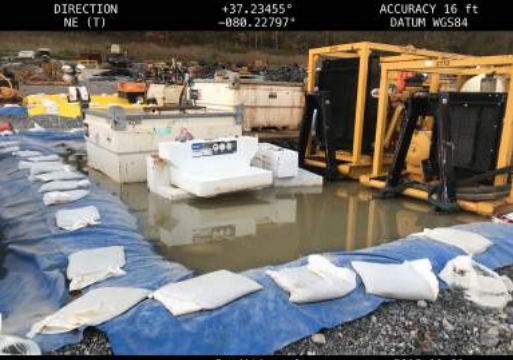
<p>DIRECTION NE (T) +37.23455° -080.22797° ACCURACY 16 ft DATUM WGS84</p> <p>MVP-PY-006_110119 Condition of containment 2019-11-01 07:51:13-04:00</p>	
GPS Location	MVP-PY-006 See photo for gps data		GPS Location	MVP-PY-006 See photo for gps data	
Field Station#	+0		Field Station#	+0	
Pic 5 Desc.	Condition of compost filter sock on East LOD boundary. Looking NW.		Pic 6 Desc.	Condition of poly lined containment no sheen present. Looking NE.

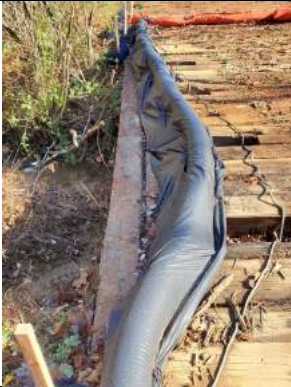
GPS Location	000000	GPS Location	00000		
Field Station#	13659+03	Field Station#	13659+03		
Pic 1 Desc.	Bridge shifted from heavy flow of the stream during rain events	Pic 2 Desc.	Geo fabric ripped when bridge shifted during high water

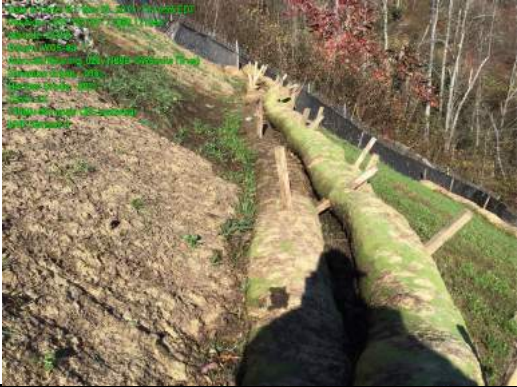
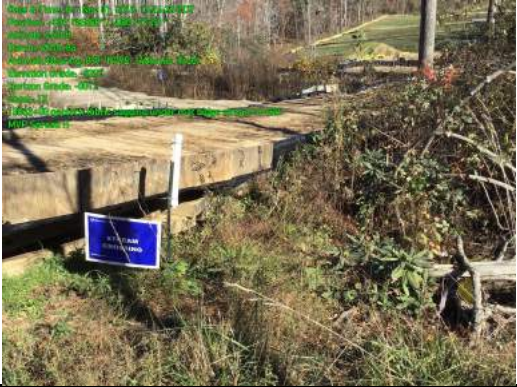
GPS Location	See pic for GPS location	GPS Location	See pic for GPS location		
Field Station#	13061+00	Field Station#	13062+00		
Pic 13 Desc.	Undermined CFS to be repaired by contractor has been added to the punch list.	Pic 14 Desc.	Sagging Geotech under the mat bridge at stream S-G26 added to the punch list.		
Insert image here		Insert image here			
GPS Location		GPS Location			
Field Station#		Field Station#			
Pic 15 Desc.		Pic 16 Desc.			
Insert image here		Insert image here			
GPS Location		GPS Location			
Field Station#		Field Station#			
Pic 17 Desc.		Pic 18 Desc.

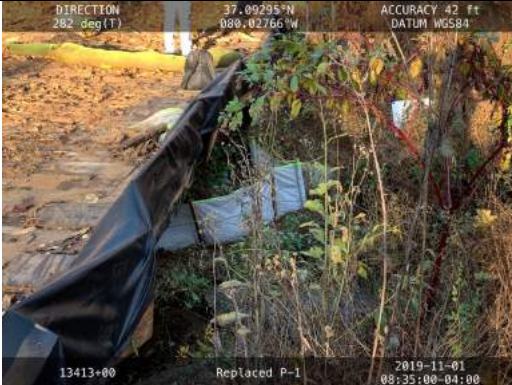
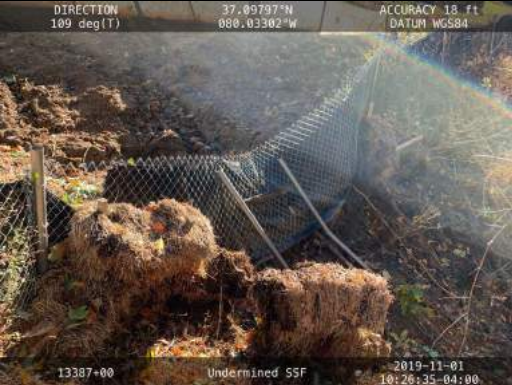
GPS Location	See photo for gps data.		GPS Location	See photo for gps data.	
Field Station#	13413+00		Field Station#	13387+00	
Pic 1 Desc.	Photo shows the repaired P-1 silt fence along stream S-IJ1.		Pic 2 Desc.	Photo shows the undermined super silt fence.

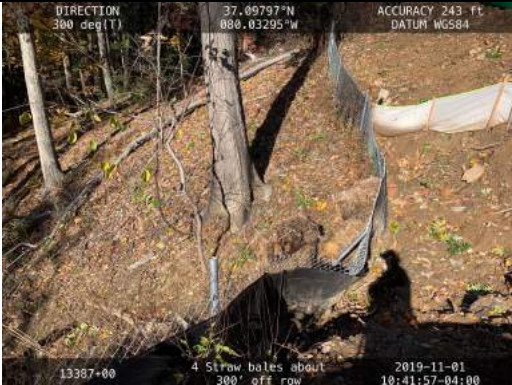
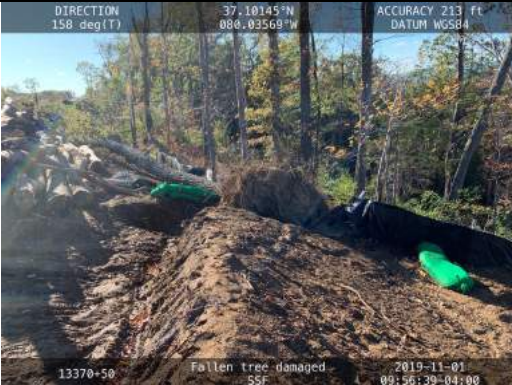
GPS Location	See photo for gps data.		GPS Location	See photo for gps data.	
Field Station#	13387+00		Field Station#	13370+50	
Pic 3 Desc.	Photo shows the undermined super silt fence.		Pic 4 Desc.	Photo shows the fallen tree and damaged SSF.

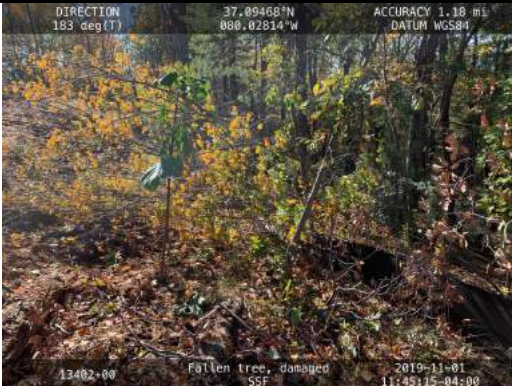
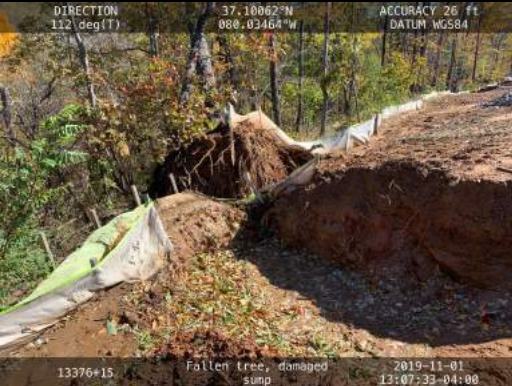
GPS Location	See photo for gps data.		GPS Location	See photo for gps data.	
Field Station#	13402+00		Field Station#	13376+15	
Pic 5 Desc.	Photo shows fallen tree and damaged SSF.		Pic 6 Desc.	Photo shows the fallen tree and damaged P-1 silt Sump pit.

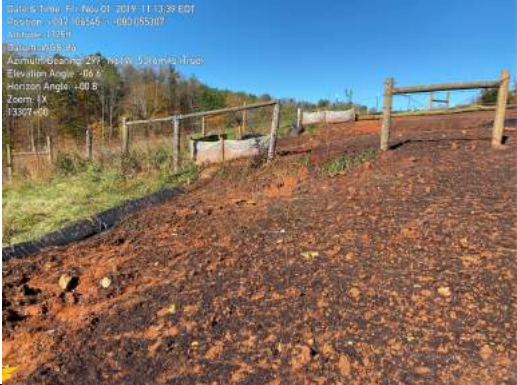
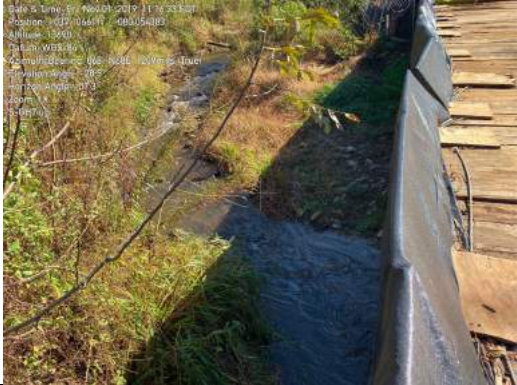
GPS Location	See photo for coordinates.	GPS Location	See photo for coordinates.		
Field Station#	13307+00	Field Station#	13309+09		
Pic 7 Desc.	Erosion noted across hard crossings.	Pic 8 Desc.	S-GH7, looking upstream of equipment bridge, no ECD failure noted.
