Visual Site Inspection Report

Project Name	H-600 Pipeline Spread H	AFE	124300138	Spread	H-600 Pipeline Spread H
Contractor	Precision			Report #	5995
Inspector	Pat Davis			Date/Time	11/19/2019 5:33 AM
Permit #	TBD	Inspection Type	VA SWPP	Station Begin	+0
State	VA	Inspection Area	Partial	Station End	+0
County	Montgomery	Ground	Wet	Temperature (°F)	54.00
Municipality	N/A	Weather	Cloudy	Rain Gauge (in)	0.20
				Rain Accumulation Time (days)	0.00

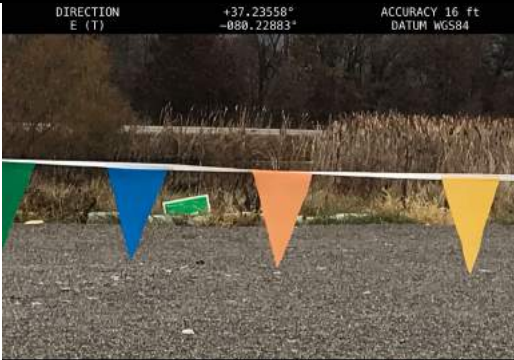
<p>DIRECTION E (T) +37.23558° -080.22883° ACCURACY 16 ft DATUM WGS84</p> <p>MVP-PY-006_111919 Flagging and signage for feature 2019-11-19 08:21:39-05:00</p>

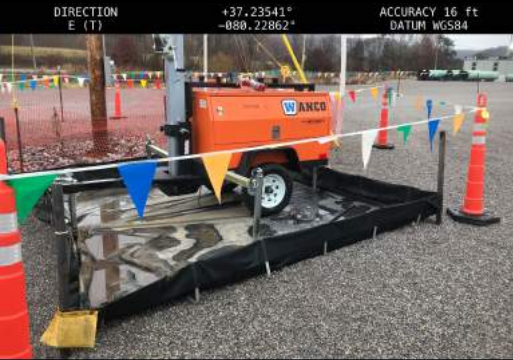
<p>DIRECTION E (T) +37.23541° -080.22862° ACCURACY 16 ft DATUM WGS84</p> <p>MVP-PY-006_111919 Condition of containment 2019-11-19 08:22:04-05:00</p>			
GPS Location	MVP-PY-006 See photo for gps data		GPS Location	MVP-PY-006 See photo for gps data	
Field Station#	+0		Field Station#	+0	
Pic 1 Desc.	Flagging and signage for feature in place. Looking NE.		Pic 2 Desc.	Condition of containment under light plant. Looking E.

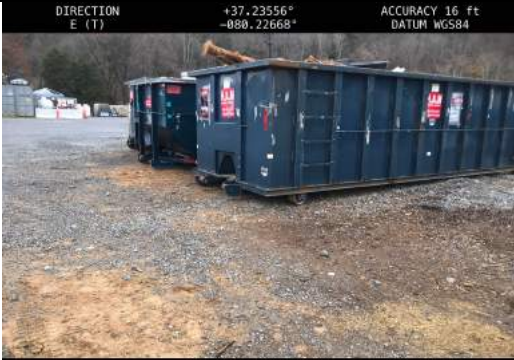
<p>DIRECTION E (T) +37.23556° -080.22668° ACCURACY 16 ft DATUM WGS84</p> <p>MVP-PY-006_111919 No loose trash around dumpsters 2019-11-19 08:23:50-05:00</p>

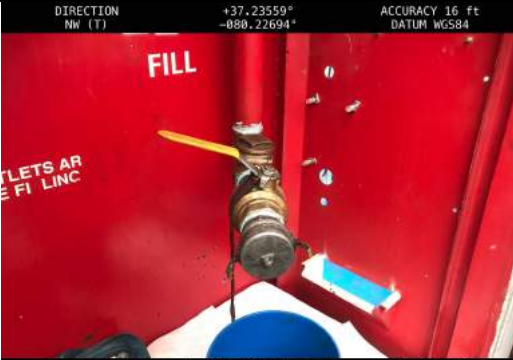
<p>DIRECTION NW (T) +37.23559° -080.22694° ACCURACY 16 ft DATUM WGS84</p> <p>MVP-PY-006_111919 Off Road Fuel unit no leaky internal fittings 2019-11-19 08:25:32-05:00</p>

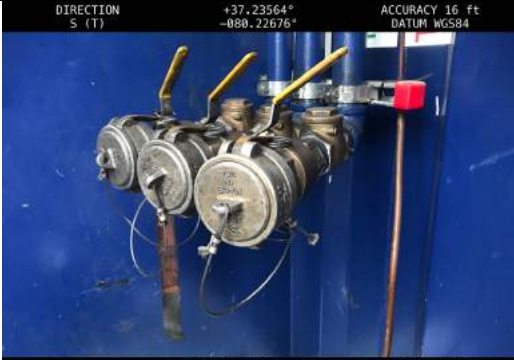
<p>DIRECTION S (T) +37.23564° -080.22676° ACCURACY 16 ft DATUM WGS84</p> <p>MVP-PY-006_111919 Blue Bulk Fuel tanks no leaky internal fittings 2019-11-19 08:27:14-05:00</p>

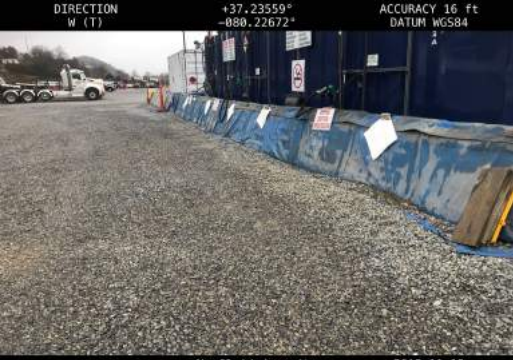
<p>DIRECTION W (T) +37.23559° -080.22672° ACCURACY 16 ft DATUM WGS84</p> <p>MVP-PY-006_111919 No fluid deposits South of bulk tanks 2019-11-19 08:24:01-05:00</p>			
GPS Location	MVP-PY-006 See photo for gps data		GPS Location	MVP-PY-006 See photo for gps data	
Field Station#	+0		Field Station#	+0	
Pic 5 Desc.	Blue Bulk Fuel tanks no leaky internal fittings. Looking S.		Pic 6 Desc.	No fluid deposits on South side of bulk tanks. Looking W.

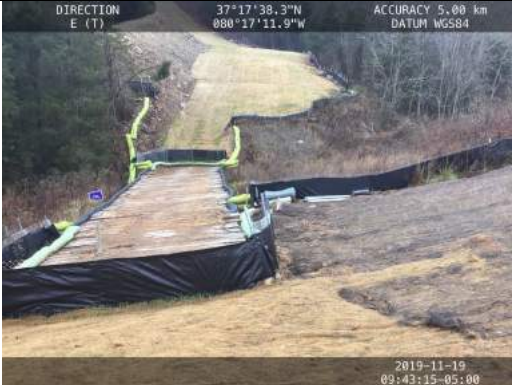
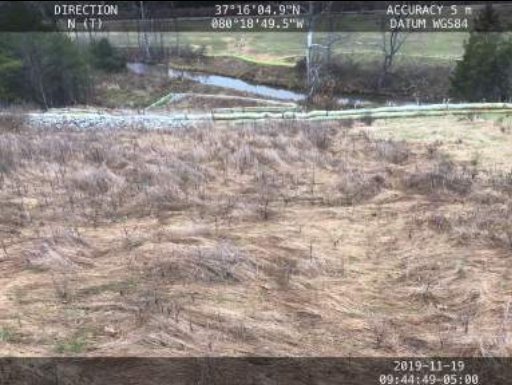
GPS Location	See photo		GPS Location	See photo	
Field Station#	12015+84		Field Station#	12008+65	
Pic 1 Desc.	Stream S-G38, facing east		Pic 2 Desc.	Stream S-G36, facing north

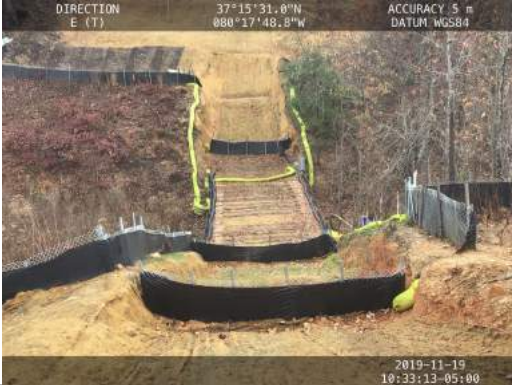
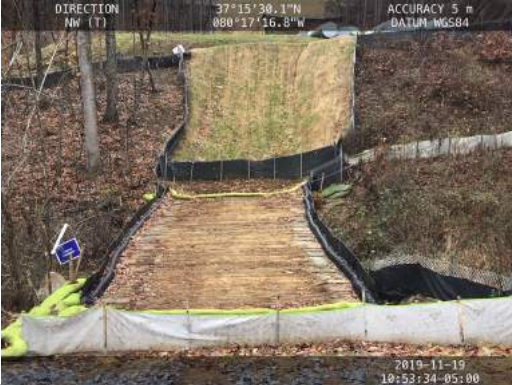
GPS Location	See photo		GPS Location	See photo	
Field Station#	12076+95		Field Station#	12101+57	
Pic 3 Desc.	Stream S-MM15, facing east		Pic 4 Desc.	Stream S-MM11, facing northwest

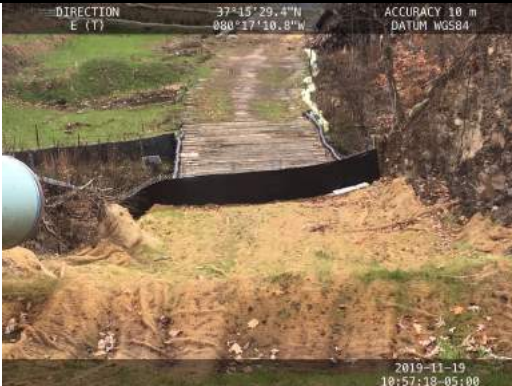
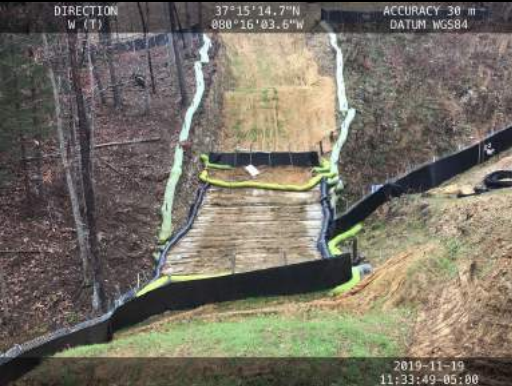
GPS Location	See photo		GPS Location	See photo	
Field Station#	12108+41		Field Station#	12163+05	
Pic 5 Desc.	Stream S-F15, facing east		Pic 6 Desc.	Stream S-C25, facing west

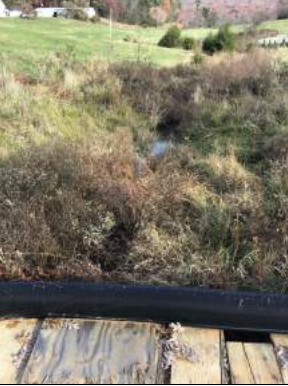
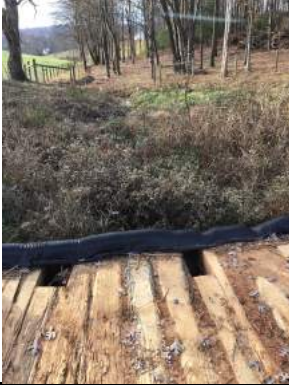
GPS Location	00000	GPS Location	0000		
Field Station#	13539+14	Field Station#	13539+14		
Pic 1 Desc.	Stream photo facing upstream	Pic 2 Desc.	Stream photo facing downstream

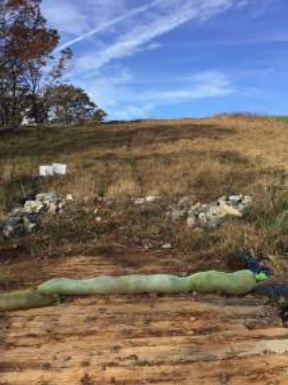
GPS Location	00000	GPS Location	0000		
Field Station#	13539+14	Field Station#	13541+60		
Pic 3 Desc.	Photo showing vegetation and ECDs	Pic 4 Desc.	Installed new signage at stream and wetland crossings.		
Insert image here			Insert image here		
GPS Location		GPS Location			
Field Station#		Field Station#			
Pic 5 Desc.		Pic 6 Desc.

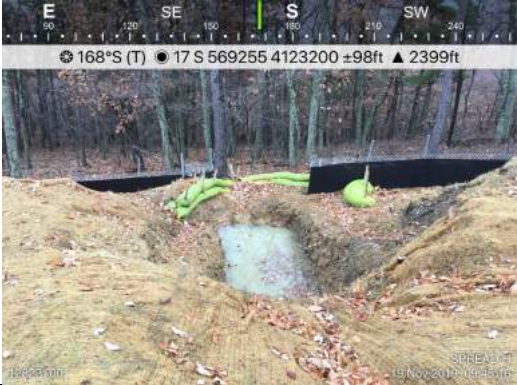
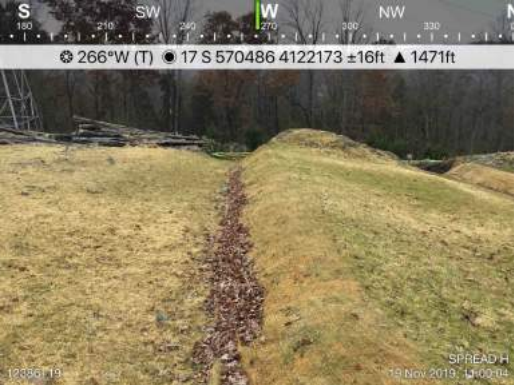
GPS Location	See photo	GPS Location	See photo		
Field Station#	12323+00	Field Station#	12386+19		
Pic 7 Desc.	Sump holding water and functioning.	Pic 8 Desc.	Waterbar stabilized and in good condition

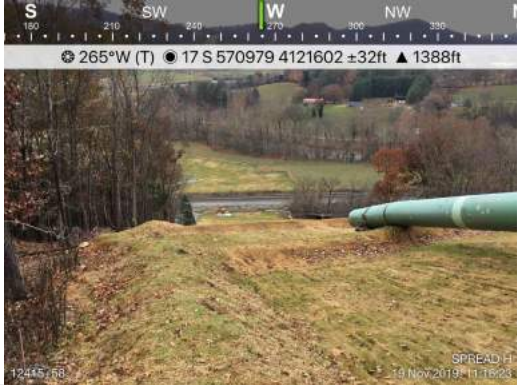
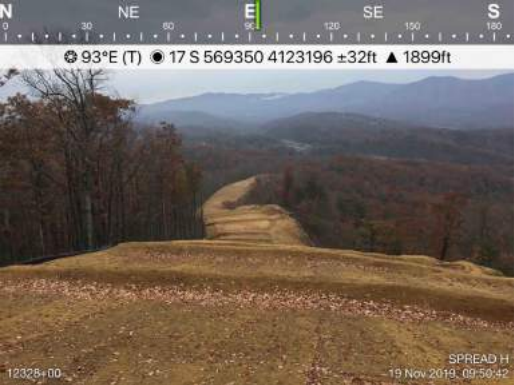
GPS Location	See photo	GPS Location	See photo		
Field Station#	12415+58	Field Station#	12328+00		
Pic 9 Desc.	Vegetation coming in well on this slope.	Pic 10 Desc.	Waterbars and end treatments in good condition along this slope.

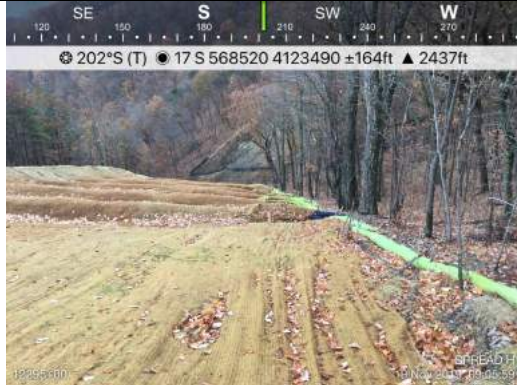
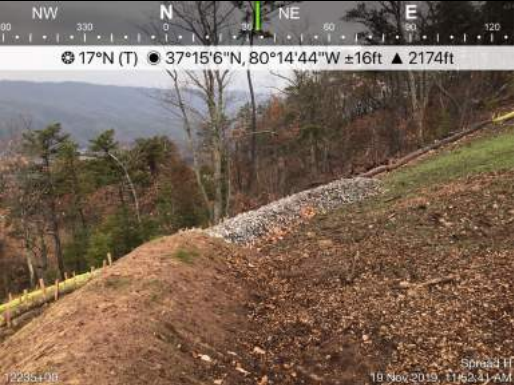
GPS Location	See photo	GPS Location	See photo		
Field Station#	12295+00	Field Station#	12235+00		
Pic 11 Desc.	CFS controls in good condition on Reese Mtn V.	Pic 12 Desc.	Gravel check dam in good condition

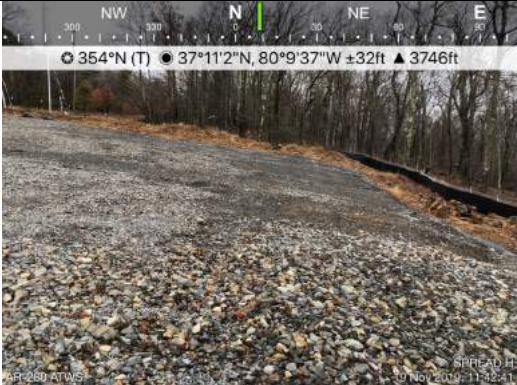
GPS Location	see photo		GPS Location	see photo	
Field Station#	280+00		Field Station#	1225+00	
Pic 11 Desc.	AR-280 controls in place and functioning.		Pic 12 Desc.	ATWS-1225 remains inactive with controls in place

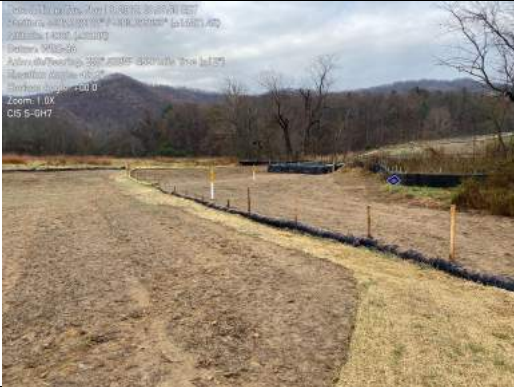
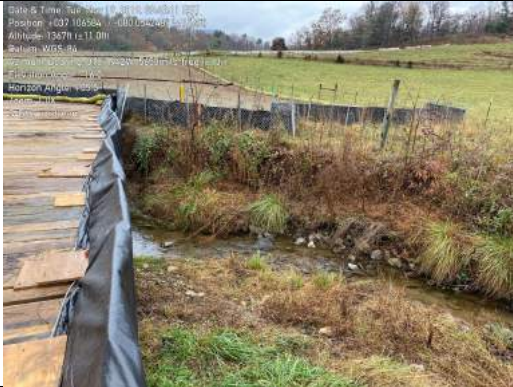
GPS Location	See photo for coordinates.		GPS Location	See photo for coordinates.	
Field Station#	13311+00		Field Station#	13309+25	
Pic 1 Desc.	ROW, permanent vegetation sparse, minimal erosion noted, ECDs and ECD upgrades functioning acceptably.		Pic 2 Desc.	S-GH7, looking upstream of equipment bridge, ECDs functioning acceptably, stream bed and banks stable, no notable changes.

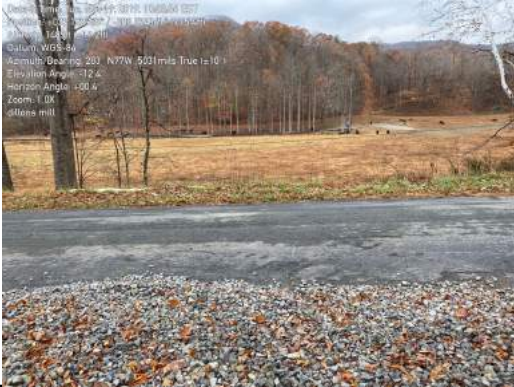
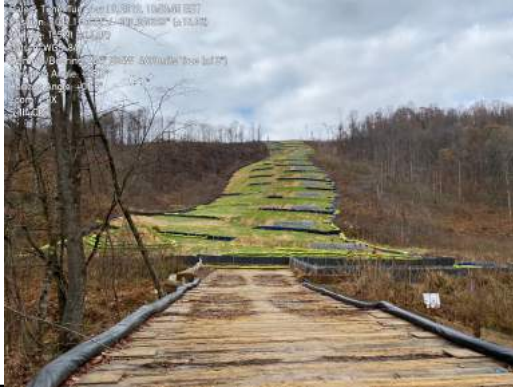
GPS Location	See photo for coordinates.		GPS Location	See photo for coordinates.	
Field Station#	13197+50		Field Station#	13360+70	
Pic 3 Desc.	Dillons Mill, road crossing clear, no changes noted at S-D10, access road in acceptable condition, cattle in adjacent field.		Pic 4 Desc.	CIS of S-II4, permanent vegetation establishing, permanent waterbars functioning acceptably, bridge clean.

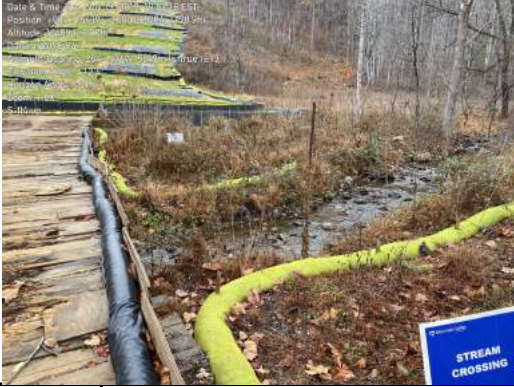
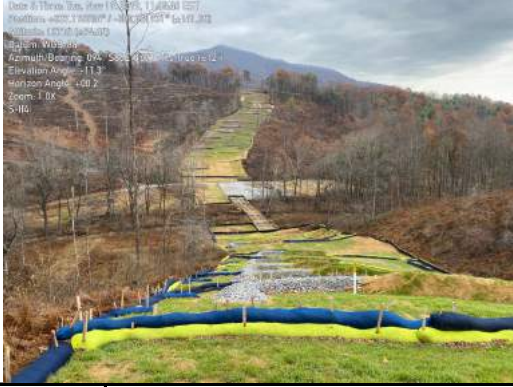
Field Station#	13360+70		Field Station#	13255+00	
Pic 5 Desc.	S-II4, looking upstream of equipment bridge, ECDs functioning acceptably, stream bed and banks stable, no turbidity noted.		Pic 6 Desc.	ROW, permanent vegetation establishing across ROW, waterbars functioning acceptably with no maintenance required.

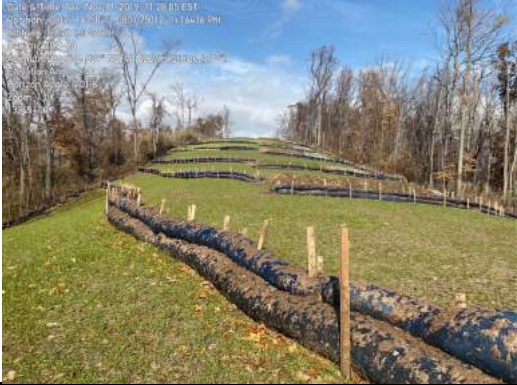
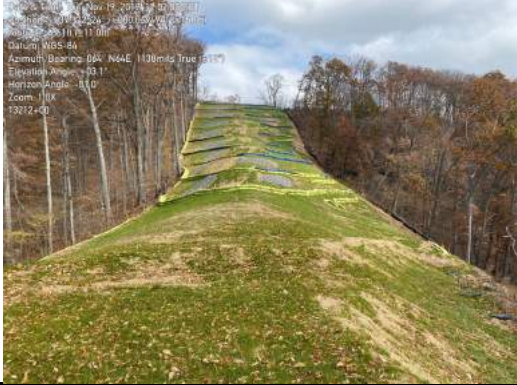
GPS Location	See photo for coordinates.		GPS Location	See photo for coordinates.	
Field Station#	13245+00		Field Station#	13212+00	
Pic 7 Desc.	ROW, permanent vegetation establishing across limits of disturbance, waterbars and waterbar extensions functioning acceptably.		Pic 8 Desc.	ROW, permanent vegetation establishing across limits of disturbance, waterbars and waterbar extensions functioning acceptably.	
Insert image here			Insert image here		
GPS Location			GPS Location		
Field Station#			Field Station#		
Pic 9 Desc.			Pic 10 Desc.		
Insert image here			Insert image here		
GPS Location			GPS Location		
Field Station#			Field Station#		
Pic 11 Desc.			Pic 12 Desc.

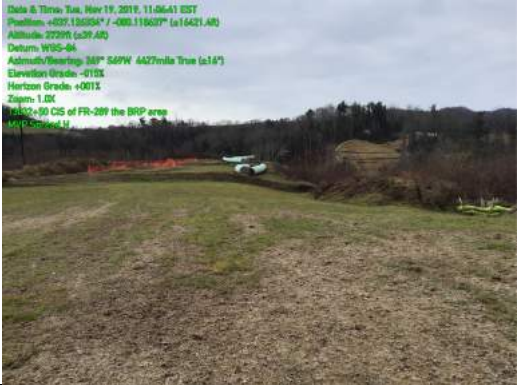
<p>Date & Time: Tue, Nov 19, 2019, 11:23:19 EST Position: +037.127970° / -080.117987° (s16.48) Altitude: 2779ft (s13.18) Datum: WGS-84 Azimuth/Bearing: 054° N74E 1314mils True (s12°) Elevation Grade: -0142 Horizon Grade: -0003 Zoom: 1.0X 13044+00 stream S-H1 GAZ 0000 000 MVP Screen 11</p>  			
GPS Location	See pic for GPS location		GPS Location	See pic for GPS location	
Field Station#	13032+50		Field Station#	13040+00	
Pic 7 Desc.	No issues or impacts found in the area of FR-289.		Pic 8 Desc.	Stream S-H1 was free of impacts from the project and final restoration started at 13044+00 to 13061+00.

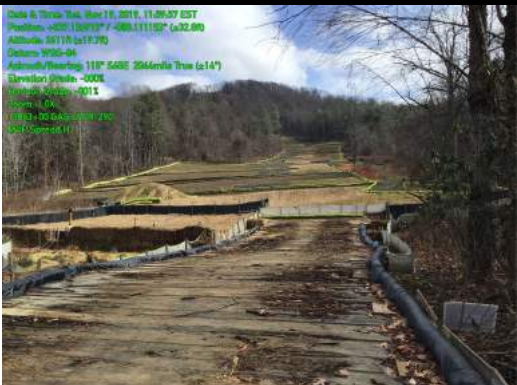
GPS Location	See pic for GPS location		GPS Location	See pic for GPS location	
Field Station#	13063+00		Field Station#	13063+00	
Pic 11 Desc.	No impacts observed at stream S-G27		Pic 12 Desc.	No ECD deficiencies or off ROW impacts observed from FR-290 to FR-291.

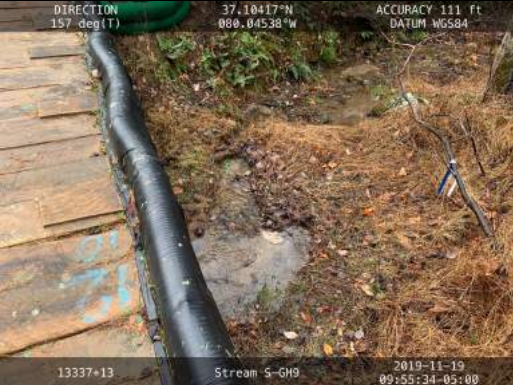
GPS Location	See photo for gps data.		GPS Location	See photo for gps data.	
Field Station#	13415+00		Field Station#	13337+13	
Pic 1 Desc.	Photo shows the rain gauge at Cahas Mountain Road.		Pic 2 Desc.	Photo shows the condition of stream S-GH9.

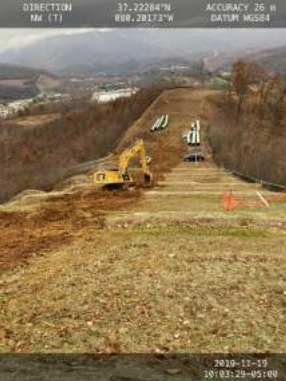
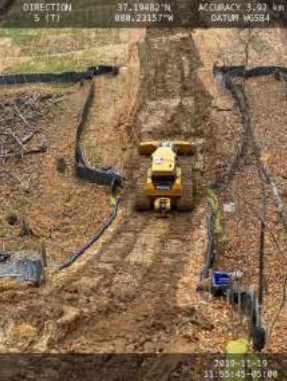
GPS Location	See picture for GPS data		GPS Location	See picture for GPS data	
Field Station#	12483+00		Field Station#	12519+48	
Pic 1 Desc.	Excavator installing waterbars in the travel lane.		Pic 2 Desc.	Dozer waiting on the excavator for help up the steep slope.

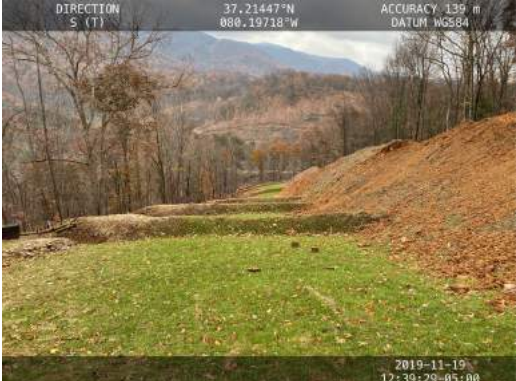
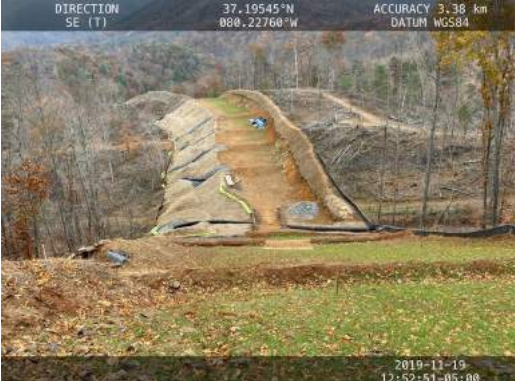
GPS Location	See picture for GPS data		GPS Location	See picture for GPS data	
Field Station#	12527+00		Field Station#	12533+56	
Pic 3 Desc.	Stabilized ROW with spoil pile that has erosion to be fixed.		Pic 4 Desc.	Stabilized ROW with clear water crossing.

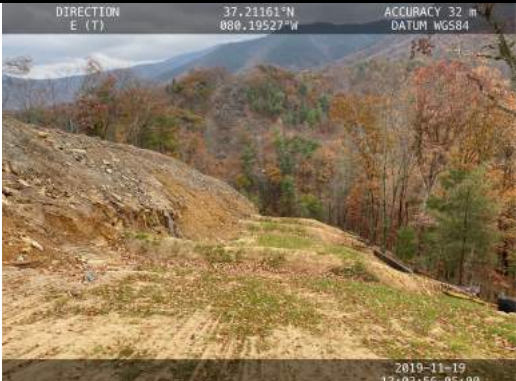
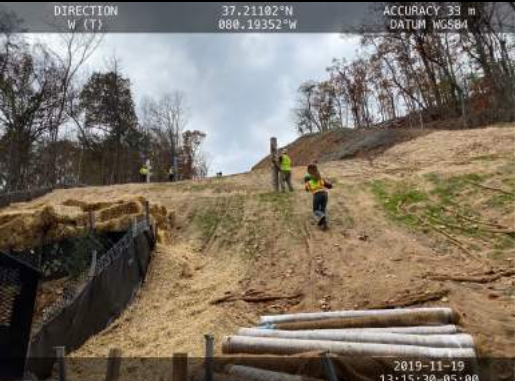
GPS Location	See picture for GPS data		GPS Location	See picture for GPS data	
Field Station#	12540+00		Field Station#	12543+00	
Pic 5 Desc.	Stabilized ROW with erosion on the spoil pile.		Pic 6 Desc.	Laborers relaying materials up the hill.
