Visual Site Inspection Report

Project Name	H-600 Pipeline Spread H	AFE	124300138	Spread	H-600 Pipeline Spread H
Contractor	Precision			Report #	6078
Inspector	Logan Box			Date/Time	11/25/2019 5:02 PM
Permit #	TBD	Inspection Type	VA SWPP	Station Begin	13415+51
State	VA	Inspection Area	Partial	Station End	13670+00
County	Franklin	Ground	Wet	Temperature (°F)	48.00
Municipality	N/A	Weather	Cloudy	Rain Gauge (in)	0.00
				Rain Accumulation Time (days)	1.00

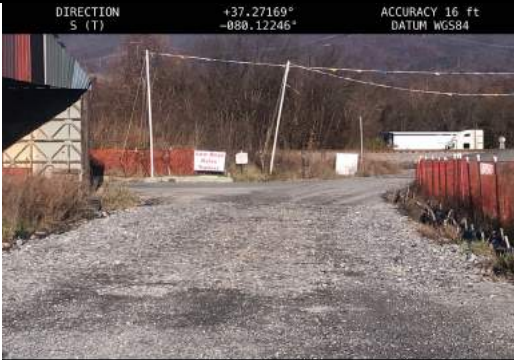
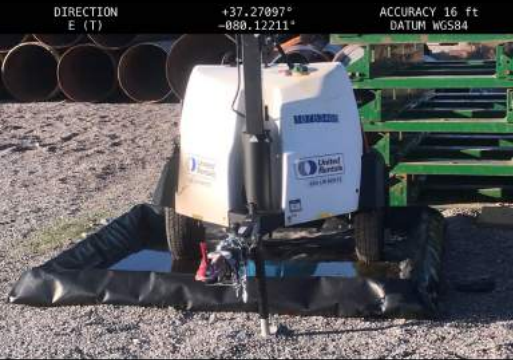
GPS Location	MVP-LY-049 See photo for gps data		GPS Location	MVP-LY-049 See photo for gps data	
Field Station#	+0		Field Station#	+0	
Pic 1 Desc.	Condition of rock entrance on center drive. Looking N.		Pic 2 Desc.	Condition of containment under light plant. Looking E.

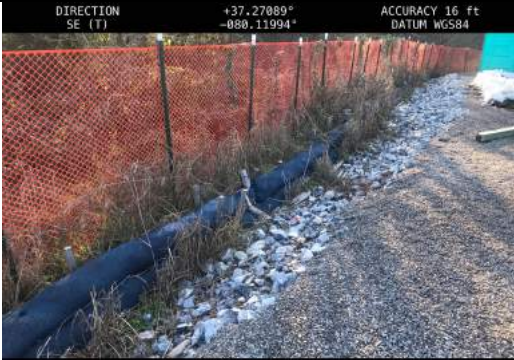
GPS Location	MVP-LY-049 See photo for gps data		GPS Location	MVP-LY-049 See photo for gps data	
Field Station#	+0		Field Station#	+0	
Pic 3 Desc.	Condition of compost filter sock and safety fence along East LOD. Looking SE.		Pic 4 Desc.	Condition of trays and containment under toilets. Looking W.

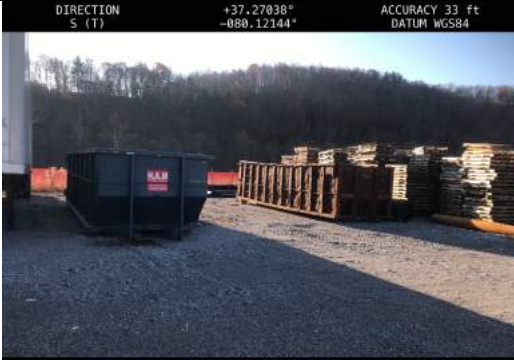
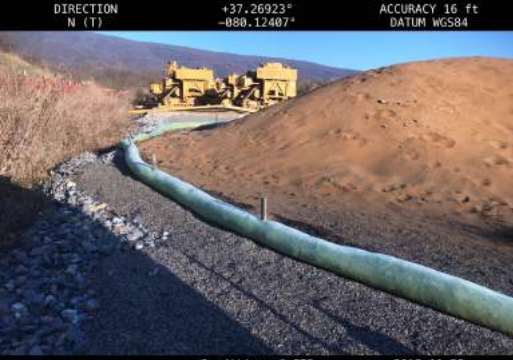
GPS Location	MVP-LY-049 See photo for gps data		GPS Location	MVP-LY-049 See photo for gps data	
Field Station#	+0		Field Station#	+0	
Pic 5 Desc.	No loose trash around south dumpsters. Looking S.		Pic 6 Desc.	Condition of CFS around sand pile. Looking N

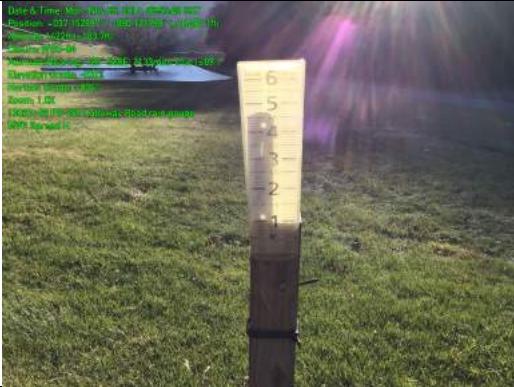
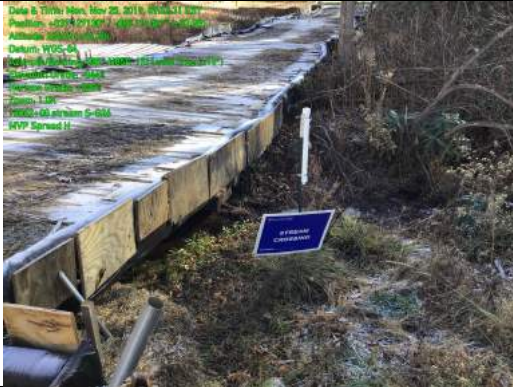
GPS Location	See pic for GPS location	GPS Location	See pic for GPS location
Field Station#	13033+59	Field Station#	13062+00
Pic 1 Desc.	0.6" total precipitation at Callaway Road.	Pic 2 Desc.	No impacts to stream S-G26 observed

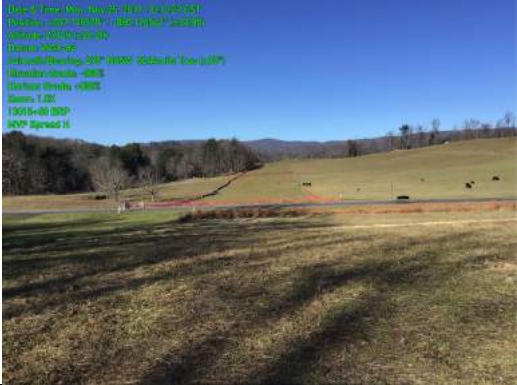
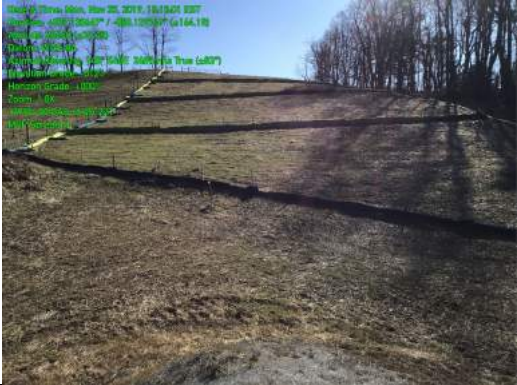
GPS Location	See pic for GPS location		GPS Location	See pic for GPS location	
Field Station#	13015+00		Field Station#	12995+50	
Pic 7 Desc.	Good permanent vegetative stabilization seen here throughout the BRP.		Pic 8 Desc.	Final restoration performed and in good condition on the GAS of the US-221 crossing.

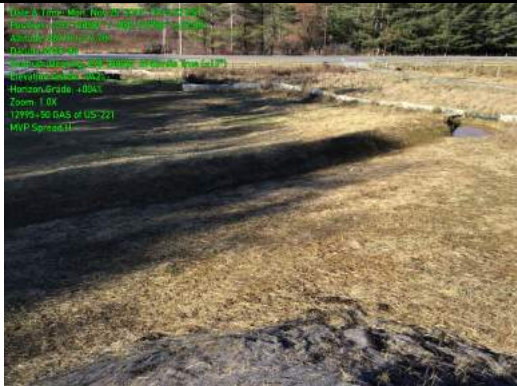
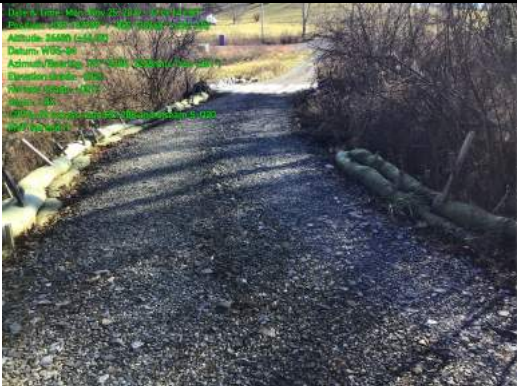
GPS Location	See pic for GPS location		GPS Location	See pic for GPS location	
Field Station#	12995+50		Field Station#	12974+29	
Pic 9 Desc.	GAS of the US-221 temporary stabilization remains in good condition.		Pic 10 Desc.	No issues or impacts observed on access road RO-288.

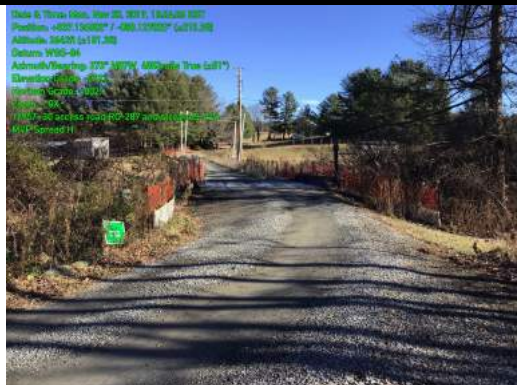
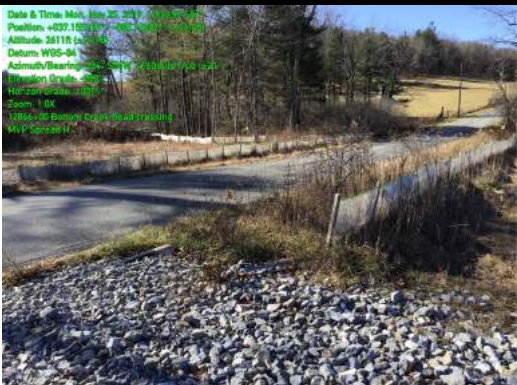
GPS Location	See pic for GPS location		GPS Location	See pic for GPS location	
Field Station#	12957+30		Field Station#	12866+00	
Pic 11 Desc.	No issues or impacts observed on access road RO-287.		Pic 12 Desc.	No issues or impacts observed near Bottom Creek road.

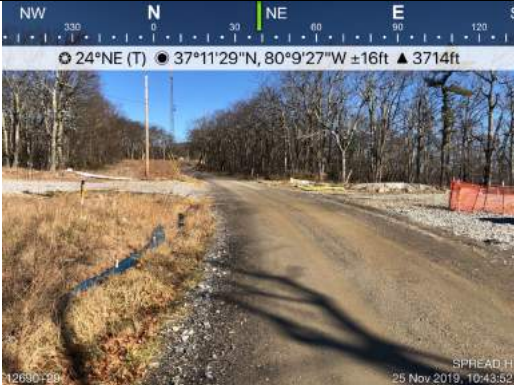
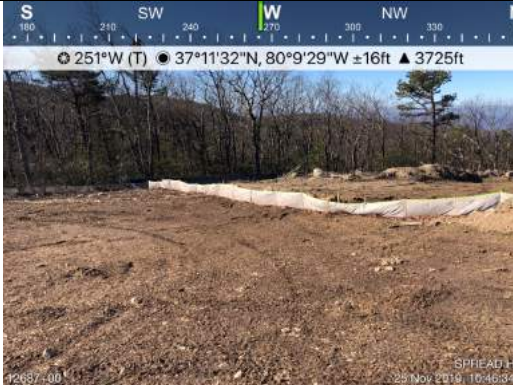
GPS Location	see photo	GPS Location	see photo		
Field Station#	12690+29	Field Station#	12687+00		
Pic 1 Desc.	Both CE's at the Honeysuckle Rd. crossing remain in good condition.	Pic 2 Desc.	Workspace at this location remains temporarily stabilized.

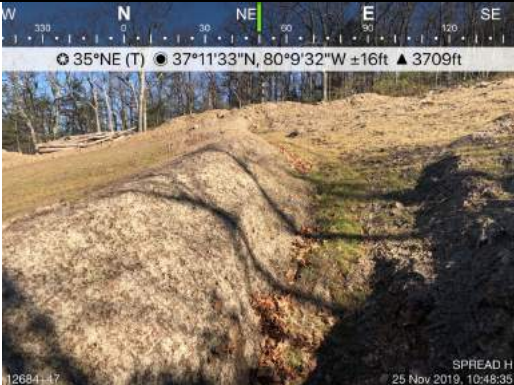
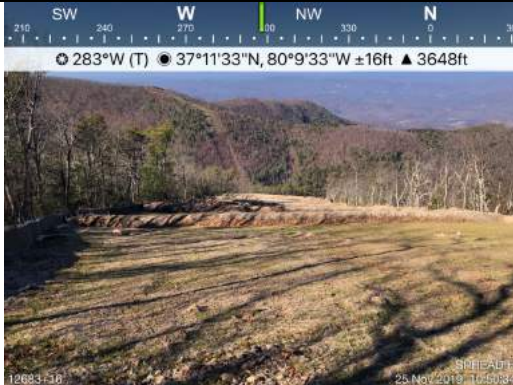
GPS Location	see photo	GPS Location	see photo		
Field Station#	12684+47	Field Station#	12683+16		
Pic 3 Desc.	Waterbars are in good condition on this slope and sumps have received minimal amounts of runoff.	Pic 4 Desc.	Vegetation filling in ROW on this slope.

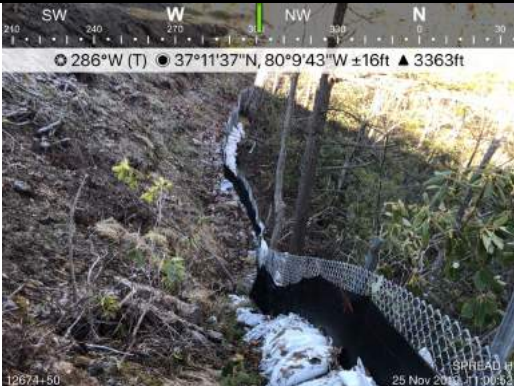
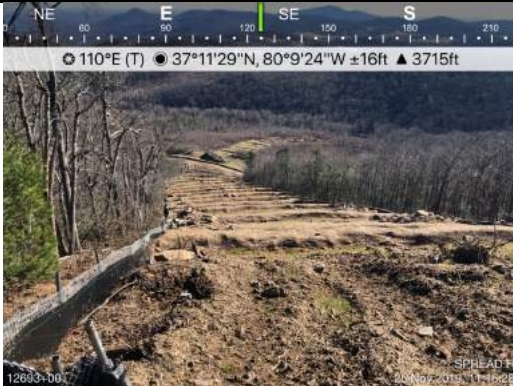
GPS Location	see photo	GPS Location	see photo		
Field Station#	12674+50	Field Station#	12693+00		
Pic 5 Desc.	Sandbag reinforcement at this location continues to function.	Pic 6 Desc.	Vegetation filling in ROW on this slope.

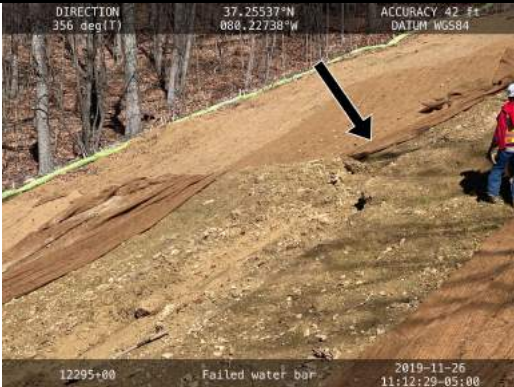
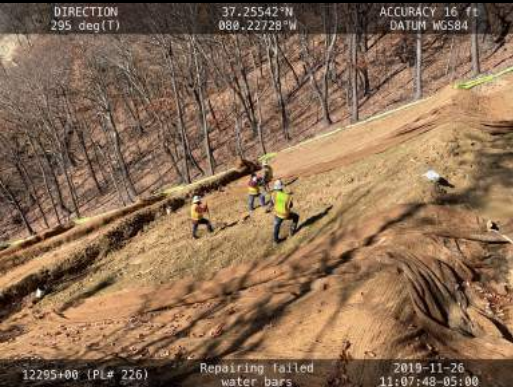
GPS Location	See photo for gps data.		GPS Location	See photo for gps data.	
Field Station#	12295+00		Field Station#	12295+00	
Pic 1 Desc.	Photo shows the failed water bar at 12295+00.		Pic 2 Desc.	Photo shows the contractor removing the erosion control blanket and repairing the damaged water bar.

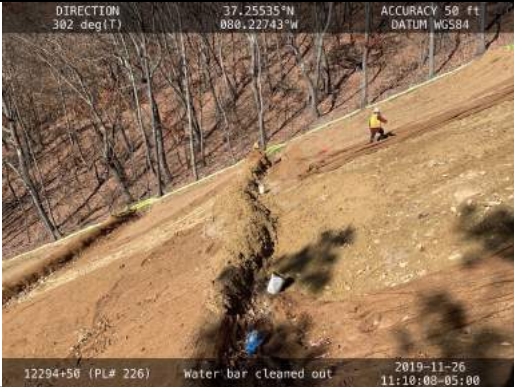
GPS Location	See photo for gps data.		GPS Location	See photo for gps data.	
Field Station#	12294+50		Field Station#	12295+00	
Pic 3 Desc.	Photo shows the water bar at 12294+50 after it was manually cleaned out.		Pic 4 Desc.	Photo shows the contractor rebuilding the failed water bar at 12295+00.

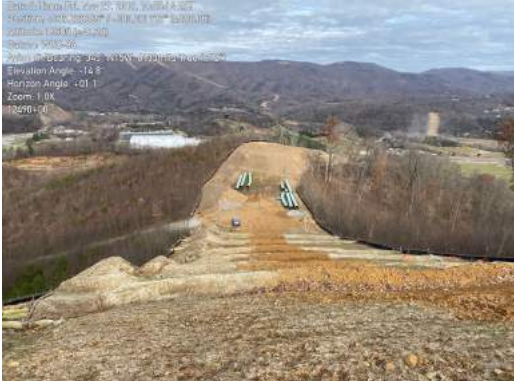
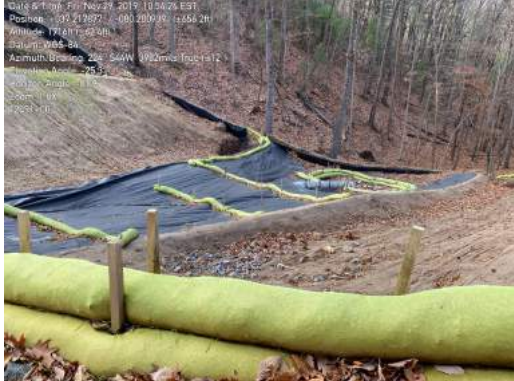
GPS Location	See photo for coordinates.		GPS Location	See photo for coordinates.	
Field Station#	12490+00		Field Station#	12451+00	
Pic 1 Desc.	ROW stabilized, with re-stabilization of travel lane in progress.		Pic 2 Desc.	Cleanwater conveyance functioning acceptably, ECDs in acceptable condition.

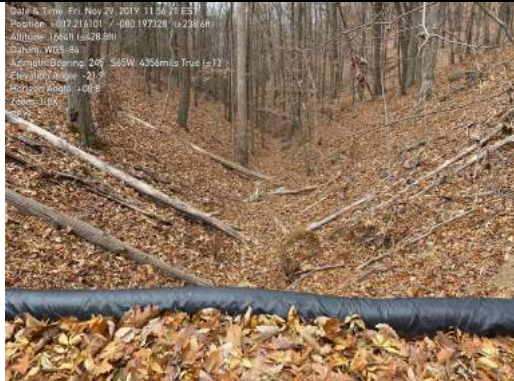
GPS Location	See photo for coordinates.		GPS Location	See photo for coordinates.	
Field Station#	12519+41		Field Station#	12519+41	
Pic 3 Desc.	Waterbars repaired and stabilized on the GAS of S-EF19.		Pic 4 Desc.	S-EF19, looking downstream of equipment bridge, no environmental issues noted, no water observed.

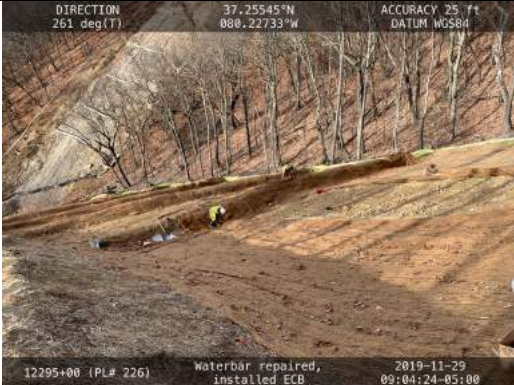
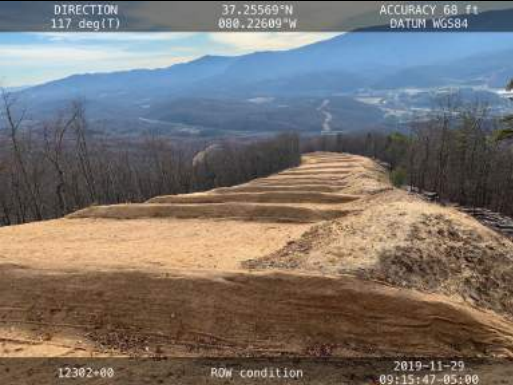
GPS Location	See photo for gps data.		GPS Location	See photo for gps data.	
Field Station#	12395+00		Field Station#	12302+00	
Pic 1 Desc.	Photo shows the contractor reinstalling the erosion control blanket at about 12295+00, where the water bar was repaired (PL#226)		Pic 2 Desc.	Photo shows the ROW condition from about 12302+00 to about 12308+00.
