## Visual Site Inspection Report

| <b>Project Name</b> | H-600 Pipeline Spread H | <b>AFE</b> | 124300138 | <b>Spread</b> | H-600 Pipeline Spread |
| <b>Inspector</b> | Logan Box | | | <b>Date/Time</b> | 8/26/2019 5:30 PM |

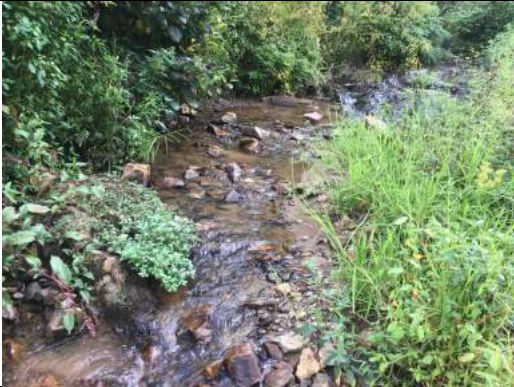
| <b>Pic 1 Desc.</b> | Stream photo facing upstream | <b>Pic 2 Desc.</b> | Stream photo facing down stream | | |

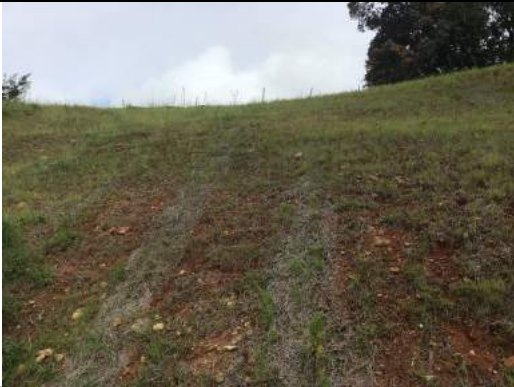
| <b>Pic 3 Desc.</b> | Stream bank stabilized | <b>Pic 4 Desc.</b> | Travel lane wore down during line marker activities, recommended to have seed along with earth guard and pellet mulch added . | | |

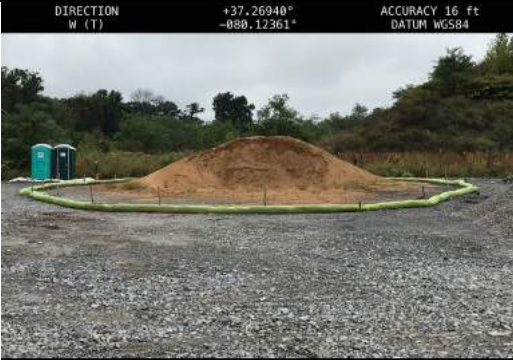
| <b>Pic 3 Desc.</b> | No loose trash around FAB Area dumpsters. Looking SE. | | <b>Pic 4 Desc.</b> | Sand pile stabilized with Compost Filter Sock. Looking W. | |

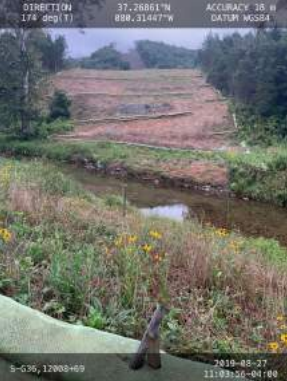
| <b>Pic 1 Desc.</b> | 0.10" @ Catawba. | | <b>Pic 2 Desc.</b> | Creek bank is stable and ECDs are acceptable. Final restoration has new permanent growth establishing. Area is stable. | |

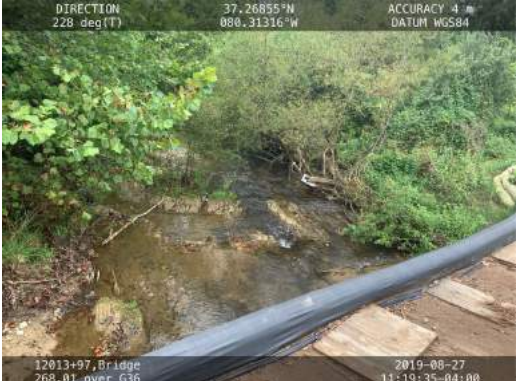
| <b>Pic 3 Desc.</b> | Bridge is in acceptable condition at this time. | | <b>Pic 4 Desc.</b> | Bridge is in good condition and ECDs are acceptable. This | |

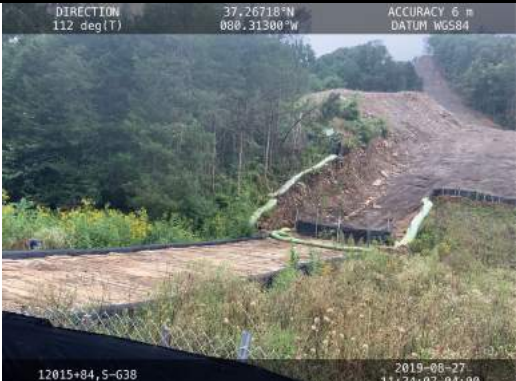
| <b>Pic 5 Desc.</b> | S-G38 bridge and surrounding ECDs are in acceptable condition and very stable. | | <b>Pic 6 Desc.</b> | GAS OF S-G39 is stable and bridge is in acceptable condition. | |

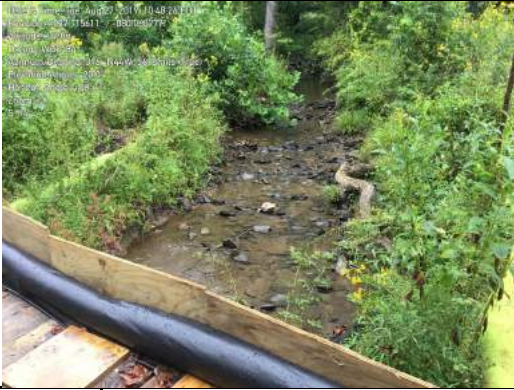
| <b>Pic 1 Desc.</b> | S-II4, looking upstream of equipment bridge, no environmental issues noted. | <b>Pic 2 Desc.</b> | ROW stable, waterbars and sumps beginning to need maintenance, soil piles stabilized. | | |

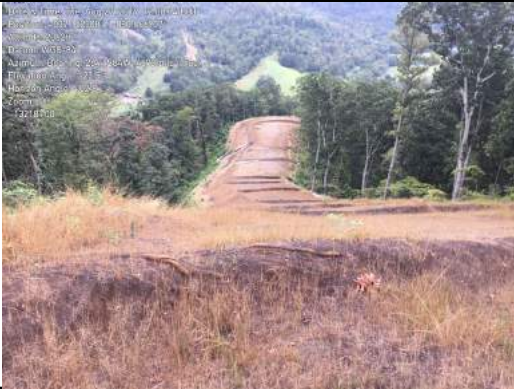
| <b>Pic 3 Desc.</b> | ROW stabilized, waterbars and outlets functioning acceptably, soil piles stable and vegetated. | <b>Pic 4 Desc.</b> | ROW, waterbar in travel lane repaired, waterbars and sumps functioning acceptably. | | |

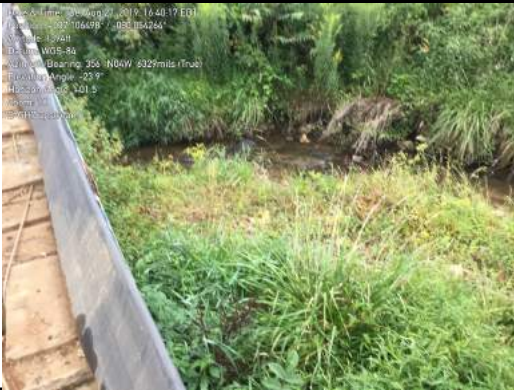
| <b>Pic 5 Desc.</b> | S-GH7, looking upstream of equipment bridge, no environmental issues noted. | <b>Pic 6 Desc.</b> | Approved off ROW dewatering structures for S-GH7 bore activities. | | |

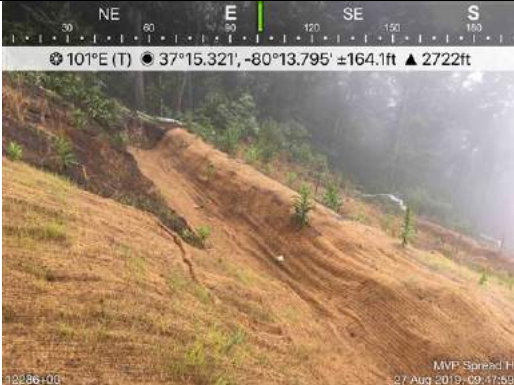
| <b>Pic 1 Desc.</b> | Erosion control matting and waterbars in good condition. | | <b>Pic 2 Desc.</b> | Accumulated sediment within waterbar flowpath should be cleaned out. | |

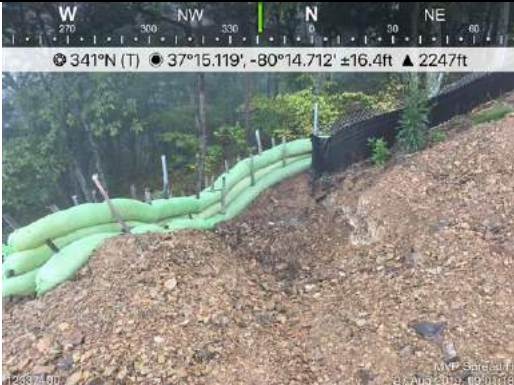
| <b>Pic 3 Desc.</b> | Waterbar end treatment, CFS, and sump pit installed and functioning as intended. Station # on picture is incorrect. | | <b>Pic 4 Desc.</b> | Super silt fence installed and functioning properly at bottom of "V". | |

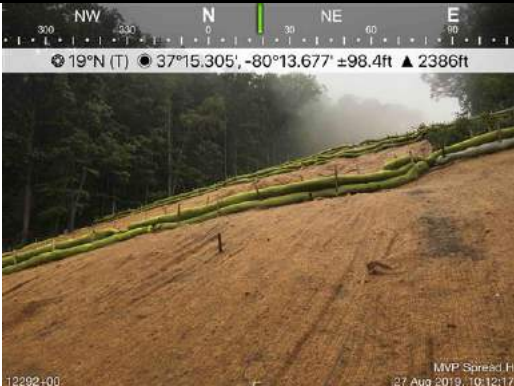
| <b>Pic 5 Desc.</b> | Erosion control matting, CFS, and slope protection in good condition. | | <b>Pic 6 Desc.</b> | False fill inlet protection should be cleaned out due to sediment deposition. | |

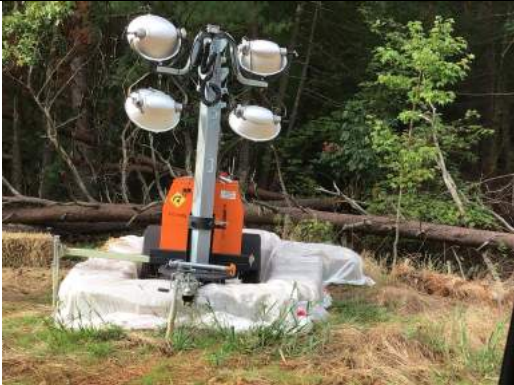
| <b>Pic 1 Desc.</b> | Light plant in containment | <b>Pic 2 Desc.</b> | ECDs in place and hill side, temporary vegetation photo | | |
