# Visual Site Inspection Report

<b>Project Name</b>	H-600 Pipeline Spread H	<b>AFE</b>	124300138	<b>Spread</b>	H-600 Pipeline Spread
<b>Contractor</b>	Precision			<b>Report #</b>	100102
<b>Inspector</b>	Jason Nielsen			<b>Date/Time</b>	9/12/2019 6:48 PM
<b>Permit #</b>	TBD	<b>Inspection Type</b>	VA SWPP	<b>Station Begin</b>	12450+87
<b>State</b>	VA	<b>Inspection Area</b>	Partial	<b>Station End</b>	12543+56
<b>County</b>	Montgomery	<b>Ground</b>	Dry	<b>Temperature (°F)</b>	93.00
<b>Municipality</b>	N/A	<b>Weather</b>	Sunny	<b>Rain Gauge (in)</b>	0.00
				<b>Rain Accumulation Time (days)</b>	0.00

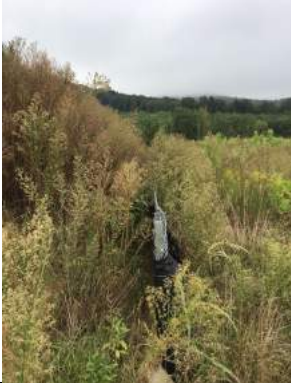
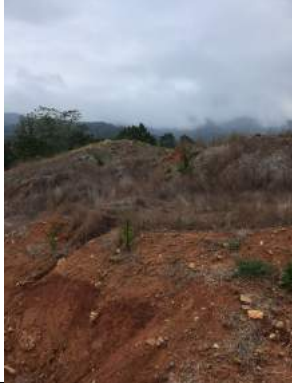
<b>GPS Location</b>	00000	<b>GPS Location</b>	00000		
<b>Field Station#</b>	13421+89	<b>Field Station#</b>	13420+00		
<b>Pic 1 Desc.</b>	Silt fence in place , photo showing good vegetation	<b>Pic 2 Desc.</b>	Spoil pile stabilized

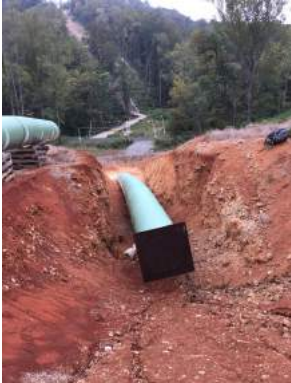
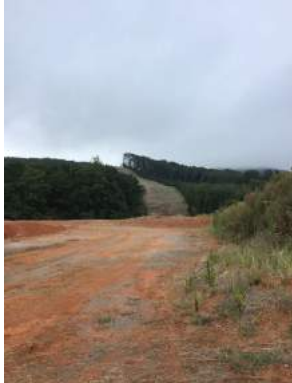
<b>GPS Location</b>	00000	<b>GPS Location</b>	00000		
<b>Field Station#</b>	13420+00	<b>Field Station#</b>	13422+00		
<b>Pic 3 Desc.</b>	Photo showing metal plate welded to the pipe in the ditch	<b>Pic 4 Desc.</b>	Bare area of stabilized		
Insert image here			Insert image here		
<b>GPS Location</b>		<b>GPS Location</b>			
<b>Field Station#</b>		<b>Field Station#</b>			
<b>Pic 5 Desc.</b>		<b>Pic 6 Desc.</b>

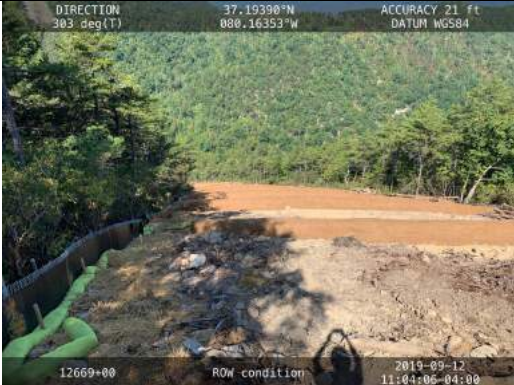
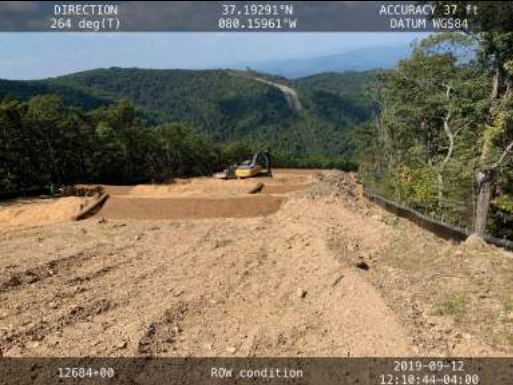
<b>GPS Location</b>	See photo for gps data.		<b>GPS Location</b>	See photo for gps data.	
<b>Field Station#</b>	12669+00		<b>Field Station#</b>	12684+00	
<b>Pic 1 Desc.</b>	Photo shows the ROW condition from about 12667+00 to 12669+00.		<b>Pic 2 Desc.</b>	Photo shows the ROW condition from about 12682+00 to 12684+00.

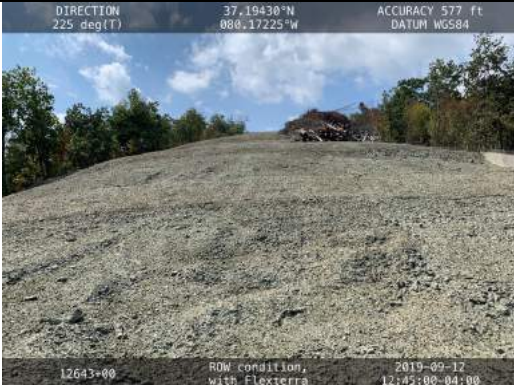
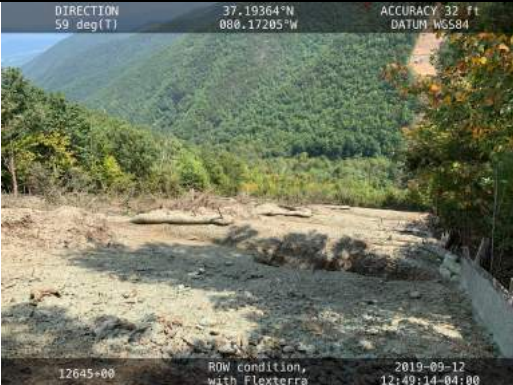
<b>GPS Location</b>	See photo for gps data.		<b>GPS Location</b>	See photo for gps data.	
<b>Field Station#</b>	12643+00		<b>Field Station#</b>	12645+00	
<b>Pic 3 Desc.</b>	Photo shows the ROW condition from about 12640+00 to 12643+00. Flexterra is visible on the surface.		<b>Pic 4 Desc.</b>	Photo shows the ROW condition from about 12645+00 to 12646+30. Flexterra is visible on the surface.

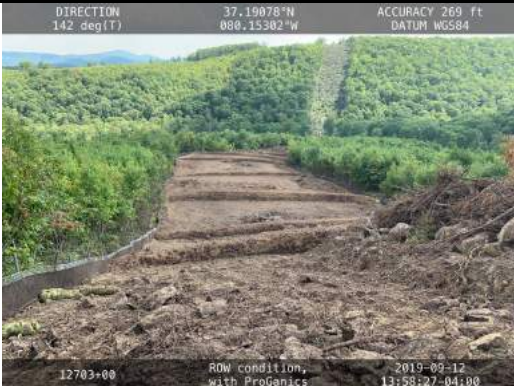
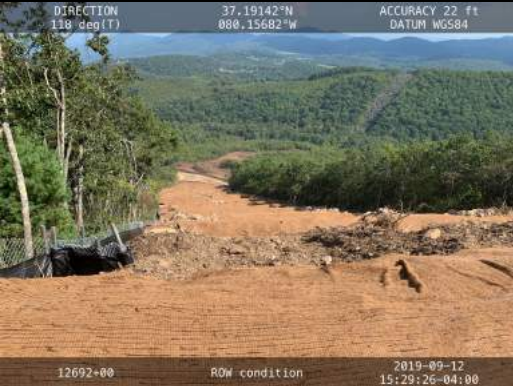
<b>Field Station#</b>	12703+00		<b>Field Station#</b>	12692+00	
<b>Pic 5 Desc.</b>	Photo shows the ROW condition from about 12703+00 to 12710+00. ProGanics Dual is visible on the surface.		<b>Pic 6 Desc.</b>	Photo shows the ROW condition from about 12692+00 to 12702+00.

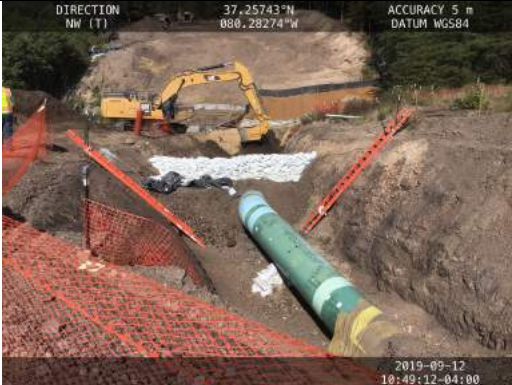
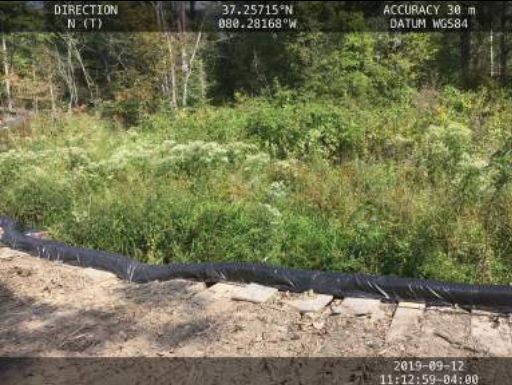
<b>GPS Location</b>	See photo		<b>GPS Location</b>	See photo	
<b>Field Station#</b>	12118+00		<b>Field Station#</b>	12121+33	
<b>Pic 1 Desc.</b>	Ruben Carrillo's crew were padding and backfilling pipe on the coming in side of Flatwoods Road.		<b>Pic 2 Desc.</b>	Stream S-C33, facing north, upstream

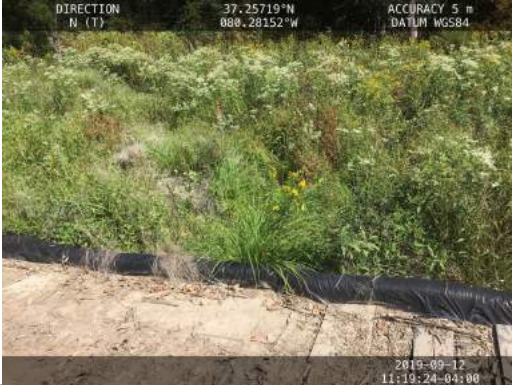
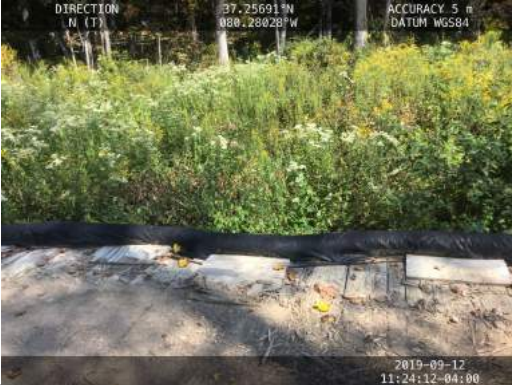
<b>GPS Location</b>	See photo		<b>GPS Location</b>	See photo	
<b>Field Station#</b>	12121+83		<b>Field Station#</b>	12125+65	
<b>Pic 3 Desc.</b>	Stream S-C36, facing north, upstream		<b>Pic 4 Desc.</b>	Stream S-MM31, facing north, upstream

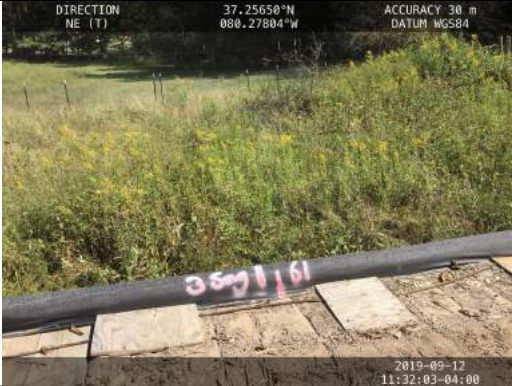
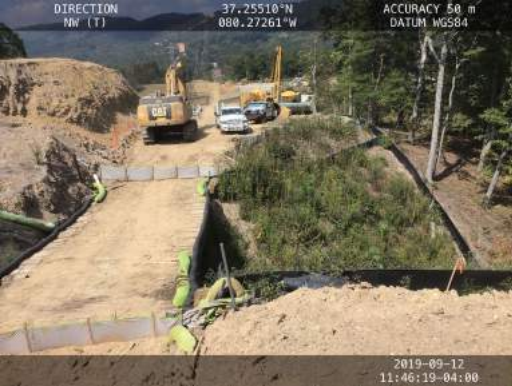
<b>GPS Location</b>	See photo		<b>GPS Location</b>	See photo	
<b>Field Station#</b>	12132+73		<b>Field Station#</b>	12147+00	
<b>Pic 5 Desc.</b>	Stream S-C29, facing northeast, upstream		<b>Pic 6 Desc.</b>	Ruben Carrillo's crew was welding a pipe section that will tie in existing pipe on both sides of this drainage feature.

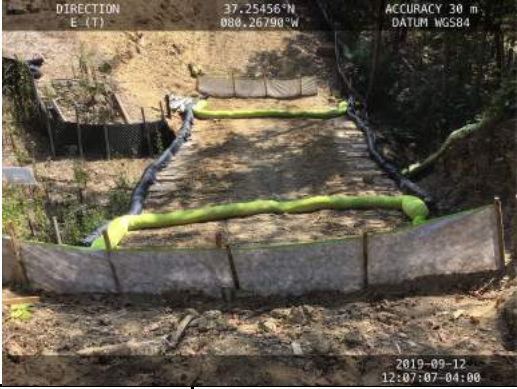
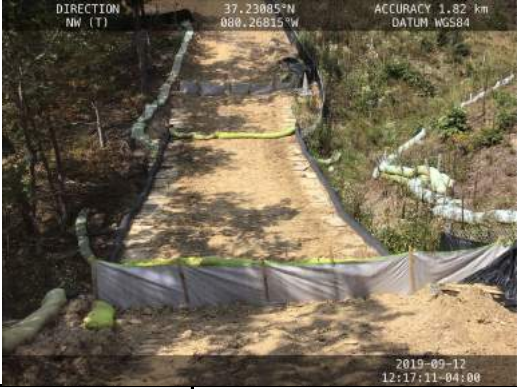
<b>GPS Location</b>	See photo	<b>GPS Location</b>	See photo		
<b>Field Station#</b>	12163+05	<b>Field Station#</b>	12166+47		
<b>Pic 7 Desc.</b>	Stream S-C25, facing east	<b>Pic 8 Desc.</b>	Stream S-C24, facing north

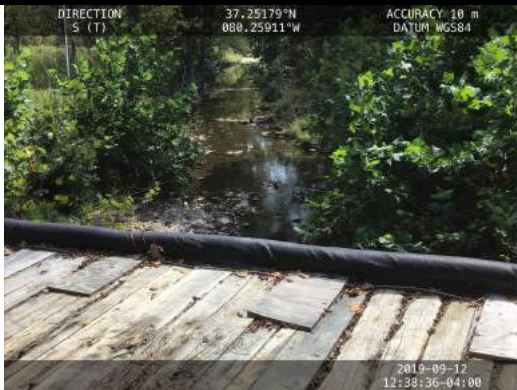
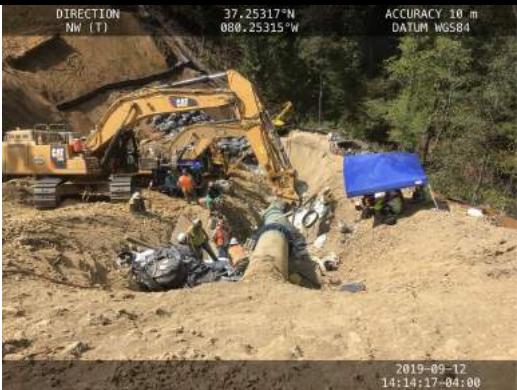
<b>GPS Location</b>	See photo	<b>GPS Location</b>	See photo		
<b>Field Station#</b>	12192+50	<b>Field Station#</b>	12213+00		
<b>Pic 9 Desc.</b>	Stream S-C21, facing south, downstream	<b>Pic 10 Desc.</b>	Zane Hudson's crew worked on getting the pipe lined up for the last weld on the GAS of the ravine between Bradshaw Rd & Reese Mt		
Insert image here		Insert image here			
<b>GPS Location</b>		<b>GPS Location</b>			
<b>Field Station#</b>		<b>Field Station#</b>			
<b>Pic 11 Desc.</b>		<b>Pic 12 Desc.</b>

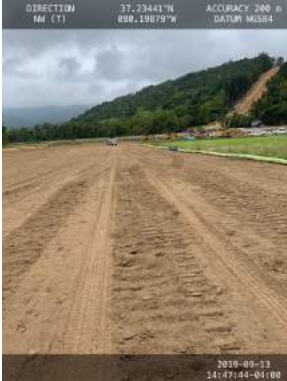
<b>GPS Location</b>	See picture for GPS data		<b>GPS Location</b>	See picture for GPS data	
<b>Field Station#</b>	12431+00		<b>Field Station#</b>	12428+00	
<b>Pic 3 Desc.</b>	Crew blowing straw mulch on the ROW for stabilization		<b>Pic 4 Desc.</b>	CFS completely reinstalled and repaired.

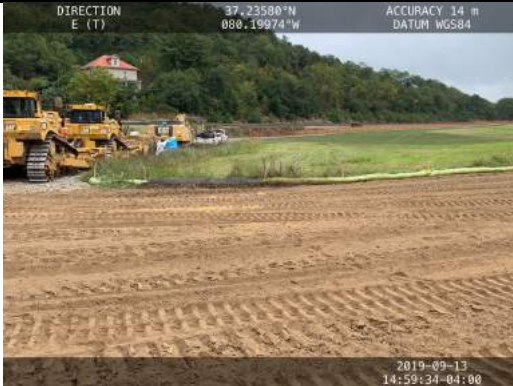
<b>GPS Location</b>	See picture for GPS data		<b>GPS Location</b>	See picture for GPS data	
<b>Field Station#</b>	12424+46		<b>Field Station#</b>	12424+46	
<b>Pic 5 Desc.</b>	Triangular silt dike installed for land owner crossing.		<b>Pic 6 Desc.</b>	Triangular silt dike installed for landowner crossing.

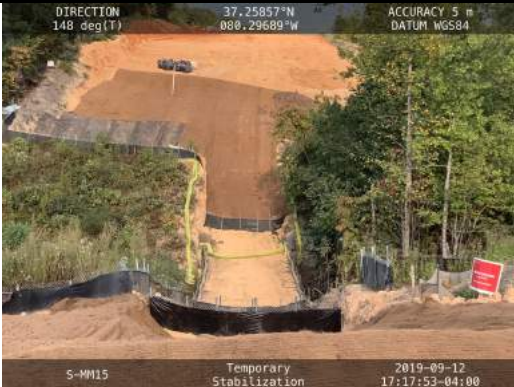
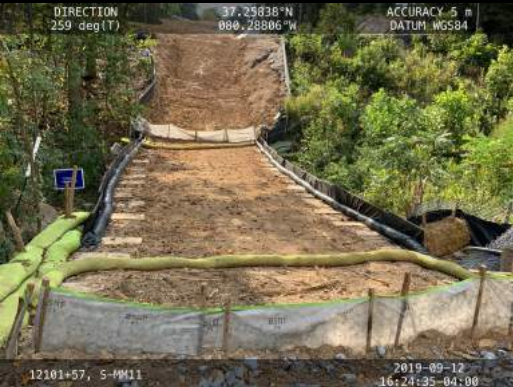
<b>GPS Location</b>	See photo GPS for location		<b>GPS Location</b>	See photo GPS for location	
<b>Field Station#</b>	12076+95		<b>Field Station#</b>	12101+57	
<b>Pic 1 Desc.</b>	Temporary stabilization complete. Erosion blanket, and CFS replaced and SSF Installed.		<b>Pic 2 Desc.</b>	Bridge over S-MM11 in acceptable condition.

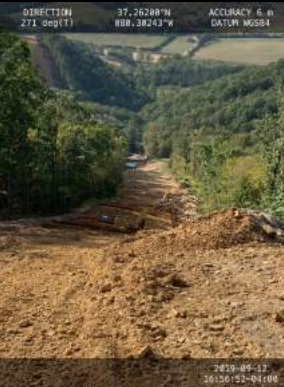
<b>GPS Location</b>	See photo GPS for location		<b>GPS Location</b>	See photo GPS for location	
<b>Field Station#</b>	12040+00		<b>Field Station#</b>	12008+00	
<b>Pic 3 Desc.</b>	Water bars being replaced.		<b>Pic 4 Desc.</b>	CFS replaced on east side of MVP-MN-268.

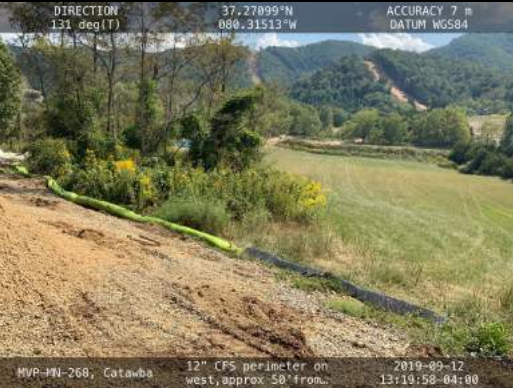
<b>GPS Location</b>	See photo GPS for location		<b>GPS Location</b>	See photo GPS for location	
<b>Field Station#</b>	12008+00		<b>Field Station#</b>	12008+00	
<b>Pic 5 Desc.</b>	Topsoil pile contained with P1.		<b>Pic 6 Desc.</b>	Triangle wattle installed for landowner's drive-through access to hay field.

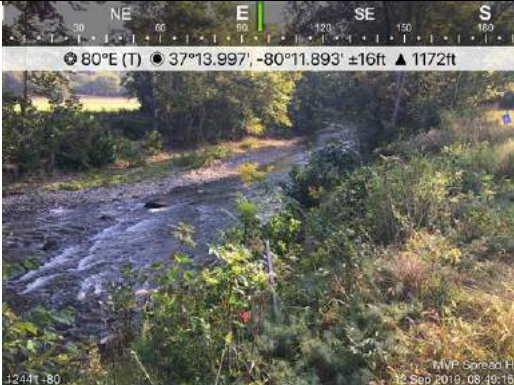
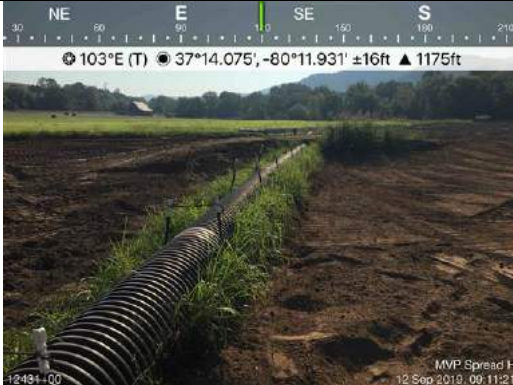
<b>GPS Location</b>	See picture watermark		<b>GPS Location</b>	See picture watermark	
<b>Field Station#</b>	12441+80		<b>Field Station#</b>	12431+00	
<b>Pic 1 Desc.</b>	Aquatic Resource Buffer for Roanoke River remains undisturbed.		<b>Pic 2 Desc.</b>	Clean water diversion pipe installed and in good condition.

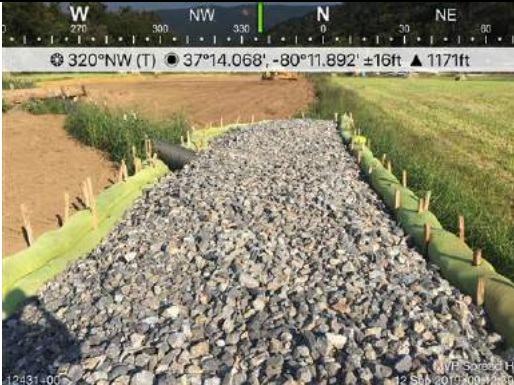
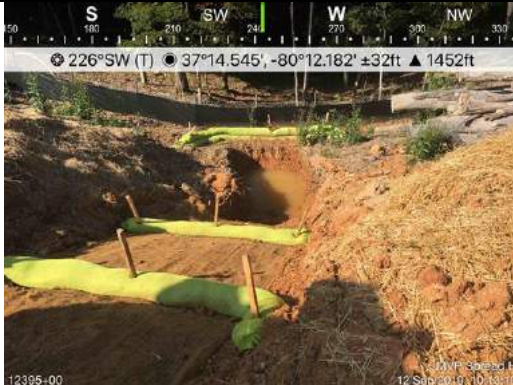
<b>GPS Location</b>	See picture watermark.		<b>GPS Location</b>	See picture watermark.	
<b>Field Station#</b>	12431+00		<b>Field Station#</b>	12395+00	
<b>Pic 3 Desc.</b>	Clean Water Diversion Inlet appears to be in good condition and functioning correctly.		<b>Pic 4 Desc.</b>	Slope protection and conveyance in good condition.

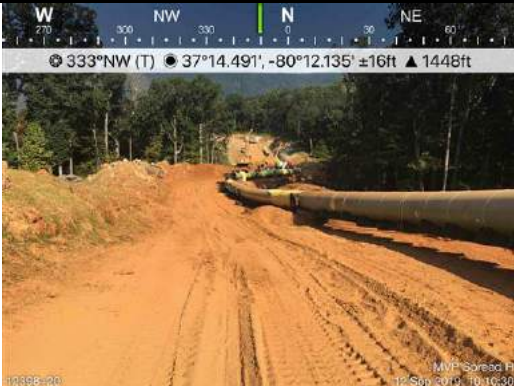
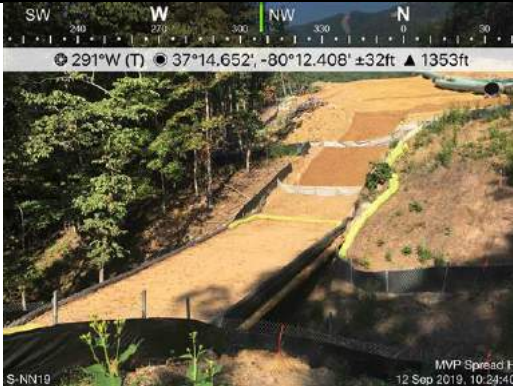
<b>Pic 5 Desc.</b>	Pipe staging and welding underway on MLV-27.		<b>Pic 6 Desc.</b>	Resource buffer S-NN19 protected and controls in good condition.

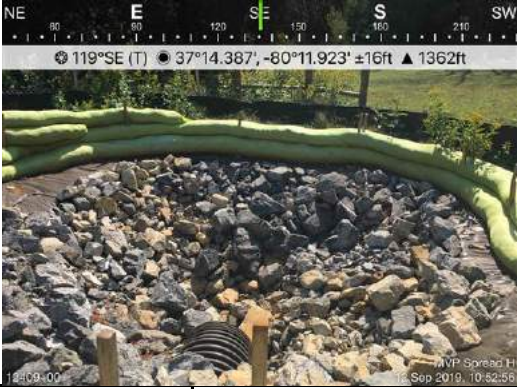
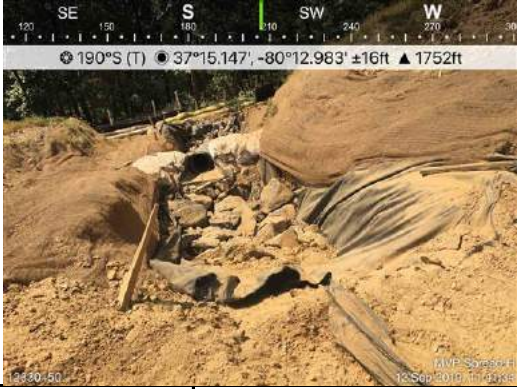
<b>GPS Location</b>	See picture watermark.		<b>GPS Location</b>	See picture watermark.	
<b>Field Station#</b>	12409+00		<b>Field Station#</b>	12330+50	
<b>Pic 7 Desc.</b>	Clean water diversion plunge pool in good condition and appears to be functioning.		<b>Pic 8 Desc.</b>	Slope drain inlet fabric should be re-keyed in. Crews in area continue to maintain these items as they arise.

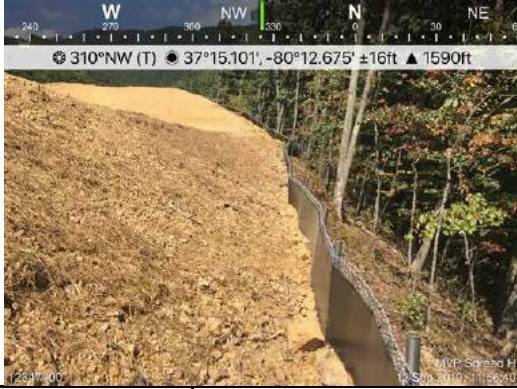
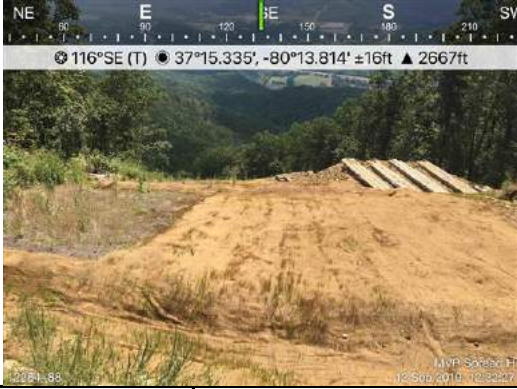
<b>GPS Location</b>	See picture watermark.		<b>GPS Location</b>	See picture watermark.	
<b>Field Station#</b>	12347+00		<b>Field Station#</b>	12284+88	
<b>Pic 9 Desc.</b>	Installed SSF in good condition.		<b>Pic 10 Desc.</b>	Reese Mountain "V" still well stabilized and controls in good condition.

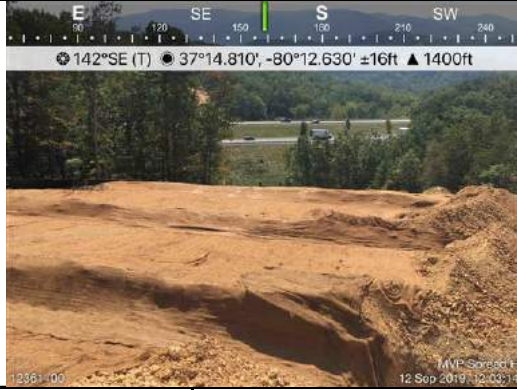
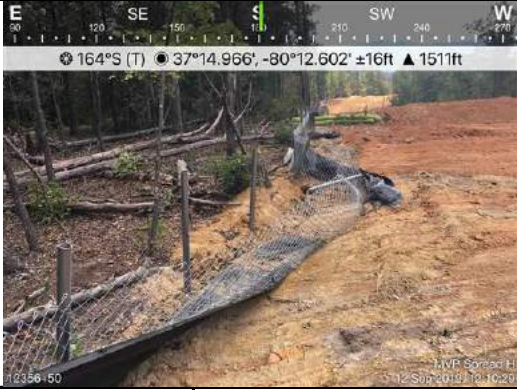
<b>Pic 11 Desc.</b>	Newly installed stabilization matting near CIS I-81.		<b>Pic 12 Desc.</b>	Down SSF from grading activities in need of repair. Item communicated to MVP LEI and PPL environmental foreman.

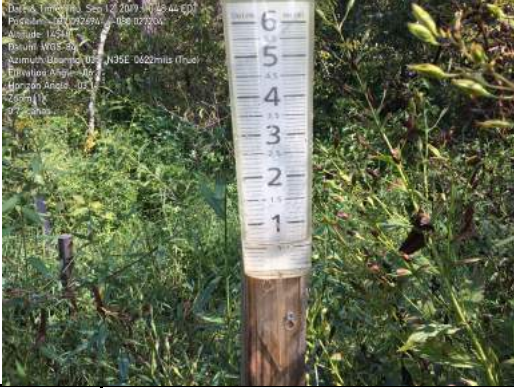
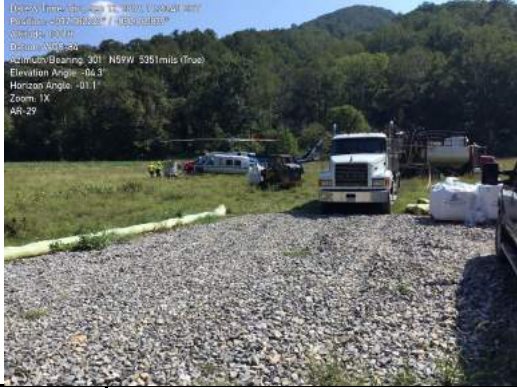
<b>GPS Location</b>	See photo for coordinates.		<b>GPS Location</b>	See photo for coordinates.	
<b>Field Station#</b>	13415+83		<b>Field Station#</b>	13190+00	
<b>Pic 1 Desc.</b>	Rain gauge at Cahas Mountain Road crossing, 0.7\"		<b>Pic 2 Desc.</b>	MVP-MLV-AR-29, landing and staging area for aerial application of fertilizer, seed, ProGanics and Flexterra.

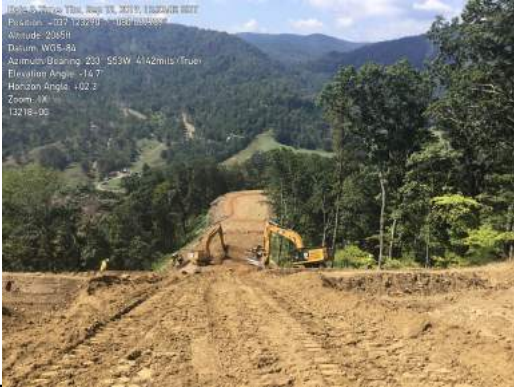
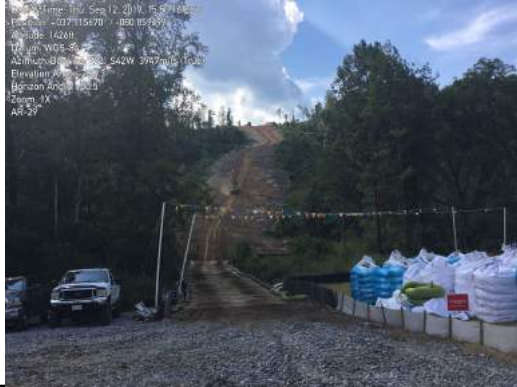
<b>GPS Location</b>	See photo for coordinates.		<b>GPS Location</b>	See photo for coordinates.	
<b>Field Station#</b>	13218+00		<b>Field Station#</b>	13261+00	
<b>Pic 3 Desc.</b>	ROW, restoring ROW to original contour, beginning temporary waterbars on contour.		<b>Pic 4 Desc.</b>	S-II4, ECDs functioning acceptably along stream crossing, bridge in good condition.

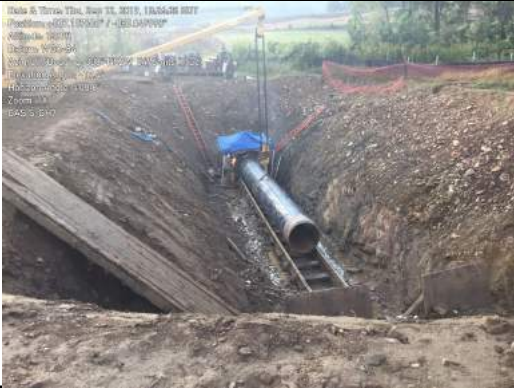
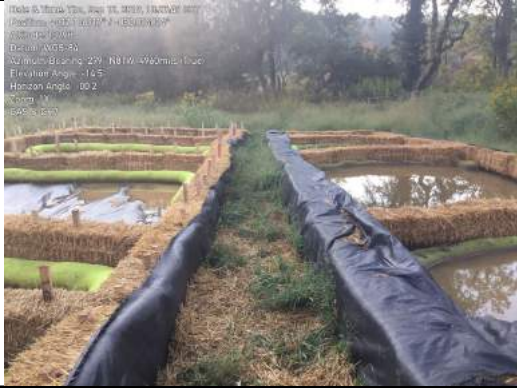
<b>Field Station#</b>	13310+00		<b>Field Station#</b>	13311+00	
<b>Pic 5 Desc.</b>	S-GH7, GAS bore bit, welding production pipe, added additional support to back wall of bore pit.		<b>Pic 6 Desc.</b>	S-GH7, approved off ROW dewatering structures functioning acceptably, no sedimentation noted in vegetated field.

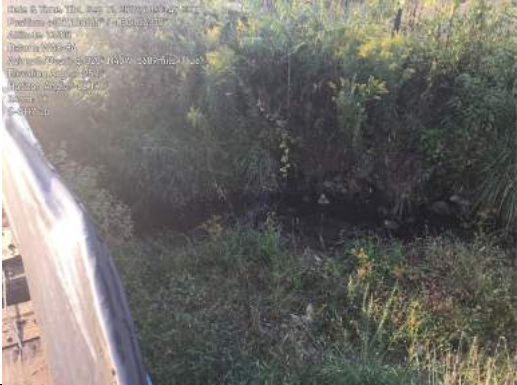
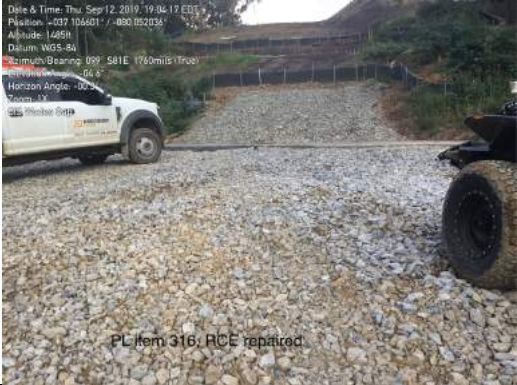
<b>GPS Location</b>	See photo for coordinates.		<b>GPS Location</b>	See photo for coordinates.	
<b>Field Station#</b>	13309+09		<b>Field Station#</b>	13315+50	
<b>Pic 7 Desc.</b>	S-GH7, looking upstream of equipment bridge, no changes observed to stream bed or banks, no sedimentation noted.		<b>Pic 8 Desc.</b>	Wade's Gap, RCE refreshed with new stone by end of day.	
Insert image here			Insert image here		
<b>GPS Location</b>			<b>GPS Location</b>		
<b>Field Station#</b>			<b>Field Station#</b>		
<b>Pic 9 Desc.</b>			<b>Pic 10 Desc.</b>		
Insert image here			Insert image here		
<b>GPS Location</b>			<b>GPS Location</b>		
<b>Field Station#</b>			<b>Field Station#</b>		
<b>Pic 11 Desc.</b>			<b>Pic 12 Desc.</b>

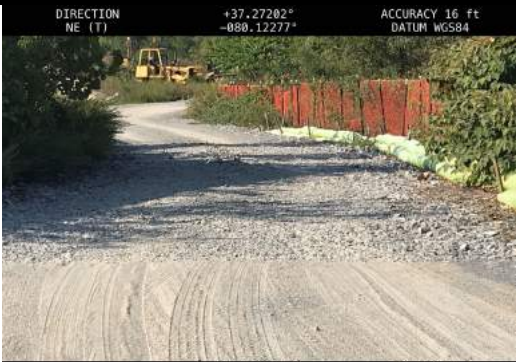
<p>DIRECTION NE (T) +37.27202° -080.12277° ACCURACY 16 ft DATUM WGS84</p> <p>MVP-LY-049_091219 Condition of rock entrance 2019-09-12 09:58:33-04:00</p>

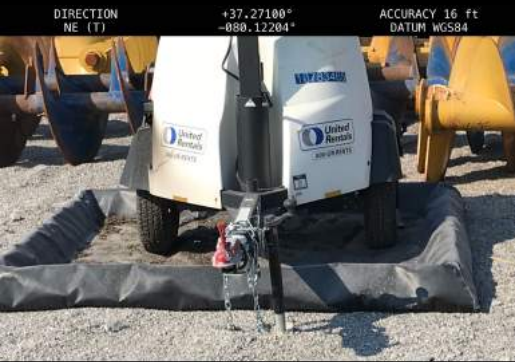
<p>DIRECTION NE (T) +37.27100° -080.12204° ACCURACY 16 ft DATUM WGS84</p> <p>MVP-LY-049_091219 Condition of containment 2019-09-12 09:59:48-04:00</p>	
GPS Location	MVP-LY-049 See photo for gps data		GPS Location	MVP-LY-049 See photo for gps data	
Field Station#	+0		Field Station#	+0	
Pic 1 Desc.	Condition of rock entrance on north drive. Looking NW.		Pic 2 Desc.	Condition of containment under light plant. Looking NW.

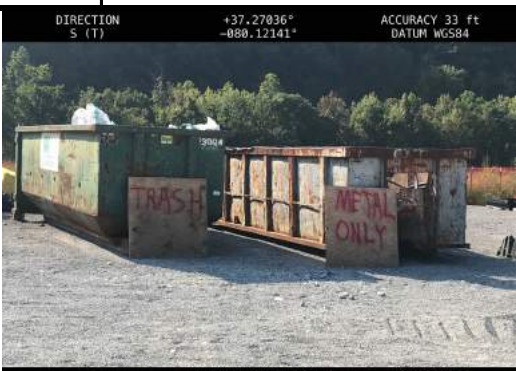
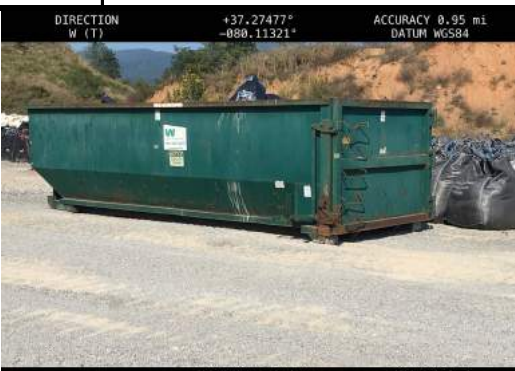
<p>DIRECTION S (T) +37.27036° -080.12141° ACCURACY 33 ft DATUM WGS84</p> <p>MVP-LY-049_091219 No loose trash around FAB Area dumpsters 2019-09-12 10:02:20-04:00</p>

<p>DIRECTION W (T) +37.27477° -080.11321° ACCURACY 0.95 mi DATUM WGS84</p> <p>MVP-LY-049_091219 No loose trash at West dumpster 2019-09-12 10:03:42-04:00</p>

GPS Location	MVP-LY-049 See photo for gps data		GPS Location	MVP-LY-049 See photo for gps data	
Field Station#	+0		Field Station#	+0	
Pic 3 Desc.	No loose trash around the FAB Area dumpsters. Looking S.		Pic 4 Desc.	No loose trash around West dumpster. Looking NW.

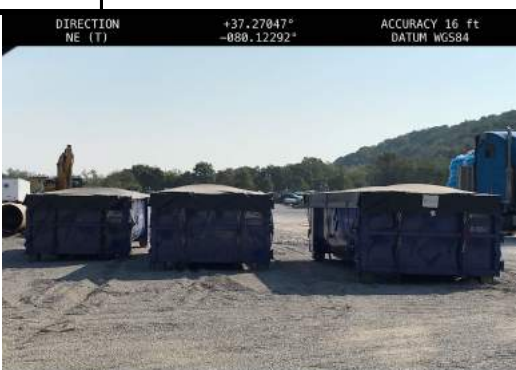
<p>DIRECTION NE (T) +37.27047° -080.12292° ACCURACY 16 ft DATUM WGS84</p> <p>MVP-LY-049_091219 3 covered dumpsters for contaminated mat_ 2019-09-12 10:04:17-04:00</p>

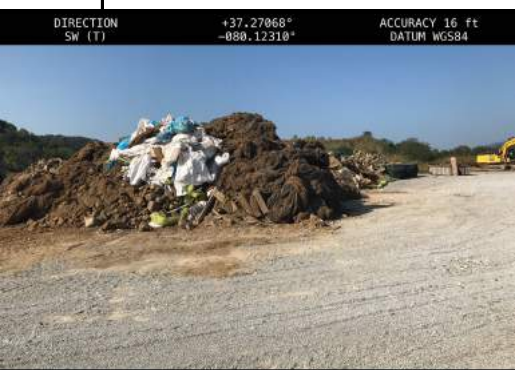
<p>DIRECTION SW (T) +37.27068° -080.12310° ACCURACY 16 ft DATUM WGS84</p> <p>MVP-LY-049_091219 Status of ROW debris pile in yard 2019-09-12 10:04:38-04:00</p>	
GPS Location	MVP-LY-049 See photo for gps data		GPS Location	MVP-LY-049 See photo for gps data	
Field Station#	+0		Field Station#	+0	
Pic 5 Desc.	3 covered dumpsters for contaminated materials. Looking NE.		Pic 6 Desc.	Status of ROW debris pile stacked in yard. Looking SW.
