Visual Site Inspection Report

Project Name H-600 Pipeline Spread I		AFE 124300139	Spread H-600 Pipeline Spread I
Contractor Precision		Report # 18328	
Inspector Glenn Mike Renfro		Date/Time 6/5/2019 10:08 AM	
Permit # TBD	Inspection Type VA SWPP	Station Begin	0000+00
State VA	Inspection Area Full	Station End	0000+00
County Franklin	Ground Dry	Temperature (°F)	84.00
Municipality N/A	Weather Cloudy	Rain Gauge (in)	0.25
			Rain Accumulation Time (days) 6.00

Project Name H-600 Pipeline Spread I		AFE 124300139	Spread H-600 Pipeline Spread I
Contractor Precision		Report # 18209	
Inspector Ben Davenport		Date/Time 6/5/2019 7:36 AM	
Permit # TBD	Inspection Type VA SWPP	Station Begin 13670+00	
State VA	Inspection Area Full	Station End 16027+46	
County Franklin/Pittsylvania	Ground Dry	Temperature (°F) 76.00	
Municipality Chatham	Weather Cloudy	Rain Gauge (in) 0.00	
			Rain Accumulation Time (days) 0.00

Project Name Transco Interconnect Station		AFE 124300113	Spread Transco Interconnect Station
Contractor Kanahwa		Report # 18215	
Inspector John White		Date/Time 6/5/2019 9:13 AM	
Permit # TBD	Inspection Type VA SWPP	Station Begin	00+00
State VA	Inspection Area Full	Station End	00+00
County

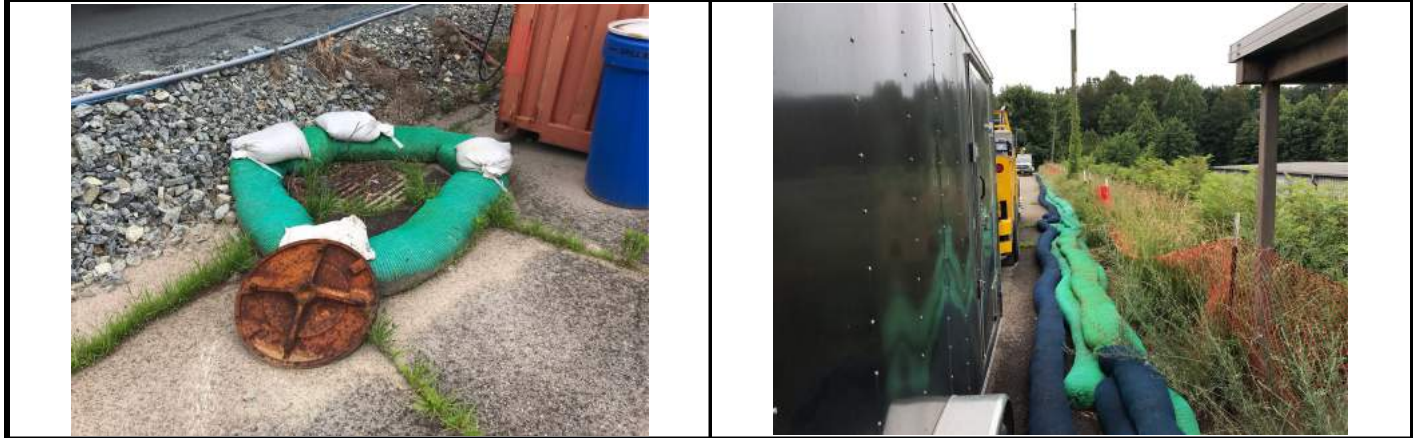
GPS Location	36.97	Field Station#	0000+00	GPS Location	36.97	Field Station#	0000+00
Description	Inlet protection for parking lot drain inlet in good condition			Description	Perimeter ECD's in good condition on the west side of paved yard

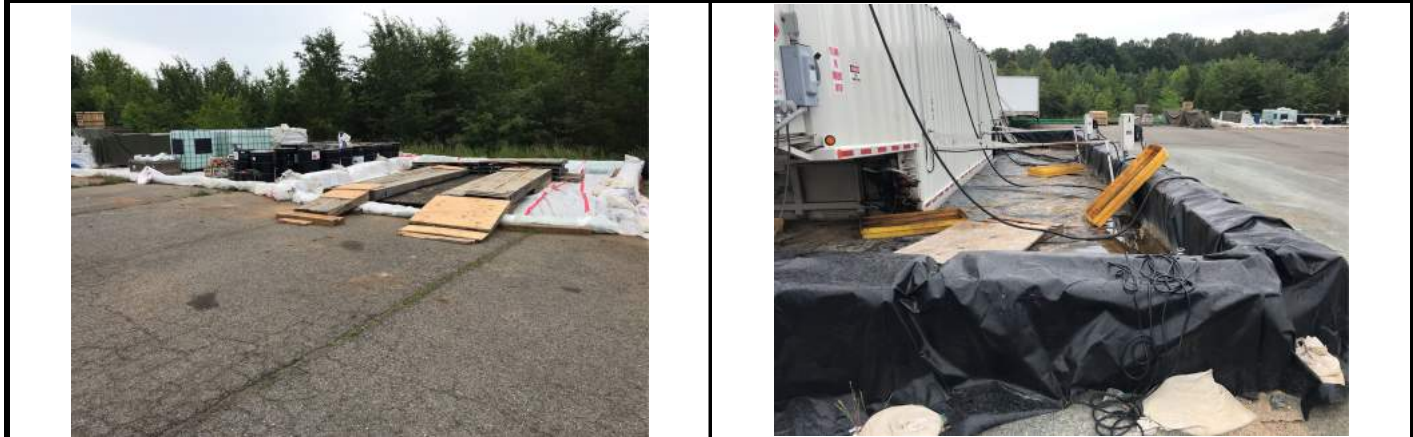
GPS Location	36.97	Field Station#	0000+00	GPS Location	36.97	Field Station#	0000+00
Description	Secondary containment structure for on south end of paved yard in good condition			Description	Secondary containment structure for fuel cell.

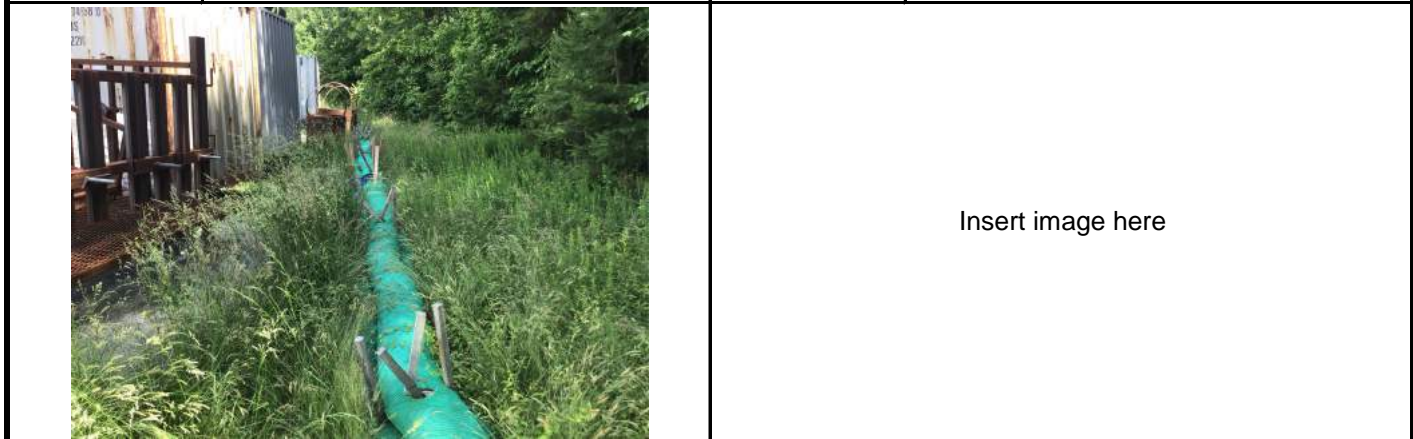
GPS Location	36.97	Field Station#	0000+00	GPS Location		Field Station#	
Description	Perimeter ECD's in good condition on west side of gravel yard.			Description

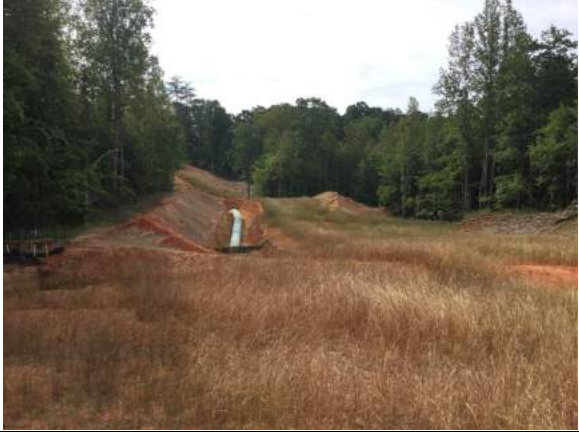
GPS Location			37.00		Field Station#			15772+22		GPS Location			37.00		Field Station#			15070+00	
Description			CFS more than 1/2 full and requires maintenance						Description			Temporary vegetation growing across ROW

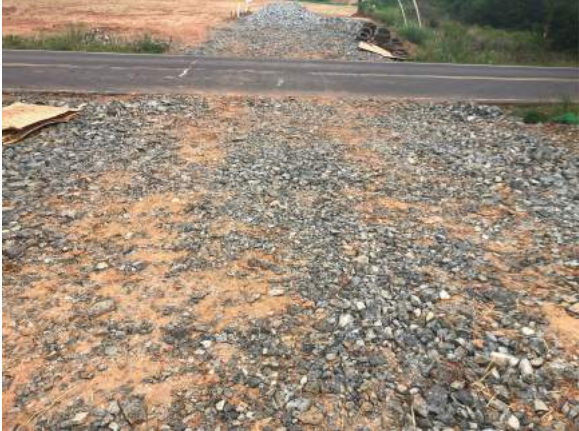
GPS Location			37.00		Field Station#			14694+30		GPS Location			37.00		Field Station#			14577+00	
Description			Rock construction entrance requires maintenance						Description			Seed and straw applied to ROW during temporary stabilization process

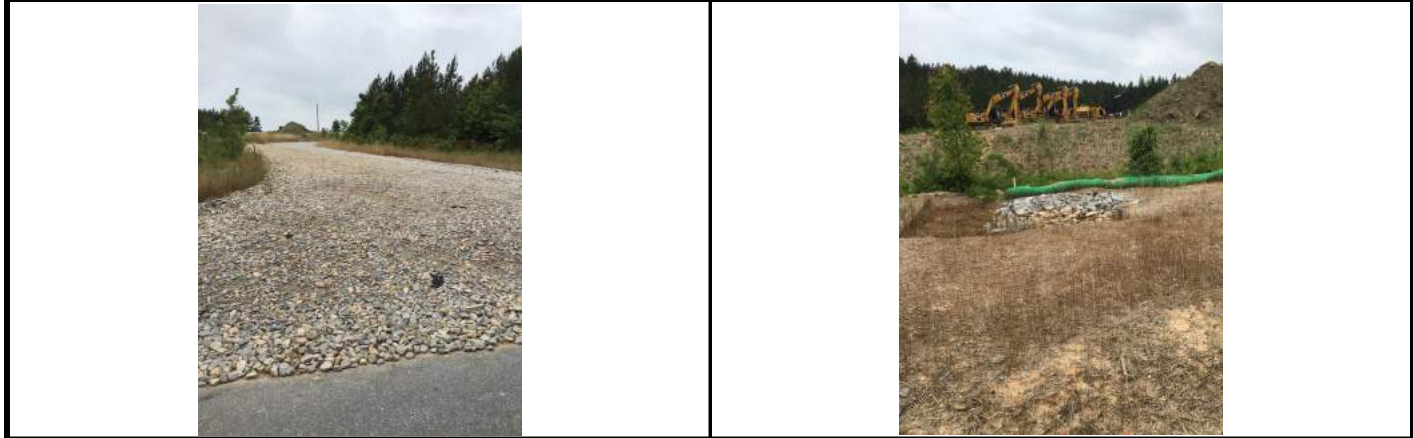
Description	Observing RCE at Transco.	Description	Observing outlet and ECD's performing as they should.
--------------------	---------------------------	--------------------	---

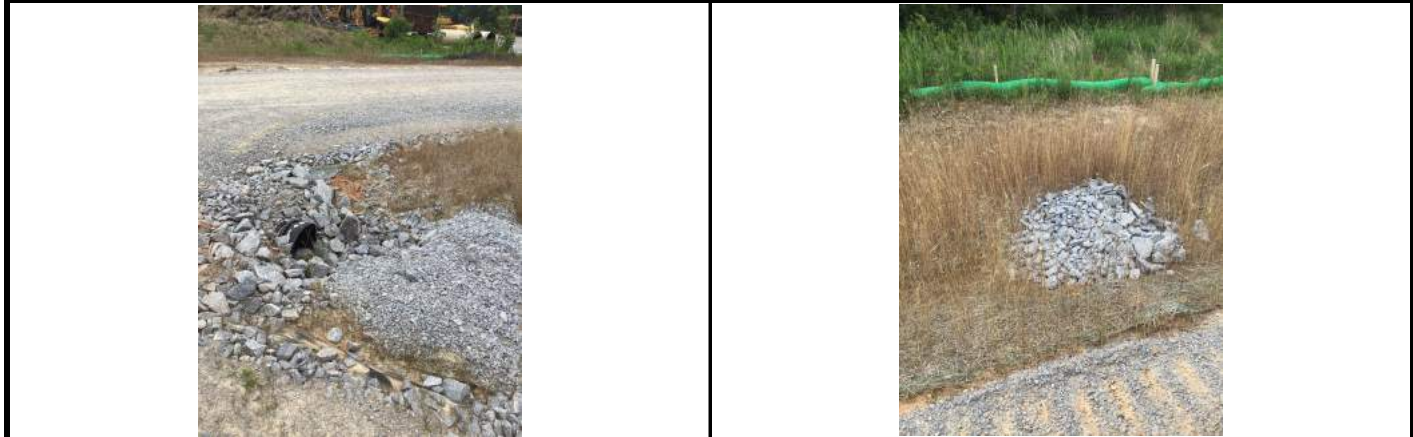
Description	Observing outlet and outlet protection.	Description	Observing rock check dam in road side ditch.
--------------------	---	--------------------	--

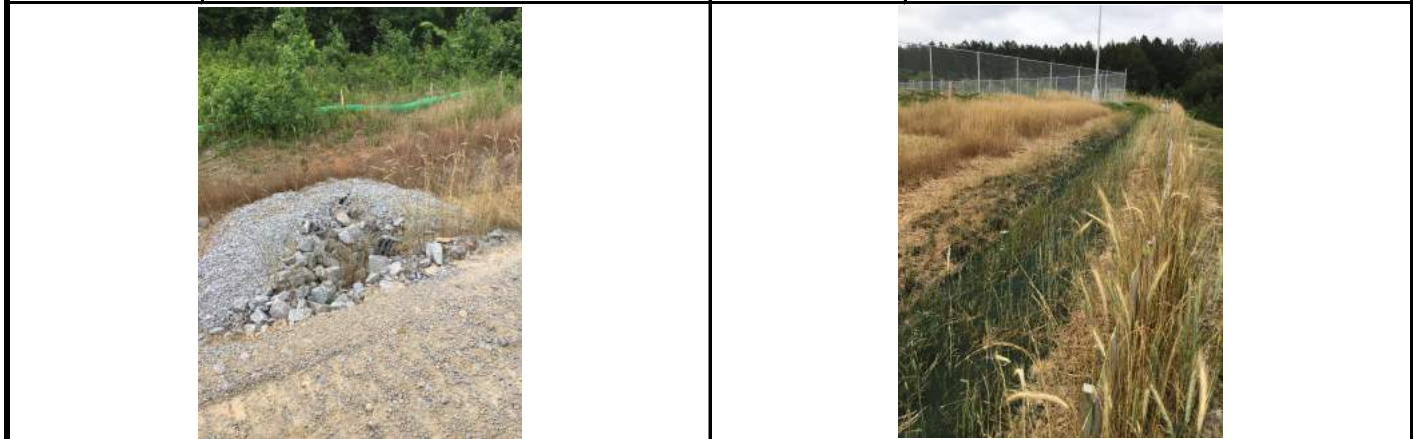
Description	Observing outlet and outlet protection.	Description	Observing stabilized channel.
--------------------	---	--------------------	-------------------------------

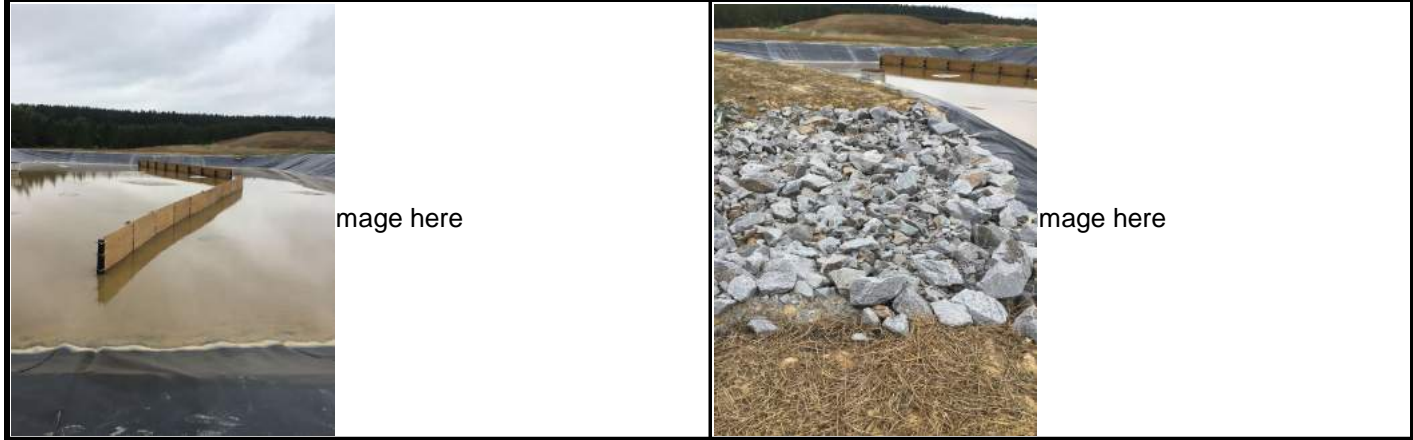
Description Observing baffles in the storm water pond.	Description Observing rock drain.
---	--
