Visual Site Inspection Report

Project Name	H-600 Pipeline Spread I	AFE	124300139	Spread	H-600 Pipeline Spread I
Contractor	Precision			Report #	6079
Inspector	Logan Box			Date/Time	11/25/2019 4:04 PM
Permit #	TBD	Inspection Type	VA SWPP	Station Begin	13670+00
State	VA	Inspection Area	Partial	Station End	13853+45
County	Franklin	Ground	Damp	Temperature (°F)	56.00
Municipality	N/A	Weather	Sunny	Rain Gauge (in)	0.00
				Rain Accumulation Time (days)	0.00

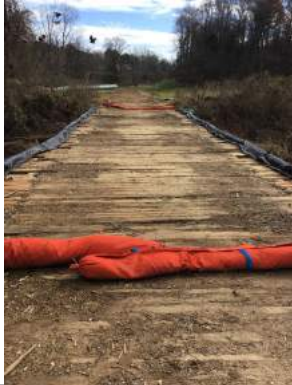
GPS Location	00000	GPS Location	0000		
Field Station#	13690+80	Field Station#	13784+35		
Pic 1 Desc.	Wet row photo during light rain showers.		Pic 2 Desc.	Construction debris along access rd FR-300 sent in for punch list

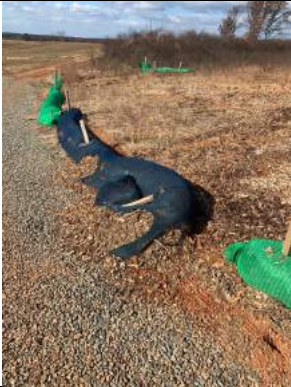
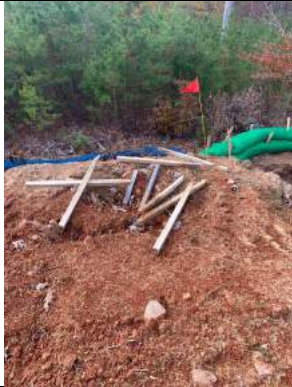
GPS Location	O	GPS Location	O		
Field Station#	15734+40	Field Station#	15717+00		
Pic 1 Desc.	Observing ECD's that require maintenance.	Pic 2 Desc.	Observing debris that needs to be removed.

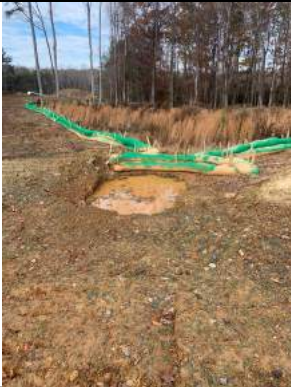
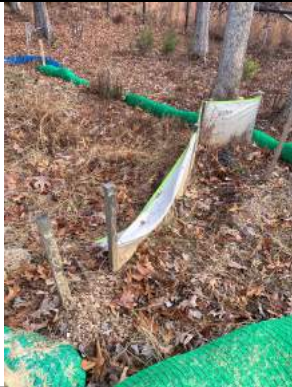
GPS Location	O	GPS Location	O		
Field Station#	15679+00	Field Station#	15677+48		
Pic 3 Desc.	Observing sump and end treatment.	Pic 4 Desc.	Observing ECD's that require maintenance.		
Insert image here			Insert image here		
GPS Location		GPS Location			
Field Station#		Field Station#			
Pic 5 Desc.		Pic 6 Desc.

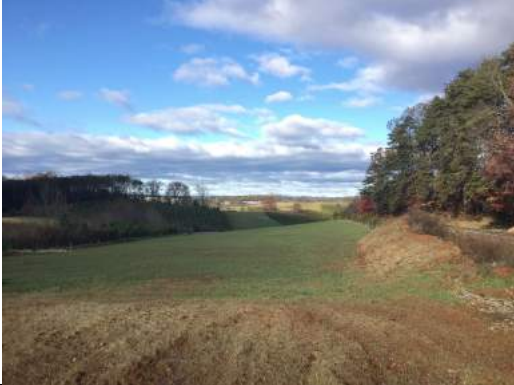
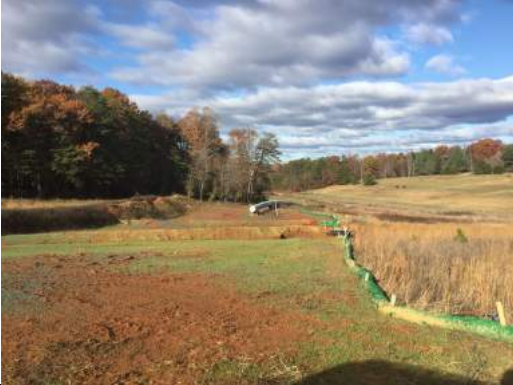
GPS Location	1	GPS Location	2		
Field Station#	15367+00	Field Station#	15616+00		
Pic 1 Desc.	View of ROW and ECD's in place CIS Snowberry Rd	Pic 2 Desc.	View of ROW and ECD's in place CIS Anderson Mill RC2

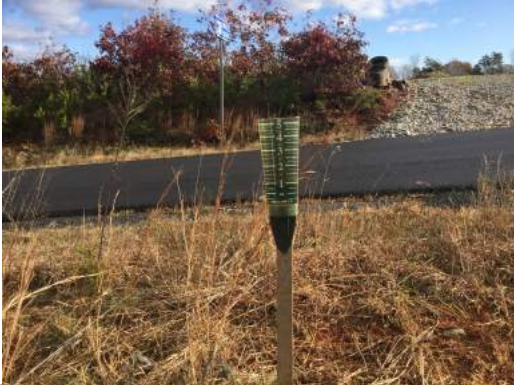
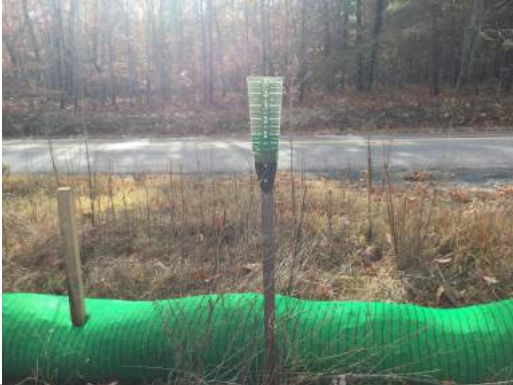
GPS Location	3	GPS Location	4		
Field Station#	15619+48	Field Station#	15826+77		
Pic 3 Desc.	1.00 inches of rain recorded at Anderson Mill RC2	Pic 4 Desc.	1.00 inches of rain recorded at Mill Creek Rd		
Insert image here			Insert image here		
GPS Location		GPS Location			
Field Station#		Field Station#			
Pic 5 Desc.		Pic 6 Desc.

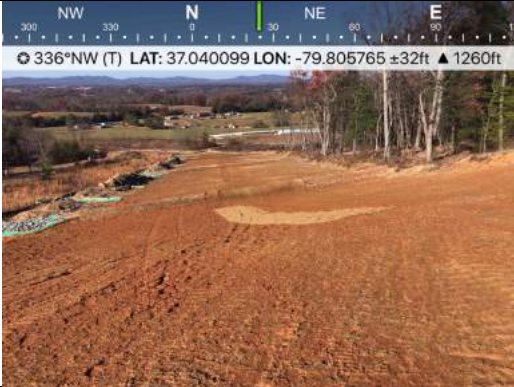
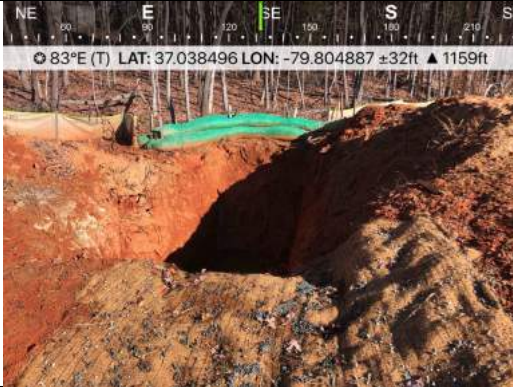
GPS Location	0	GPS Location	0		
Field Station#	14328+00	Field Station#	14336+00		
Pic 1 Desc.	Temporary stabilization on the CIS of Golden View Road	Pic 2 Desc.	Sump pit to spec on that GAS of Golden View Road

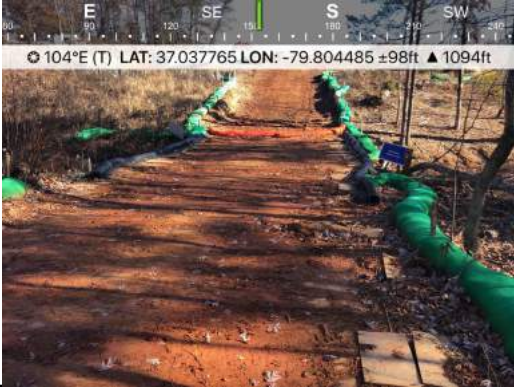
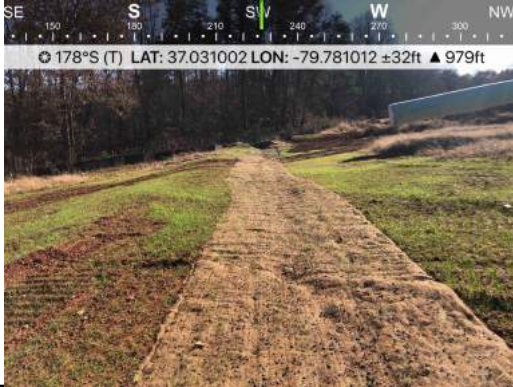
GPS Location	0	GPS Location	0		
Field Station#	14338+56	Field Station#	14415+00		
Pic 3 Desc.	Equipment bridge clean at stream S-A36	Pic 4 Desc.	Erosion fixed and curlex installed in water bar flow path		
Insert image here			Insert image here		
GPS Location		GPS Location			
Field Station#		Field Station#			
Pic 5 Desc.		Pic 6 Desc.

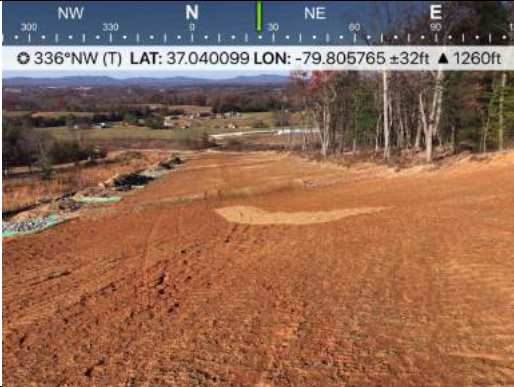
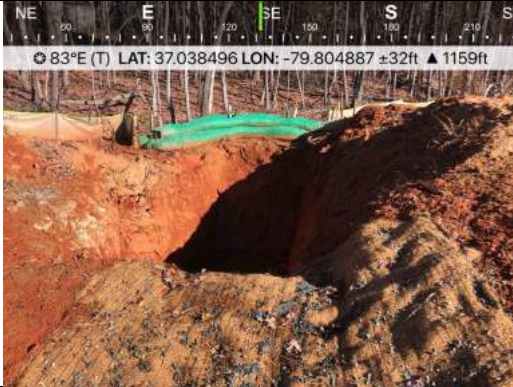
GPS Location	0	GPS Location	0		
Field Station#	14328+00	Field Station#	14336+00		
Pic 1 Desc.	Temporary stabilization on the CIS of Golden View Road	Pic 2 Desc.	Sump pit to spec on the GAS of Golden View Road

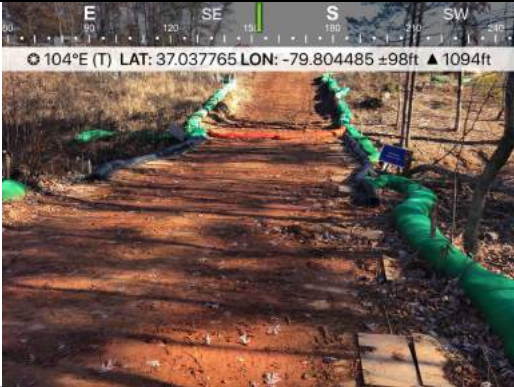
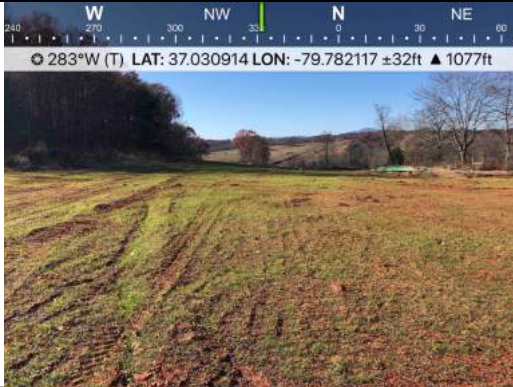
GPS Location	0	GPS Location	0		
Field Station#	14338+56	Field Station#	14405+00		
Pic 3 Desc.	Equipment bridge clean at stream S-A36	Pic 4 Desc.	Temporary stabilization

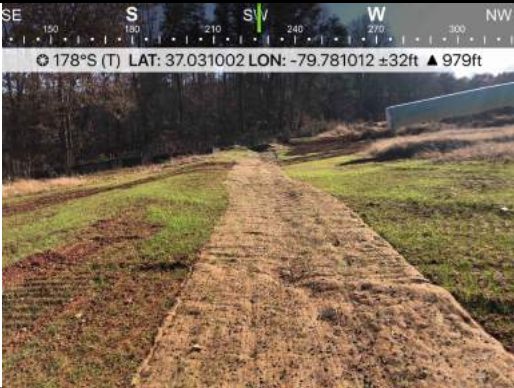
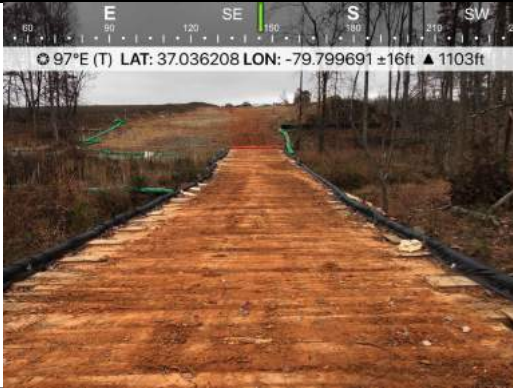
GPS Location	0	GPS Location	0		
Field Station#	4415+00	Field Station#	4353+53		
Pic 5 Desc.	Erosion fixed and curlex installed in water bar flow path	Pic 6 Desc.	Equipment bridge clean at stream S-A38

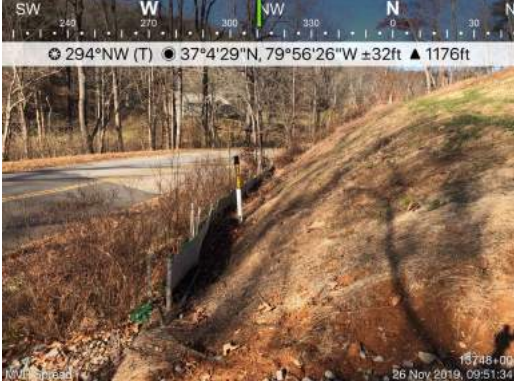
GPS Location	0	GPS Location	0		
Field Station#	13748+00	Field Station#	13733+39		
Pic 1 Desc.	P1 silt fence is acceptable	Pic 2 Desc.	Waterbar is acceptable

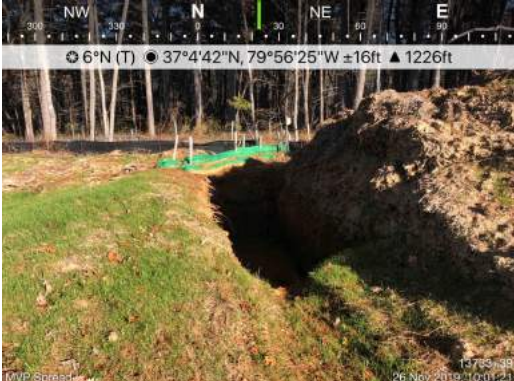
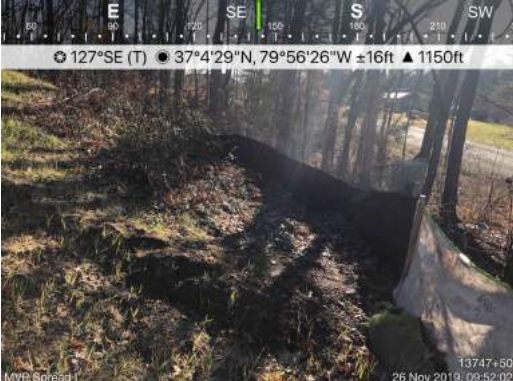
GPS Location	0	GPS Location	0		
Field Station#	13733+39	Field Station#	13747+50		
Pic 3 Desc.	Waterbar end treatment is acceptable	Pic 4 Desc.	Super silt fence is acceptable

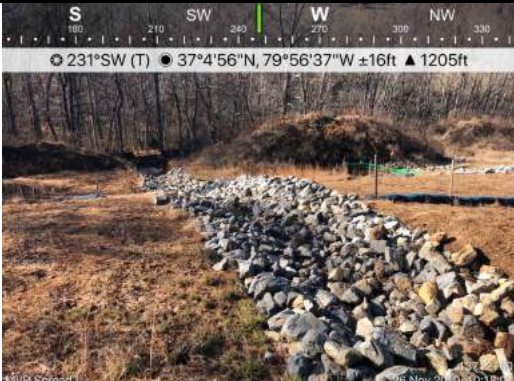
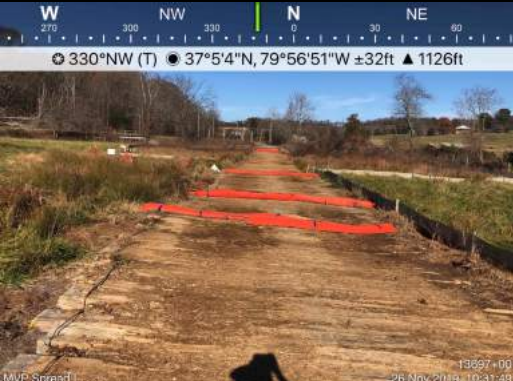
GPS Location	0	GPS Location	0		
Field Station#	13712+00	Field Station#	13697+00		
Pic 5 Desc.	Rock lined channel is acceptable	Pic 6 Desc.	Timber mats are acceptable

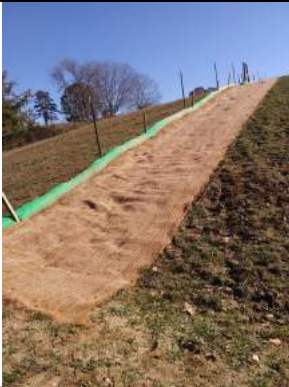
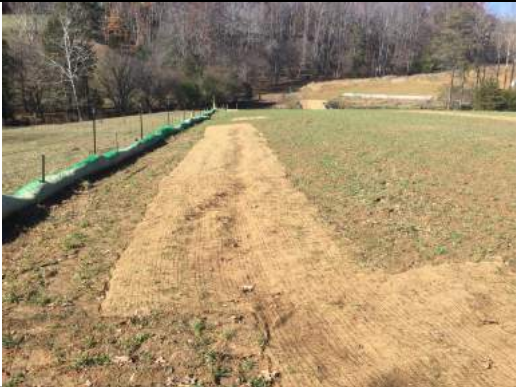
GPS Location	3	GPS Location	4		
Field Station#	14094+00	Field Station#	14097+00		
Pic 3 Desc.	Contractor installed erosion control blanket to help curb erosion		Pic 4 Desc.	Continue to monitor erosion occurring in final cleanup area CIS Museville Rd	
Insert image here			Insert image here		
GPS Location		GPS Location			
Field Station#		Field Station#			
Pic 5 Desc.			Pic 6 Desc.

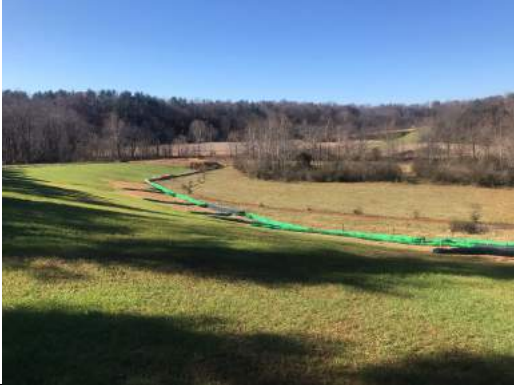
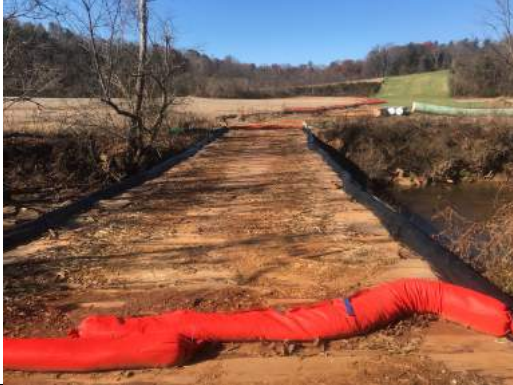
GPS Location	0	GPS Location	0		
Field Station#	13925+00.	Field Station#	13915+82		
Pic 1 Desc.	Approximately 13925+00. Overview of ROW. ECDs installed and appear to be functioning correctly. Winter vegetation and stabilization of ROW in this area.		Pic 2 Desc.	Approximately 13915+82. Overview of stream crossing and equipment bridge at stream S-II2.

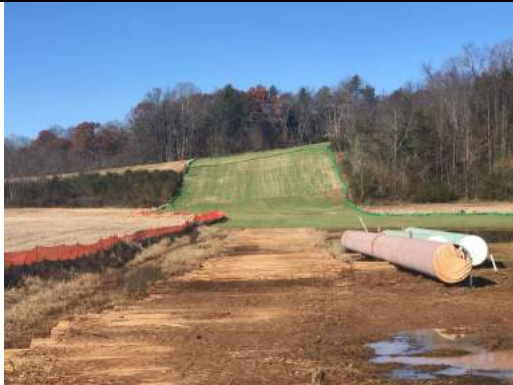
GPS Location	0	GPS Location	0		
Field Station#	13915+82	Field Station#	13910+00		
Pic 3 Desc.	Approximately 13915+82. Downstream view of stream S-II2.		Pic 4 Desc.	Approximately 13910+00. ROW stabilized and has winter vegetation.	
Insert image here			Insert image here		
GPS Location		GPS Location			
Field Station#		Field Station#			
Pic 5 Desc.		Pic 6 Desc.

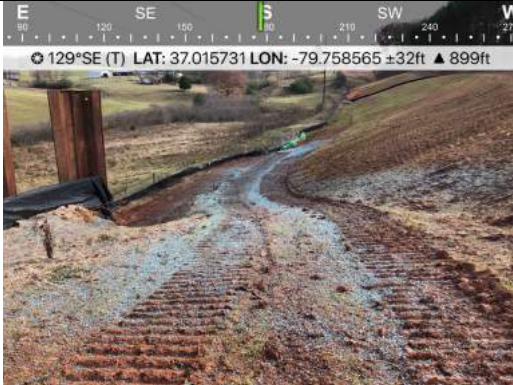
GPS Location	0	GPS Location	0		
Field Station#	14487+00	Field Station#	14504+00		
Pic 1 Desc.	Curlex installed on steep slope	Pic 2 Desc.	Area stabilized with earth guard edge

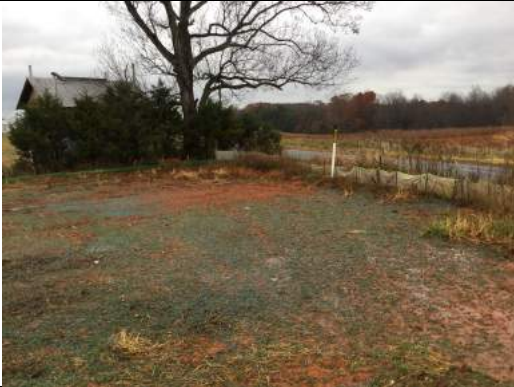
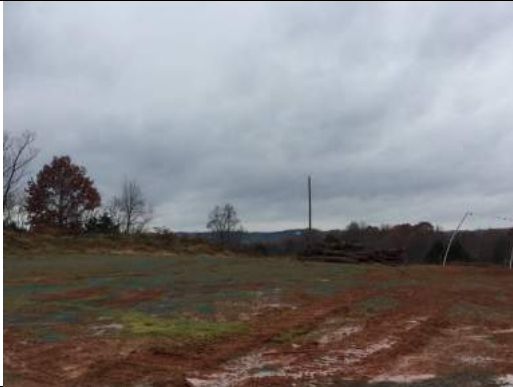
GPS Location	1	GPS Location	2		
Field Station#	15063+75	Field Station#	15062+00		
Pic 1 Desc.	Subsidence beginning to appear in ditch line once again		Pic 2 Desc.	Stabilized extra work space. Little vegetation growing but no signs of erosion.

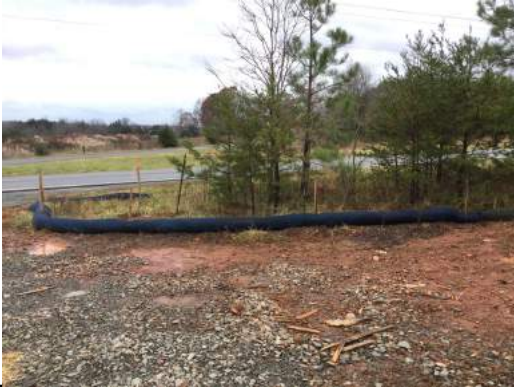
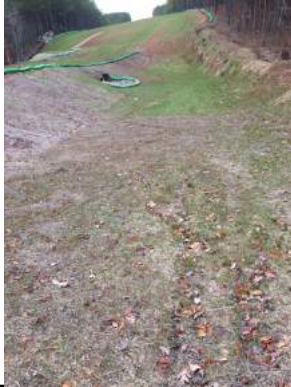
GPS Location	3	GPS Location	4		
Field Station#	14981+50	Field Station#	14976+00		
Pic 3 Desc.	CFS replaced per punch list item		Pic 4 Desc.	Erosion channel forming down ROW	
Insert image here			Insert image here		
GPS Location		GPS Location			
Field Station#		Field Station#			
Pic 5 Desc.			Pic 6 Desc.

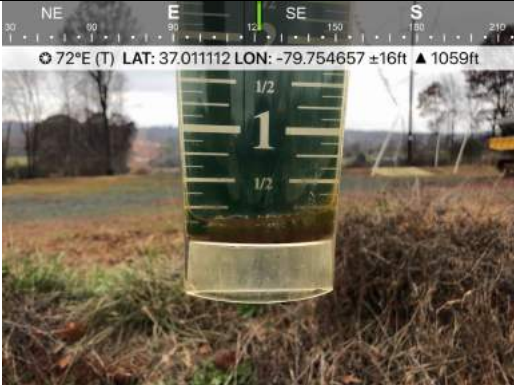
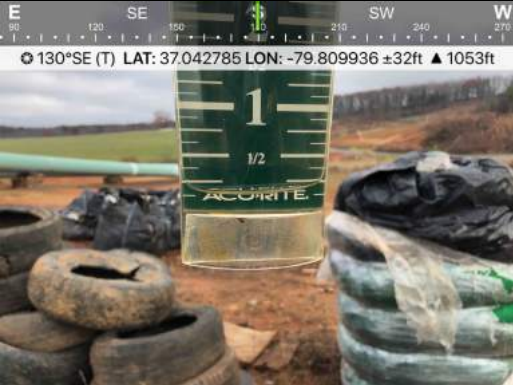
GPS Location	0	GPS Location	0		
Field Station#	14524+76	Field Station#	14311+57		
Pic 1 Desc.	Rain gauge at Timber Ridge Road 0.2"	Pic 2 Desc.	Rain gauge at Farm View Road 0.25"

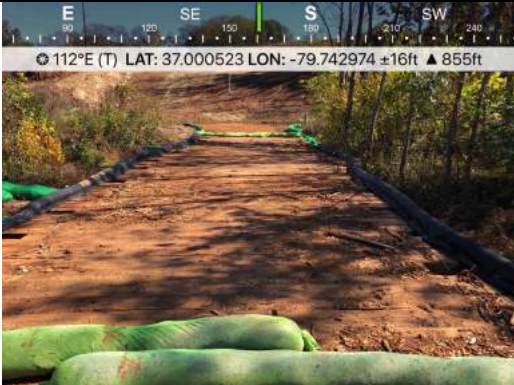
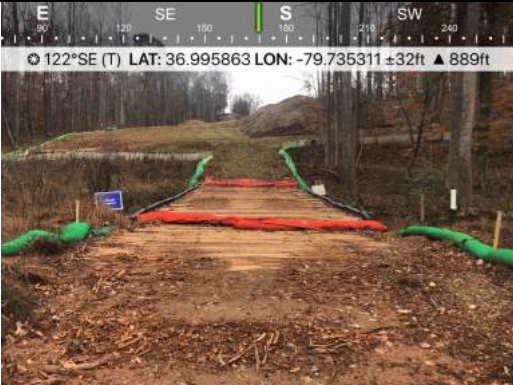
GPS Location	0	GPS Location	0		
Field Station#	14582+85	Field Station#	14611+17		
Pic 3 Desc.	Equipment bridge clean at stream S-E17	Pic 4 Desc.	Equipment bridge clean at stream S-E14		
Insert image here		Insert image here			
GPS Location		GPS Location			
Field Station#		Field Station#			
Pic 5 Desc.		Pic 6 Desc.

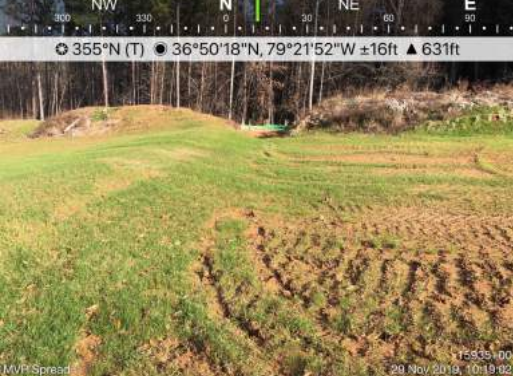
GPS Location	0	GPS Location	0		
Field Station#	15834+92	Field Station#	15935+00		
Pic 1 Desc.	Rock construction entrance is acceptable		Pic 2 Desc.	Waterbar is acceptable

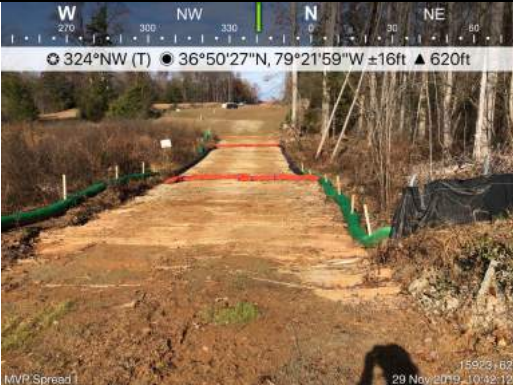
GPS Location	0	GPS Location	0		
Field Station#	15935+00	Field Station#	15923+62		
Pic 3 Desc.	Waterbar end treatment is acceptable		Pic 4 Desc.	Equipment bridge is acceptable

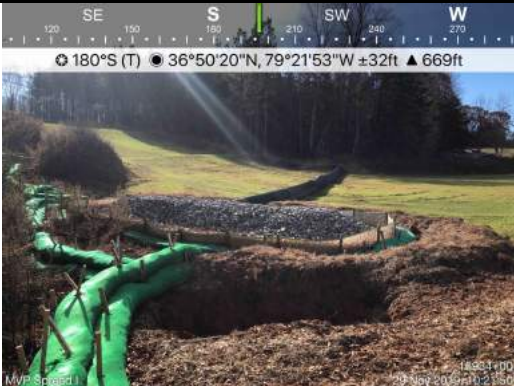
GPS Location	0	GPS Location	0		
Field Station#	15934+00	Field Station#	15852+00		
Pic 5 Desc.	Clean water diversion pipe is acceptable		Pic 6 Desc.	P1 silt fence is acceptable

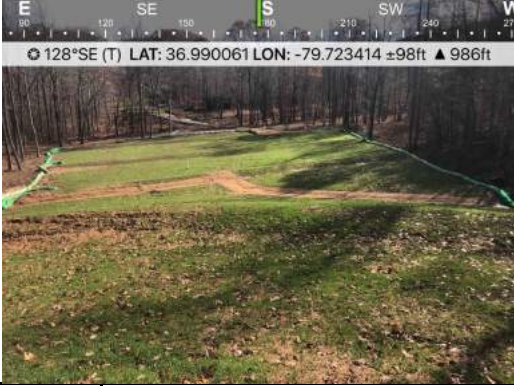
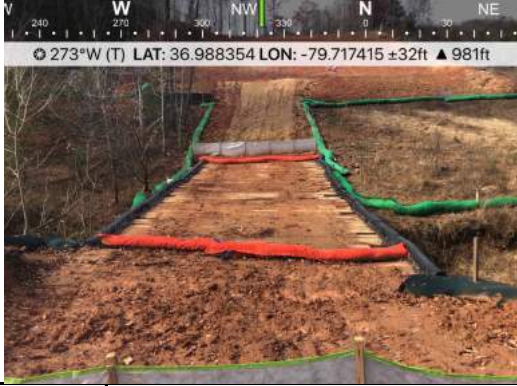
GPS Location	0	GPS Location	0		
Field Station#	14655+00	Field Station#	14673+10		
Pic 1 Desc.	Permanent stabilization on the GAS of Hwy 40	Pic 2 Desc.	Equipment bridge clean at stream S-H37

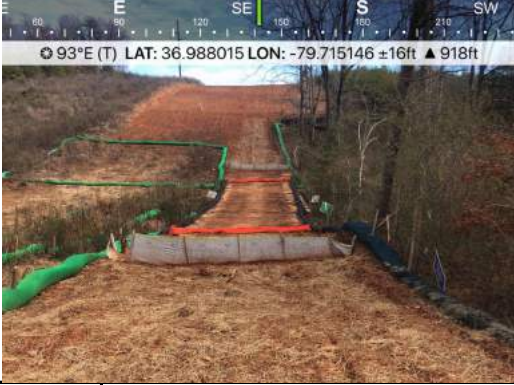
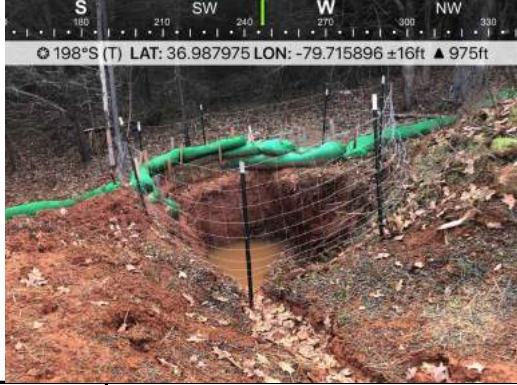
GPS Location	0	GPS Location	0		
Field Station#	14680+37	Field Station#	14685+00		
Pic 3 Desc.	Equipment bridge clean at stream S-H36	Pic 4 Desc.	Sump pit functioning as intended		
Insert image here		Insert image here			
GPS Location		GPS Location			
Field Station#		Field Station#			
Pic 5 Desc.		Pic 6 Desc.

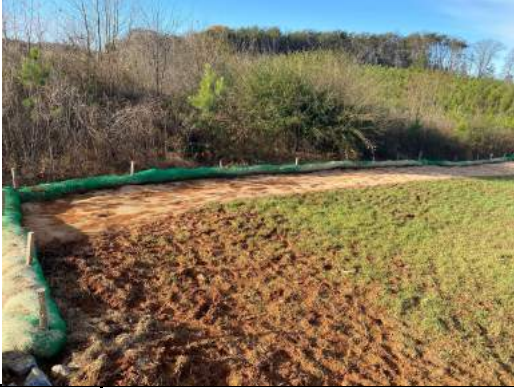
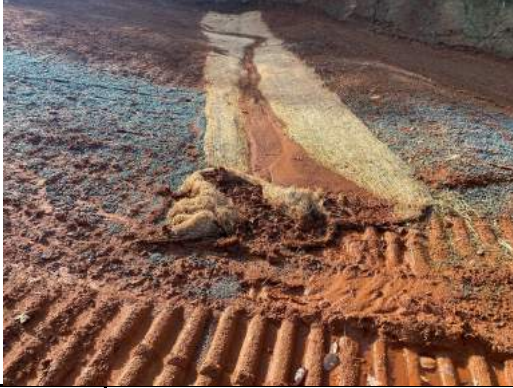
GPS Location	0	GPS Location	0		
Field Station#	15363+50	Field Station#	15580+00		
Pic 1 Desc.	Erosion issue repaired and curlex installed.	Pic 2 Desc.	Repair rutting issues and replace the curlex in breaker throats across travel lane.

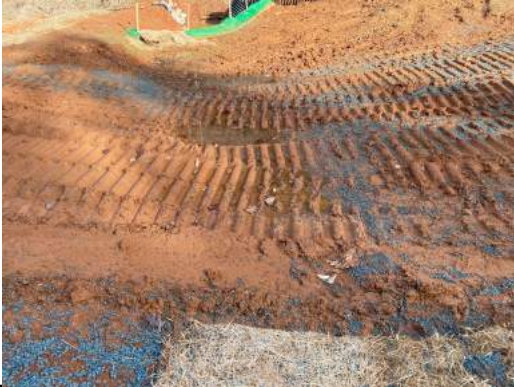
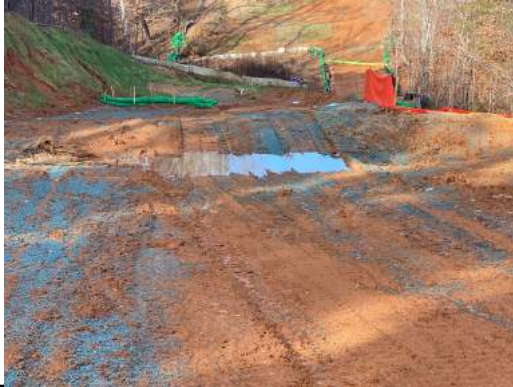
GPS Location	0	GPS Location	0		
Field Station#	15576+00	Field Station#	15575+00		
Pic 3 Desc.	Repair rutting issues and replace the curlex in breaker throats across travel lane.	Pic 4 Desc.	Repair rutting issues and replace the curlex in breaker throats across travel lane.		
Insert image here			Insert image here		
GPS Location		GPS Location			
Field Station#		Field Station#			
Pic 5 Desc.		Pic 6 Desc.
