Visual Site Inspection Report

Project Name H-600 Pipeline Spread I		AFE 124300139	Spread H-600 Pipeline Spread I
Contractor Precision		Report # 5638	
Inspector Logan Box		Date/Time 11/7/2019 11:17 AM	
Permit # TBD	Inspection Type VA SWPP	Station Begin 13670+00	
State VA	Inspection Area Partial	Station End 13898+31	
County Franklin	Ground Damp	Temperature (°F) 61.00	
Municipality N/A	Weather Sunny	Rain Gauge (in) 0.00	
Rain Accumulation Time (days)			0.00

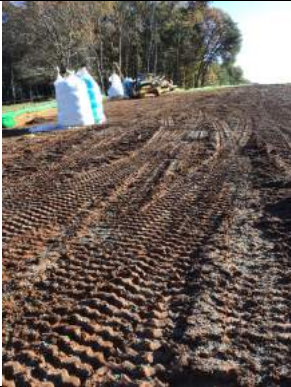
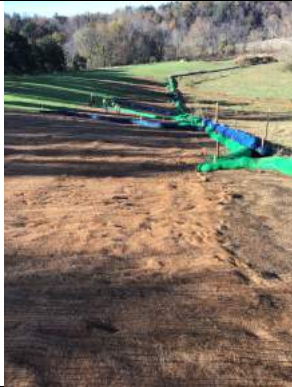
GPS Location	00000	GPS Location	0000		
Field Station#	13927+00	Field Station#	13926+00		
Pic 1 Desc.	Area being seeded and mulched	Pic 2 Desc.	Erosion issues repaired and ECDs installed to complete punch list items in the area

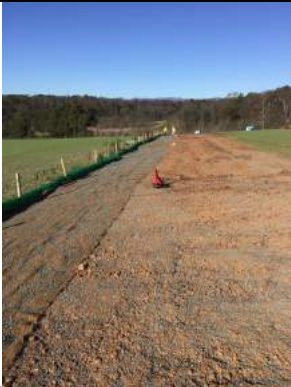
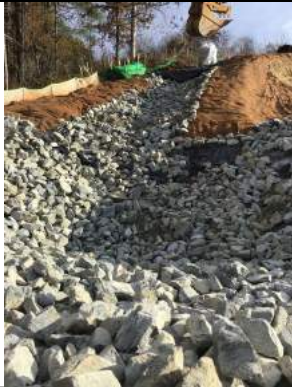
GPS Location	0000	GPS Location	00000		
Field Station#	13930+00	Field Station#	13784+31		
Pic 3 Desc.	Erosion repaired and ECDs being installed	Pic 4 Desc.	Rock lined channel and plunge pool being installed		
Insert image here			Insert image here		
GPS Location		GPS Location			
Field Station#		Field Station#			
Pic 5 Desc.		Pic 6 Desc.

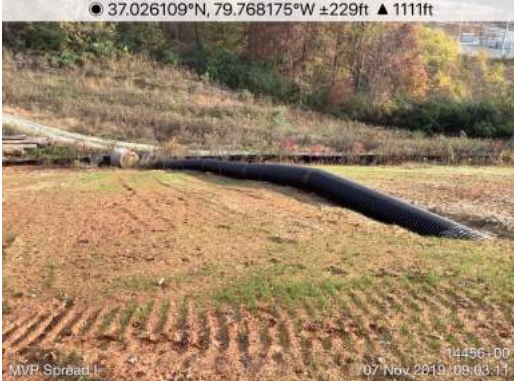
GPS Location	0	GPS Location	0		
Field Station#	14456+00	Field Station#	14523+00		
Pic 1 Desc.	Clean water diversion pipe is acceptable		Pic 2 Desc.	Waterbar is acceptable

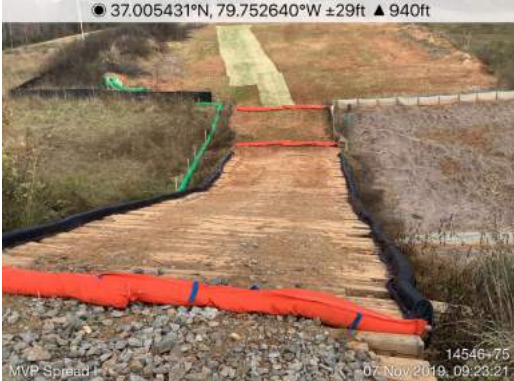
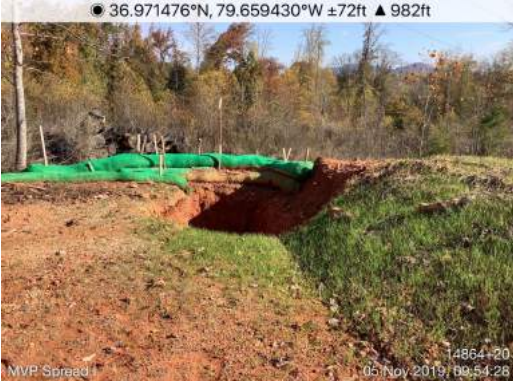
GPS Location	0	GPS Location	0		
Field Station#	14546+75	Field Station#	14864+20		
Pic 3 Desc.	Equipment bridge is acceptable		Pic 4 Desc.	Waterbar end treatment is acceptable

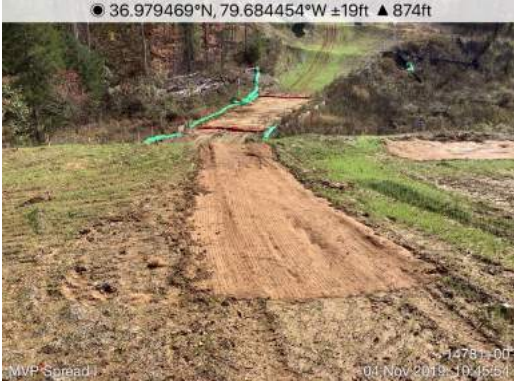
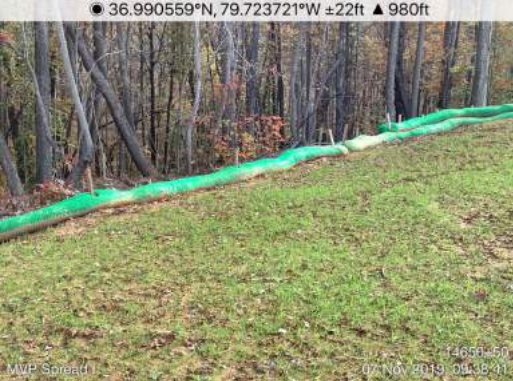
GPS Location	0	GPS Location	0		
Field Station#	14781+00	Field Station#	14650+50		
Pic 5 Desc.	Erosion control blanket is acceptable		Pic 6 Desc.	CFS is acceptable

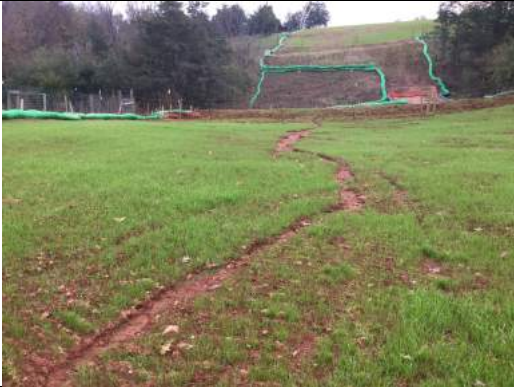
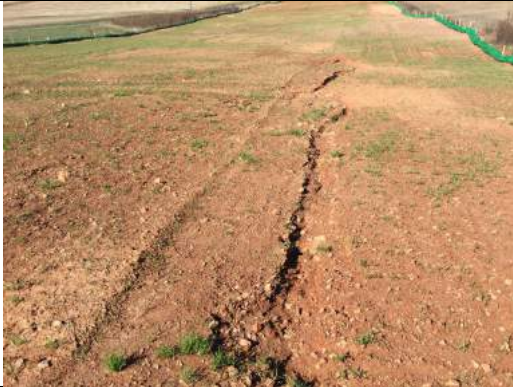
GPS Location 1		GPS Location 2			
Field Station# 14990+00		Field Station# 15493+00			
Pic 1 Desc. Erosion channels forming in final restoration area and require maintenance		Pic 2 Desc. Rill erosion occurring in final restoration area and requires attention

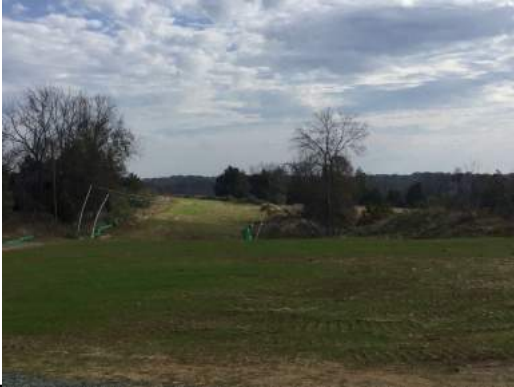
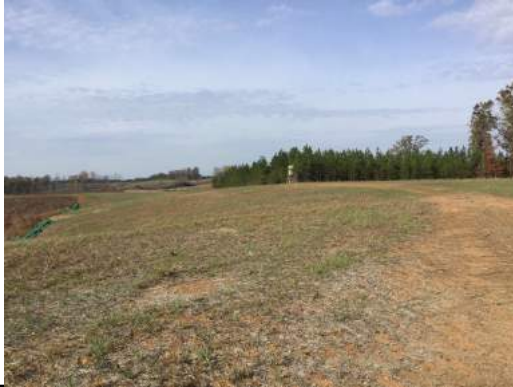
GPS Location 3		GPS Location 4			
Field Station# 14997+00		Field Station# 15254+00			
Pic 3 Desc. Vegetation growing in temporary stabilized area GAS MVP-FR-324		Pic 4 Desc. View of final restoration area near HDD exit site. Lack of vegetation in travel lane from landowner use.

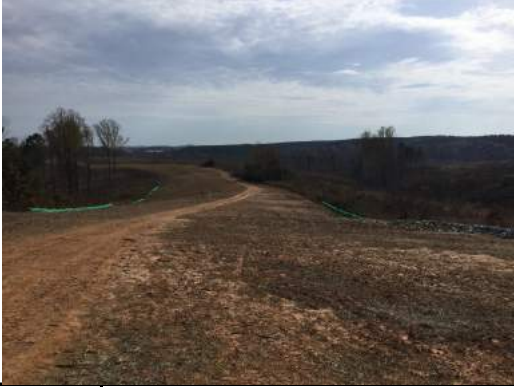
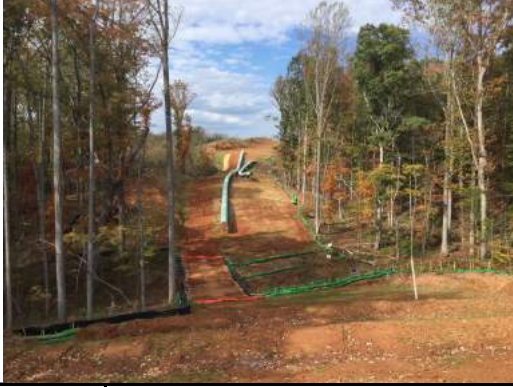
GPS Location 5		GPS Location 6			
Field Station# 15231+00		Field Station# 15140+00			
Pic 5 Desc. View of final restoration area near HDD exit site. Lack of vegetation in travel lane from landowner use.		Pic 6 Desc. Temporary stabilization CIS Rock Creek Rd with ECD's in place. Travel lane requires additional stabilization.

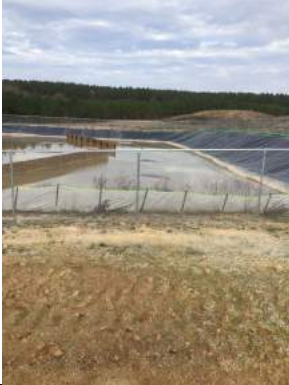
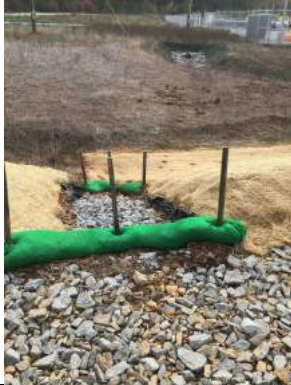
GPS Location	O		GPS Location	O	
Field Station#	00+00		Field Station#	00+00	
Pic 1 Desc.	Observing storm water pond.		Pic 2 Desc.	Observing stabilized stock drain.

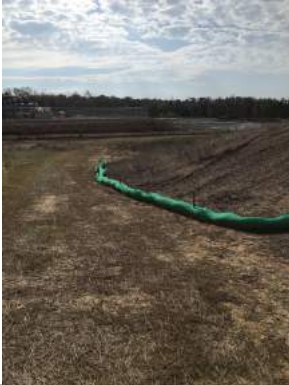
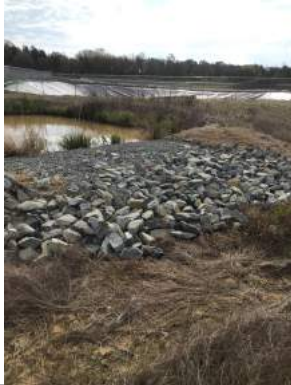
GPS Location	O		GPS Location	O	
Field Station#	00+00		Field Station#	00+00	
Pic 3 Desc.	Observing ECD's performing as they should.		Pic 4 Desc.	Observing overflow.	
Insert image here			Insert image here		
GPS Location			GPS Location		
Field Station#			Field Station#		
Pic 5 Desc.			Pic 6 Desc.

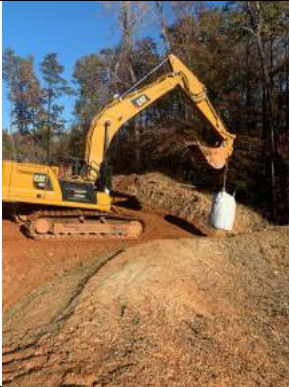
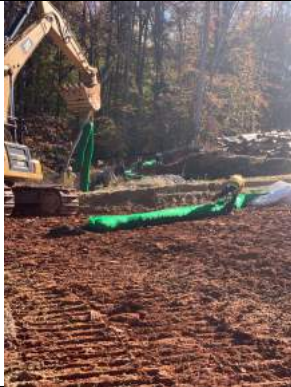
GPS Location O		GPS Location O			
Field Station# 15633+00		Field Station# 15606+00			
Pic 1 Desc. Observing the Contractor repairing punch list items.		Pic 2 Desc. Observing the Contractor repairing punch list items.

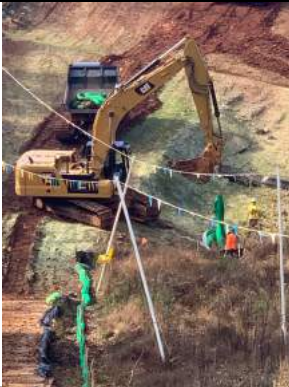
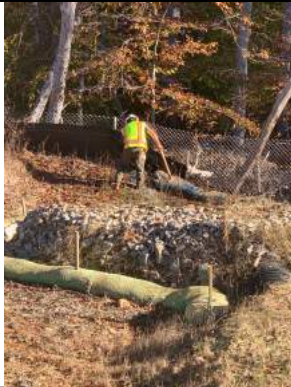
GPS Location O		GPS Location O			
Field Station# 15595+00		Field Station# 15610+00			
Pic 3 Desc. Observing the Contractor repairing punch list items.		Pic 4 Desc. Observing the Contractor repairing punch list items.			
Insert image here			Insert image here		
GPS Location		GPS Location			
Field Station#		Field Station#			
Pic 5 Desc.		Pic 6 Desc.

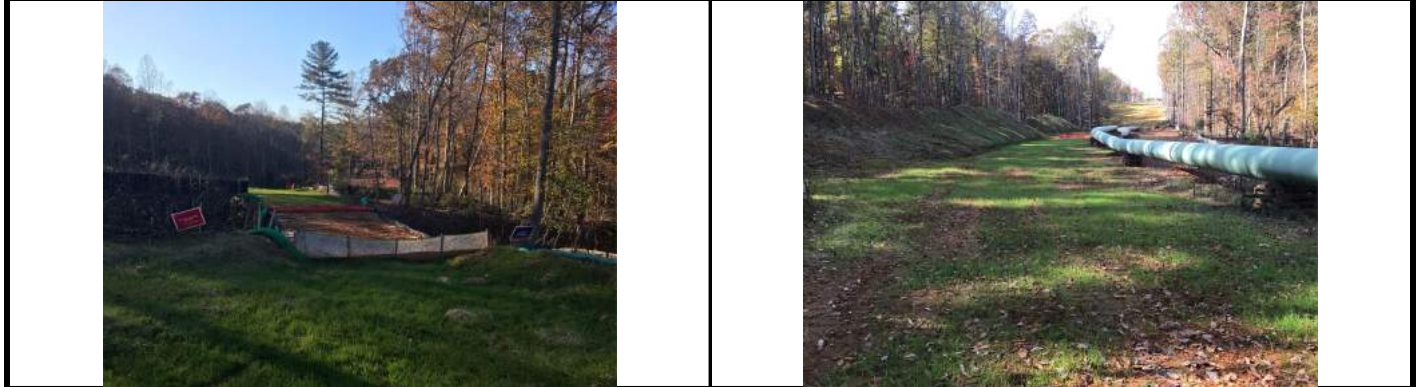
Field Station# 14222+09	Field Station# 14436+00
--------------------------------	--------------------------------

Pic 1 Desc. Approximately 14222+09. Over of stream crossing and equipment bridge at stream S-C20. ROW temporarily stabilized and has winter vegetation growing.	Pic 2 Desc. Approximately 14436+00. Overview of ROW. ROW temporarily seeded and stabilized in this area.
--	---

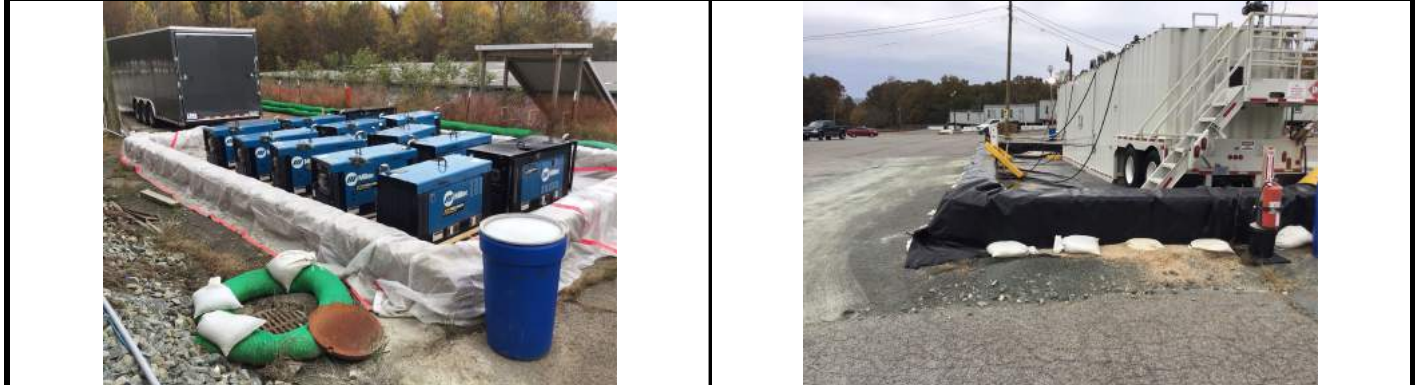
GPS Location	00000000	GPS Location	00000000
Field Station#	0000+00	Field Station#	0000+00
Pic 1 Desc.	Secondary containment and inlet protection near storage building in acceptable condition.	Pic 2 Desc.	Secondary containment structure for fuel cell in compliance.

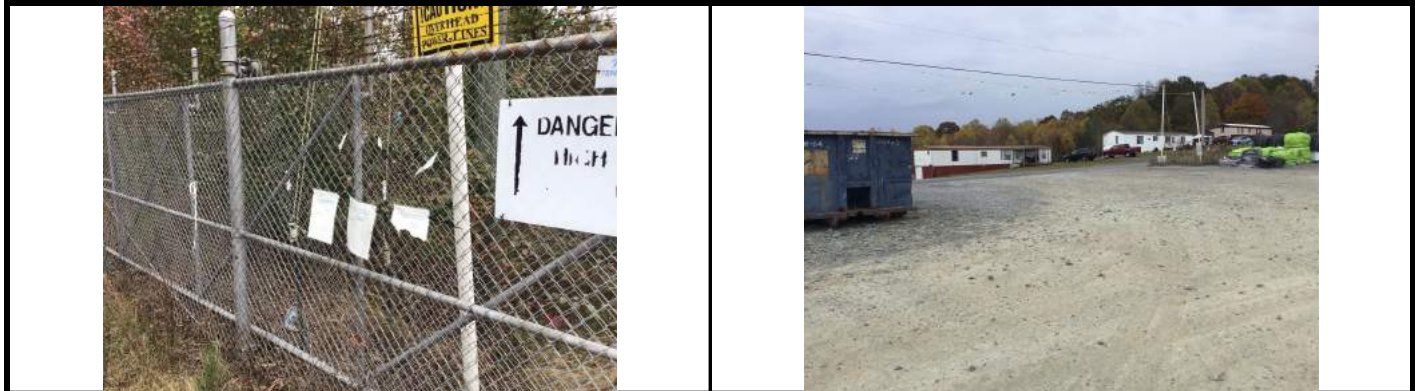
GPS Location	00000000	GPS Location	00000000
Field Station#	0000+00	Field Station#	0000+00
Pic 3 Desc.	General construction permits missing at main entrance needs reposted.	Pic 4 Desc.	RCE at gravel yard in good condition.

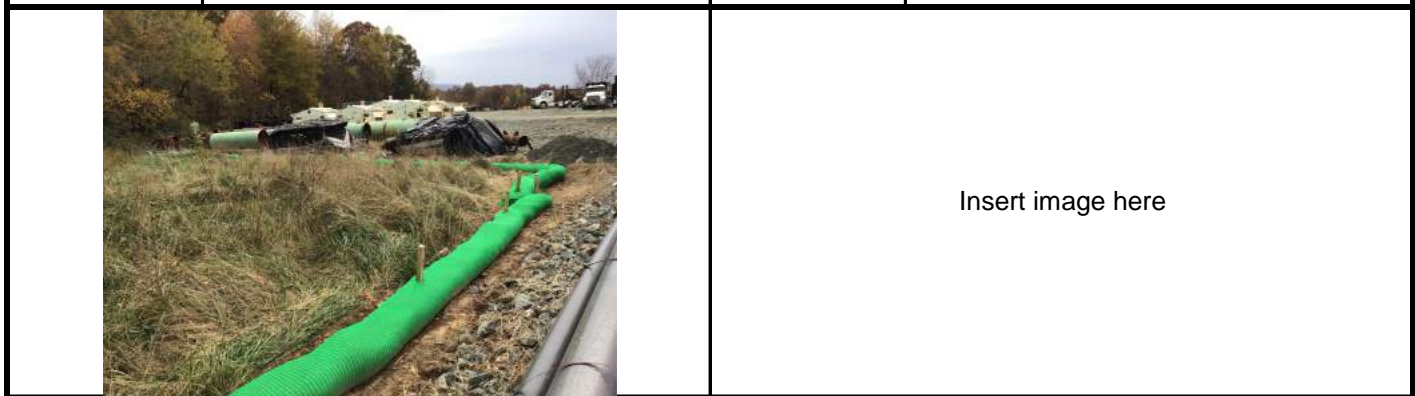
GPS Location	00000000	GPS Location	
Field Station#	0000+00	Field Station#	
Pic 5 Desc.	Perimeter ECD's on west side of gravel yard in good condition.	Pic 6 Desc.
