Visual Site Inspection Report

Project Name H-600 Pipeline Spread I		AFE 124300139	Spread H-600 Pipeline Spread I
Contractor Precision		Report # 18618	
Inspector Logan Box		Date/Time 6/17/2019 5:44 PM	
Permit # TBD	Inspection Type VA SWPP	Station Begin	13670+00
State VA	Inspection Area Partial	Station End	13958+31
County Franklin	Ground Dry	Temperature (°F)	74.00
Municipality N/A	Weather Sunny	Rain Gauge (in)	0.00
Rain Accumulation Time (days)			0.00

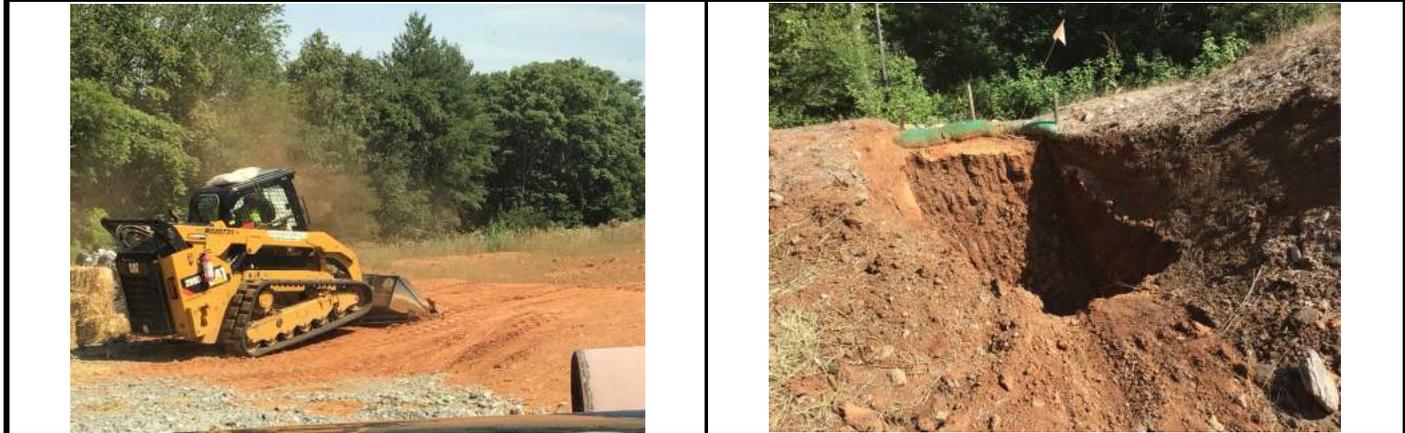
GPS Location	37.08	Field Station#	13784+22	GPS Location	37.08	Field Station#	13771+00
---------------------	-------	-----------------------	----------	---------------------	-------	-----------------------	----------

Description	Crew smoothing out a breaker to allow trucks to enter the row	Description	Sump pit after maintenance done
--------------------	---	--------------------	---------------------------------

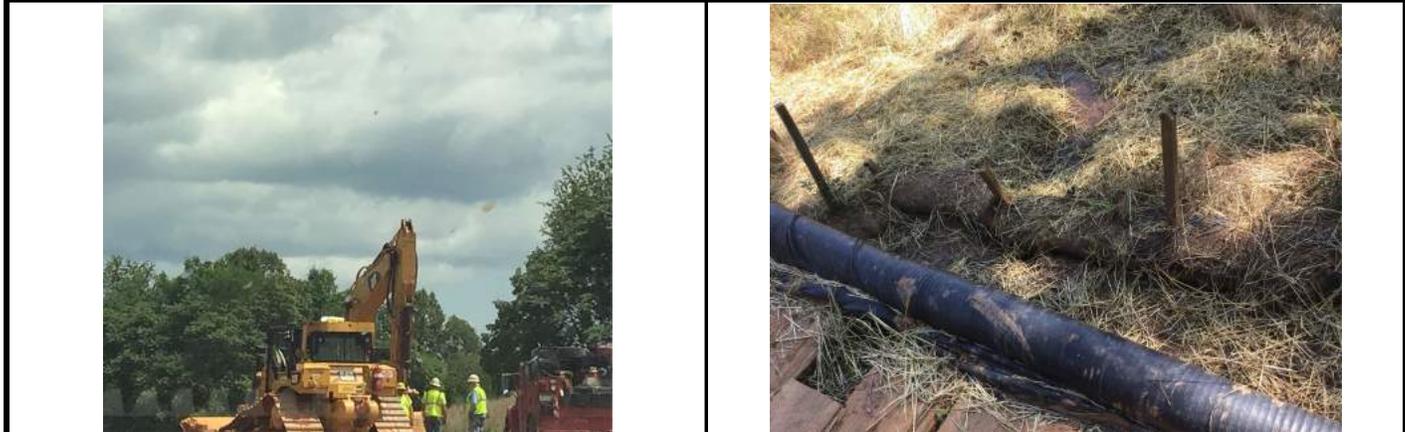
GPS Location	37.08	Field Station#	13785+00	GPS Location	37.08	Field Station#	13770+69
---------------------	-------	-----------------------	----------	---------------------	-------	-----------------------	----------

Description	Crew unloading equipment and installing blade on a dozer	Description	CFS needing removed from small stream channel to prevent blocking flow
--------------------	--	--------------------	--

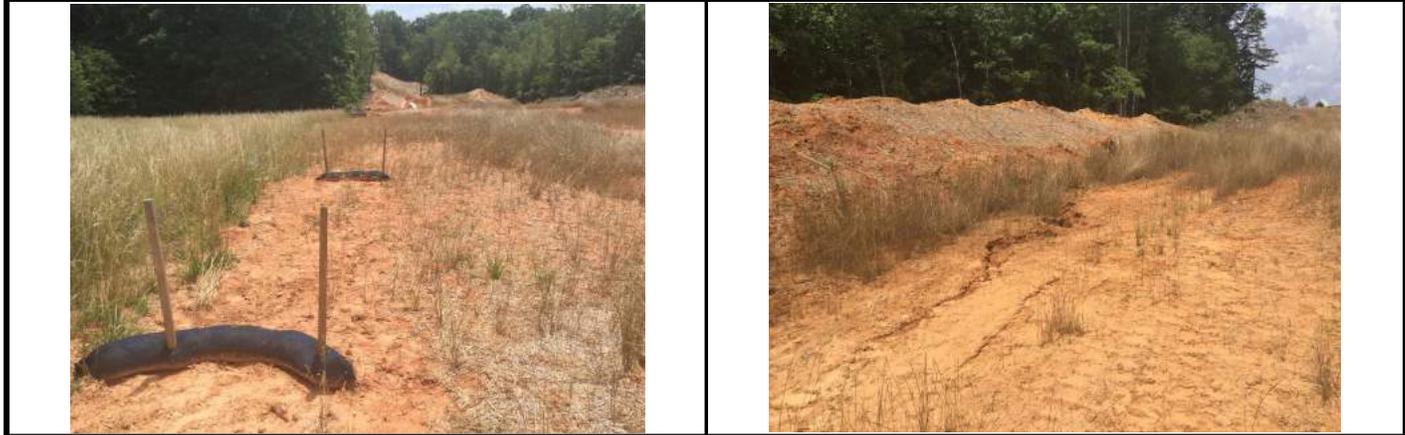
GPS Location 36.96	Field Station# 15068+00	GPS Location 36.96	Field Station# 15072+00
Description CFS check dams maintained and erosion channel corrected per punch list item		Description Rill erosion channel forming along travel lane and requires maintenance

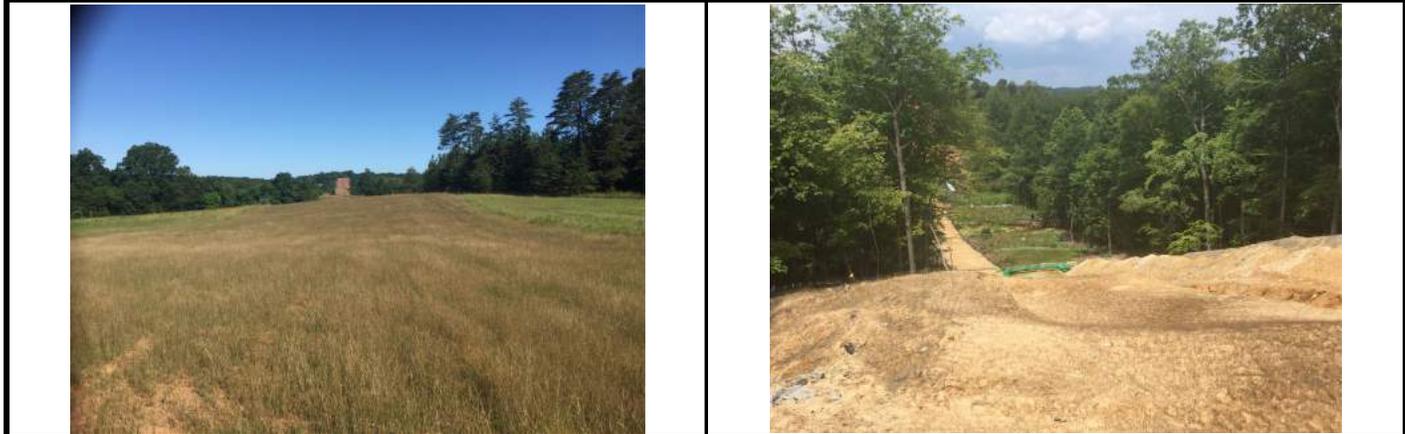
GPS Location 36.96	Field Station# 15190+00	GPS Location 36.96	Field Station# 15047+00
Description View of permanent vegetation growing along ROW		Description Temporary vegetation growing along ROW and perimeter controls/ECD's performing intended functions

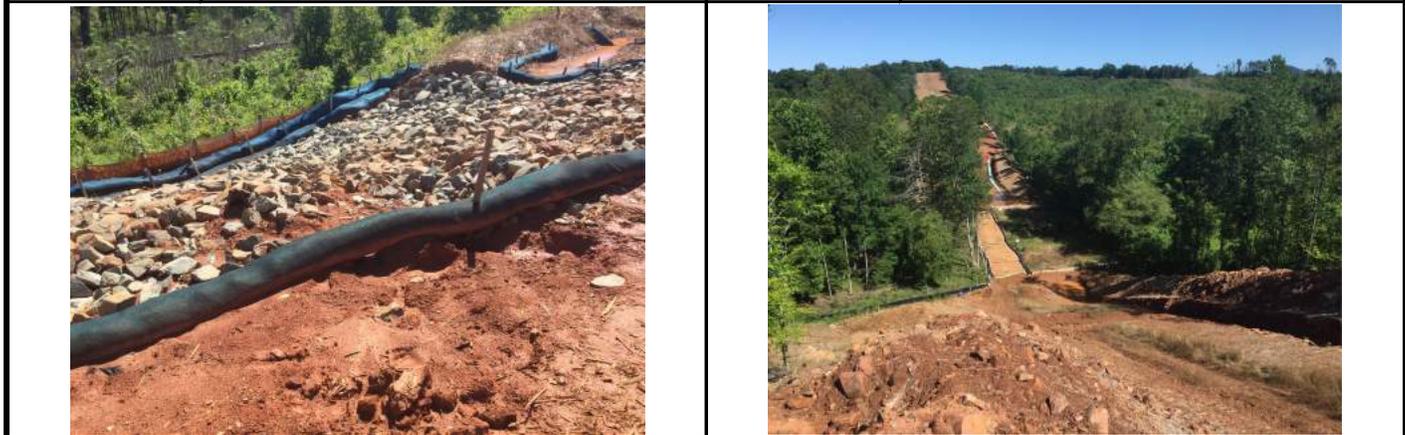
GPS Location 36.96	Field Station# 15245+00	GPS Location 36.96	Field Station# 15174+00
Description CFS undermining and requires maintenance		Description Temporary vegetation growing along ROW and perimeter controls/ECD's performing intended functions

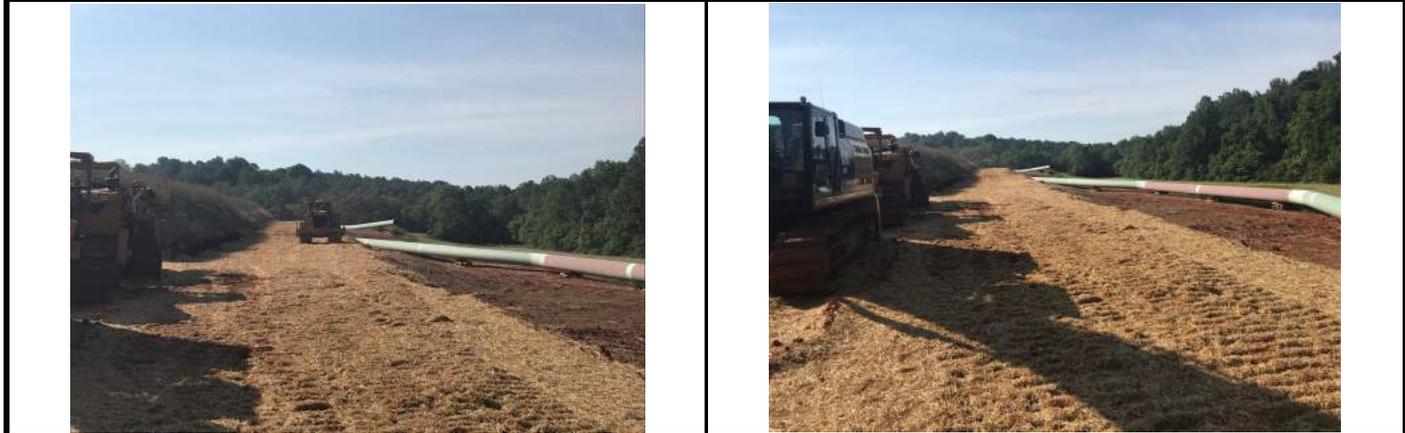
GPS Location	37.06	Field Station#	14240+00	GPS Location	37.06	Field Station#	14240+00
---------------------	-------	-----------------------	----------	---------------------	-------	-----------------------	----------

Description	Approximately 14240+00. Equipment crimping in straw mulch. This area has been temporarily seeded and stabilized.	Description	Approximately 14240+00. Area of ROW recently has been temporarily seeded and stabilized.
--------------------	--	--------------------	--

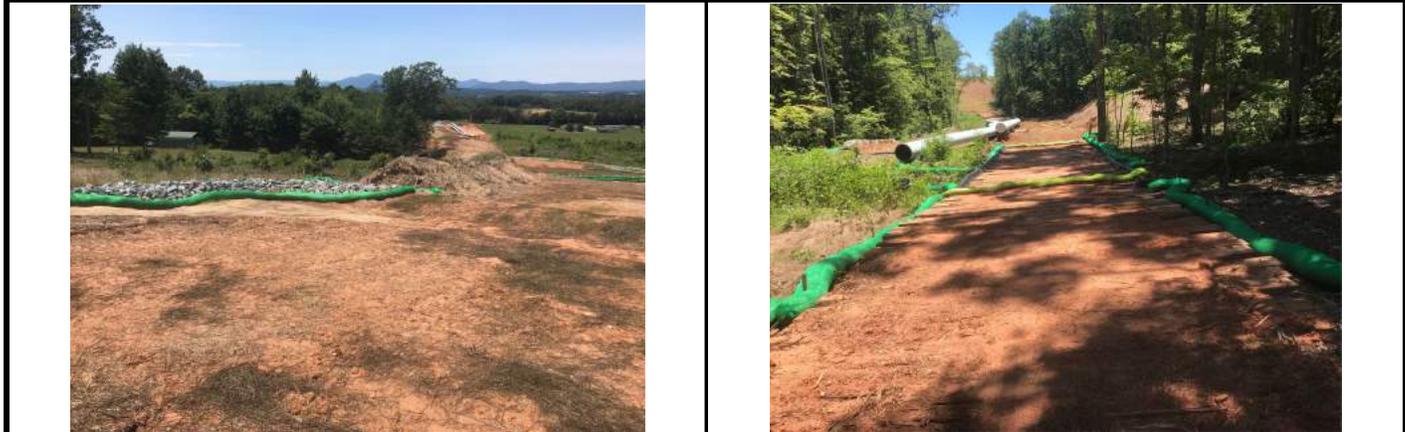
GPS Location	36.98	Field Station#	14326+00	GPS Location	37.06	Field Station#	14434+01
---------------------	-------	-----------------------	----------	---------------------	-------	-----------------------	----------

Description	Approximately 14326+00. ROW has been temporarily seeded and stabilized in this area. CFS and rip rap end treatment also pictured..	Description	Overview of stream crossing and equipment bridge at stream S-GH40. Approximately 14434+01.
--------------------	--	--------------------	--

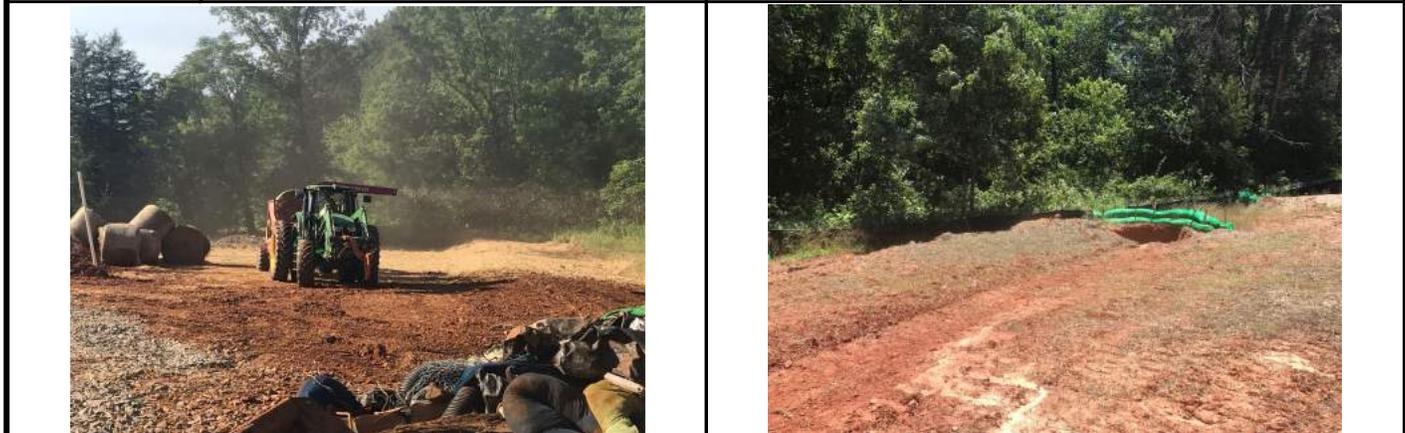
GPS Location	36.98	Field Station#	14237+75	GPS Location	36.98	Field Station#	14413+50
---------------------	-------	-----------------------	----------	---------------------	-------	-----------------------	----------

Description	Approximately 14237+75. Contractor blowing straw mulch for temporary stabilization of area.	Description	Approximately 14413+50. Water bar, sump, and CFS end treatment. All appear to be installed and functioning correctly at time of inspection.
--------------------	---	--------------------	---

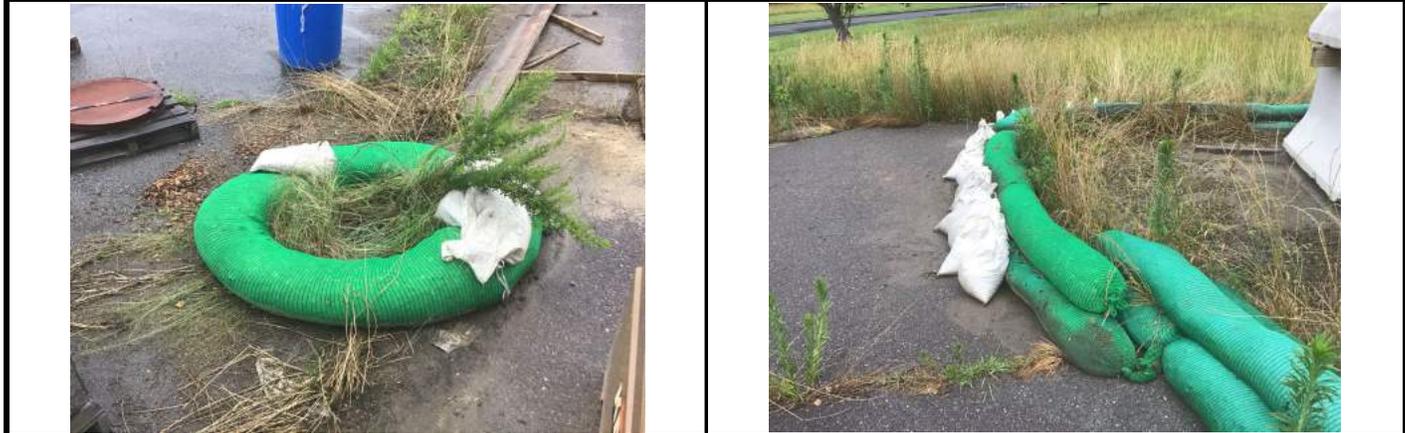
GPS Location	36.97	Field Station#	0000+00	GPS Location	36.97	Field Station#	0000+00
Description	Inlet protection for middle parking lot drain at paved yard in good condition.			Description	Issue addressed by contractor, CFS needs do to be re-stacked at north west corner of paved yard.

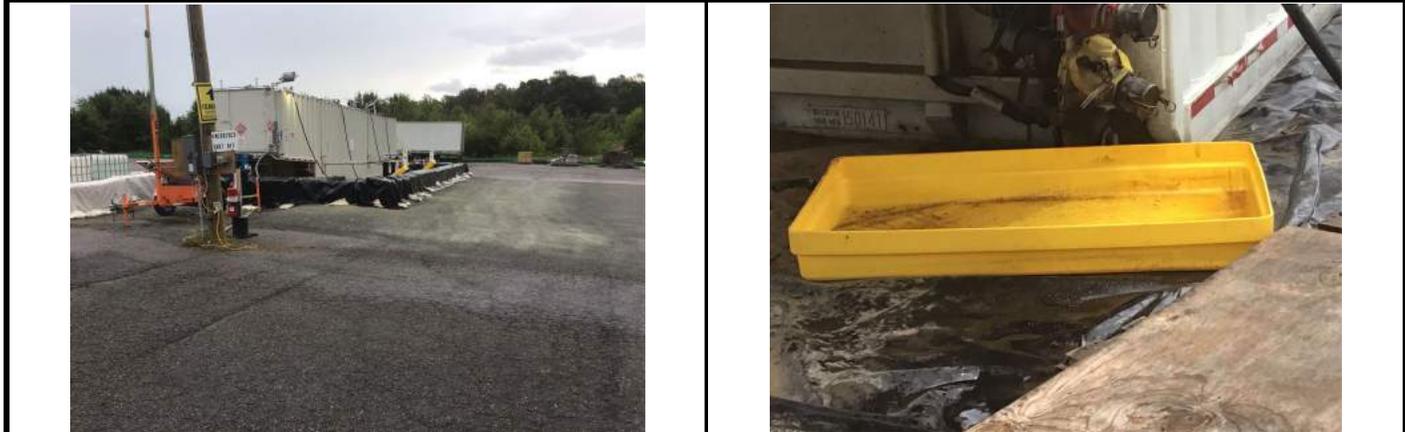
GPS Location	36.97	Field Station#	0000+00	GPS Location	36.97	Field Station#	0000+00
Description	Secondary containment structure for fuel cell in good condition.			Description	Concern by KCI Inspector Jacob H potential leaking check valve on fuel cell. Will in addressed in fuel contractor.

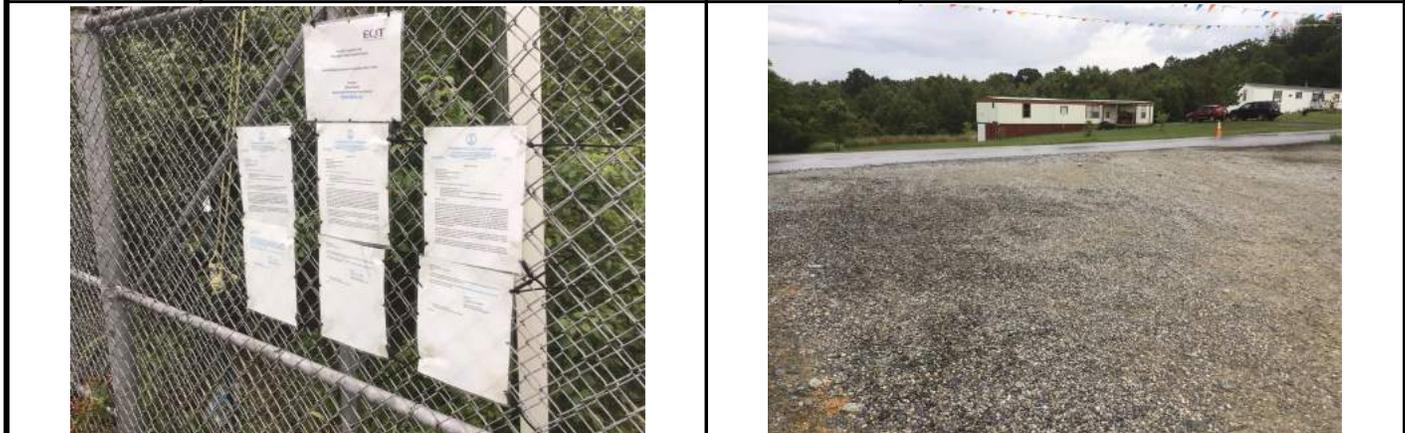
GPS Location	36.97	Field Station#	0000+00	GPS Location	36.97	Field Station#	0000+00
Description	Construction permits posted at main entrance			Description	RCE for gravel yard in good condition.

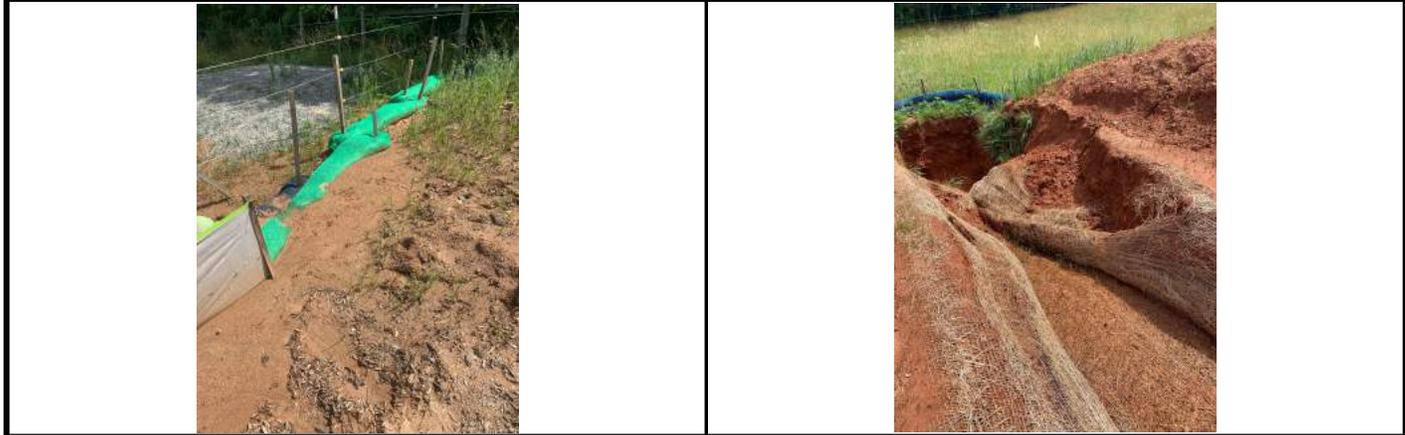
GPS Location	36.97	Field Station#	15964+50	GPS Location	36.97	Field Station#	15966+00
---------------------	-------	-----------------------	----------	---------------------	-------	-----------------------	----------

Description	Observing CFS that requires maintenance.	Description	Observing drainage channel that requires maintenance.
--------------------	--	--------------------	---

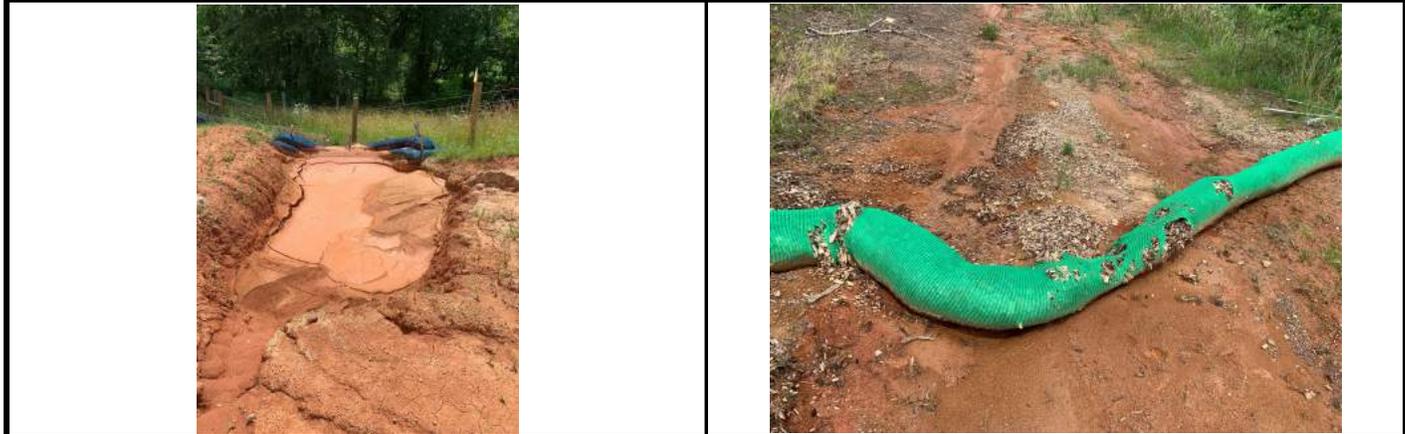
GPS Location	36.97	Field Station#	15999+00	GPS Location	36.97	Field Station#	15817+00
---------------------	-------	-----------------------	----------	---------------------	-------	-----------------------	----------

Description	Observing sump that requires maintenance.	Description	Observing CFS that requires maintenance.
--------------------	---	--------------------	--

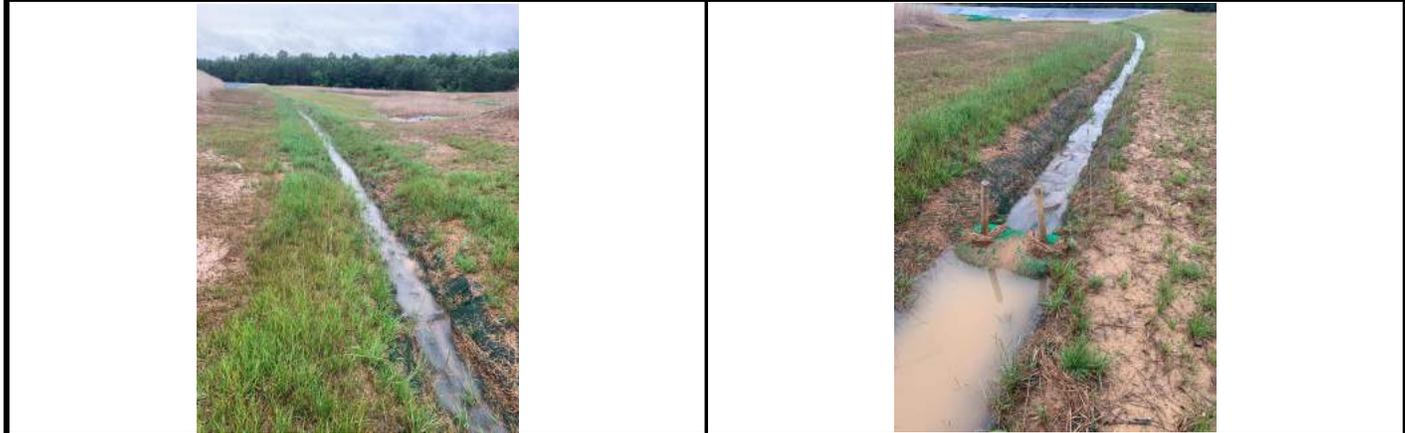
GPS Location	36.97	Field Station#	00+00	GPS Location	36.97	Field Station#	00+00
---------------------	-------	-----------------------	-------	---------------------	-------	-----------------------	-------

Description	Observing stabilized channel.	Description	Observing stabilized channel
--------------------	-------------------------------	--------------------	------------------------------

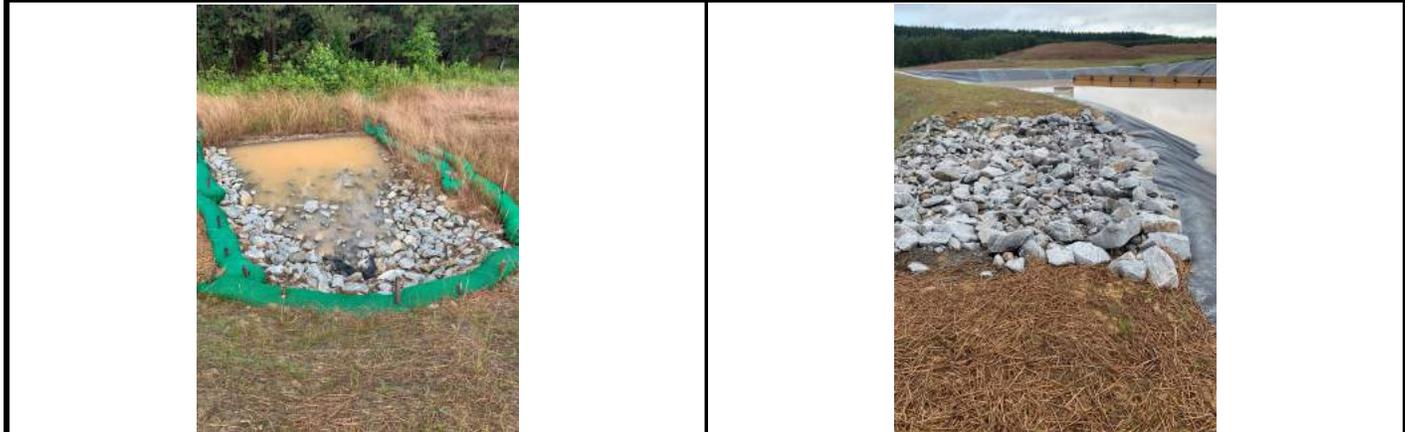
GPS Location	36.97	Field Station#	00+00	GPS Location	36.97	Field Station#	00+00
---------------------	-------	-----------------------	-------	---------------------	-------	-----------------------	-------

Description	Observing outlet and outlet protection.	Description	Observing rock level spreader.
--------------------	---	--------------------	--------------------------------

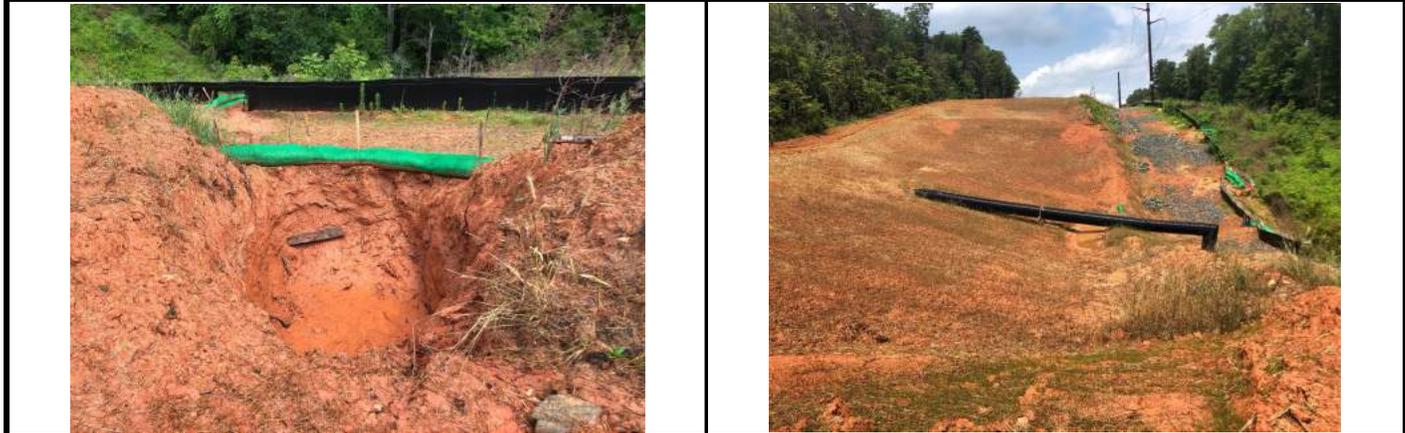
GPS Location	37.00	Field Station#	14470+00	GPS Location	37.00	Field Station#	14468+00
---------------------	-------	-----------------------	----------	---------------------	-------	-----------------------	----------

Description	Sump pit and end treatment functioning properly	Description	CWD pipe functioning properly
--------------------	---	--------------------	-------------------------------

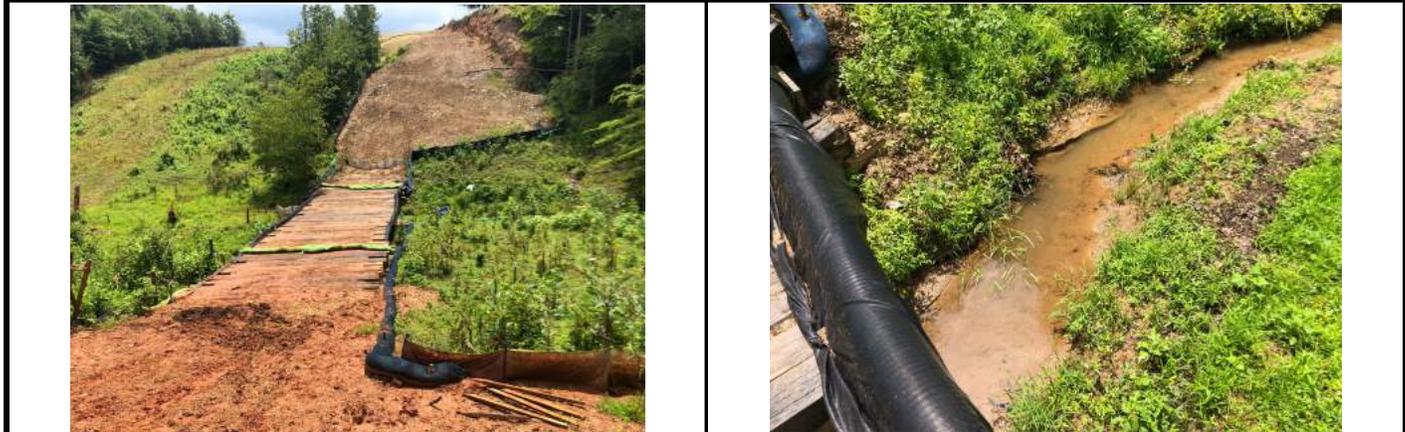
GPS Location	37.00	Field Station#	14486+56	GPS Location	37.00	Field Station#	14486+56
---------------------	-------	-----------------------	----------	---------------------	-------	-----------------------	----------

Description	Equipment bridge is clean	Description	Upstream side of stream S-G22 clean
--------------------	---------------------------	--------------------	-------------------------------------

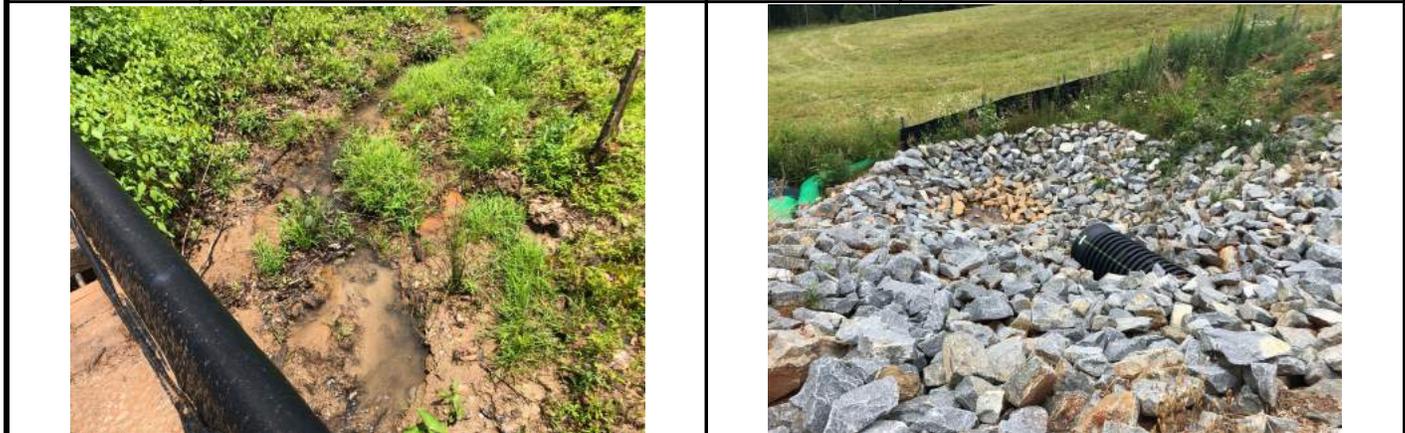
GPS Location	37.00	Field Station#	14486+56	GPS Location	37.00	Field Station#	14540+00
---------------------	-------	-----------------------	----------	---------------------	-------	-----------------------	----------

Description	Downstream side of stream S-G22 clean	Description	Plunge pool functioning properly
--------------------	---------------------------------------	--------------------	----------------------------------
