# Visual Site Inspection Report

<b>Project Name</b>	H-600 Pipeline Spread I	<b>AFE</b>	124300139	<b>Spread</b>	H-600 Pipeline Spread I
<b>Contractor</b>	Precision			<b>Report #</b>	100735
<b>Inspector</b>	Glenn Mike Renfro			<b>Date/Time</b>	9/24/2019 9:07 PM
<b>Permit #</b>	TBD	<b>Inspection Type</b>	VA SWPP	<b>Station Begin</b>	0000+00
<b>State</b>	VA	<b>Inspection Area</b>	Full	<b>Station End</b>	0000+00
<b>County</b>	Franklin	<b>Ground</b>	Dry	<b>Temperature (°F)</b>	88.00
<b>Municipality</b>	N/A	<b>Weather</b>	Sunny	<b>Rain Gauge (in)</b>	0.00
				<b>Rain Accumulation Time (days)</b>	6.00

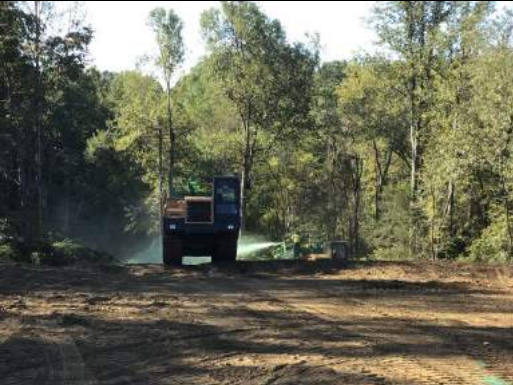
<b>GPS Location</b>	00000	<b>GPS Location</b>	00000		
<b>Field Station#</b>	13690+00	<b>Field Station#</b>	13725+00		
<b>Pic 1 Desc.</b>	Photo showing the row after being seeded and stabilized	<b>Pic 2 Desc.</b>	Seeding activities

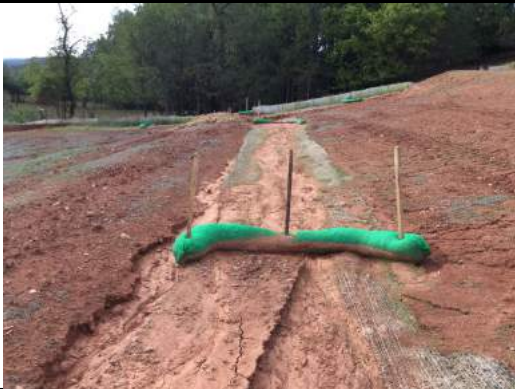
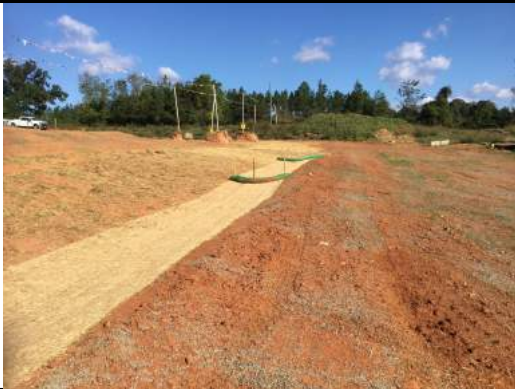
GPS Location	1	GPS Location	2		
Field Station#	15298+00	Field Station#	15298+00		
Pic 1 Desc.	CFS check dams require maintenance as sediment is building up and water flow moving around checks creating erosion channels		Pic 2 Desc.	Erosion channels corrected, erosion control blanket replaced, and CFS check dams cleaned per punch list item

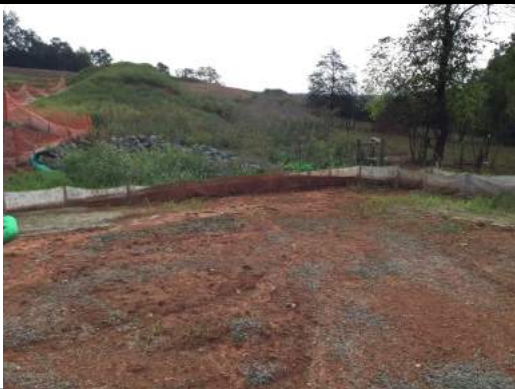
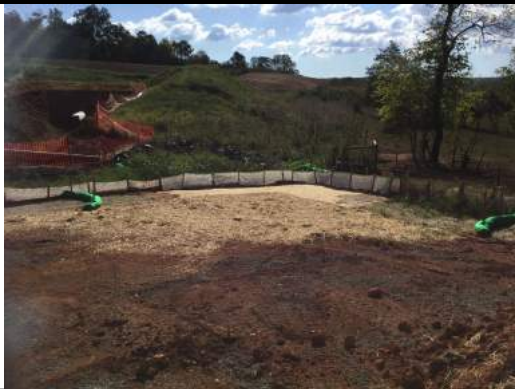
GPS Location	3	GPS Location	4		
Field Station#	15300+00	Field Station#	15300+00		
Pic 3 Desc.	Replace P1 silt fence		Pic 4 Desc.	P1 silt fence replaced and disturbed area seeded and stabilized

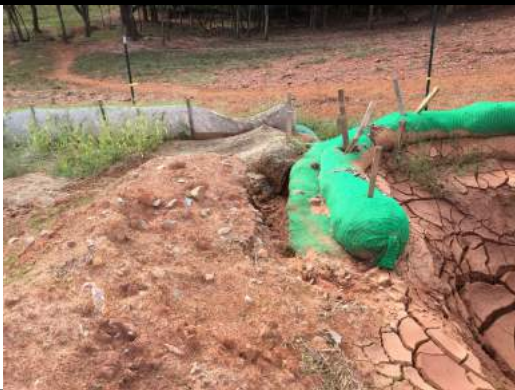
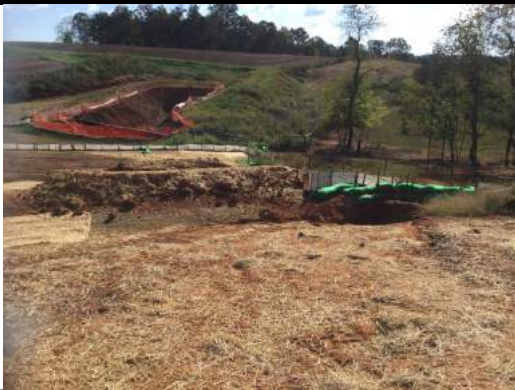
GPS Location	5	GPS Location	6		
Field Station#	15298+50	Field Station#	15298+50		
Pic 5 Desc.	Sump requires maintenance as water flowing around end treatment creating erosion channel		Pic 6 Desc.	Sump, water bar, and end treatment corrected per punch list item

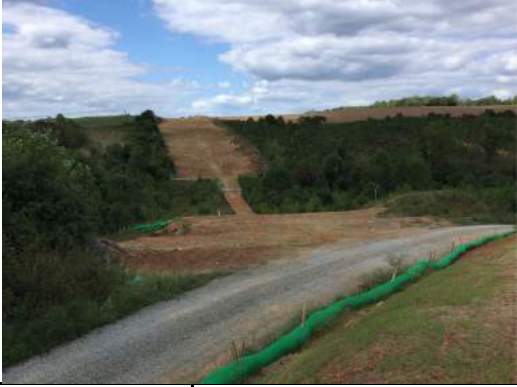
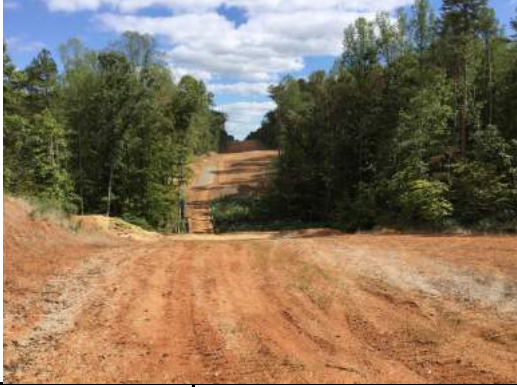
<b>GPS Location</b>	7	<b>GPS Location</b>	8		
<b>Field Station#</b>	15350+39	<b>Field Station#</b>	15381+00		
<b>Pic 7 Desc.</b>	Temporary stabilized ROW and functioning ECD's with MVP-PI-332 RCE in good condition		<b>Pic 8 Desc.</b>	Temporary vegetation growing along ROW with ECD's in place	
Insert image here			Insert image here		
<b>GPS Location</b>		<b>GPS Location</b>			
<b>Field Station#</b>		<b>Field Station#</b>			
<b>Pic 9 Desc.</b>			<b>Pic 10 Desc.</b>		
Insert image here			Insert image here		
<b>GPS Location</b>		<b>GPS Location</b>			
<b>Field Station#</b>		<b>Field Station#</b>			
<b>Pic 11 Desc.</b>			<b>Pic 12 Desc.</b>

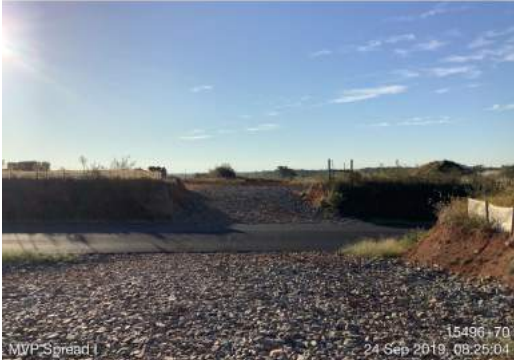
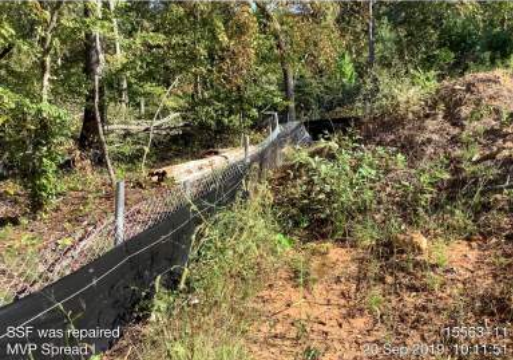
<p>● 36.897443°N, 79.456397°W ±42ft ▲ 803ft</p> <p>BSF was repaired</p> <p>MVP Spread I</p> <p>15563+11</p> <p>24 Sep 2019, 10:11:51</p>			
<b>GPS Location</b>	0	<b>GPS Location</b>	0		
<b>Field Station#</b>	15496+70	<b>Field Station#</b>	15563+11		
<b>Pic 1 Desc.</b>	RCEs are acceptable at Climax Road	<b>Pic 2 Desc.</b>	Punch list item for damaged super silt fence was addressed by the contractor

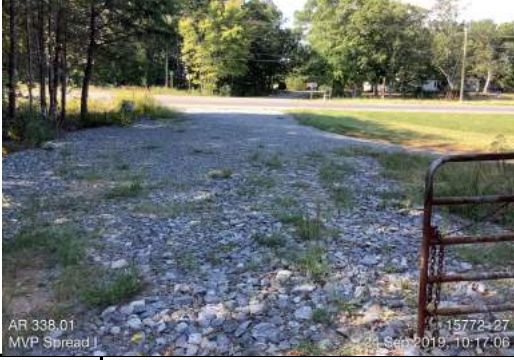
<p>● 36.864832°N, 79.402998°W ±34m ▲ 254m</p> <p>AR 338.01</p> <p>MVP Spread I</p> <p>15772+27</p> <p>24 Sep 2019, 10:17:06</p>

<b>Field Station#</b>	15772+27	<b>Field Station#</b>	15745+00		
<b>Pic 3 Desc.</b>	RCE on access road MVP-PI-338.01 is acceptable	<b>Pic 4 Desc.</b>	CFS is acceptable

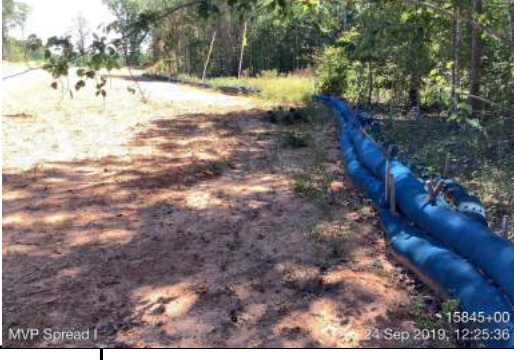
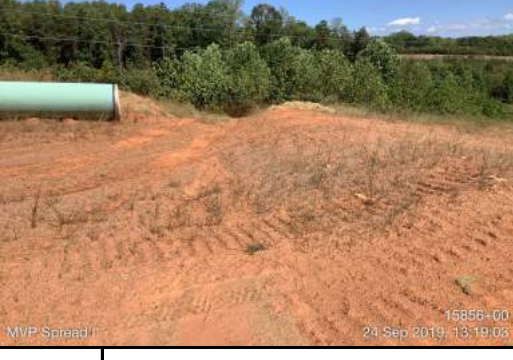
<p>● 36.851344°N, 79.384345°W ±9m ▲ 236m</p> <p>MVP Spread I</p> <p>15856+00</p> <p>24 Sep 2019, 13:19:03</p>			
<b>GPS Location</b>	0	<b>GPS Location</b>	0		
<b>Field Station#</b>	15845+00	<b>Field Station#</b>	15856+00		
<b>Pic 5 Desc.</b>	CFS is acceptable	<b>Pic 6 Desc.</b>	Waterbar is acceptable

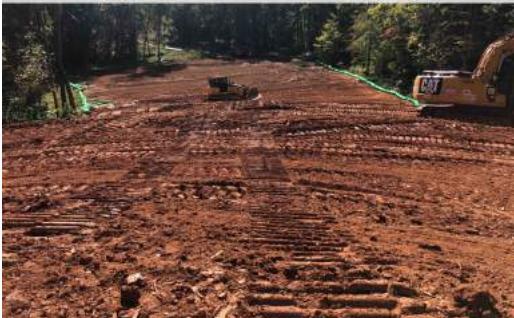
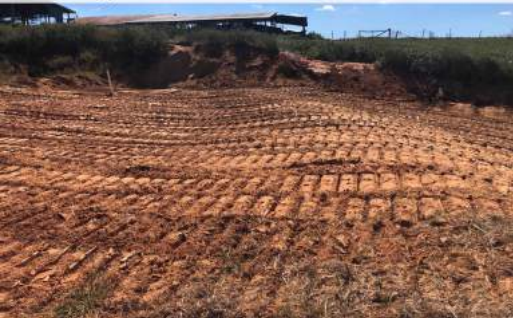
<b>GPS Location</b>	0	<b>GPS Location</b>	0		
<b>Field Station#</b>	14653+00	<b>Field Station#</b>	14835+00		
<b>Pic 1 Desc.</b>	Permanent water bars installed on the GAS of HWy 40	<b>Pic 2 Desc.</b>	Water bar put back to grade once open trench was backfilled		
<b>North West Elevation</b> 157°SE (T) LAT: 36.972087 LON: -79.663354 ±16ft ▲ 940ft		<b>West Elevation</b> 84°E (T) LAT: 36.972076 LON: -79.663888 ±16ft ▲ 978ft

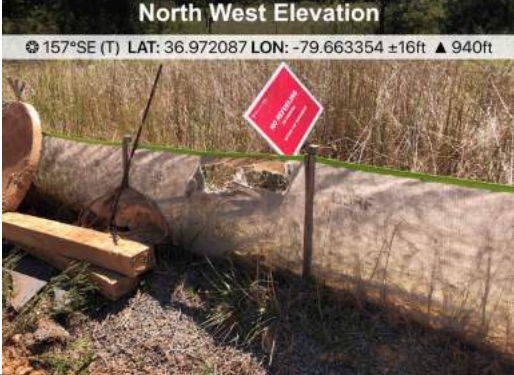
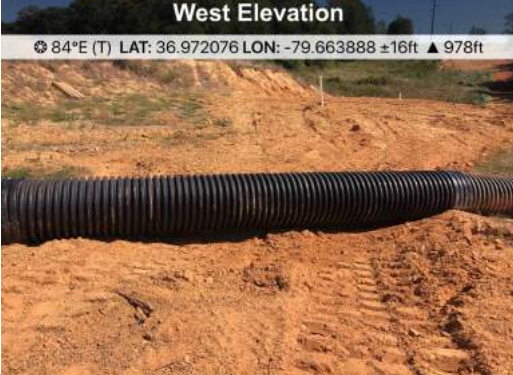
<b>GPS Location</b>	0	<b>GPS Location</b>	0		
<b>Field Station#</b>	14853+00	<b>Field Station#</b>	14852+00		
<b>Pic 3 Desc.</b>	P1 silt fence torn and requires maintenance	<b>Pic 4 Desc.</b>	CWD pipe put back once the contractor finished in the area

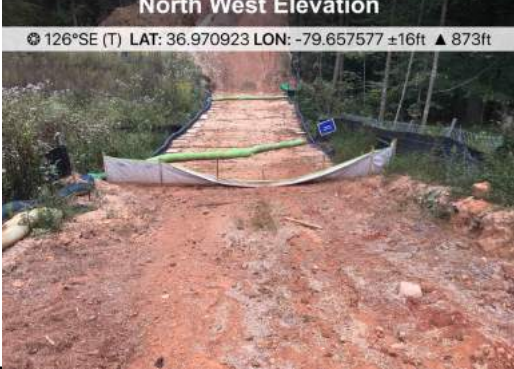
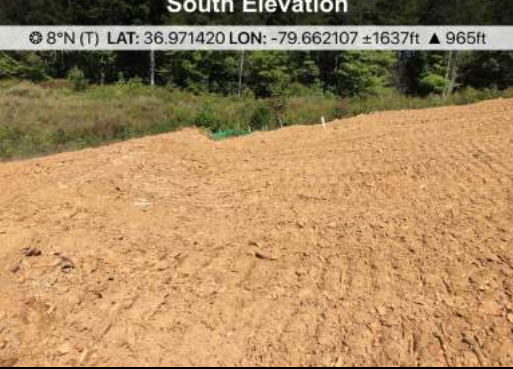
<b>GPS Location</b>	0	<b>GPS Location</b>	0		
<b>Field Station#</b>	14870+00	<b>Field Station#</b>	14856+00		
<b>Pic 5 Desc.</b>	P1 silt fence down and requires maintenance	<b>Pic 6 Desc.</b>	Water bar put back to grade once open trench was backfilled
