# Visual Site Inspection Report

<b>Project Name</b>	H-600 Pipeline Spread I	<b>AFE</b>	124300139	<b>Spread</b>	H-600 Pipeline Spread I
<b>Contractor</b>	Precision			<b>Report #</b>	100154
<b>Inspector</b>	Ben Davenport			<b>Date/Time</b>	9/6/2019 7:36 PM
<b>Permit #</b>	TBD	<b>Inspection Type</b>	VA SWPP	<b>Station Begin</b>	14981+55
<b>State</b>	VA	<b>Inspection Area</b>	Partial	<b>Station End</b>	15496+70
<b>County</b>	Franklin/Pittsylvania	<b>Ground</b>	Dry	<b>Temperature (°F)</b>	81.00
<b>Municipality</b>	Chatham	<b>Weather</b>	Cloudy	<b>Rain Gauge (in)</b>	0.00
				<b>Rain Accumulation Time (days)</b>	0.00

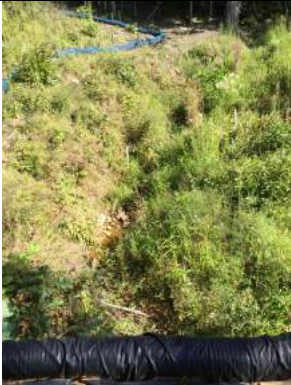
<b>GPS Location</b> 1		<b>GPS Location</b> 2			
<b>Field Station#</b> 15072+86		<b>Field Station#</b> 15072+86			
<b>Pic 1 Desc.</b> Upstream view of S-G11 at ROW crossing		<b>Pic 2 Desc.</b> Downstream view of S-G11 at ROW crossing

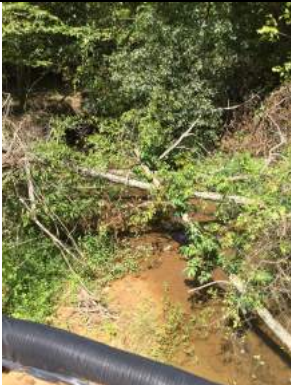
<b>GPS Location</b> 3		<b>GPS Location</b> 4			
<b>Field Station#</b> 15426+50		<b>Field Station#</b> 15426+50			
<b>Pic 3 Desc.</b> Upstream view of S-G4 at ROW crossing		<b>Pic 4 Desc.</b> Downstream view of S-G4 at ROW crossing

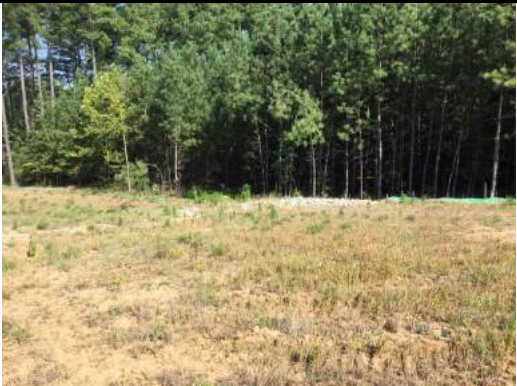
<b>GPS Location</b> 5		<b>GPS Location</b> 6			
<b>Field Station#</b> 15025+50		<b>Field Station#</b> 15306+00			
<b>Pic 5 Desc.</b> Permanent vegetation and end treatment CIS Star Land Dr		<b>Pic 6 Desc.</b> View of cleaned up and stabilized ROW with open trench between Oxford Rd and Lark Dr

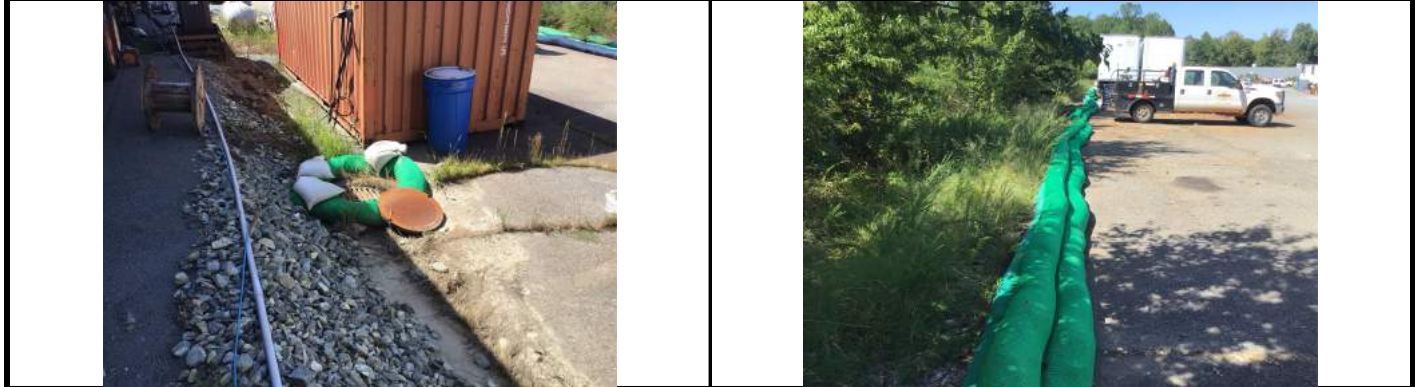
<b>GPS Location</b>	0000	<b>GPS Location</b>	0000
<b>Field Station#</b>	0000+00	<b>Field Station#</b>	0000+00
<b>Pic 1 Desc.</b>	Inlet protection for parking lot drain near storage building in good condition	<b>Pic 2 Desc.</b>	Perimeter ECD's in good condition on south side of paved yard.

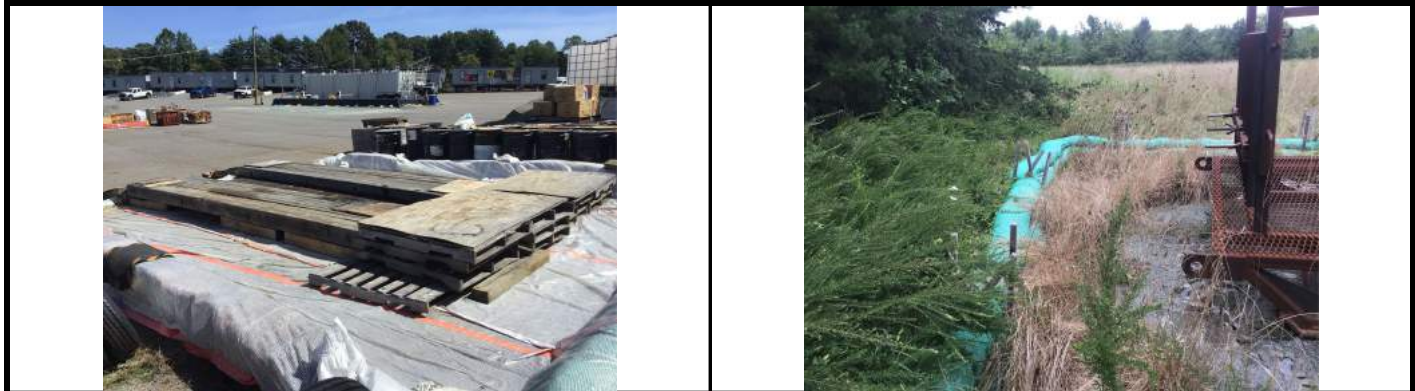
<b>GPS Location</b>	0000	<b>GPS Location</b>	0000
<b>Field Station#</b>	0000+00	<b>Field Station#</b>	0000+00
<b>Pic 3 Desc.</b>	Secondary containment structure at oil changing station in compliance.	<b>Pic 4 Desc.</b>	Perimeter ECD's on northwest corner of gravel yard in good condition.

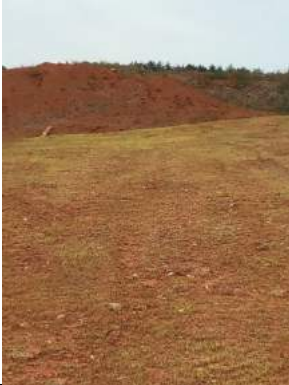
<b>GPS Location</b>	0		<b>GPS Location</b>	0	
<b>Field Station#</b>	15694+50		<b>Field Station#</b>	15694+50	
<b>Pic 1 Desc.</b>	Observing temporary stabilization.		<b>Pic 2 Desc.</b>	Observing sump and end treatment.

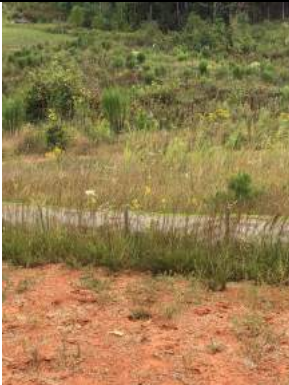
<b>GPS Location</b>	0		<b>GPS Location</b>	0	
<b>Field Station#</b>	15696+00		<b>Field Station#</b>	15695+00	
<b>Pic 3 Desc.</b>	Observing ECD's performing as they should.		<b>Pic 4 Desc.</b>	Observing sump and end treatment.	
Insert image here			Insert image here		
<b>GPS Location</b>			<b>GPS Location</b>		
<b>Field Station#</b>			<b>Field Station#</b>		
<b>Pic 5 Desc.</b>			<b>Pic 6 Desc.</b>

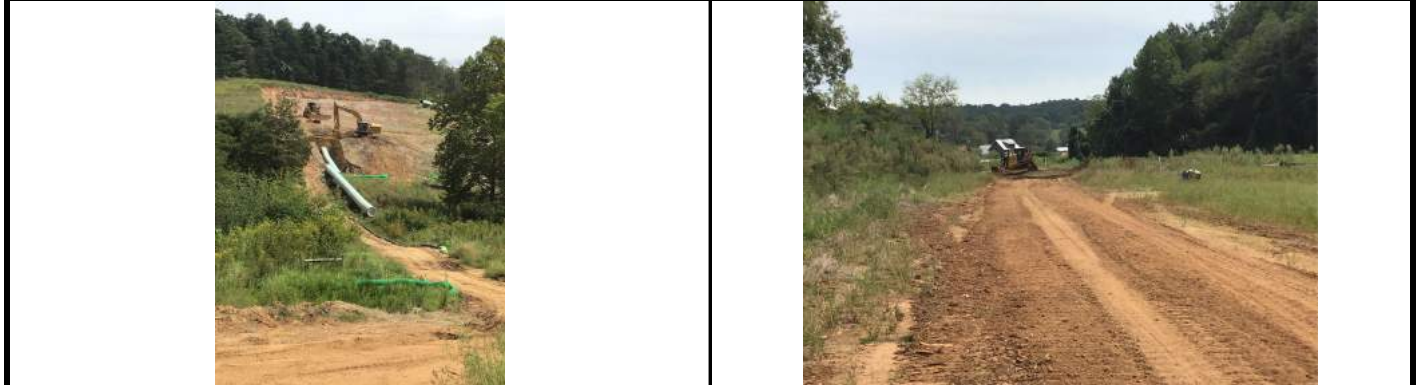
<b>Pic 1 Desc.</b>	Section of pipe having a end cap welded on before being backfilled	<b>Pic 2 Desc.</b>	Ditch being backfilled
--------------------	--	--------------------	------------------------

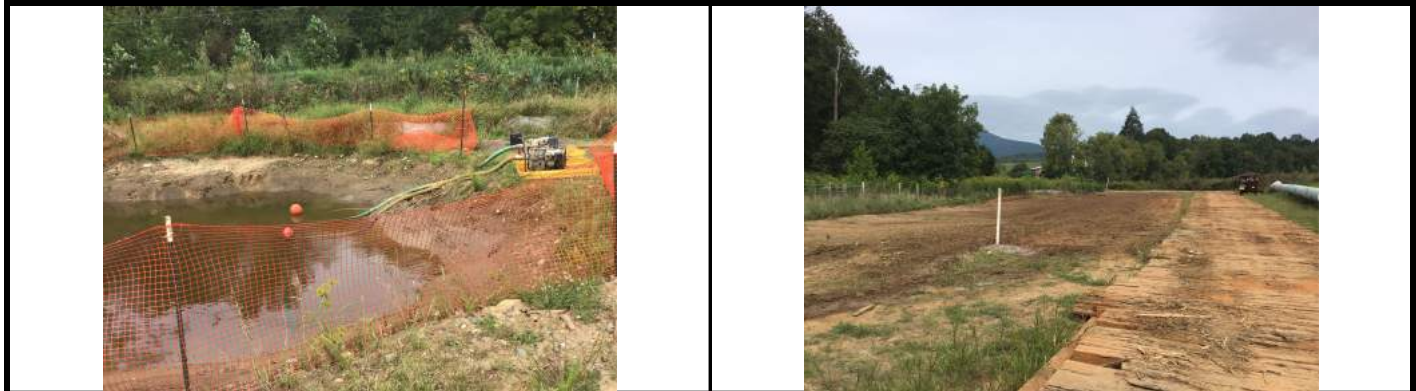
<b>Pic 3 Desc.</b>	Bell hole being pumped out, secondary containment being used for pumps	<b>Pic 4 Desc.</b>	Recently backfilled section of ditch, waiting to be stabilized
--------------------	--	--------------------	--

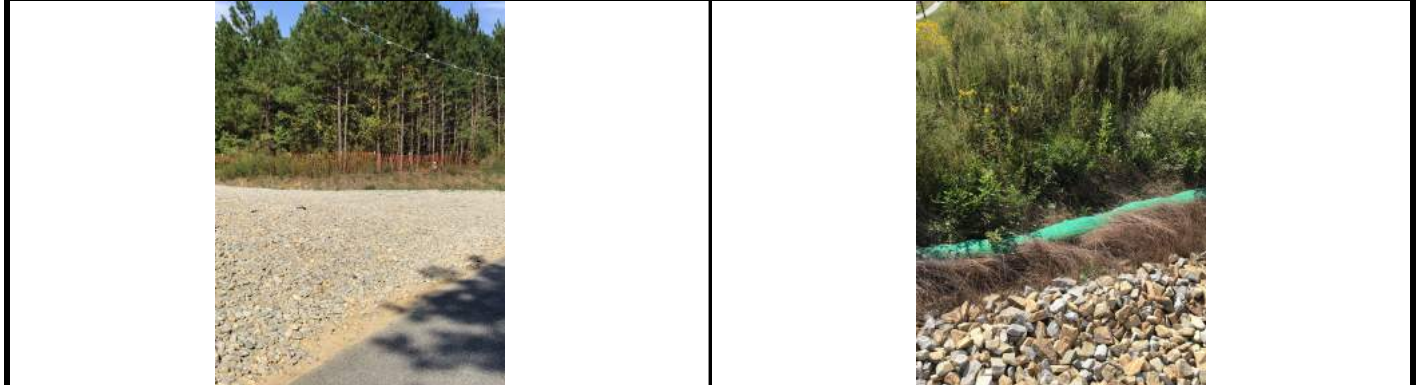
<b>Pic 1 Desc.</b> Observing RCE.	<b>Pic 2 Desc.</b> Observing ECD's performing as they should.
-----------------------------------	---

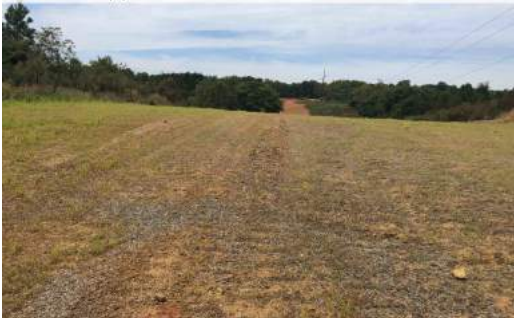
<b>GPS Location</b> 0		<b>GPS Location</b> 0			
<b>Field Station#</b> 14685+00		<b>Field Station#</b> 14681+00			
<b>Pic 1 Desc.</b> Temporary stabilization		<b>Pic 2 Desc.</b> Dewatering structure built			
<p><b>East Elevation</b>            ☉ 269°W (T) LAT: 36.988012 LON: -79.714466 ±16ft ▲ 949ft</p>

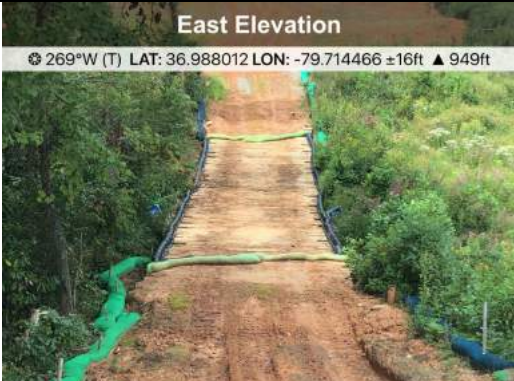
<b>GPS Location</b> 0		<b>GPS Location</b> 0			
<b>Field Station#</b> 14680+37		<b>Field Station#</b> 14745+00			
<b>Pic 3 Desc.</b> Equipment bridge clean at stream S-H36		<b>Pic 4 Desc.</b> Temporary stabilization

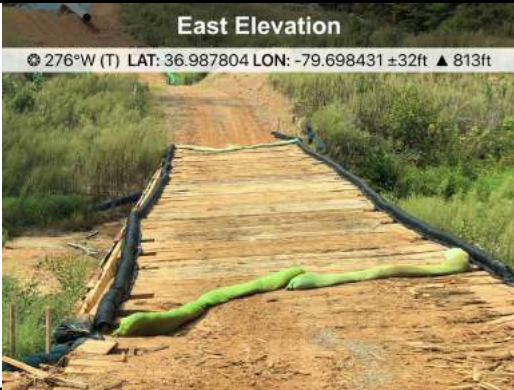
<b>GPS Location</b> 0		<b>GPS Location</b> 0			
<b>Field Station#</b> 14729+19		<b>Field Station#</b> 14740+00			
<b>Pic 5 Desc.</b> Equipment bridge clean at stream S-A20		<b>Pic 6 Desc.</b> Sump pit functioning as intended

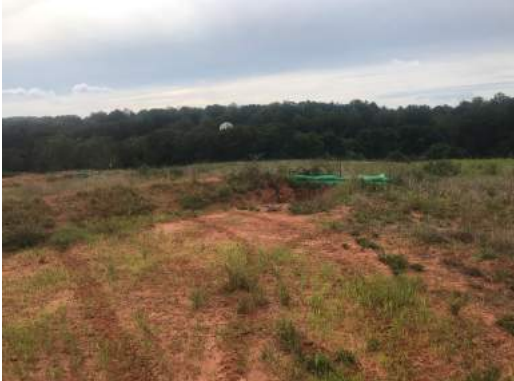
<b>GPS Location</b>	0		<b>GPS Location</b>	0	
<b>Field Station#</b>	14168+00		<b>Field Station#</b>	14236+75	
<b>Pic 1 Desc.</b>	Approximately 14168+00. Water bar, sump, and end treatment installed and appear to be functioning correctly at time of inspection. Area temporarily seeded and stabilized.		<b>Pic 2 Desc.</b>	Approximately 14236+75. CWD piping, berm, and level spreader installed and appear to be functioning correctly at time of inspection.

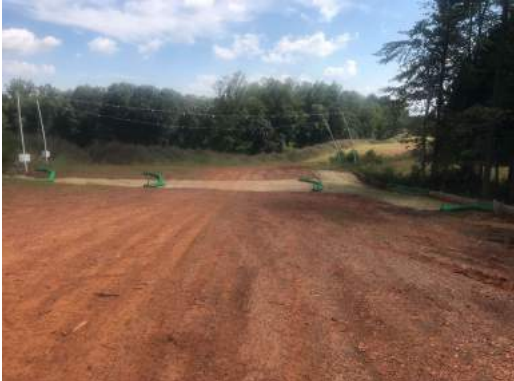
<b>GPS Location</b>	0		<b>GPS Location</b>	0	
<b>Field Station#</b>	14083+20		<b>Field Station#</b>	14157+55	
<b>Pic 3 Desc.</b>	Approximately 14083+20. Erosion control blanket installed in high flow area for storm water. Area temporarily seeded and stabilized.		<b>Pic 4 Desc.</b>	Approximately 14157+55. Overview of stream crossing and equipment bridge at stream S-KL51.
