Visual Site Inspection Report

Project Name	H-600 Pipeline Spread I	AFE	124300139	Spread	H-600 Pipeline Spread I
Contractor	Precision			Report #	100136
Inspector	Ben Davenport			Date/Time	9/30/2019 8:44 AM
Permit #	TBD	Inspection Type	VA SWPP	Station Begin	14981+55
State	VA	Inspection Area	Partial	Station End	15496+70
County	Franklin/Pittsylvania	Ground	Dry	Temperature (°F)	81.00
Municipality	Chatham	Weather	Cloudy	Rain Gauge (in)	0.00
				Rain Accumulation Time (days)	0.00

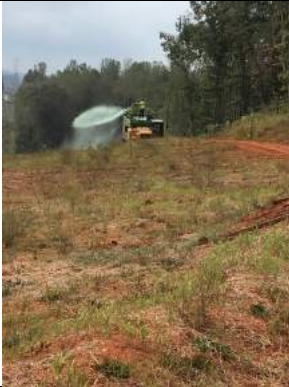
GPS Location	0000	GPS Location	0000		
Field Station#	13828+00	Field Station#	13827+56		
Pic 1 Desc.	Additional photo showing stabilization in progress.		Pic 2 Desc.	Stabilization crews working near Brick Church rd

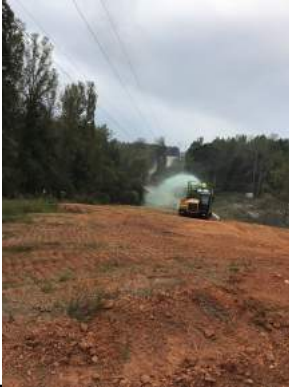
GPS Location	0000	GPS Location	0000		
Field Station#	13831+31	Field Station#	13850+12		
Pic 3 Desc.	Crew continuing to stabilize the row.		Pic 4 Desc.	Stabilization crew working to stabilize/seed the row	
Insert image here			Insert image here		
GPS Location		GPS Location			
Field Station#		Field Station#			
Pic 5 Desc.			Pic 6 Desc.

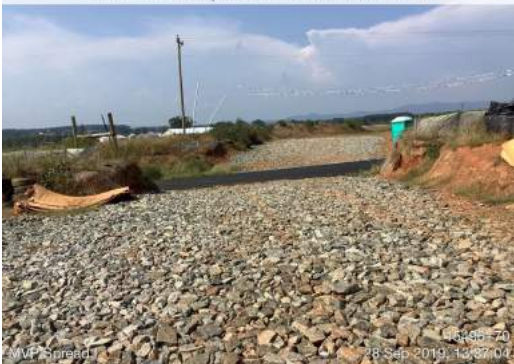
<p>● 36.906363°N, 79.474848°W ±22ft ▲ 936ft</p> <p>MVP Spread I</p> <p>15496+70</p> <p>30 Sep 2019, 12:52:04</p>

<p>● 36.894453°N, 79.450270°W ±101ft ▲ 812ft</p> <p>MVP Spread I</p> <p>15584+23</p> <p>30 Sep 2019, 08:49:47</p>			
GPS Location	0	GPS Location	0		
Field Station#	15496+70	Field Station#	15584+23		
Pic 1 Desc.	RCE is acceptable	Pic 2 Desc.	RCE is acceptable

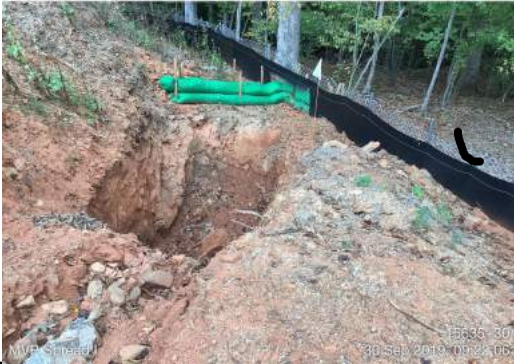
<p>● 36.892208°N, 79.435138°W ±137ft ▲ 792ft</p> <p>MVP Spread I</p> <p>15635+30</p> <p>30 Sep 2019, 09:27:05</p>

<p>● 36.870471°N, 79.402570°W ±59ft ▲ 798ft</p> <p>MVP Spread I</p> <p>15763+80</p> <p>30 Sep 2019, 10:48:08</p>			
GPS Location	0	GPS Location	0		
Field Station#	15635+30	Field Station#	15763+80		
Pic 3 Desc.	Waterbar end treatment is acceptable	Pic 4 Desc.	Equipment bridge is acceptable at stream S-DD4

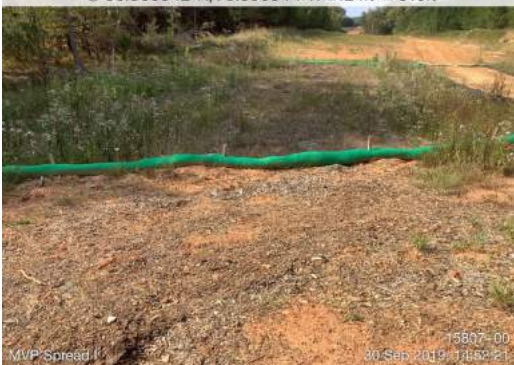
<p>● 36.860942°N, 79.395344°W ±124ft ▲ 816ft</p> <p>MVP Spread I</p> <p>15807+00</p> <p>30 Sep 2019, 11:59:21</p>

GPS Location	0	GPS Location	0		
Field Station#	15807+00	Field Station#	15733+50		
Pic 5 Desc.	CFS is acceptable	Pic 6 Desc.	Waterbar is acceptable

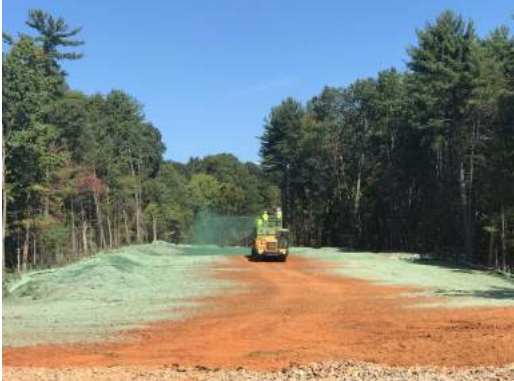
GPS Location	0	GPS Location	0		
Field Station#	14023+00	Field Station#	14030+75		
Pic 1 Desc.	Approximately 14023+00. Seeding contractor spraying hydro seed and mulch for temporary stabilization.		Pic 2 Desc.	Approximately 14030+75. Aerial view of temporary seeding and stabilization practices.

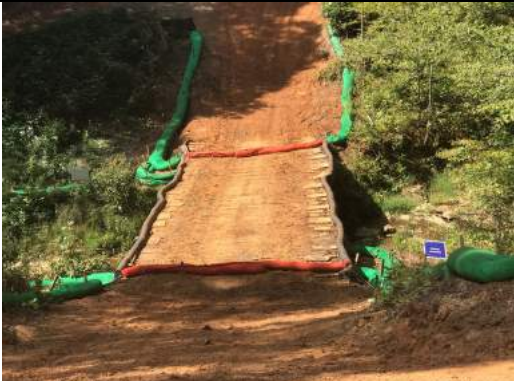
GPS Location	0	GPS Location	0		
Field Station#	14105+26	Field Station#	14082+00		
Pic 3 Desc.	Approximately 14105+26. Overview of stream crossing and equipment bridge at stream S-KL41.		Pic 4 Desc.	Approximately 14082+00. Water bar, sump, CFS end treatment, and LOD ECDs.	
Insert image here			Insert image here		
GPS Location		GPS Location			
Field Station#		Field Station#			
Pic 5 Desc.			Pic 6 Desc.

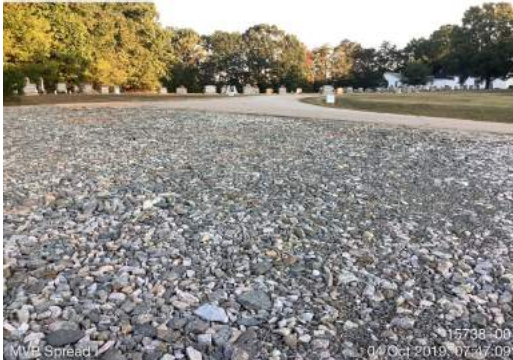
GPS Location	0		GPS Location	0	
Field Station#	15738+00		Field Station#	16012+80	
Pic 1 Desc.	Rock construction entrance is acceptable		Pic 2 Desc.	Clean water diversion pipe is acceptable

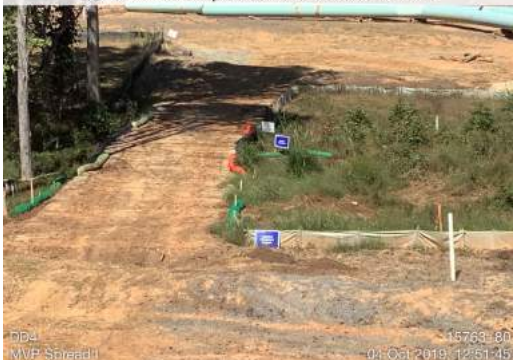
GPS Location	0		GPS Location	0	
Field Station#	15763+80		Field Station#	15699+50	
Pic 3 Desc.	Equipment bridge is acceptable		Pic 4 Desc.	P1 silt fence is acceptable

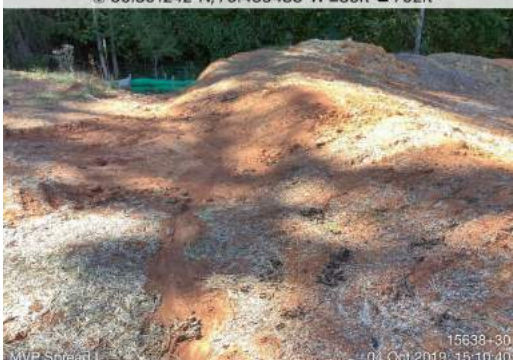
GPS Location	0		GPS Location	0	
Field Station#	15638+30		Field Station#	15499+25	
Pic 5 Desc.	Waterbar is acceptable		Pic 6 Desc.	Waterbar is acceptable

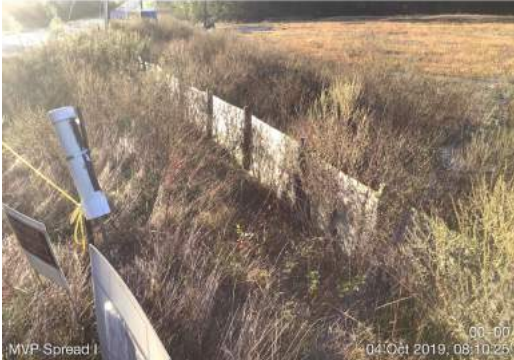
GPS Location	0	GPS Location	0		
Field Station#	00+00	Field Station#	00+00		
Pic 1 Desc.	P1 silt fence is acceptable	Pic 2 Desc.	Culvert outlet protection is acceptable

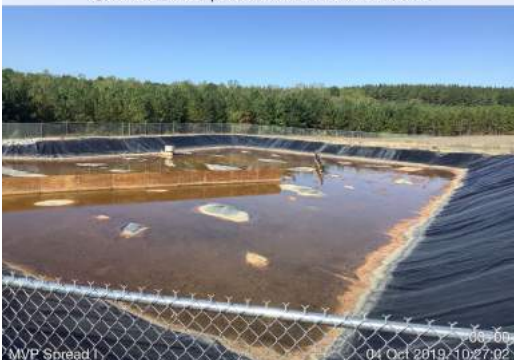
GPS Location	0	GPS Location	0		
Field Station#	00+00	Field Station#	00+00		
Pic 3 Desc.	Sediment Basin is acceptable	Pic 4 Desc.	Rock filter outlet is acceptable		
Insert image here			Insert image here		
GPS Location		GPS Location			
Field Station#		Field Station#			
Pic 5 Desc.		Pic 6 Desc.

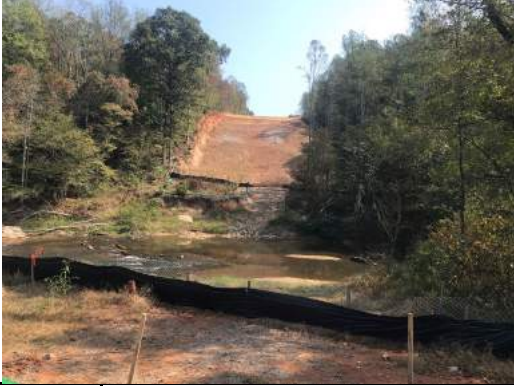
GPS Location	0	GPS Location	0		
Field Station#	14249+65	Field Station#	14129+00		
Pic 1 Desc.	Approximately 14249+65. Overview of stream S-F11 ECDs.		Pic 2 Desc.	Approximately 14129+00. ROW temporarily seeded and stabilized in this area.

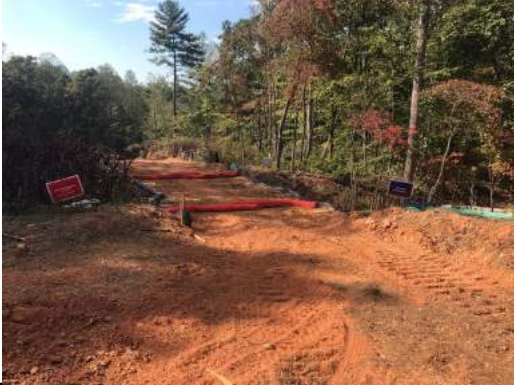
GPS Location	0	GPS Location	0		
Field Station#	14222+09	Field Station#	14335+00		
Pic 3 Desc.	Approximately 14222+09. Overview of stream crossing and equipment bridge at stream S-C20.		Pic 4 Desc.	Approximately 14335+00. ROW temporarily seeded and stabilized in this area.	
Insert image here			Insert image here		
GPS Location		GPS Location			
Field Station#		Field Station#			
Pic 5 Desc.		Pic 6 Desc.

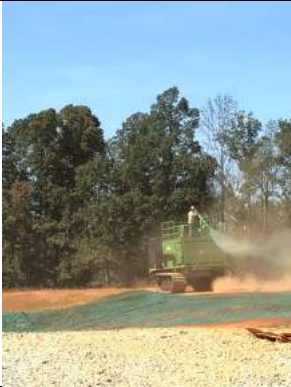
GPS Location	0000		GPS Location	0000	
Field Station#	13958+00		Field Station#	13957+89	
Pic 1 Desc.	Seeding contractor continuing to spray the row for stabilization		Pic 2 Desc.	Seeding contractor continuing to spray the row for stabilization

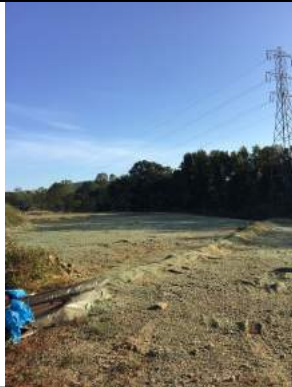
GPS Location	0000		GPS Location	0000	
Field Station#	13826+96		Field Station#	13826+98	
Pic 3 Desc.	Row photo after stabilization activities		Pic 4 Desc.	Row photo after stabilization activities	
Insert image here			Insert image here		
GPS Location			GPS Location		
Field Station#			Field Station#		
Pic 5 Desc.			Pic 6 Desc.
