# Visual Site Inspection Report

<b>Project Name</b> H-600 Pipeline Spread I		<b>AFE</b> 124300139	<b>Spread</b> H-600 Pipeline Spread I
<b>Contractor</b> Precision		<b>Report #</b> 100103	
<b>Inspector</b> Logan Box		<b>Date/Time</b> 9/12/2019 11:59 AM	
<b>Permit #</b> TBD	<b>Inspection Type</b> VA SWPP	<b>Station Begin</b>	13670+00
<b>State</b> VA	<b>Inspection Area</b> Partial	<b>Station End</b>	13958+31
<b>County</b> Franklin	<b>Ground</b> Damp	<b>Temperature (°F)</b>	95.00
<b>Municipality</b> N/A	<b>Weather</b> Sunny	<b>Rain Gauge (in)</b>	0.10
			<b>Rain Accumulation Time (days)</b> 1.00

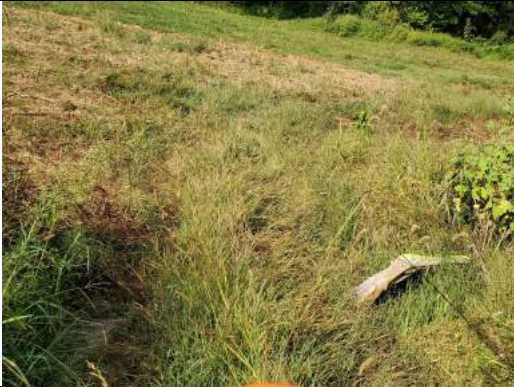
Traveled the row and inspected all ECDs, monitored vegetation growth throughout.  
 Inspected row conditions, discussed issues with the contractor and added punch list items.  
 Noticed 3rd party damages to silt fence. Discussed with the contractor to make repairs .  
 Total measurable rainfall for this period was 0.1" .

<b>GPS Location</b>	0000	<b>GPS Location</b>	0000		
<b>Field Station#</b>	13755+74	<b>Field Station#</b>	13770+12		
<b>Pic 1 Desc.</b>	P1 damaged from land owner		<b>Pic 2 Desc.</b>	Sump pit not to spec, needing end treatment, discussed with the contractor

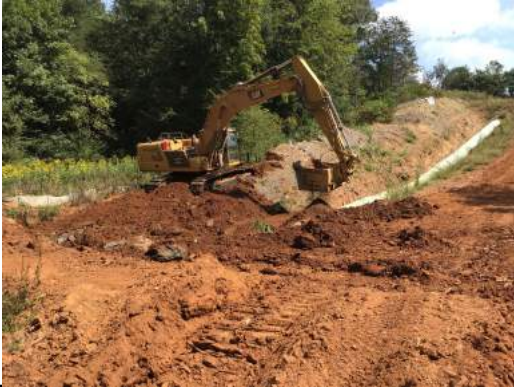
<b>GPS Location</b>	00000	<b>GPS Location</b>	0000		
<b>Field Station#</b>	+0	<b>Field Station#</b>	13753+00		
<b>Pic 3 Desc.</b>	Back fill activities		<b>Pic 4 Desc.</b>	CFS installed along row edge.	
Insert image here			Insert image here		
<b>GPS Location</b>		<b>GPS Location</b>			
<b>Field Station#</b>		<b>Field Station#</b>			
<b>Pic 5 Desc.</b>		<b>Pic 6 Desc.</b>

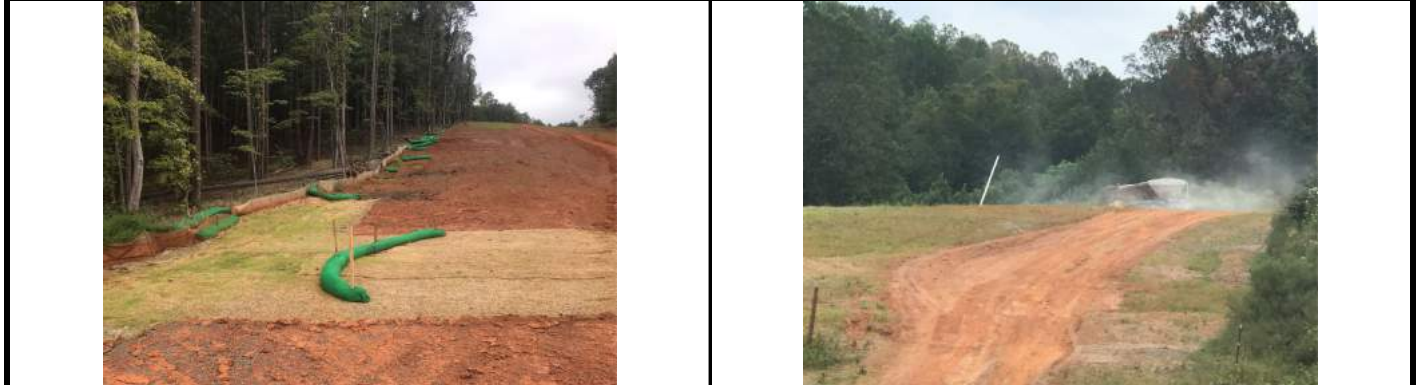
<b>GPS Location</b>	0	<b>GPS Location</b>	0
<b>Field Station#</b>	14083+20	<b>Field Station#</b>	14177+00
<b>Pic 1 Desc.</b>	Approximately 14083+20. ECDs installed and appear to be functioning correctly.	<b>Pic 2 Desc.</b>	Approximately 14177+00. Contractor stabilizing ROW.

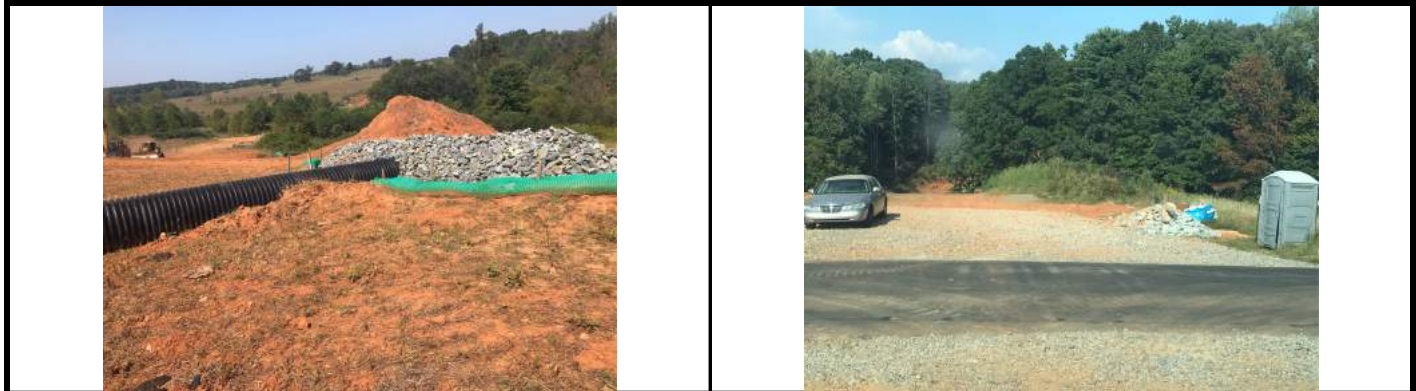
<b>GPS Location</b>	0	<b>GPS Location</b>	0
<b>Field Station#</b>	14397+50	<b>Field Station#</b>	14171+36
<b>Pic 3 Desc.</b>	Approximately 14397+50. CWD piping and level spreader appears to be installed and functioning correctly at time of inspection.	<b>Pic 4 Desc.</b>	Approximately 14171+36. RCEs and road crossing.

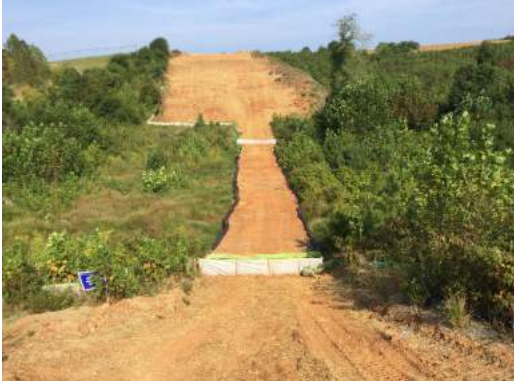
<b>GPS Location</b> 1		<b>GPS Location</b> 2			
<b>Field Station#</b> 15346+80		<b>Field Station#</b> 15346+80			
<b>Pic 1 Desc.</b> View of bridge crossing of S-H13 with ECD's and perimeter controls performing intended function		<b>Pic 2 Desc.</b> Upstream view of S-H13 at ROW crossing

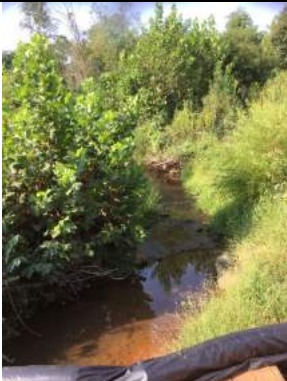
<b>GPS Location</b> 3		<b>GPS Location</b> 4			
<b>Field Station#</b> 15346+80		<b>Field Station#</b> 15142+66			
<b>Pic 3 Desc.</b> Downstream view of S-H13 at ROW crossing		<b>Pic 4 Desc.</b> View of RCE in good condition with newly installed ECD's CIS Rock Creek Rd

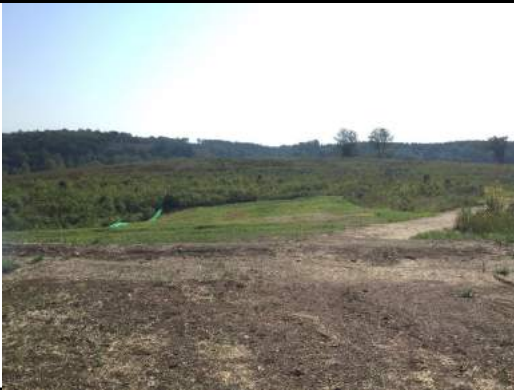
Insert image here			
<b>GPS Location</b> 5		<b>GPS Location</b> 6			
<b>Field Station#</b> 15259+00		<b>Field Station#</b> 15098+00			
<b>Pic 5 Desc.</b> View of vegetation growing along ROW at former pad at HDD exit site		<b>Pic 6 Desc.</b> Temporary vegetation growing along ROW

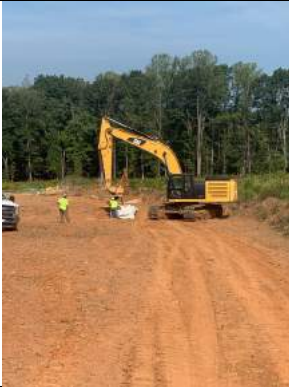
GPS Location	0	GPS Location	0		
Field Station#	15634+00	Field Station#	15680+00		
Pic 1 Desc.	Observing the Contractor performing ECD maintenance.	Pic 2 Desc.	Observing the Contractor repairing punch list items.

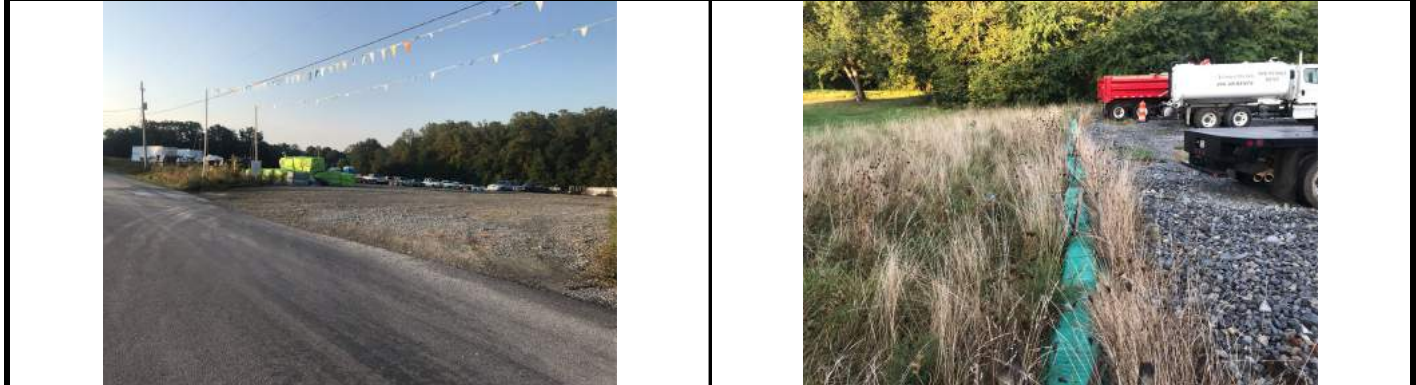
<b>GPS Location</b>	000000	<b>GPS Location</b>	000000
<b>Field Station#</b>	0000+00	<b>Field Station#</b>	0000+00
<b>Pic 1 Desc.</b>	RCE at gravel yard in good condition.	<b>Pic 2 Desc.</b>	Perimeter ECD's on southwest end of gravel yard in good condition.

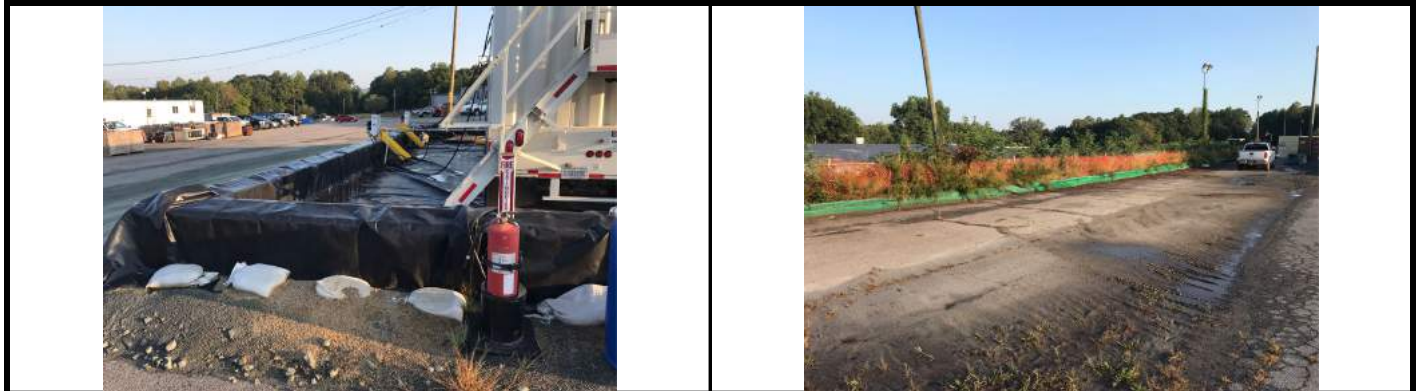
<b>GPS Location</b>	000000	<b>GPS Location</b>	000000
<b>Field Station#</b>	0000+00	<b>Field Station#</b>	0000+00
<b>Pic 3 Desc.</b>	Secondary containment structure for fuel cell in compliance.	<b>Pic 4 Desc.</b>	Perimeter ECD's on west side of paved yard in acceptable condition.

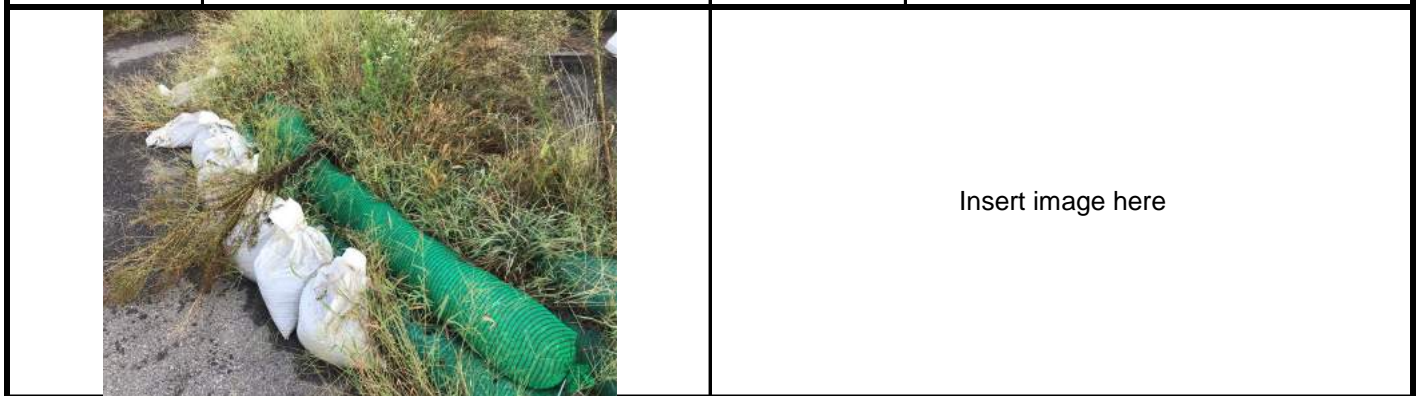
Performed SWPPP inspection of Spread I main yard in Rocky Mount, Va. The location received .40" on rainfall overnight. All perimeter ECD's were inspected and one issue was observed in the northwest corner of paved yard, the CFS needs to be re-stacked and sediment removed. The RCE at the gravel yard was in good condition. All secondary containment structures were found to be in compliance. The inlet protection for the parking lot drains in the paved yard were found to be in good condition. Any issue observed during the inspection were placed on the punch list and given to the contractor to address.

<b>GPS Location</b>	000000	<b>GPS Location</b>	
<b>Field Station#</b>	0000+00	<b>Field Station#</b>	
<b>Pic 5 Desc.</b>	Perimeter ECD's on northwest corner of paved yard need maintenance.	<b>Pic 6 Desc.</b>

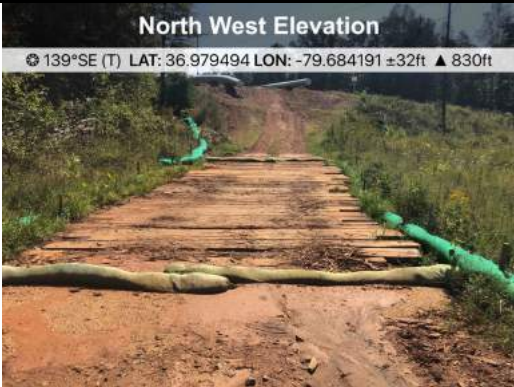
GPS Location 0		GPS Location 0			
Field Station# 14782+25		Field Station# 14793+00			
Pic 1 Desc. Equipment bridge clean at stream S-MM48		Pic 2 Desc. Sump pit functioning as intended			
<p><b>North Elevation</b>  <small>⊕ 202°S (T) LAT: 36.978266 LON: -79.680929 ±16ft ▲ 859ft</small></p>

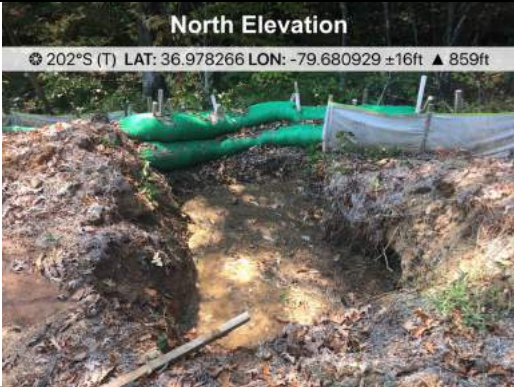
GPS Location 0		GPS Location 0			
Field Station# 14795+00		Field Station# 14793+78			
Pic 3 Desc. Sump pit functioning as intended		Pic 4 Desc. Equipment bridge clean at stream S-H24			
<p><b>South Elevation</b>  <small>⊕ 344°N (T) LAT: 36.977147 LON: -79.678949 ±16ft ▲ 931ft</small></p>

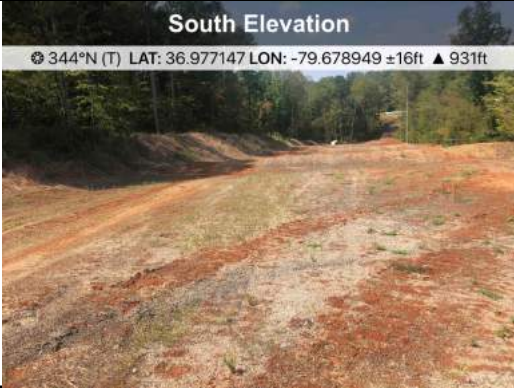
GPS Location 0		GPS Location 0			
Field Station# 14800+00		Field Station# 14840+00			
Pic 5 Desc. Temporary stabilization		Pic 6 Desc. Temporary stabilization
