Visual Site Inspection Report

Project Name	H-600 Pipeline Spread G	AFE	124300137	Spread	H-600 Pipeline Spread G
Contractor	Precision			Report #	7292
Inspector	Garrett Barclay			Date/Time	1/13/2020 7:13 AM
Permit #	TBD	Inspection Type	VA SWPP	Station Begin	11520+00
State	VA	Inspection Area	Partial	Station End	11640+00
County	Craig	Ground	Wet	Temperature (°F)	38.00
Municipality	N/A	Weather	Sunny	Rain Gauge (in)	1.60
				Rain Accumulation Time (days)	1.00

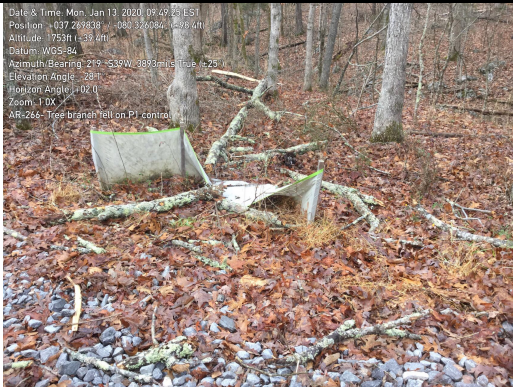
<p>Date & Time: Mon Jan 13, 2020 09:49:53 EST Position: +037.230348 / -080.323208 (+16.4ft) Altitude: 1751ft (+59.4ft) Datum: WGS-84 Azimuth/Bearing: 219° S35W 353mils True (+25°) Elevation Angle: -28° Horizon Angle: +01.0° Zoom: 1.0X AR-266- Tree branch fell on P1, Contractor notified and will address.</p>

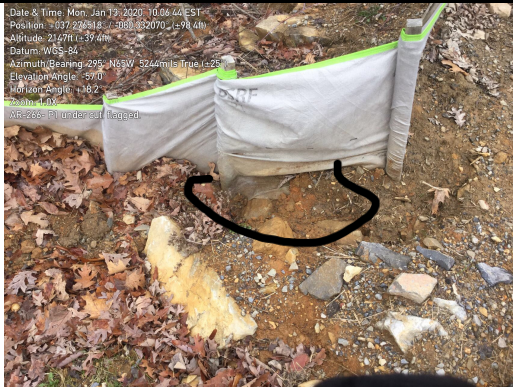
<p>Date & Time: Mon Jan 13, 2020 10:06:44 EST Position: +037.230348 / -080.320702 (+16.4ft) Altitude: 2147ft (+139.4ft) Datum: WGS-84 Azimuth/Bearing: 295° N45W 524mils True (+25°) Elevation Angle: -5.0° Horizon Angle: +00.2° Zoom: 1.0X AR-266- P1 under cut, Contractor notified and will address.</p>			
GPS Location	See photo GPS	GPS Location	See photo GPS		
Field Station#	11989+00	Field Station#	11989+00		
Pic 1 Desc.	AR-266- Tree limb fell on P1, Contractor notified and will address.	Pic 2 Desc.	AR-266- P1 under cut, Contractor notified and will address.

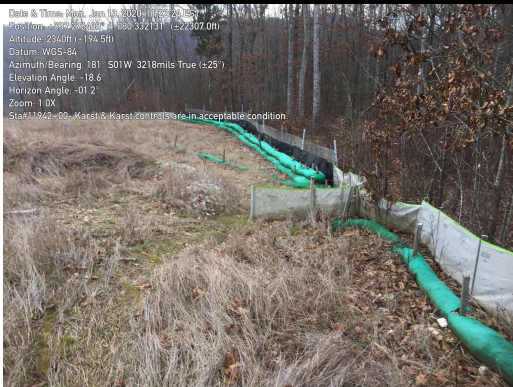
<p>Date & Time: Mon Jan 13, 2020 11:42:00 EST Position: +037.272322 / -080.325192 (+16.4ft) Altitude: 2360ft (+194.5ft) Datum: WGS-84 Azimuth/Bearing: 181° S01W 321mils True (+25°) Elevation Angle: -18.6° Horizon Angle: -01.2° Zoom: 1.0X Karst & Karst controls are in acceptable condition.</p>

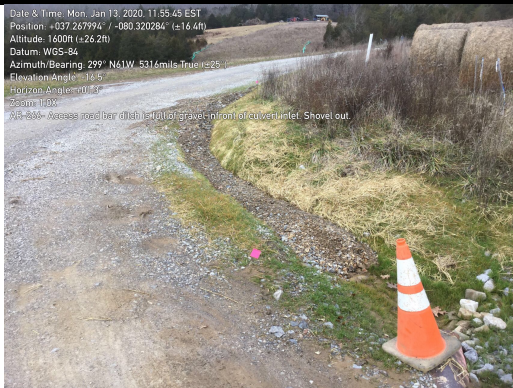
<p>Date & Time: Mon Jan 13, 2020 11:55:45 EST Position: +037.267994 / -080.320284 (+16.4ft) Altitude: 1600ft (+26.2ft) Datum: WGS-84 Azimuth/Bearing: 299° N41W 531mils True (+25°) Elevation Angle: -16.5° Horizon Angle: -00.6° Zoom: 1.0X Access road bar ditch is full of gravel up stream of culvert inlet. Shovel out.</p>

GPS Location	See photo GPS	GPS Location	See photo GPS		
Field Station#	11979+00	Field Station#	11989+00		
Pic 5 Desc.	Karst and Karst ECD's and sensitive resource signage are in acceptable condition.	Pic 6 Desc.	AR-266- Access road bar ditch is full of gravel up stream of culvert inlet, will be shoveled out.

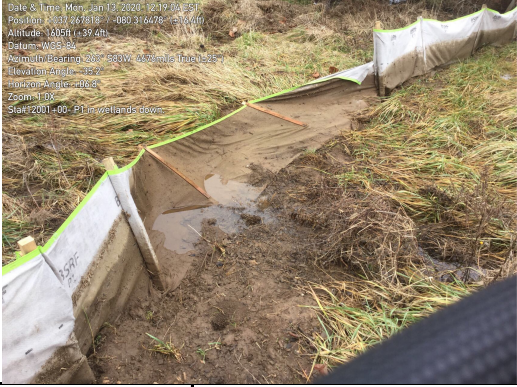
GPS Location	See photo GPS	GPS Location	See photo GPS		
Field Station#	12001+00	Field Station#	12000+00		
Pic 7 Desc.	P1 damaged from heavy rain, contractor notified, will address issue	Pic 8 Desc.	P1 damaged from heavy rain, contractor notified, will address issue.		
Insert image here		Insert image here			
GPS Location		GPS Location			
Field Station#		Field Station#			
Pic 9 Desc.		Pic 10 Desc.			
Insert image here		Insert image here			
GPS Location		GPS Location			
Field Station#		Field Station#			
Pic 11 Desc.		Pic 12 Desc.

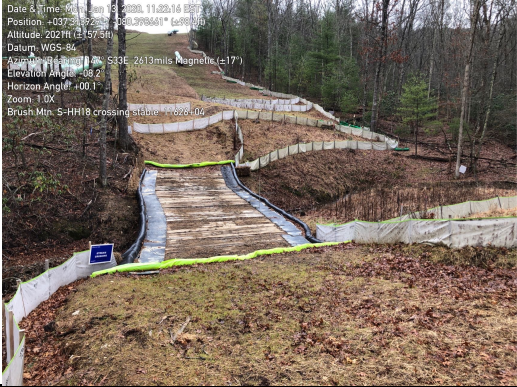
<p> Date & Time: 01/13/2020 11:55:14 EST Position: -037.215726, 36.378861 (s=99.95) Altitude: 2027ft (615.3m) Datum: WGS-84 Azimuth/Bearing: 288.5647 (S80E 2613mils True (±17°)) Elevation Angle: -015° Horizon Angle: -00.1° Zoom: 1.0X Brush Mtn. S-HH18 crossing stable </p>

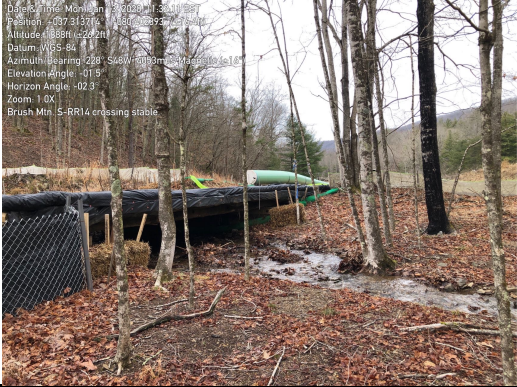
<p> Date & Time: 01/13/2020 11:55:14 EST Position: -037.215726, 36.378861 (s=99.95) Altitude: 2027ft (615.3m) Datum: WGS-84 Azimuth/Bearing: 288.5647 (S80E 2613mils True (±17°)) Elevation Angle: -015° Horizon Angle: -02.3° Zoom: 1.0X Brush Mtn. S-RR14 crossing stable </p>			
GPS Location	On photo	GPS Location	On photo		
Field Station#	11626+04	Field Station#	11614+20		
Pic 7 Desc.	The S-HH18 crossing is stable with no sign of impact		Pic 8 Desc.	S-RR14 crossing is stable with no visible signs of impact from storm

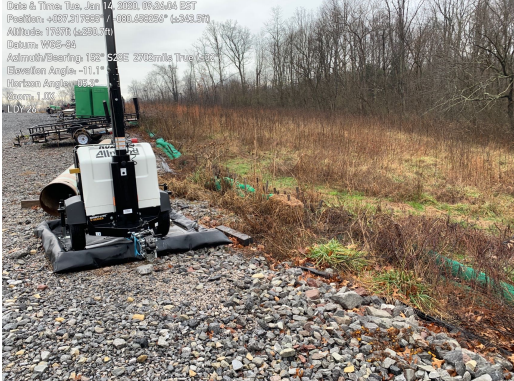
GPS Location	See photo for GPS location.		GPS Location	See photo for GPS location.	
Field Station#	12011+25		Field Station#	12011+25	
Pic 1 Desc.	Triple stack 12 inch CFS in place along LOD.		Pic 2 Desc.	18 inch CFS in place along LOD.

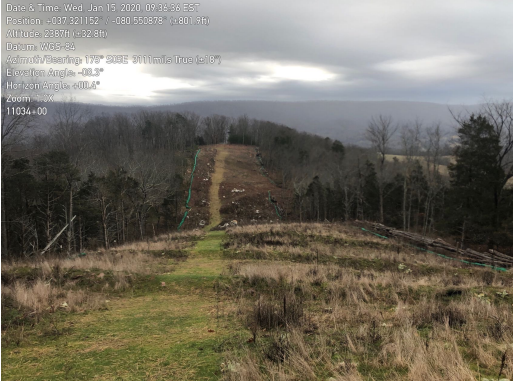
GPS Location				1		GPS Location				2	
Field Station#				11025+50		Field Station#				11034+00	
Pic 1 Desc.				S-IJ18.		Pic 2 Desc.				Vegetation or stabilization sufficient.

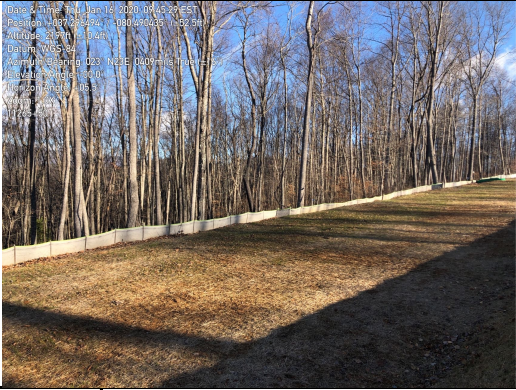
GPS Location	1	GPS Location	2		
Field Station#	11265+50	Field Station#	11269+90		
Pic 1 Desc.	P-1 perimeter controls functional.	Pic 2 Desc.	Plunge pool functional.

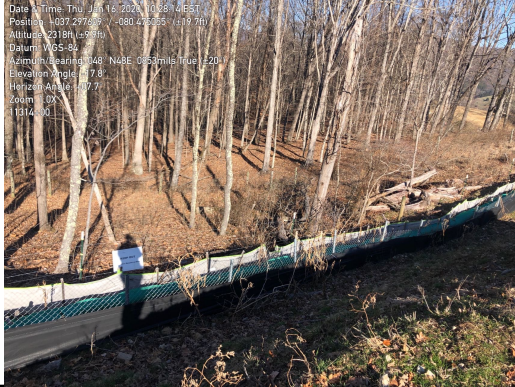
GPS Location	3	GPS Location	4		
Field Station#	11292+80	Field Station#	11314+00		
Pic 3 Desc.	S-MM18.	Pic 4 Desc.	Multiple layers of perimeter control functional on sensitive resource.

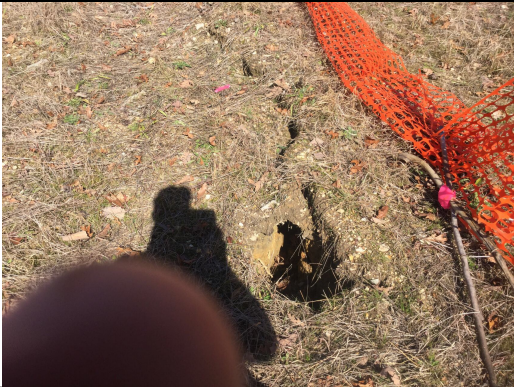
GPS Location	See photo GPS		GPS Location	See photo GPS	
Field Station#	11950+00		Field Station#	11976+50	
Pic 3 Desc.	Subsidence has grown		Pic 4 Desc.	Karst and Karst ECD's are in acceptable condition

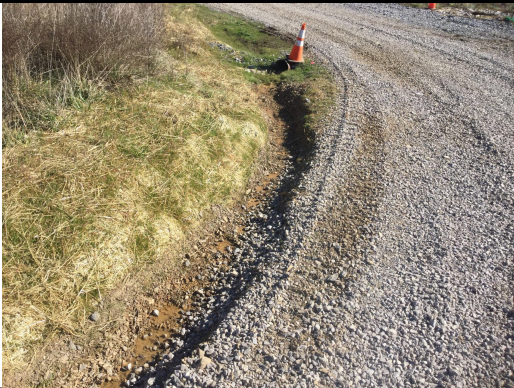
GPS Location	See photo GPS		GPS Location	See photo GPS	
Field Station#	11989+00		Field Station#	12001+00	
Pic 5 Desc.	AR-266 bar ditch has been cleaned out.		Pic 6 Desc.	Wetland ECD's have been repaired.
