Visual Site Inspection Report

Project Name	H-600 Pipeline Spread G	AFE	124300137	Spread	H-600 Pipeline Spread G
Contractor	Precision			Report #	7679
Inspector	Garrett Barclay			Date/Time	1/27/2020 7:21 AM
Permit #	TBD	Inspection Type	VA SWPP	Station Begin	10843+00
State	VA	Inspection Area	Partial	Station End	10930+00
County	Giles	Ground	Wet	Temperature (°F)	32.00
Municipality	N/A	Weather	Cloudy	Rain Gauge (in)	1.40
				Rain Accumulation Time (days)	1.00

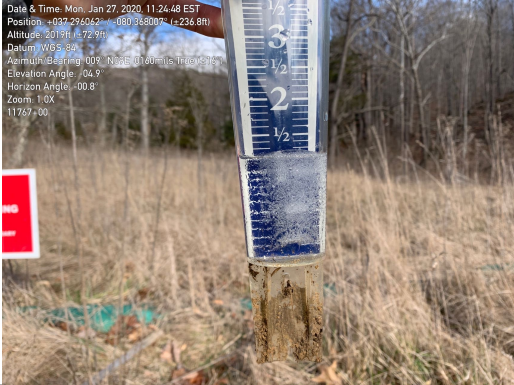
GPS Location		See photo for GPS location.		GPS Location	
Field Station#		11767+00		Field Station#	
Pic 3 Desc.		Rain gauge at Mount Tabor Road reads 1.3 inches.		Pic 4 Desc.

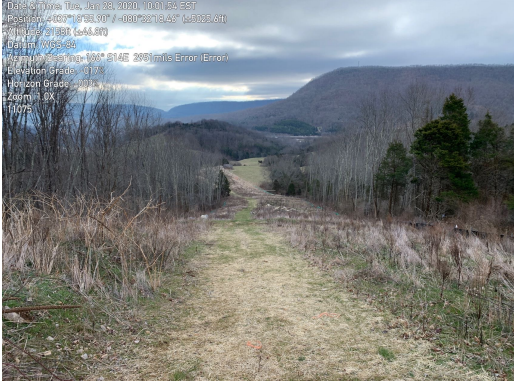
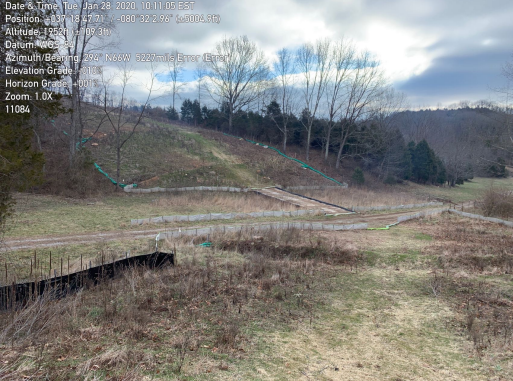
GPS Location	See picture above for GPS coordinates		GPS Location	See picture above for GPS coordinates	
Field Station#	11075+00		Field Station#	11084+00	
Pic 1 Desc.	ECD's and row conditions		Pic 2 Desc.	ECD's and row conditions

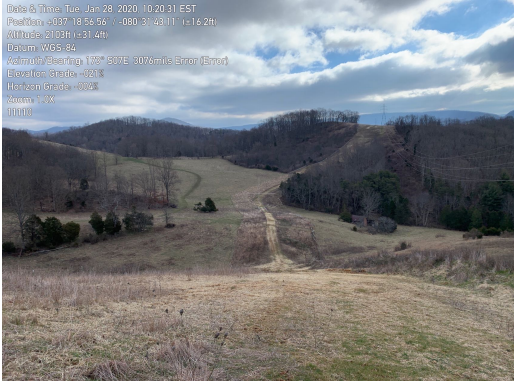
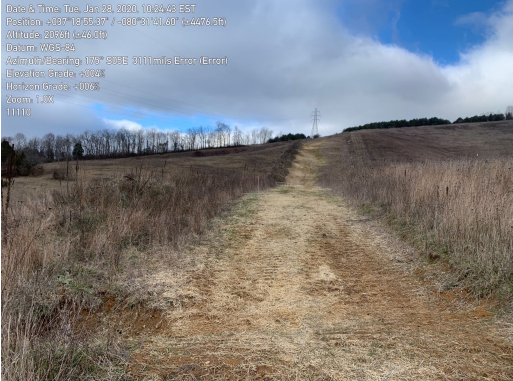
GPS Location	See picture above for GPS coordinates		GPS Location	See picture above for GPS coordinates	
Field Station#	11110+00		Field Station#	11110+00	
Pic 3 Desc.	ECD's and row conditions		Pic 4 Desc.	ECD's and row conditions

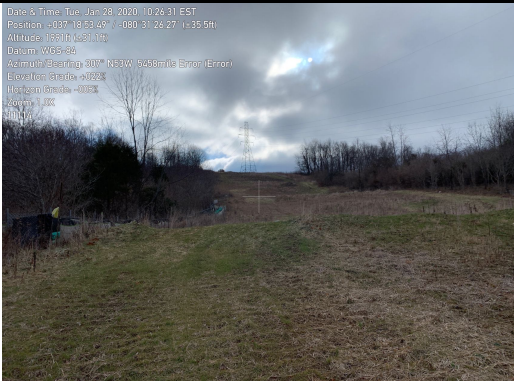
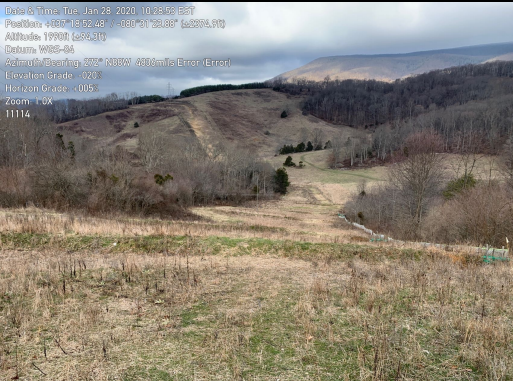
GPS Location	See picture above for GPS coordinates		GPS Location	See picture above for GPS coordinates	
Field Station#	11114+00		Field Station#	11140+00	
Pic 5 Desc.	ECD's and row conditions		Pic 6 Desc.	ECD's and row conditions

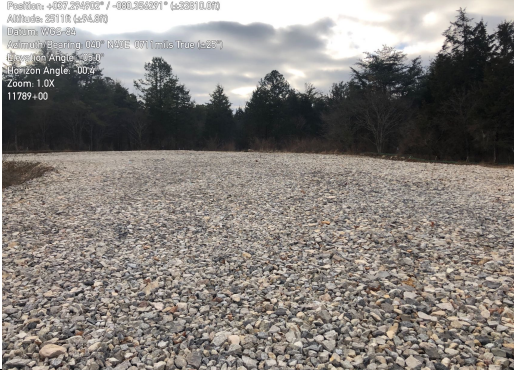
GPS Location	1	GPS Location	2		
Field Station#	11789+00	Field Station#	11792+00		
Pic 1 Desc.	RCE South of Mt Tabor rd.	Pic 2 Desc.	Section of restored RoW.		
<p> <small> Date & Time: Wed, Jan 29, 2020, 11:02:01 EST Position: +037.253532° / -86.356291° (-86.351100) Altitude: 2159ft (-85.80) Datum: WGS-84 Datum Bearing: 090° 59'00" 000mils True (+2°) Elevation Angle: +00° Horizontal Angle: -000° Zoom: 1.0x 11863+65 </small> </p>

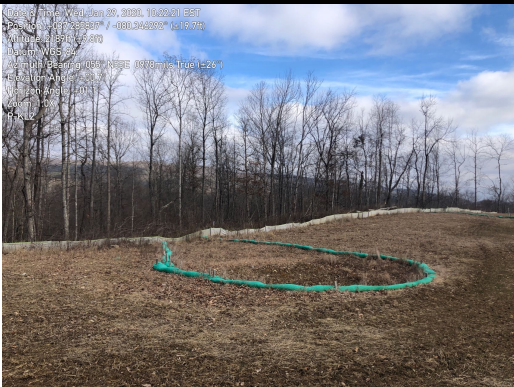
GPS Location	3	GPS Location	4		
Field Station#	11863+65	Field Station#	11886+00		
Pic 3 Desc.	P-KL2.	Pic 4 Desc.	Section of restored RoW.		
<p> <small> Date & Time: Wed, Jan 29, 2020, 11:39:42 EST Position: +037.232218° / -86.057629° (-86.052650) Altitude: 1714ft (-80.00) Datum: WGS-84 Datum Bearing: 115° 34'00" 000mils True (+3°) Elevation Angle: +32° Horizontal Angle: -000° Zoom: 1.0x 11976+75 </small> </p>

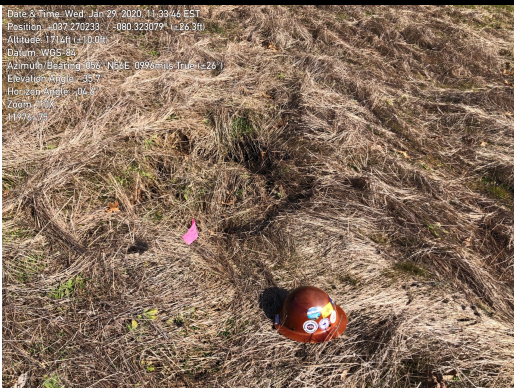
GPS Location	5	GPS Location	6		
Field Station#	11976+75	Field Station#	11991+00		
Pic 5 Desc.	Sink hole located.	Pic 6 Desc.	Section of restored RoW.

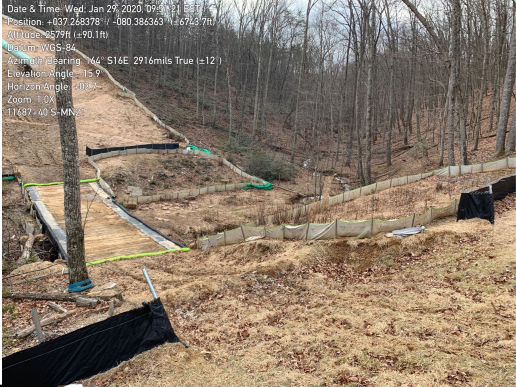
GPS Location	See photo for GPS location.		GPS Location	See photo for GPS location.	
Field Station#	11687+40		Field Station#	11759+00	
Pic 3 Desc.	Sensitive resource buffer in place at stream S-MN21.		Pic 4 Desc.	Super silt fence in place along LOD.

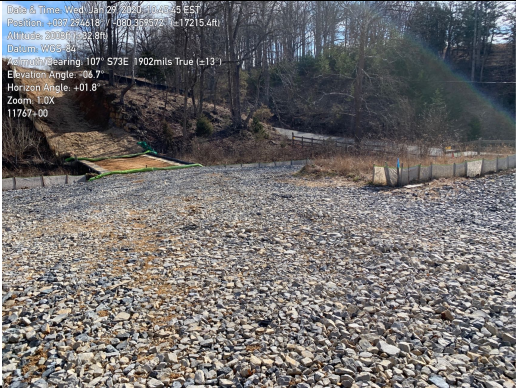
GPS Location	See photo for GPS location.		GPS Location	See photo for GPS location.	
Field Station#	11767+00		Field Station#	11778+00	
Pic 5 Desc.	RCE in place at main line valve 26.		Pic 6 Desc.	Clean water diversion berm and pipe in place. ROW stabilized with mulch.

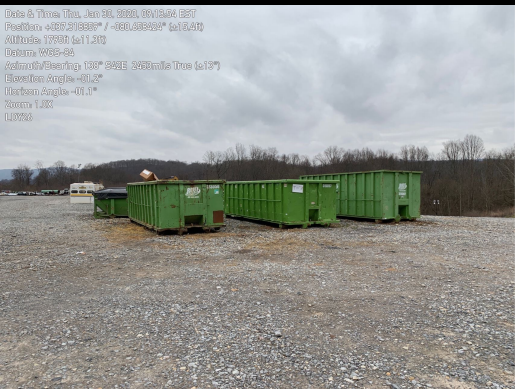
<p>Date & Time: Thu, Jan 30, 2020 09:16:04 EST Position: +489.21694° / -080.65738° (+120.3ft) Altitude: 1900 (+11.2ft) Datum: WGS-84 Azimuth/Bearing: 138° S48E 320mils True (+13°) Elevation Angle: -01.2° Horizon Angle: -01.1° Zoom: 1.0X LDY26</p>			
GPS Location	See photo for GPS location.		GPS Location	See photo for GPS location.	
Field Station#	12005+00		Field Station#	12005+00	
Pic 1 Desc.	Triple stack compost filter sock in place around drainage.		Pic 2 Desc.	Dumpsters being utilized for trash management.

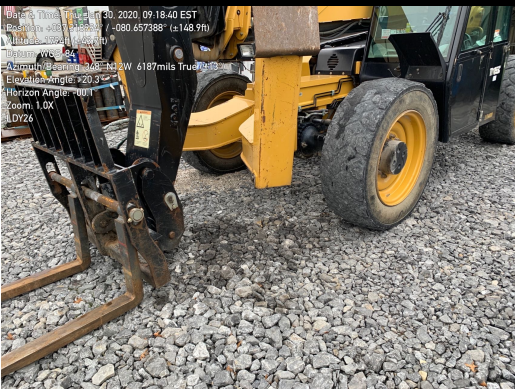
GPS Location	See photo for GPS location.		GPS Location	See photo for GPS location.	
Field Station#	12005+00		Field Station#	12005+00	
Pic 3 Desc.	Checked equipment for leaks. No leaks observed.		Pic 4 Desc.	Leak observed under forklift. Less than one quart of hydraulic fluid released.

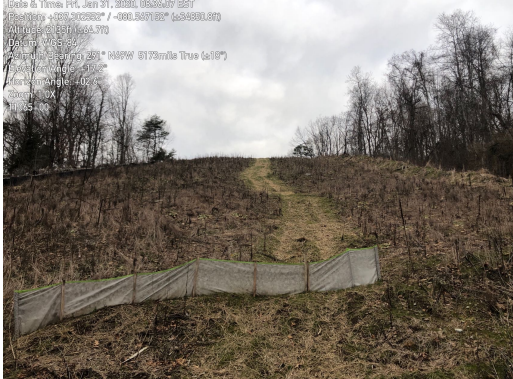
GPS Location	1	GPS Location	2		
Field Station#	11065+00	Field Station#	11055+00		
Pic 1 Desc.	Vegetation or stabilization sufficient.	Pic 2 Desc.	Triple layer perimeter controls protecting karst area.		
<p>Date & Time: Fri, Jan 31, 2020, 06:35:10 EST Position: +037.32292° / -080.59911° (+310.0ft) Altitude: 266ft (+91.2ft) Datum: WGS-84 Azimuth/Bearing: 303° N87W 338mils True (+22°) Elevation Angle: -10.8° Horizon Angle: +01.8° Zoom: 1.0x Landowner travel: 11007+00</p>

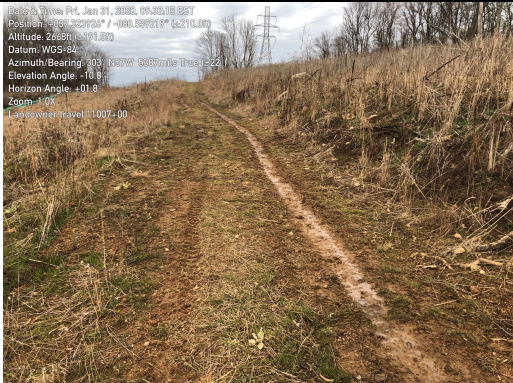
GPS Location	3	GPS Location	4		
Field Station#	11007+00	Field Station#	10964+00		
Pic 3 Desc.	Landowner disturbance being monitored.	Pic 4 Desc.	Wildlife damage P-1 silt fence. (Repaired prior to end of day).		
<p>Date & Time: Fri, Jan 31, 2020, 09:55:16 EST Position: +037.34142° / -080.55761° (+362.0ft) Altitude: 233ft (+64.7ft) Datum: WGS-84 Azimuth/Bearing: 072° N72E 1290mils True (+14°) Elevation Angle: -09.2° Horizon Angle: -00.3° Zoom: 1.0x 10971+00</p>

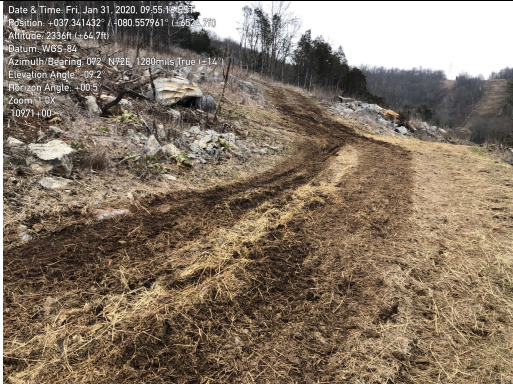
GPS Location	5	GPS Location	6		
Field Station#	10971+00	Field Station#	10950+50		
Pic 5 Desc.	Landowner disturbance being mo monitored.	Pic 6 Desc.	Heavily used landowner crossing denuded and being monitored.

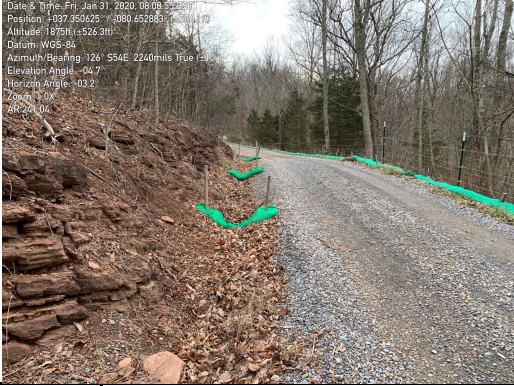
GPS Location	See photo for GPS location.		GPS Location	See photo for GPS location.	
Field Station#	10695+00		Field Station#	10712+50	
Pic 1 Desc.	Compost filter sock checks in place in bar ditch along access road 241.04.		Pic 2 Desc.	Sensitive resource buffer in place at stream S-G33.	
<p>Date & Time: Fri Jan 31, 2020 08:00:00 EST Position: 4327.355425, -8080.652685 (±15.3ft) Altitude: 1875ft (±52.3ft) Datum: WGS-84 Azimuth/Bearing: 222.542W 3947mils True (±13°) Elevation Angle: -20.1° Horizon Angle: -00.7° Zoom: 1.0X 10711+00</p>

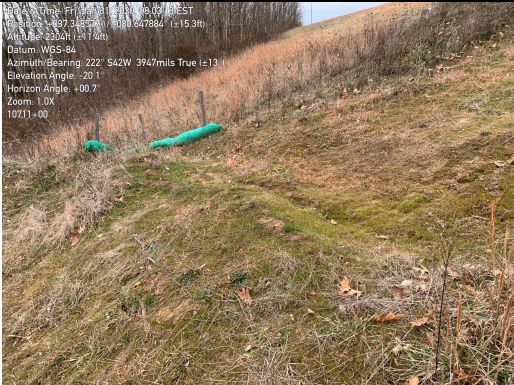
GPS Location	See photo for GPS location.		GPS Location	See photo for GPS location.	
Field Station#	10711+00		Field Station#	10710+00	
Pic 3 Desc.	Waterbar with end treatment in place across travel lane.		Pic 4 Desc.	ROW is stabilized with natural vegetation.	
<p>Date & Time: Fri Jan 31, 2020 08:07:45 EST Position: 4327.355425, -8080.652685 (±15.3ft) Altitude: 1875ft (±52.3ft) Datum: WGS-84 Azimuth/Bearing: 124.554E 2204mils True (±13°) Elevation Angle: -01.3° Horizon Angle: -00.2° Zoom: 1.0X 10698+00</p>

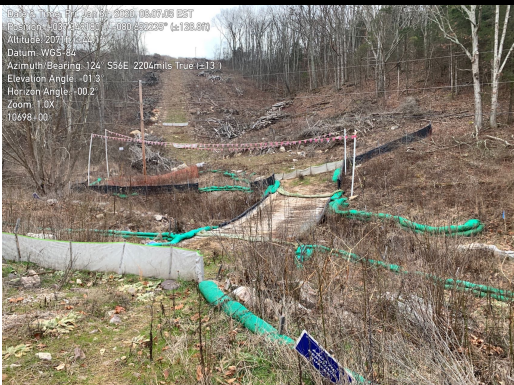
Pic 5 Desc.	Sensitive resource buffer in place at stream S-G32.		Pic 6 Desc.	RCE in place at Buffalo Anklets Road.
