Visual Site Inspection Report

Project Name	H-600 Pipeline Spread G	AFE	124300137	Spread	H-600 Pipeline Spread G
Contractor	Precision			Report #	6679
Inspector	Len Kruizenga			Date/Time	12/16/2019 7:05 AM
Permit #	TBD	Inspection Type	VA SWPP	Station Begin	11354+00
State	VA	Inspection Area	Full	Station End	11161+00
County	Giles	Ground	Muddy	Temperature (°F)	42.00
Municipality	N/A	Weather	Light Rain	Rain Gauge (in)	0.00
				Rain Accumulation Time (days)	1.00

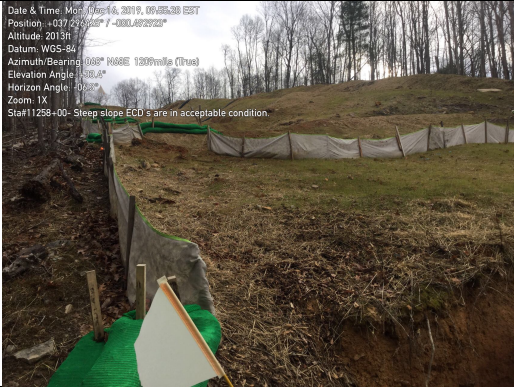
AFE	124300137	Date/Time	12/16/2019 7:05 AM	Report #	
Pictures					
<p>Date & Time: Mon, Dec 16, 2019, 09:55:30 EST Position: +017.294188° / -088.302602° Altitude: 2019ft Datum: WGS-84 Azimuth/Bearing: 000° N000E 1300mils (True) Elevation Angle: -13.6° Horizon Angle: -08.6° Zoom: 1X Sta#11258+00- Slope slope ECD's are in acceptable condition.</p>

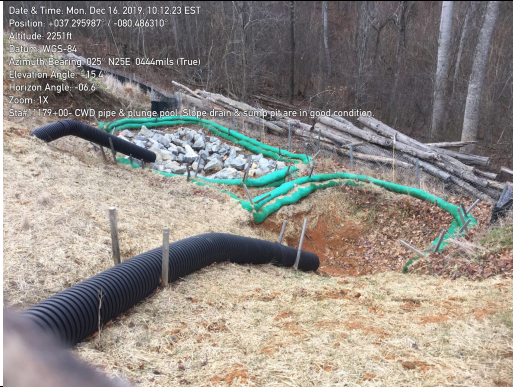
<p>Date & Time: Mon, Dec 16, 2019, 10:12:23 EST Position: +017.295987° / -088.466310° Altitude: 2251ft Datum: WGS-84 Azimuth/Bearing: 025° N25E 0664mils (True) Elevation Angle: -15.6° Horizon Angle: -08.6° Zoom: 1X Sta#11279+00- CWD pipe & plunge pool slope drain & controls are in good condition.</p>

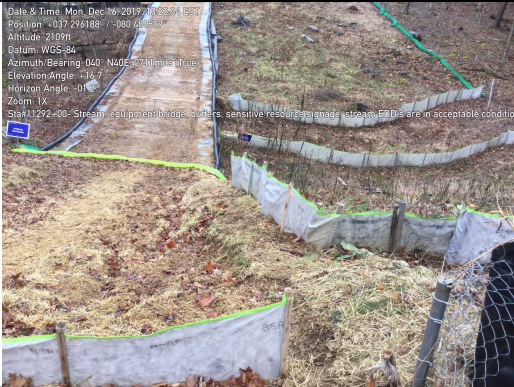
<p>Date & Time: Mon, Dec 16, 2019, 10:04:53 EST Position: +017.294188° / -088.302602° Altitude: 2109ft Datum: WGS-84 Azimuth/Bearing: 040° N40E 300mils (True) Elevation Angle: -14.7° Horizon Angle: -01.7° Zoom: 1X Sta#11292+00- Stream, equipment bridge, buffers, sensitive resource signage, stream ECD's are in acceptable condition.</p>

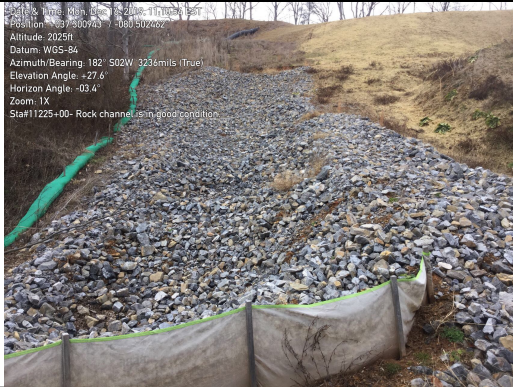
<p>Date & Time: Mon, Dec 16, 2019, 10:12:23 EST Position: +017.295987° / -088.466310° Altitude: 2025ft Datum: WGS-84 Azimuth/Bearing: 182° S02W 3236mils (True) Elevation Angle: -27.4° Horizon Angle: -03.4° Zoom: 1X Sta#11225+00- Rock channel is in good condition.</p>

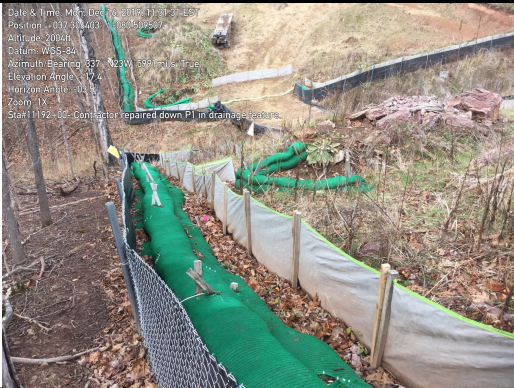
<p>Date & Time: Mon, Dec 16, 2019, 11:31:31 EST Position: +017.295987° / -088.466310° Altitude: 2019ft Datum: WGS-84 Azimuth/Bearing: 327° N23W 5991mils (True) Elevation Angle: -17.4° Horizon Angle: -01.3° Zoom: 1X Sta#11192+00- Contractor repaired down P1 in drainage feature.</p>

GPS Location	See photo GPS	GPS Location	See photo GPS		
Field Station#	11192+00	Field Station#	11184+00		
Pic 5 Desc.	Contractor has repaired P1 controls in drainage feature.	Pic 6 Desc.	CWD pipe and plunge pool are in good condition.

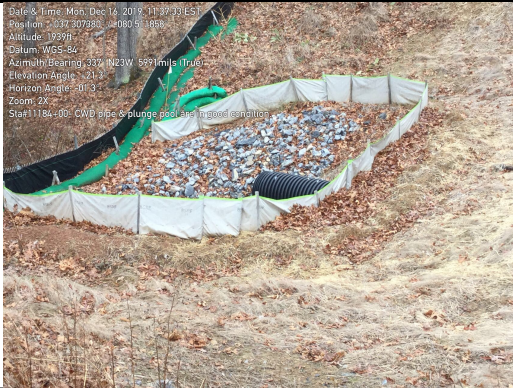
<p>Date & Time: Mon, Dec 16, 2019, 11:37:31 EST Position: +017.295987° / -088.466310° Altitude: 1939ft Datum: WGS-84 Azimuth/Bearing: 327° N23W 5991mils (True) Elevation Angle: -21.2° Horizon Angle: -01.3° Zoom: 1X Sta#11184+00- CWD pipe & plunge pool are in good condition.</p>

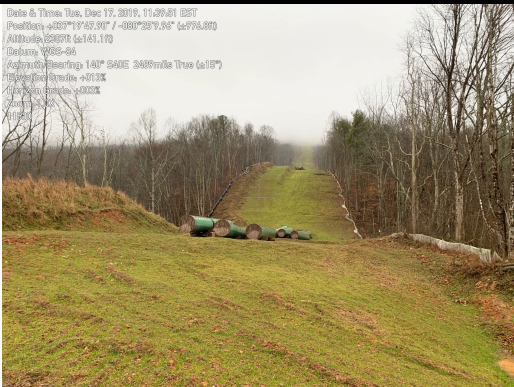
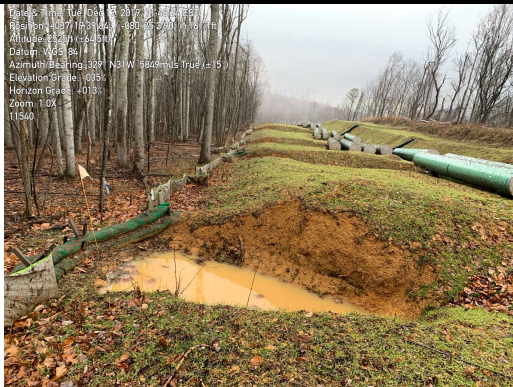
GPS Location	See picture above for GPS coordinates		GPS Location	See picture above for GPS coordinates	
Field Station#	11530+00		Field Station#	11540+00	
Pic 3 Desc.	ECD's and row conditions		Pic 4 Desc.	ECD's and row conditions

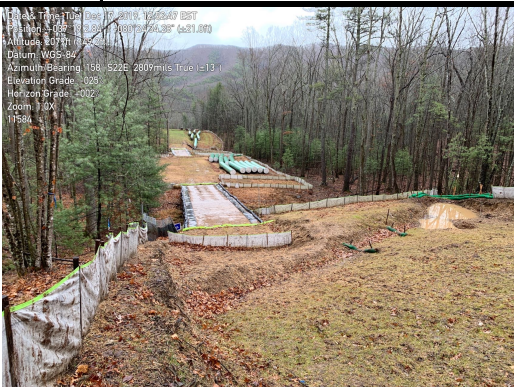
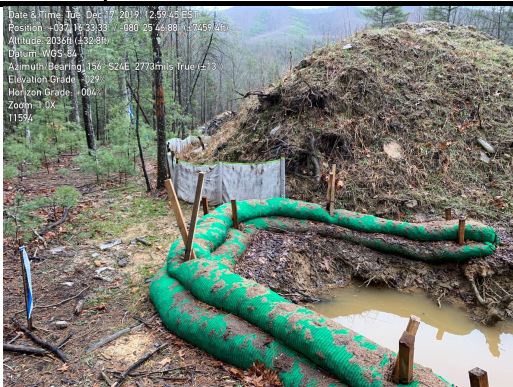
GPS Location	See picture above for GPS coordinates		GPS Location	See picture above for GPS coordinates	
Field Station#	11584+00		Field Station#	11594+00	
Pic 5 Desc.	ECD's and row conditions		Pic 6 Desc.	ECD's and row conditions

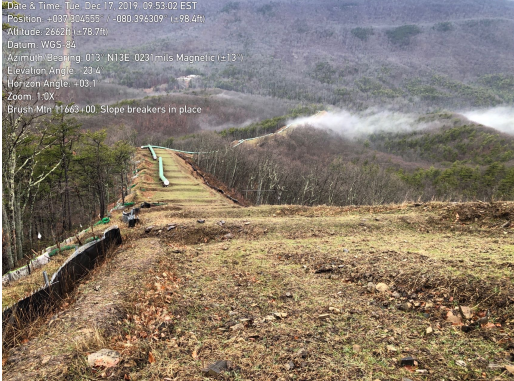
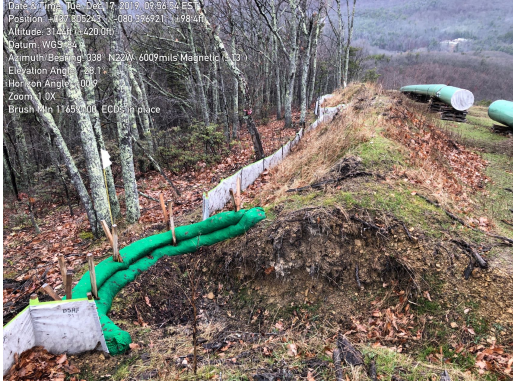
GPS Location	On photo	GPS Location	On photo		
Field Station#	11663+00	Field Station#	11659+00		
Pic 1 Desc.	Slope breakers and other ECDs functional	Pic 2 Desc.	Perimeter controls effective

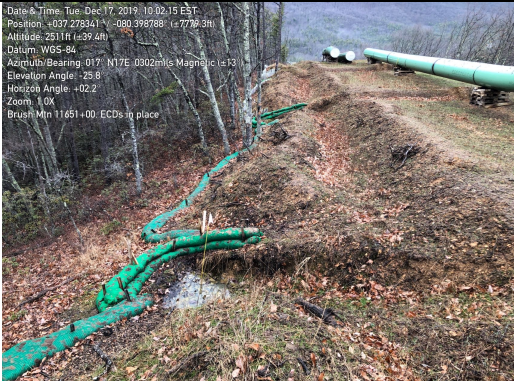
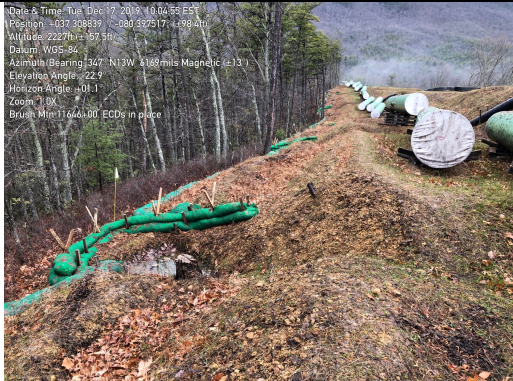
GPS Location	On photo	GPS Location	On photo		
Field Station#	11651+00	Field Station#	11646+00		
Pic 3 Desc.	End treatments in place and functioning	Pic 4 Desc.	End treatments in place and functioning

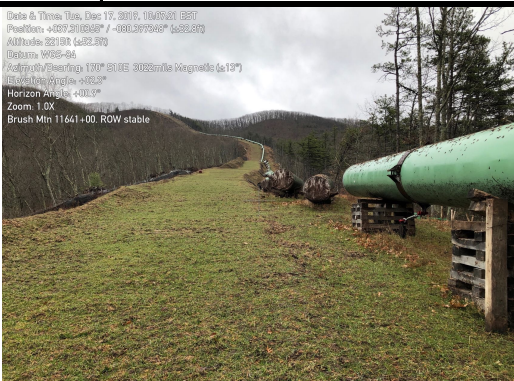
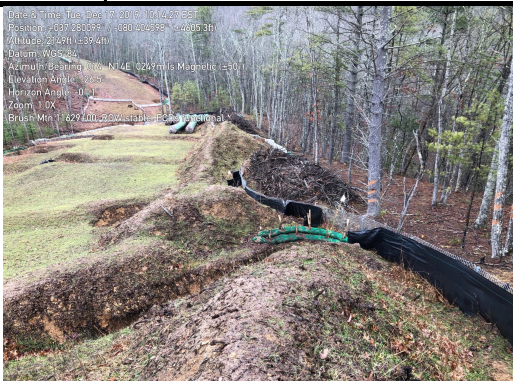
GPS Location	On photo	GPS Location	On photo		
Field Station#	11641+00	Field Station#	11629+00		
Pic 5 Desc.	ROW stable.	Pic 6 Desc.	Perimeter controls and slope breakers functional

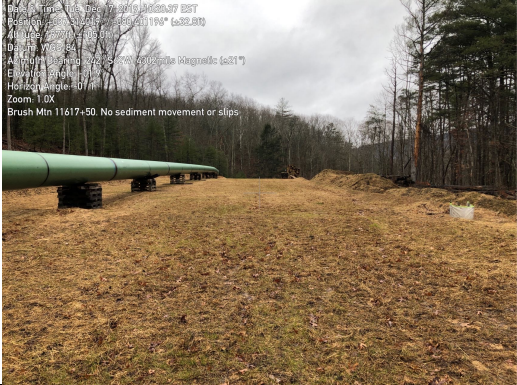
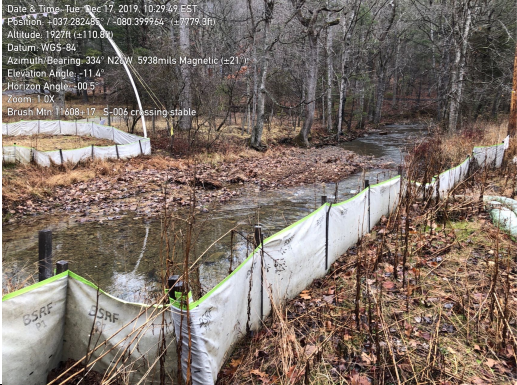
GPS Location	On photo	GPS Location	On photo		
Field Station#	11617+50	Field Station#	11608+17		
Pic 7 Desc.	ROW stable with ECDs in place and functional	Pic 8 Desc.	Resource crossings are stable with no sign of impact		
Insert image here		Insert image here			
GPS Location		GPS Location			
Field Station#		Field Station#			
Pic 9 Desc.		Pic 10 Desc.			
Insert image here		Insert image here			
GPS Location		GPS Location			
Field Station#		Field Station#			
Pic 11 Desc.		Pic 12 Desc.

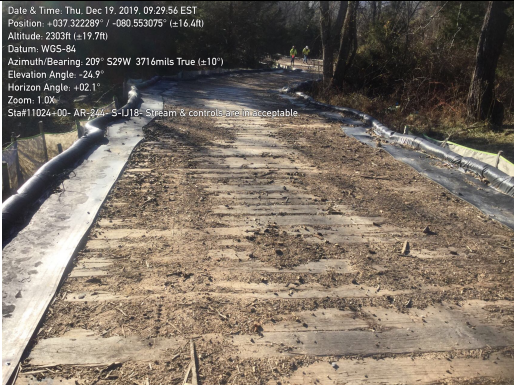
<p>Date & Time: Thu, Dec 19, 2019, 09:29:56 EST Position: +037.322289° / -080.553079° (±16.4ft) Altitude: 2303ft (±19.7ft) Datum: WGS-84 Azimuth/Bearing: 209° S29W 3716mils True (±10°) Elevation Angle: -24.7° Horizon Angle: +02.1° Zoom: 1.0x Sta#11024+00 - AR-34 - S-IJ18- Stream & controls are in acceptable</p>

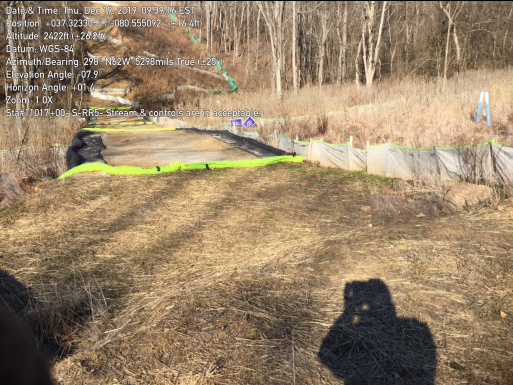
<p>Date & Time: Thu, Dec 19, 2019, 09:35:16 EST Position: +037.322289° / -080.555072° (±16.4ft) Altitude: 2422ft (±19.8ft) Datum: WGS-84 Azimuth/Bearing: 299° N82W 5298mils True (±10°) Elevation Angle: -07.9° Horizon Angle: +01.0° Zoom: 1.0x Sta#11017+00 - S-RR5- Stream & controls are in acceptable</p>			
GPS Location	See photo GPS		GPS Location	See photo GPS	
Field Station#	11024+00		Field Station#	11017+00	
Pic 1 Desc.	Stream S-IJ18, Equipment bridge, ECD's, sensitive resource signage, buffers are in acceptable condition.		Pic 2 Desc.	Stream S-RR5- equipment bridge, buffers, ECD's, sensitive resource signage are in acceptable condition.

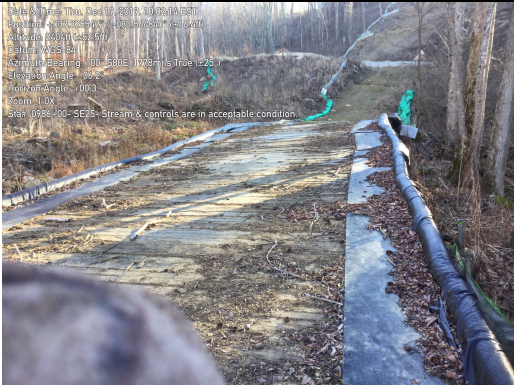
<p>Date & Time: Thu, Dec 19, 2019, 10:45:00 EST Position: +037.322289° / -080.553079° (±16.4ft) Altitude: 2303ft (±19.7ft) Datum: WGS-84 Azimuth/Bearing: 100° S88W 1702mils True (±10°) Elevation Angle: -00.3° Horizon Angle: +00.3° Zoom: 1.0x Sta#10986+00 - S-E25- Stream & controls are in acceptable condition</p>

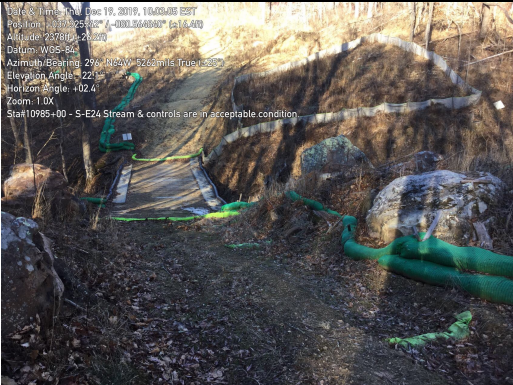
<p>Date & Time: Thu, Dec 19, 2019, 10:45:00 EST Position: +037.322289° / -080.553079° (±16.4ft) Altitude: 2303ft (±19.7ft) Datum: WGS-84 Azimuth/Bearing: 299° N82W 5298mils True (±10°) Elevation Angle: -22.5° Horizon Angle: +02.4° Zoom: 1.0x Sta#10985+00 - S-E24 Stream & controls are in acceptable condition</p>			
GPS Location	See photo GPS		GPS Location	See photo GPS	
Field Station#	10986+00		Field Station#	10985+00	
Pic 3 Desc.	Stream S-E25- Equipment bridge, buffers, ECD's, sensitive resource signage are in acceptable condition.		Pic 4 Desc.	Stream S-E24- Buffers, equipment bridge, ECD's, sensitive resource signage are in acceptable condition.

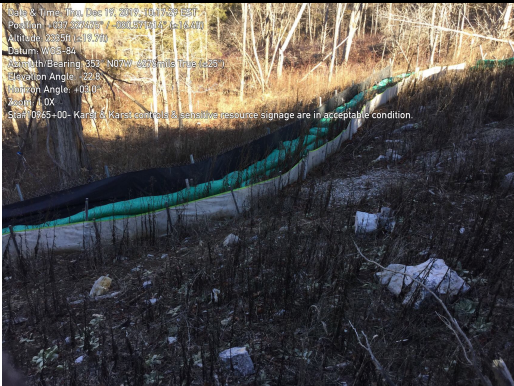
<p>Date & Time: Thu, Dec 19, 2019, 10:45:00 EST Position: +037.322289° / -080.553079° (±16.4ft) Altitude: 2303ft (±19.7ft) Datum: WGS-84 Azimuth/Bearing: 338° N02W 5476mils True (±10°) Elevation Angle: -23.6° Horizon Angle: +03.6° Zoom: 1.0x Sta#10965+00 - Karst ECD's and sensitive resource signage are in acceptable condition.</p>

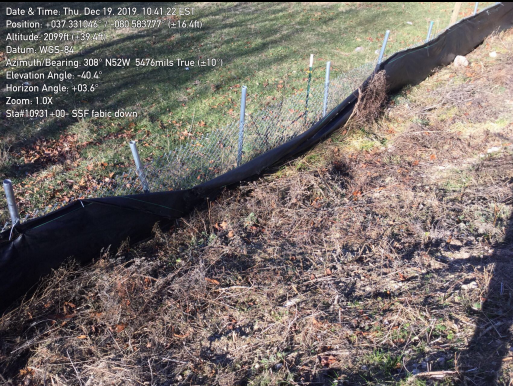
<p>Date & Time: Thu, Dec 19, 2019, 10:41:22 EST Position: +037.322289° / -080.553079° (±16.4ft) Altitude: 2099ft (±19.8ft) Datum: WGS-84 Azimuth/Bearing: 308° N52W 5476mils True (±10°) Elevation Angle: -40.6° Horizon Angle: +03.6° Zoom: 1.0x Sta#10931+00 - SSF fabric down</p>			
GPS Location	See photo GPS		GPS Location	See photo GPS	
Field Station#	10965+00		Field Station#	10931+00	
Pic 5 Desc.	Karst and Karst ECD's and sensitive resource signage are in acceptable condition.		Pic 6 Desc.	SSF fabric is torn & detached from chain link at Doe Creek RCE extra work space.

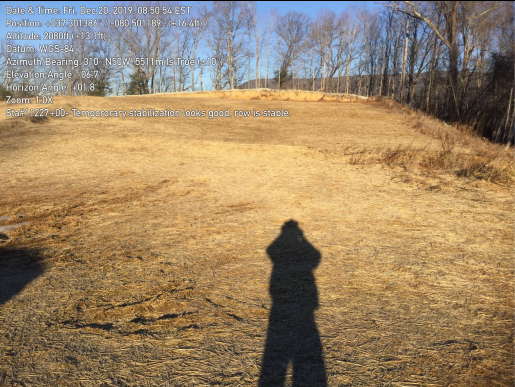
GPS Location	See photo GPS	GPS Location	See photo GPS		
Field Station#	11225+00	Field Station#	11227+00		
Pic 1 Desc.	Rock channel is in acceptable condition	Pic 2 Desc.	Temporary stabilization is acceptable, row is stable.

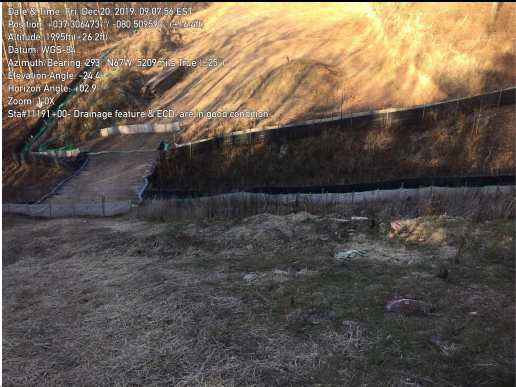
GPS Location	See photo GPS	GPS Location	See photo GPS		
Field Station#	11191+00	Field Station#	11184+50		
Pic 3 Desc.	Drainage feature and ECD's are in acceptable condition.	Pic 4 Desc.	AR- 249.02- Is maintained in acceptable condition.

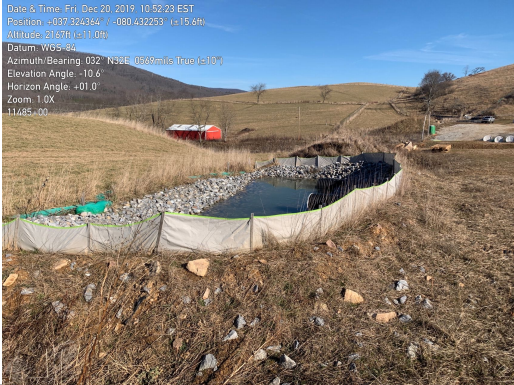
GPS Location		See photo for GPS location.		GPS Location	
Field Station#		11485+00		Field Station#	
Pic 3 Desc.		Plunge pool and clean water drainage pipe in place.		Pic 4 Desc.
