# Visual Site Inspection Report

<b>Project Name</b>	H-600 Pipeline Spread G	<b>AFE</b>	124300137	<b>Spread</b>	H-600 Pipeline Spread G
<b>Contractor</b>	Precision			<b>Report #</b>	6258
<b>Inspector</b>	Garrett Barclay			<b>Date/Time</b>	12/2/2019 7:59 AM
<b>Permit #</b>	TBD	<b>Inspection Type</b>	VA SWPP	<b>Station Begin</b>	11520+00
<b>State</b>	VA	<b>Inspection Area</b>	Partial	<b>Station End</b>	11620+00
<b>County</b>	Giles	<b>Ground</b>	Wet	<b>Temperature (°F)</b>	28.00
<b>Municipality</b>	N/A	<b>Weather</b>	Sunny	<b>Rain Gauge (in)</b>	1.60
				<b>Rain Accumulation Time (days)</b>	1.00

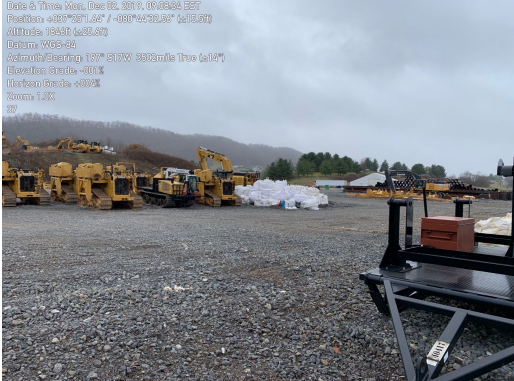
<p>Date &amp; Time: Mon, Dec 02, 2019, 08:12:43 EST Position: +37°25'1.91" / -83°44'28.25" (419.41) Altitude: 1844ft (+11.21) Datum: WGS-84 Azimuth/Bearing: 054° N 54E 0760mils True (51°) Elevation Grade: -007% Horizon Grade: +002% Zoom: 1.0X 1.4" @ 37</p>			
<b>GPS Location</b>	See picture above for GPS coordinates	<b>GPS Location</b>	See picture above for GPS coordinates		
<b>Field Station#</b>	+37	<b>Field Station#</b>	+37		
<b>Pic 1 Desc.</b>	ECD's and row conditions	<b>Pic 2 Desc.</b>	1.4" of rain recorded

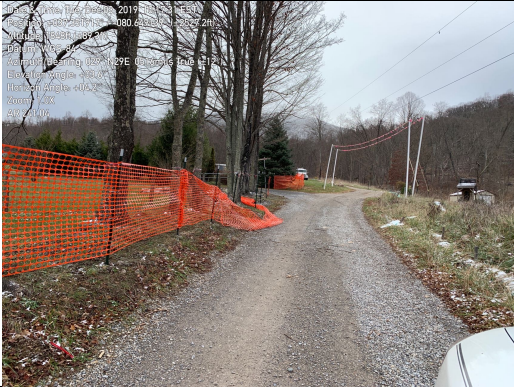
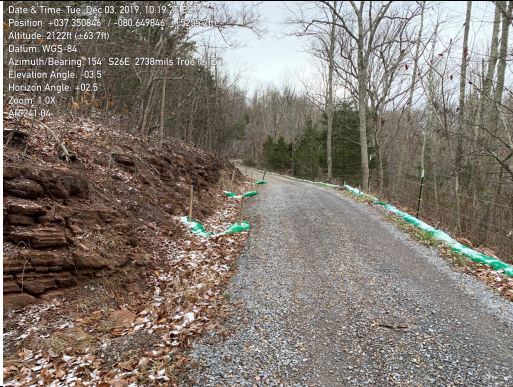
<b>GPS Location</b>	See photo for GPS location.		<b>GPS Location</b>	See photo for GPS location.	
<b>Field Station#</b>	12005+00		<b>Field Station#</b>	12005+00	
<b>Pic 1 Desc.</b>	Safety fence blow off stakes. Contractor informed and agreed to repair safety fence.		<b>Pic 2 Desc.</b>	Compost filter sock check in place in bar ditch along AR 241.04.

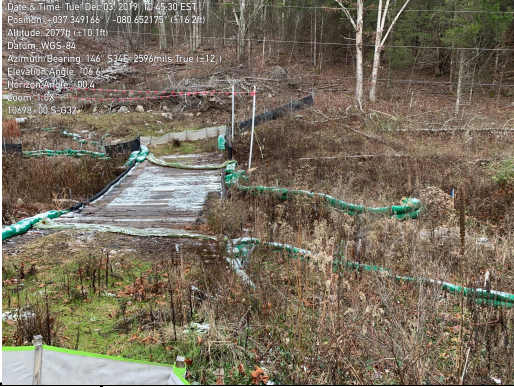
<b>GPS Location</b>	See photo for GPS location.		<b>GPS Location</b>	See photo for GPS location.	
<b>Field Station#</b>	10698+00		<b>Field Station#</b>	10696+00	
<b>Pic 5 Desc.</b>	Sensitive resource buffer in place at stream S-G32.		<b>Pic 6 Desc.</b>	RCE in place at Buffalo Anklets Road.

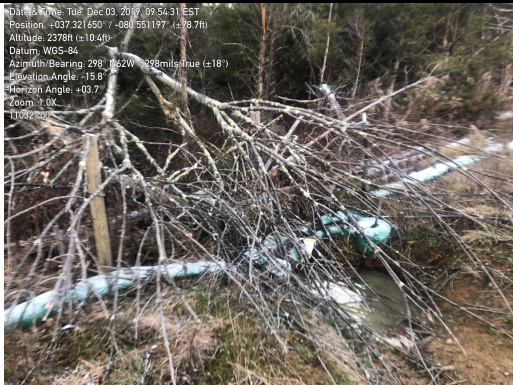
<p>Date &amp; Time: Tue Dec 03 2019 09:54:31 EST Position: +037.321650 / -080.551197 (+19.7ft) Altitude: 2378ft (+10.4ft) Datum: WGS-84 Azimuth/Bearing: 298° N22W 038mils True (±18°) Elevation Angle: -15.8° Horizon Angle: -03.7° Zoom: 1.0x 11032+00</p>			
GPS Location	1	GPS Location	2		
Field Station#	11026+00	Field Station#	11032+00		
Pic 1 Desc.	S-IJ18.	Pic 2 Desc.	Downed tree from off RoW that damaged the barbed wire fence on the edge of the RoW LoD.

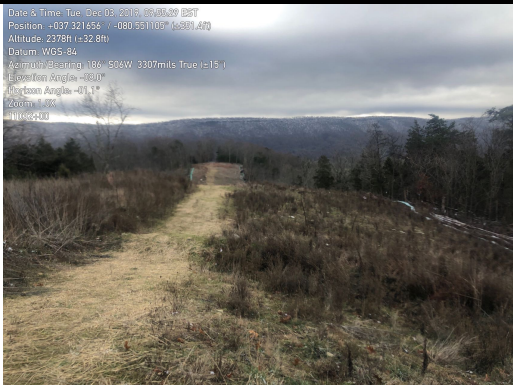
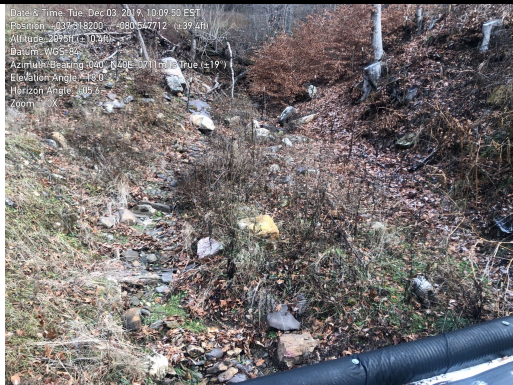
GPS Location	3	GPS Location	4		
Field Station#	11032+00	Field Station#	11050+14		
Pic 3 Desc.	Stabilization/vegetation.	Pic 4 Desc.	S-IJ16 11050+14, S-IJ17 11050+10.

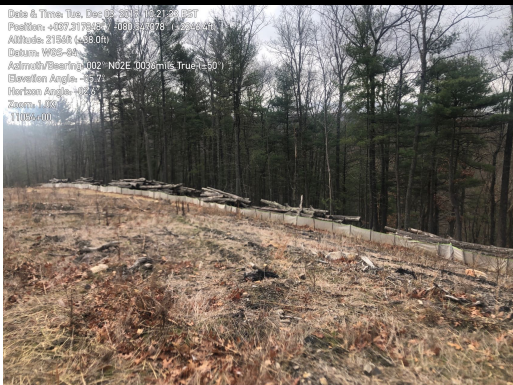
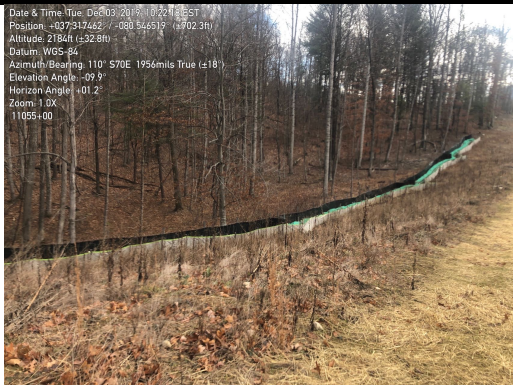
<p>Date &amp; Time: Tue Dec 03 2019 10:22:13 EST Position: +037.317400 / -080.550716 (+19.7ft) Altitude: 2150ft (+8.2ft) Datum: WGS-84 Azimuth/Bearing: 110° S70E 1956mils True (±18°) Elevation Angle: -09.9° Horizon Angle: -01.2° Zoom: 1.0x 11055+00</p>			
GPS Location	5	GPS Location	6		
Field Station#	11054+00	Field Station#	11055+00		
Pic 5 Desc.	P-1 perimeter controls in good condition.	Pic 6 Desc.	Karst: ECDs functional

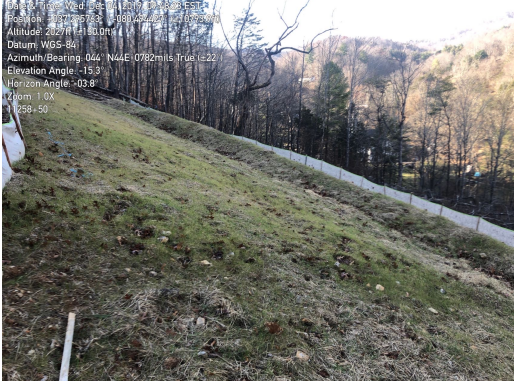
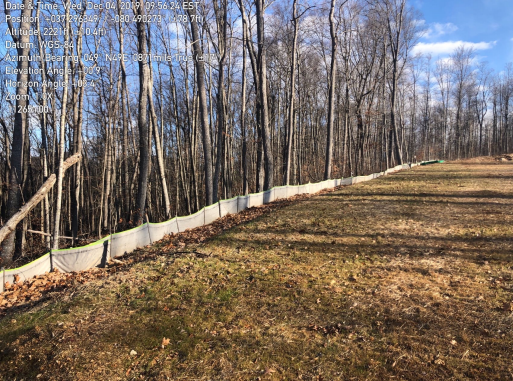
<b>GPS Location</b>	1	<b>GPS Location</b>	2		
<b>Field Station#</b>	11258+50	<b>Field Station#</b>	11265+00		
<b>Pic 1 Desc.</b>	Temporary stabilization.	<b>Pic 2 Desc.</b>	P-1 perimeter control in good condition.

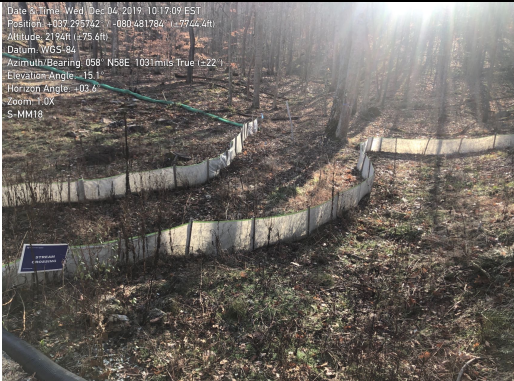
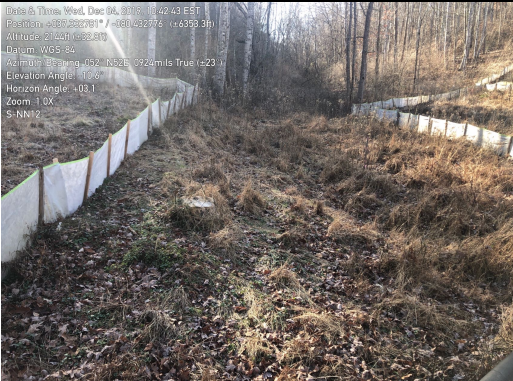
<b>GPS Location</b>	3	<b>GPS Location</b>	4		
<b>Field Station#</b>	11292+80	<b>Field Station#</b>	11327+85		
<b>Pic 3 Desc.</b>	S-MM18	<b>Pic 4 Desc.</b>	S-NN12.

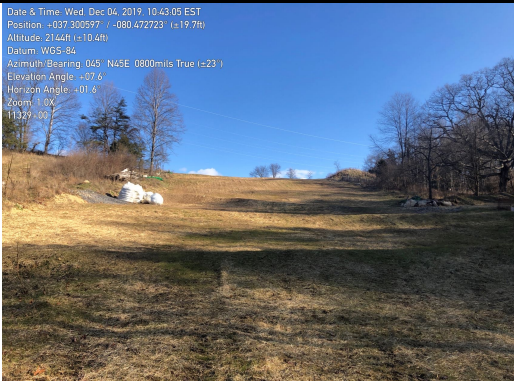
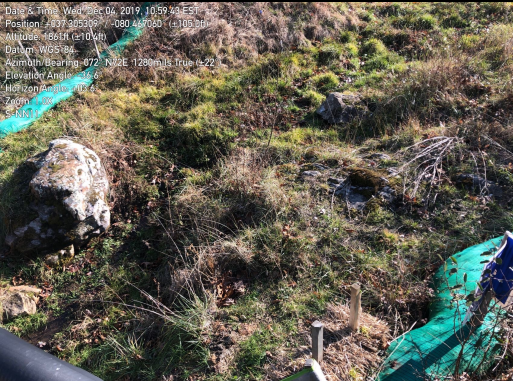
<b>GPS Location</b>	5	<b>GPS Location</b>	6		
<b>Field Station#</b>	11329+00	<b>Field Station#</b>	11352+97		
<b>Pic 5 Desc.</b>	Temporary stabilization.	<b>Pic 6 Desc.</b>	S-NN11.

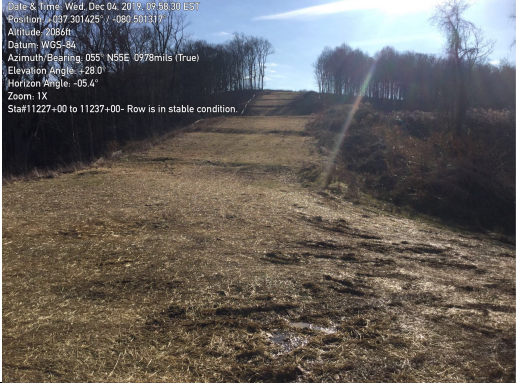
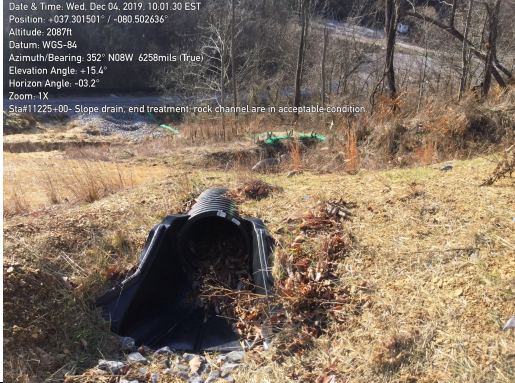
<b>GPS Location</b>	See photo GPS		<b>GPS Location</b>	See photo GPS	
<b>Field Station#</b>	11227+00		<b>Field Station#</b>	11225+00	
<b>Pic 1 Desc.</b>	Row temporary stabilization is acceptable.		<b>Pic 2 Desc.</b>	Slope drain, sump, end treatment, and rock channel are in acceptable condition.

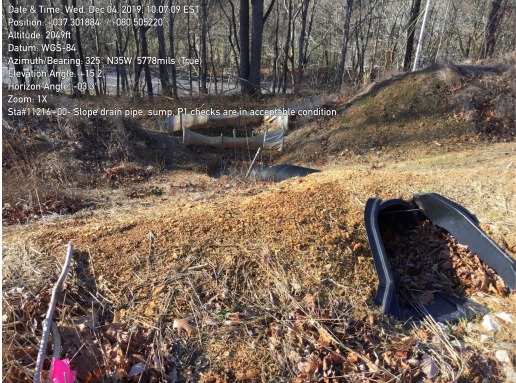
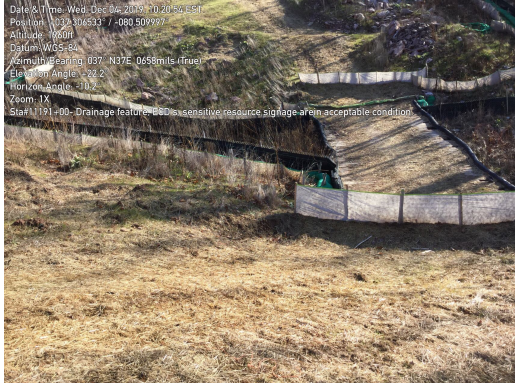
<b>GPS Location</b>	See photo GPS		<b>GPS Location</b>	See photo GPS	
<b>Field Station#</b>	11216+00		<b>Field Station#</b>	11191+00	
<b>Pic 3 Desc.</b>	Slope drain, P1 checks, sump and end treatment are in acceptable condition.		<b>Pic 4 Desc.</b>	Equipment bridge, drainage feature and ECD's, and sensitive resource signage are in acceptable condition.

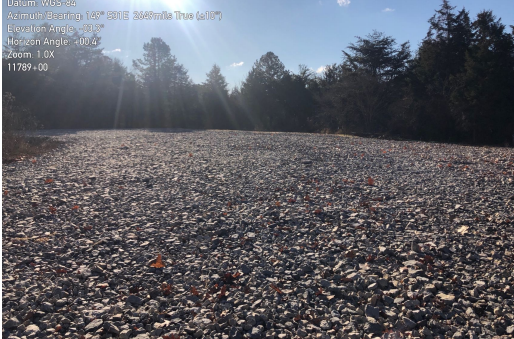
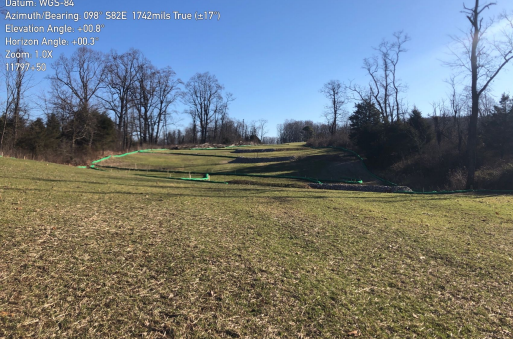
<b>GPS Location</b>	1	<b>GPS Location</b>	2		
<b>Field Station#</b>	11789+00	<b>Field Station#</b>	11797+50		
<b>Pic 1 Desc.</b>	RCE off of Mt Tabor rd.		<b>Pic 2 Desc.</b>	Restored RoW.	
<p>Date &amp; Time: Thu, Dec 05, 2019, 10:07:16 EST  Position: +037.295796° / -080.352689° (+52.5ft)  Altitude: 2198ft (+10.4ft)  Datum: WGS-84  Azimuth/Bearing: 225° S45W 4000mils True (+17.1)  Elevation Angle: +01.0°  Horizon Angle: +01.5°  Zoom: 1.0X  11814+75</p>  		<p>Date &amp; Time: Thu, Dec 05, 2019, 10:10:31 EST  Position: +037.299766° / -080.348495° (+52.5ft)  Altitude: 2161ft (+10.4ft)  Datum: WGS-84  Azimuth/Bearing: 180° S24W 3297mils True (+23.1)  Elevation Angle: +01.0°  Horizon Angle: +00.8°  Zoom: 1.0X  11841+00</p>

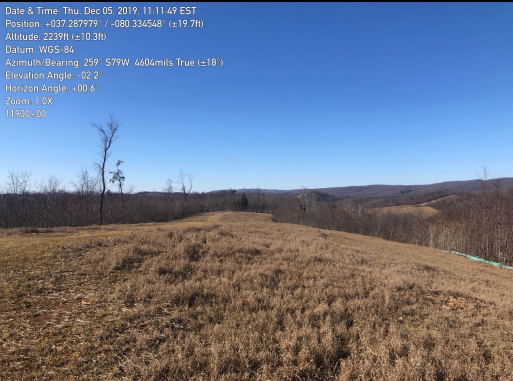
<b>GPS Location</b>	5	<b>GPS Location</b>	6		
<b>Field Station#</b>	111863+65	<b>Field Station#</b>	11900+00		
<b>Pic 5 Desc.</b>	P-KL2.		<b>Pic 6 Desc.</b>	Restored RoW.

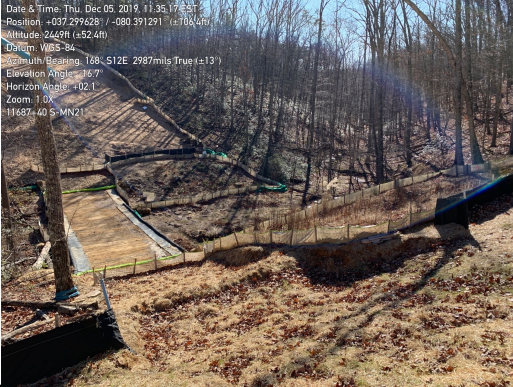
<p>Date &amp; Time: Thu, Dec 05, 2019 11:35:17 EST Position: +037.299628° / -080.391291° (+23.4m) Altitude: 2449ft (+52.4m) Datum: WGS-84 Azimuth/Bearing: 168° S12E 2987mils True (±13°) Elevation Angle: -16.7° Horizon Angle: +02.1° Zoom: 1.0X 11687+40 S-MN21</p>			
<b>GPS Location</b>	See photo for GPS location.		<b>GPS Location</b>	See photo for GPS location.	
<b>Field Station#</b>	11747+00		<b>Field Station#</b>	11687+40	
<b>Pic 3 Desc.</b>	ROW has been stabilized with seed and mulch. Minor vegetation growth present. Waterbar, sump pit, and end treatment in place.		<b>Pic 4 Desc.</b>	Sensitive resource buffer in place at stream S-MN21.

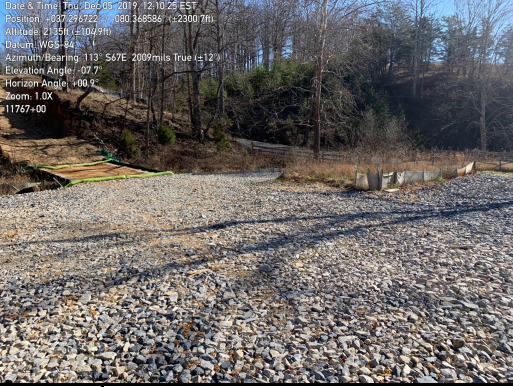
<p>Date &amp; Time: Thu, Dec 05, 2019 12:10:25 EST Position: +037.299628° / -080.391291° (+23.4m) Altitude: 2134ft (+59.1m) Datum: WGS-84 Azimuth/Bearing: 113° S67E 2009mils True (±12°) Elevation Angle: -07.7° Horizon Angle: +06.2° Zoom: 1.0X 11767+00</p>			
<b>GPS Location</b>	See photo for GPS location.		<b>GPS Location</b>	See photo for GPS location.	
<b>Field Station#</b>	11759+00		<b>Field Station#</b>	11767+00	
<b>Pic 5 Desc.</b>	Reinforced super silt fence in place along LOD.		<b>Pic 6 Desc.</b>	RCE in place at Main Line Valve 26.
