# Visual Site Inspection Report

<b>Project Name</b>	H-600 Pipeline Spread G	<b>AFE</b>	124300137	<b>Spread</b>	H-600 Pipeline Spread G
<b>Contractor</b>	Precision			<b>Report #</b>	6958
<b>Inspector</b>	Brian Shields			<b>Date/Time</b>	12/30/2019 8:37 AM
<b>Permit #</b>	TBD	<b>Inspection Type</b>	VA SWPP	<b>Station Begin</b>	11254+88
<b>State</b>	VA	<b>Inspection Area</b>	Partial	<b>Station End</b>	11158+12
<b>County</b>	Giles	<b>Ground</b>	Wet	<b>Temperature (°F)</b>	55.00
<b>Municipality</b>	N/A	<b>Weather</b>	Cloudy	<b>Rain Gauge (in)</b>	0.10
				<b>Rain Accumulation Time (days)</b>	1.00

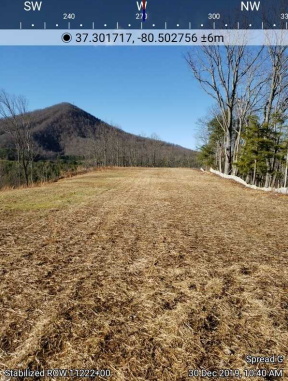
<b>GPS Location</b>	see photo		<b>GPS Location</b>	see photo	
<b>Field Station#</b>	11222+00		<b>Field Station#</b>	11218+50	
<b>Pic 1 Desc.</b>	stabilized ROW conditions		<b>Pic 2 Desc.</b>	installed waterbar, no maintenance needed

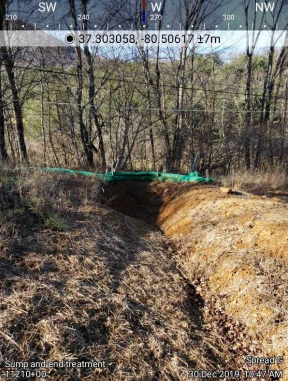
<b>GPS Location</b>	see photo		<b>GPS Location</b>	see photo	
<b>Field Station#</b>	11210+00		<b>Field Station#</b>	11185+00	
<b>Pic 3 Desc.</b>	installed sump and end treatment		<b>Pic 4 Desc.</b>	installed plunge pool

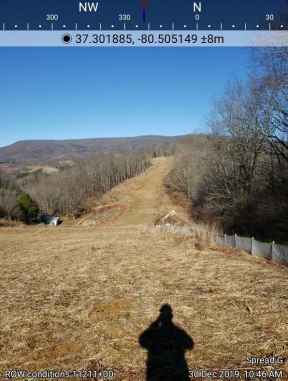
<b>GPS Location</b>	see photo		<b>GPS Location</b>	see photo	
<b>Field Station#</b>	11211+00		<b>Field Station#</b>	11201+50	
<b>Pic 5 Desc.</b>	stabilized ROW conditions		<b>Pic 6 Desc.</b>	installed sump and end treatment

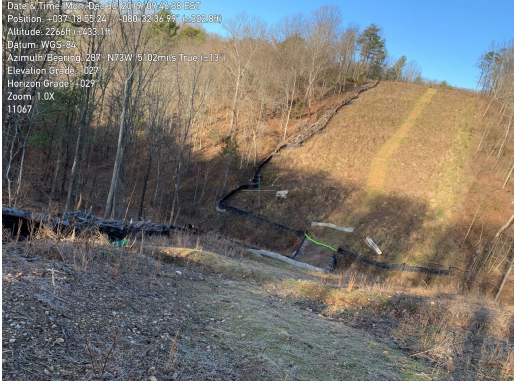
<b>GPS Location</b>		See picture above for GPS coordinates		<b>GPS Location</b>	
<b>Field Station#</b>		11067+00		<b>Field Station#</b>	
<b>Pic 1 Desc.</b>		ECD's and row conditions		<b>Pic 2 Desc.</b>

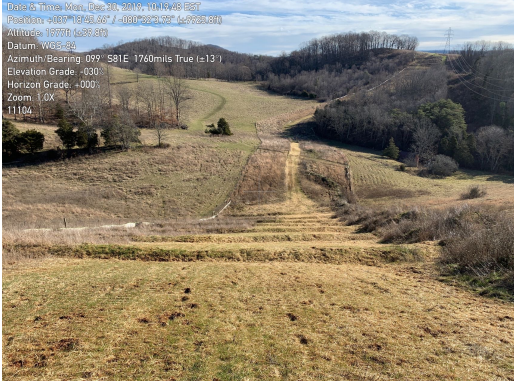
<b>GPS Location</b>		See picture above for GPS coordinates		<b>GPS Location</b>	
<b>Field Station#</b>		11104+00		<b>Field Station#</b>	
<b>Pic 3 Desc.</b>		ECD's and row conditions		<b>Pic 4 Desc.</b>

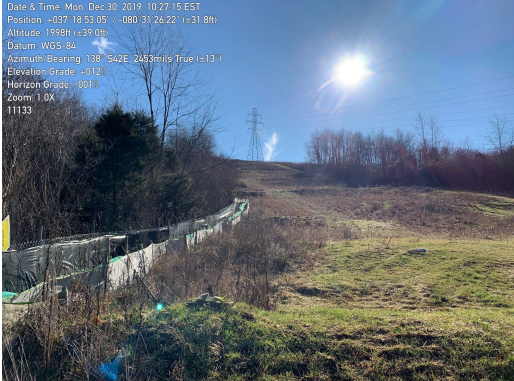
<b>GPS Location</b>		See picture above for GPS coordinates		<b>GPS Location</b>	
<b>Field Station#</b>		11133+00		<b>Field Station#</b>	
<b>Pic 5 Desc.</b>		ECD's and row conditions		<b>Pic 6 Desc.</b>	
				.1" @ Buffalo Anklets

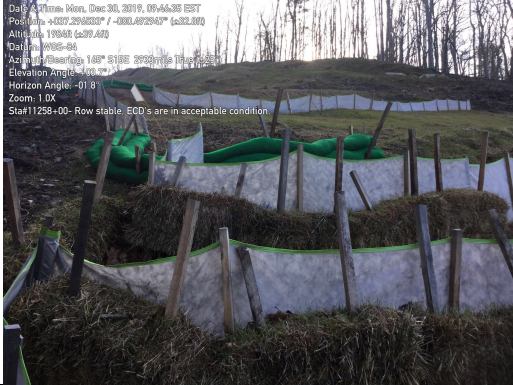
<p>Date &amp; Time: Mon, Dec 30, 2019, 09:44:35 EST Position: +402.256523° / -80.8492943° (+32.20) Altitude: 1954ft (+59.40) Datum: WGS-84 Azimuth/Bearing: 148° S10E 200mils True (+25) Elevation Angle: -10.1° Horizon Angle: -01.8° Zoom: 1.0X Sta#11258+00- Row stable. ECD's are in acceptable condition.</p>

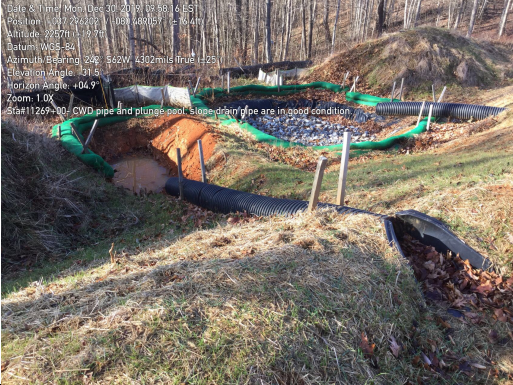
<p>Date &amp; Time: Mon, Dec 30, 2019, 09:58:16 EST Position: +402.256523° / -80.8492943° (+32.20) Altitude: 1977ft (+60.40) Datum: WGS-84 Azimuth/Bearing: 226° S42W 430mils True (+25) Elevation Angle: -31.5° Horizon Angle: +04.9° Zoom: 1.0X Sta#11269+00- CWD pipe and plunge pool. Slope drain pipe are in good condition.</p>			
GPS Location	See photo GPS		GPS Location	See photo GPS	
Field Station#	11258+00		Field Station#	11269+00	
Pic 1 Desc.	Row and ECD's are in acceptable condition.		Pic 2 Desc.	Slope drain pipe, sump, CWD pipe & plunge pool are in good condition.

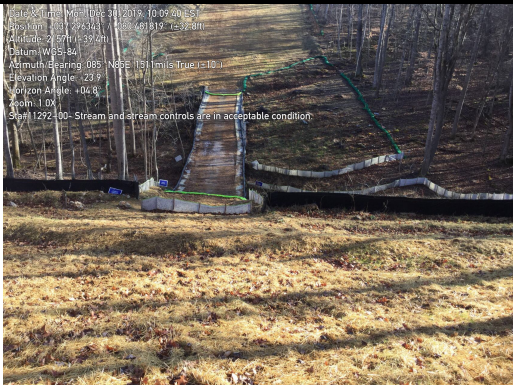
<p>Date &amp; Time: Mon, Dec 30, 2019, 10:09:20 EST Position: +402.256523° / -80.8492943° (+32.20) Altitude: 2157ft (+66.40) Datum: WGS-84 Azimuth/Bearing: 085° N85E 151mils True (+10.1) Elevation Angle: -23.9° Horizon Angle: +04.8° Zoom: 1.0X Sta#11292+00- Stream and stream controls are in acceptable condition.</p>

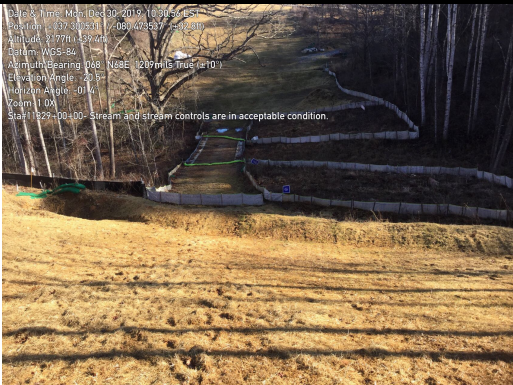
<p>Date &amp; Time: Mon, Dec 30, 2019, 10:09:51 EST Position: +402.256523° / -80.8492943° (+32.20) Altitude: 2177ft (+66.40) Datum: WGS-84 Azimuth/Bearing: 085° N85E 140mils True (+10.1) Elevation Angle: -23.9° Horizon Angle: -01.4° Zoom: 1.0X Sta#11329+00- Stream and stream controls are in acceptable condition.</p>			
GPS Location	See photo GPS		GPS Location	See photo GPS	
Field Station#	11292+00		Field Station#	11329+00	
Pic 3 Desc.	Stream and controls are in acceptable condition		Pic 4 Desc.	Stream and environmental controls are in acceptable condition.

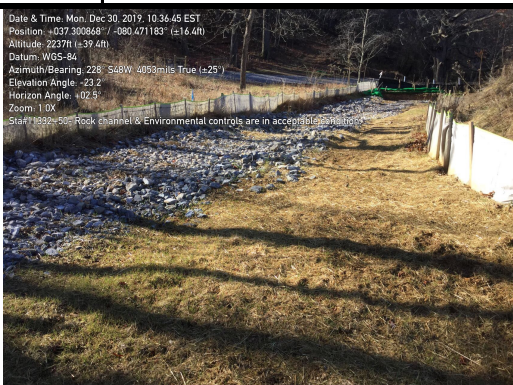
<p>Date &amp; Time: Mon, Dec 30, 2019, 10:36:45 EST Position: +402.256523° / -80.8492943° (+32.20) Altitude: 2237ft (+68.40) Datum: WGS-84 Azimuth/Bearing: 226° S46W 405mils True (+25) Elevation Angle: -23.2° Horizon Angle: +02.5° Zoom: 1.0X Sta#11332+50- Rock channel &amp; Environmental controls are in acceptable condition.</p>

GPS Location	See photo GPS		GPS Location	See photo GPS	
Field Station#	11332+50		Field Station#	11354+00	
Pic 5 Desc.	Rock channel is in acceptable condition.		Pic 6 Desc.	Cut bank has been stabilized with erosion blanket.

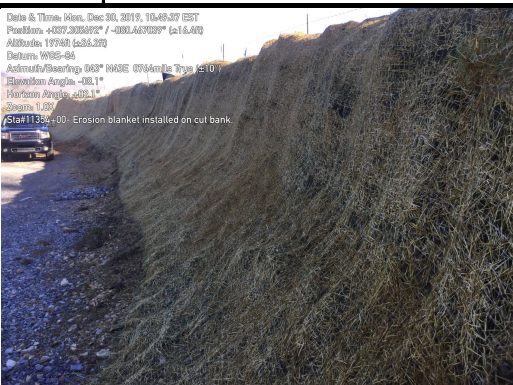
<p>Date &amp; Time: Mon, Dec 30, 2019, 10:46:37 EST Position: +402.256523° / -80.8492943° (+32.20) Altitude: 1974ft (+59.40) Datum: WGS-84 Azimuth/Bearing: 063° N43E 874mils True (+10.1) Elevation Angle: -08.1° Horizon Angle: +08.1° Zoom: 1.0X Sta#11354+00- Erosion blanket installed on cut bank.</p>

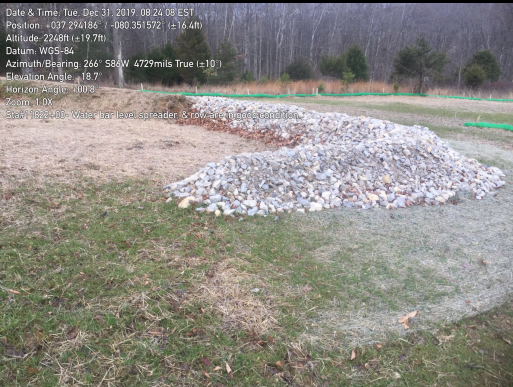
<p>Date &amp; Time: Tue, Dec 31, 2019, 08:24:08 EST Position: +037.294188, -100.351572 (+16.4ft) Altitude: 2248ft (+19.7ft) Datum: WGS-84 Azimuth/Bearing: 266° S86W 4729mils True (±10°) Elevation Angle: -18.7° Horizon Angle: -100.0° Zoom: 1.0x Star 11822+00 - Water bar level spreader &amp; row spreader in good condition.</p>		<p><b>GPS Location</b> See photo GPS</p> <p><b>Field Station#</b> 11789+00</p> <p><b>Pic 1 Desc.</b> Tabor RCE is maintained in acceptable condition.</p>

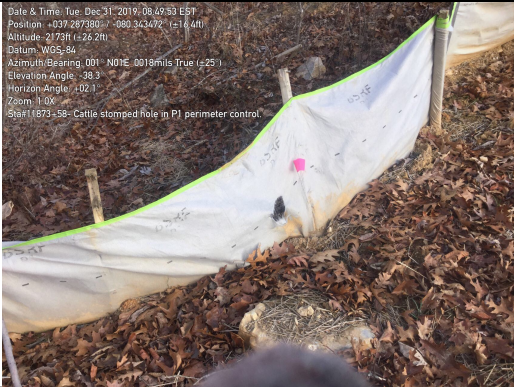
<p>Date &amp; Time: Tue, Dec 31, 2019, 08:49:53 EST Position: +039.287980, -100.342472 (+16.4ft) Altitude: 2173ft (+26.2ft) Datum: WGS-84 Azimuth/Bearing: 001° N01E 0018mils True (±25°) Elevation Angle: -38.3° Horizon Angle: -102.1° Zoom: 1.0x Star 11873+58 - Cattle stomped hole in P1 perimeter control.</p>

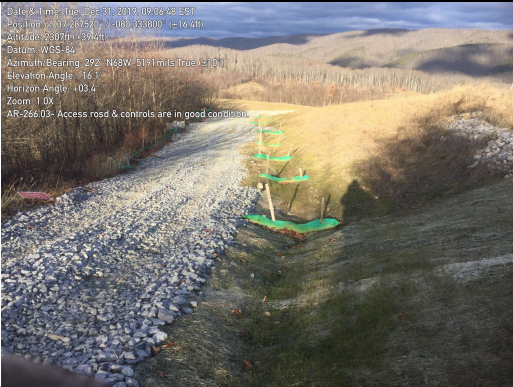
<p>Date &amp; Time: Tue, Dec 31, 2019, 09:04:41 EST Position: +037.283570, -100.333800 (+16.4ft) Altitude: 2307ft (+39.4ft) Datum: WGS-84 Azimuth/Bearing: 292° N88W 5181mils True (±10°) Elevation Angle: -16.1° Horizon Angle: -103.4° Zoom: 1.0x AR-266.03 - Access road &amp; controls are in good condition.</p>		<p><b>GPS Location</b> See photo GPS</p> <p><b>Field Station#</b> 11822+00</p> <p><b>Pic 2 Desc.</b> Level spreaders are in good condition.</p>

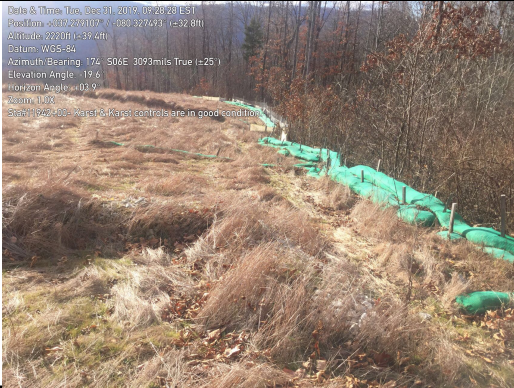
<p>Date &amp; Time: Tue, Dec 31, 2019, 09:26:28 EST Position: +039.288110, -100.347673 (+32.8ft) Altitude: 2220ft (+39.4ft) Datum: WGS-84 Azimuth/Bearing: 174° S06E 3093mils True (±25°) Elevation Angle: -19.6° Horizon Angle: -101.9° Zoom: 1.0x Star 11942+00 - Karst and Karst ECD's controls are in good condition.</p>

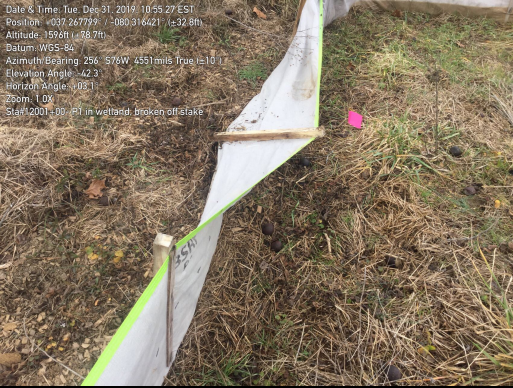
<p>Date &amp; Time: Tue, Dec 31, 2019, 10:55:27 EST Position: +039.287799, -100.316421 (+32.8ft) Altitude: 1506ft (+8.7ft) Datum: WGS-84 Azimuth/Bearing: 256° S76W 4551mils True (±10°) Elevation Angle: -42.3° Horizon Angle: -105.1° Zoom: 1.0x Star 12001+00 - P1 in wetland, broken off stake.</p>		<p><b>GPS Location</b> See photo GPS</p> <p><b>Field Station#</b> 11873+58</p> <p><b>Pic 3 Desc.</b> P1 perimeter controls has a hole in fabric and stake snapped off, caused by livestock.</p>

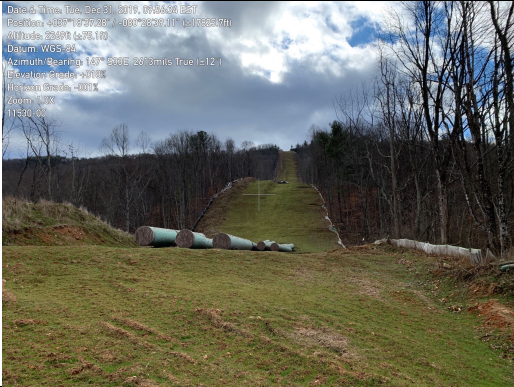
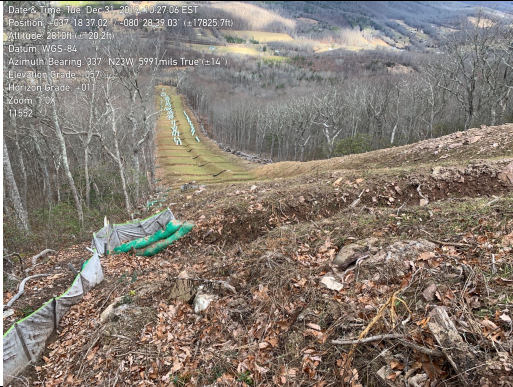
<b>GPS Location</b>	See picture above for GPS coordinates		<b>GPS Location</b>	See picture above for GPS coordinates	
<b>Field Station#</b>	11530+00		<b>Field Station#</b>	11552+00	
<b>Pic 1 Desc.</b>	ECD's and row conditions		<b>Pic 2 Desc.</b>	ECD's and row conditions

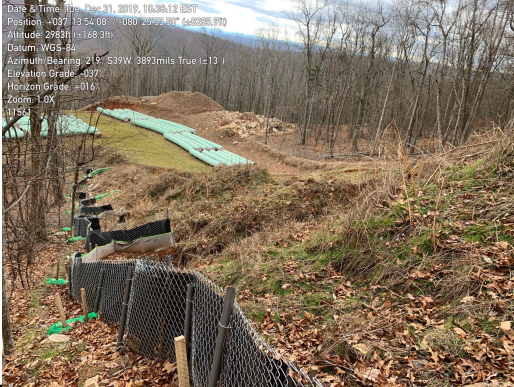
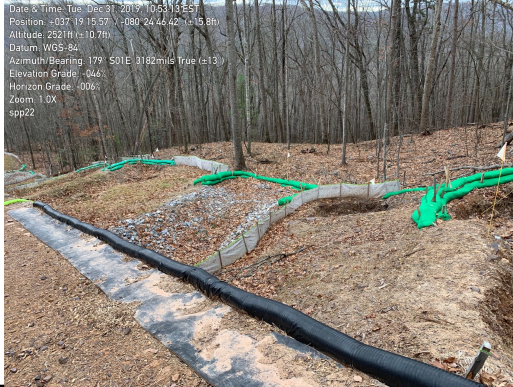
<b>GPS Location</b>	See picture above for GPS coordinates		<b>GPS Location</b>	See picture above for GPS coordinates	
<b>Field Station#</b>	11561+00		<b>Field Station#</b>	11580+00	
<b>Pic 3 Desc.</b>	ECD's and row conditions		<b>Pic 4 Desc.</b>	ECD's and row conditions

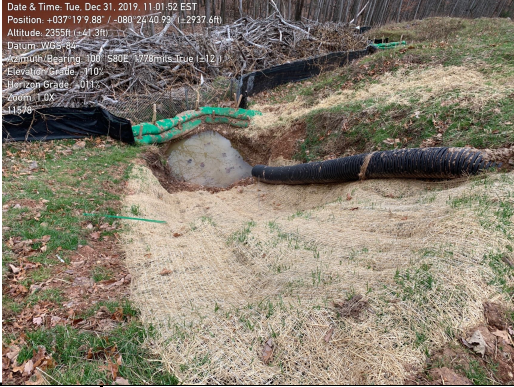
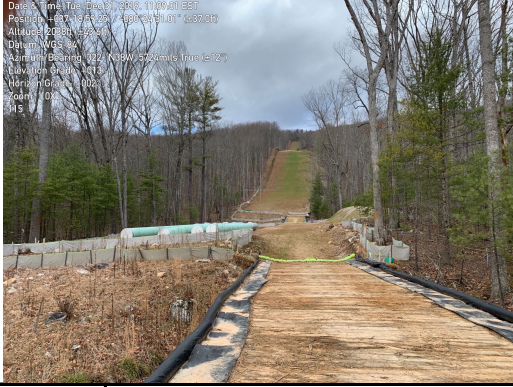
<b>GPS Location</b>	See picture above for GPS coordinates		<b>GPS Location</b>	See picture above for GPS coordinates	
<b>Field Station#</b>	11578+00		<b>Field Station#</b>	11620+00	
<b>Pic 5 Desc.</b>	ECD's and row conditions		<b>Pic 6 Desc.</b>	ECD's and row conditions

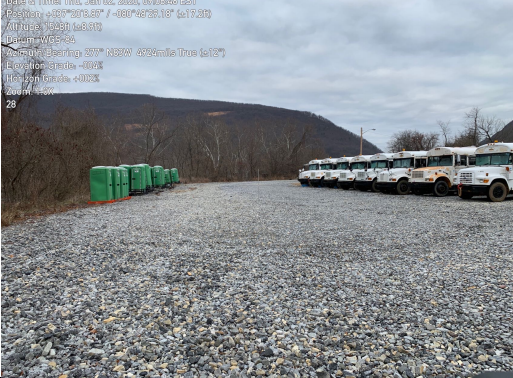
<p>Date &amp; Time: Thu Jan 02, 2020 09:45:43 EST Position: +43°20'12.68" N -080°43'39.10" W (4319.370) Altitude: 1735ft (529m) Datum: WGS-84 Azimuth/Bearing: 32° N34W 4022mils True (416°) Elevation Grade: +01% Horizon Grade: +0.01% Zoom: 1.0X 28</p>		<b>GPS Location</b> See picture above for GPS coordinates <b>Field Station#</b> +28 <b>Pic 1 Desc.</b> ECD's and row conditions

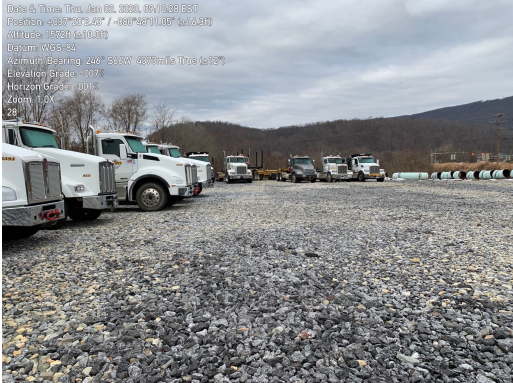
<p>Date &amp; Time: Thu Jan 02, 2020 09:45:43 EST Position: +43°20'12.68" N -080°43'39.10" W (4319.370) Altitude: 1735ft (529m) Datum: WGS-84 Azimuth/Bearing: 34° N34W 4022mils True (416°) Elevation Grade: +01% Horizon Grade: +0.01% Zoom: 1.0X 28</p>		<b>GPS Location</b> See picture above for GPS coordinates <b>Field Station#</b> +28 <b>Pic 3 Desc.</b> ECD's and row conditions

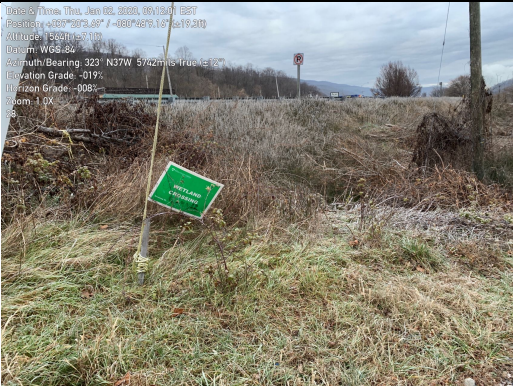
<p>Date &amp; Time: Thu Jan 02, 2020 09:45:43 EST Position: +43°20'12.68" N -080°43'39.10" W (4319.370) Altitude: 1543ft (470m) Datum: WGS-84 Azimuth/Bearing: 32° N37W 5742mils True (416°) Elevation Grade: +01% Horizon Grade: +0.01% Zoom: 1.0X 28</p>		<b>GPS Location</b> See picture above for GPS coordinates <b>Field Station#</b> +28 <b>Pic 5 Desc.</b> ECD's and row conditions

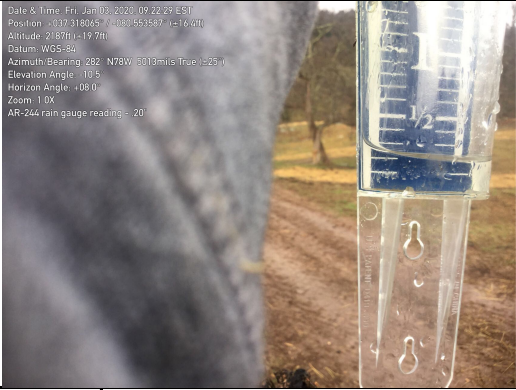
<p>Date &amp; Time: Fri Jan 03, 2020 09:30:42 EST  Position: +037.318042, +052.551587, +16.0111  Altitude: +268ft (+25.0m)  Datum: WGS-84  Azimuth/Bearing: 292, N85W, 0.13mils True (+25)  Elevation Angle: -10.8  Horizon Angle: +05.6  Zoom: 1.0x  Stream S-RR5- stan11017+00- Stream &amp; environmental controls are in acceptable condition.</p>

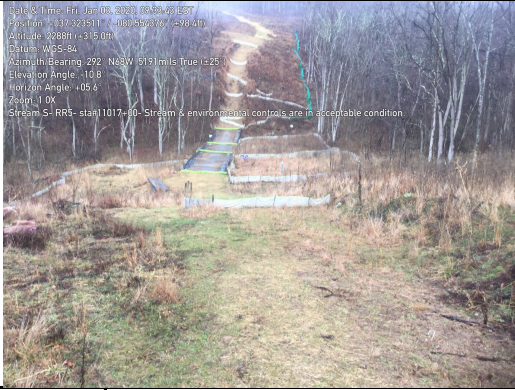
<b>GPS Location</b>	See photo GPS	<b>GPS Location</b>	See photo GPS		
<b>Field Station#</b>	11024+00	<b>Field Station#</b>	11017+00		
<b>Pic 1 Desc.</b>	AR-244 rain gauge reading- .20"	<b>Pic 2 Desc.</b>	11017- Stream S- RR5- Stream & environment controls are in acceptable condition.

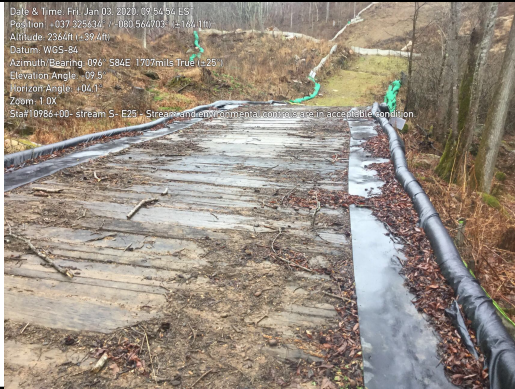
<b>GPS Location</b>	See photo GPS	<b>GPS Location</b>	See photo GPS		
<b>Field Station#</b>	10987+00	<b>Field Station#</b>	10986+00		
<b>Pic 3 Desc.</b>	Steep slope ECD's are in acceptable condition.	<b>Pic 4 Desc.</b>	Stream S -E25 is in acceptable condition.

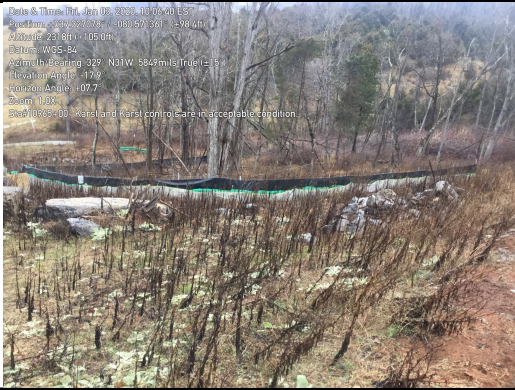
<b>GPS Location</b>	See photo GPS	<b>GPS Location</b>	See photo GPS		
<b>Field Station#</b>	10985+00	<b>Field Station#</b>	10965+00		
<b>Pic 5 Desc.</b>	Stream S-E24 is in acceptable condition	<b>Pic 6 Desc.</b>	Karst and Karst ECD's are in good condition

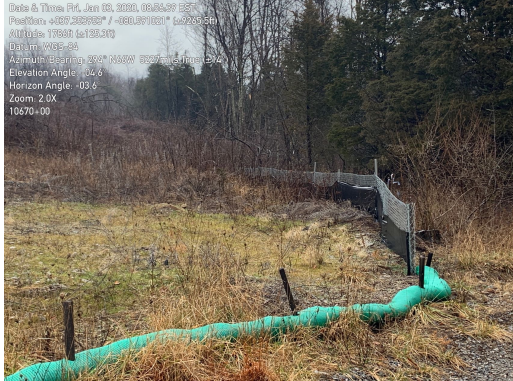
<p>Date &amp; Time: Fri, Jan 03, 2020, 08:55:59 EST Position: +037.349200° / -080.508600° (±19.2m) Altitude: 2065ft (±37.7m) Datum: WGS-84 Azimuth/Bearing: 07° N70W 1262mils True (±14°) Elevation Angle: -04.6° Horizon Angle: -03.6° Zoom: 2.0X 10670+00</p>			
GPS Location	See photo for GPS location.		GPS Location	See photo for GPS location.	
Field Station#	12005+00		Field Station#	10670+00	
Pic 1 Desc.	Rain gauge at access road 234 reads. 0.3 inches.		Pic 2 Desc.	Reinforced super silt fence in place along LOD.
