Visual Site Inspection Report

Project Name	H-600 Pipeline Spread G	AFE	124300137	Spread	H-600 Pipeline Spread G
Contractor	Precision			Report #	6475
Inspector	Chris Burns			Date/Time	12/9/2019 7:15 AM
Permit #	TBD	Inspection Type	VA SWPP	Station Begin	11024+00
State	VA	Inspection Area	Partial	Station End	11065+00
County	Giles	Ground	Wet	Temperature (°F)	50.00
Municipality	N/A	Weather	Light Rain	Rain Gauge (in)	0.30
				Rain Accumulation Time (days)	3.00

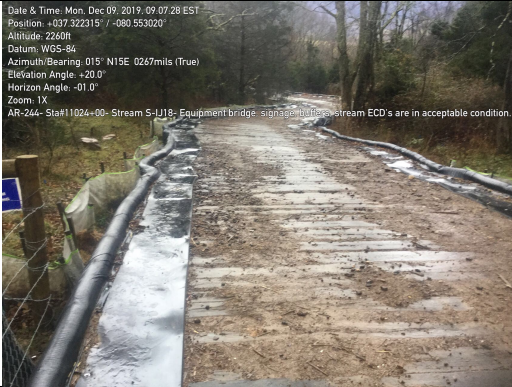
<p>Date & Time: Mon, Dec 09, 2019, 09:07:28 EST Position: +037.322315 / -080.553020 Altitude: 2260ft Datum: WGS-84 Azimuth/Bearing: 015° N15E 0267mils (True) Elevation Angle: +20.0° Horizon Angle: -01.0° Zoom: 1X AR-244- Sta#11024+00- Stream S-IJ18- Equipment bridge, sensitive resource signage, buffers. Stream ECD's are in acceptable condition.</p>

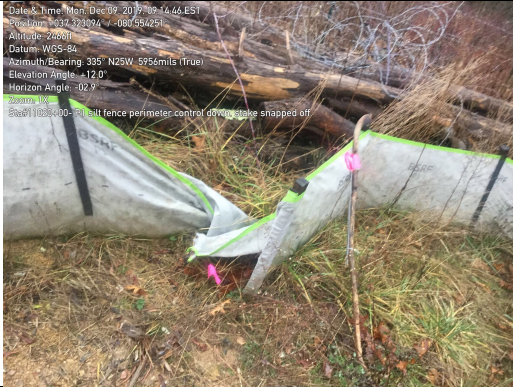
<p>Date & Time: Mon, Dec 09, 2019, 09:14:44 EST Position: +037.323794 / -080.554251 Altitude: 2403ft Datum: WGS-84 Azimuth/Bearing: 335° N25W 5956mils (True) Elevation Angle: +12.0° Horizon Angle: -02.9° Zoom: 1X Sta#11020+00- P1 salt fence perimeter control down, wooden stake snapped off.</p>			
GPS Location	See photo GPS		GPS Location	See photo GPS	
Field Station#	11024+00		Field Station#	11020+00	
Pic 1 Desc.	Stream S-IJ18- Equipment bridge, sensitive resource signage, buffers. Stream ECD's are in acceptable condition.		Pic 2 Desc.	P1 perimeter controls are are down, wooden stake snapped off

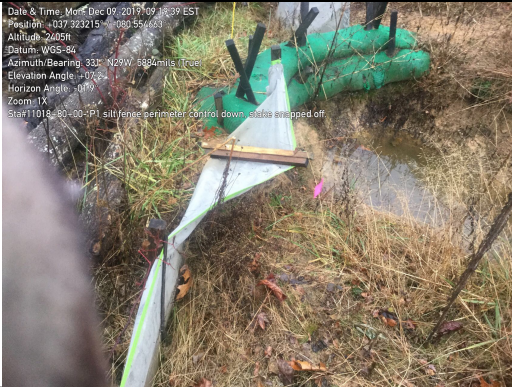
<p>Date & Time: Mon, Dec 09, 2019, 09:13:09 EST Position: +037.323215 / -080.554123 Altitude: 2405ft Datum: WGS-84 Azimuth/Bearing: 332° N25W 5904mils (True) Elevation Angle: +07.6° Horizon Angle: -01.9° Zoom: 1X Sta#11018+00- P1 salt fence perimeter control down, wooden stake snapped off.</p>

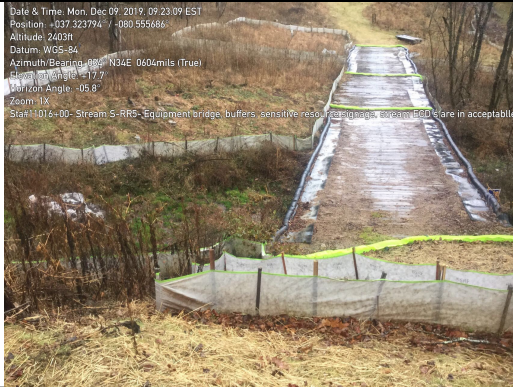
<p>Date & Time: Mon, Dec 09, 2019, 09:23:09 EST Position: +037.323794 / -080.555686 Altitude: 2403ft Datum: WGS-84 Azimuth/Bearing: 335° N25W 5904mils (True) Elevation Angle: +17.7° Horizon Angle: -05.8° Zoom: 1X Sta#11016+00- Stream S-RR5- Equipment bridge, buffers, sensitive resource signage, stream ECD's are in acceptable condition.</p>			
GPS Location	See photo GPS		GPS Location	See photo GPS	
Field Station#	11018+80		Field Station#	11016+00	
Pic 3 Desc.	P1 perimeter controls are down, wooden stake snapped off.		Pic 4 Desc.	Stream S-RR5- Equipment bridge, sensitive resource signage, buffers, stream ECD's are in acceptable condition.

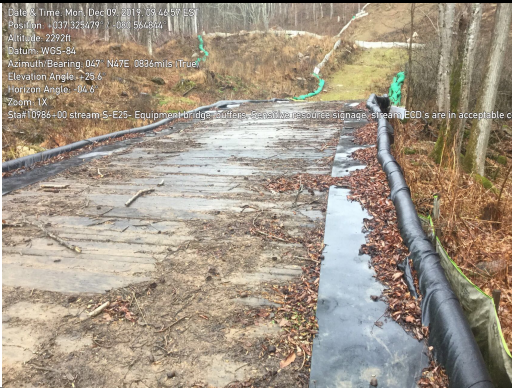
<p>Date & Time: Mon, Dec 09, 2019, 09:40:57 EST Position: +037.324075 / -080.560020 Altitude: 2220ft Datum: WGS-84 Azimuth/Bearing: 042° N47E 0396mils (True) Elevation Angle: +25.6° Horizon Angle: -02.9° Zoom: 1X Sta#10986+00 stream S-E25- Equipment bridge, buffers, sensitive resource signage, stream ECD's are in acceptable condition.</p>

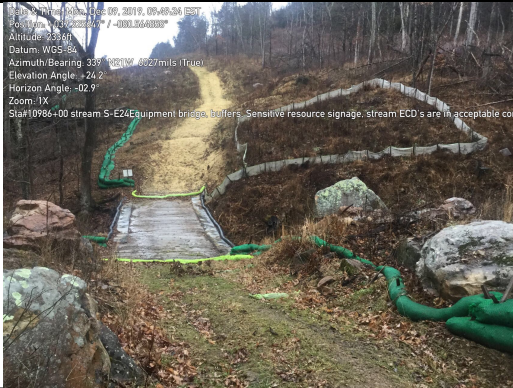
<p>Date & Time: Mon, Dec 09, 2019, 09:40:54 EST Position: +037.324075 / -080.560020 Altitude: 2220ft Datum: WGS-84 Azimuth/Bearing: 335° N25W 5902mils (True) Elevation Angle: +24.2° Horizon Angle: -02.9° Zoom: 1X Sta#10985+00 stream S-E24- Equipment bridge, buffers, sensitive resource signage, stream ECD's are in acceptable condition.</p>			
GPS Location	See photo GPS		GPS Location	See photo GPS	
Field Station#	10986+00		Field Station#	10985+00	
Pic 5 Desc.	Stream S-E25- Equipment bridge, buffers, stream ECD's. Sensitive resource signage are in acceptable condition.		Pic 6 Desc.	Stream S-E24- Equipment bridge, buffers, Stream ECD's, sensitive resource signage are in acceptable condition.

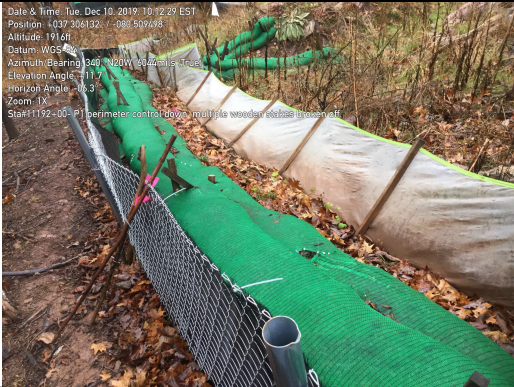
<p>Date & Time: Tue, Dec 10, 2019, 10:12:29 EST Position: +037 304132 / -080 509688 Altitude: 1916ft Datum: WGS-84 Azimuth/Bearing: 045° N60W 6844mils (True) Elevation Angle: +11.1° Horizon Angle: -03.3° Zoom: 1X Sta#11192+00- P1 perimeter control down, multiple wooden stakes broken off</p>

GPS Location	See photo GPS	GPS Location	See photo GPS		
Field Station#	11192+00	Field Station#	11217+00		
Pic 3 Desc.	Silt fence wooden stakes broken off, Contractor informed & will address today.	Pic 4 Desc.	Slope drain pipe, P1 check, sump & end treatment is in acceptable condition.		
  <p>Date & Time: Tue, Dec 10, 2019, 08:55:03 EST Position: +037 305269 / -080 507191 Altitude: 2032ft Datum: WGS-84 Azimuth/Bearing: 022° N22E 0391mils (True) Elevation Angle: +20.6° Horizon Angle: -05.0° Zoom: 1X Sta#11200+00- Row is stable, environmental controls acceptable</p>		  <p>Date & Time: Tue, Dec 10, 2019, 10:01:21 EST Position: +036 519117 / -080 511676 Altitude: 1968ft Datum: WGS-84 Azimuth/Bearing: 002° N02E 0030mils (True) Elevation Angle: +20.0° Horizon Angle: -01.6° Zoom: 1X Sta#11184+00- CWD pipe & plunge pool are in acceptable condition, along with ECD's</p>			
GPS Location	See photo GPS	GPS Location	See photo GPS

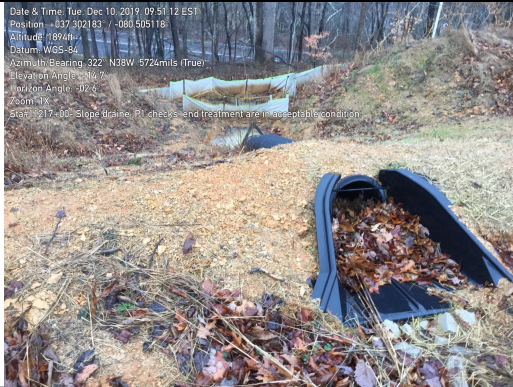
<p>Date & Time: Tue, Dec 10, 2019, 09:51:12 EST Position: +037 302183 / -080 505118 Altitude: 1894ft Datum: WGS-84 Azimuth/Bearing: 222° N38W 5724mils (True) Elevation Angle: +22.2° Horizon Angle: -02.4° Zoom: 1X Sta#11217+00- Slope drain, P1 check and treatment are in acceptable condition</p>

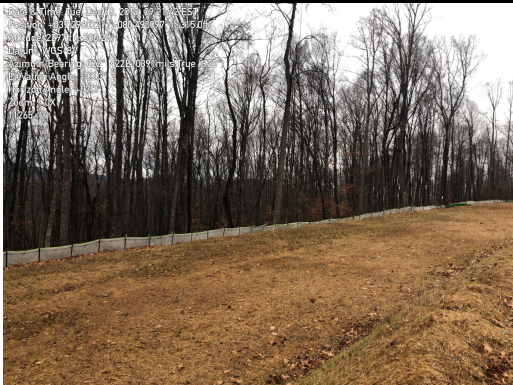
GPS Location	1	GPS Location	2		
Field Station#	11265+00	Field Station#	11280+00		
Pic 1 Desc.	P-1 perimeter controls in good condition.	Pic 2 Desc.	Perimeter control reinforced filter fabric fence in good condition.

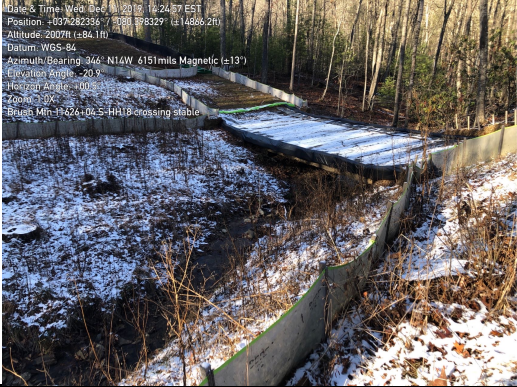
<p><small>Date & Time: Wed, Dec 11, 2019 16:24:57 EST Position: -037.282336 / -080.178329 / 14689.2ft Altitude: 2007ft (+84.1ft) Datum: WGS-84 Azimuth/Bearing: 346° N14W 615ft Magnetic (+13°) Elevation Angle: -20.9 Horizon Angle: -00.8 Zoom: 1.0x Brush Min 1424+04.5-HH18 crossing stable</small></p>

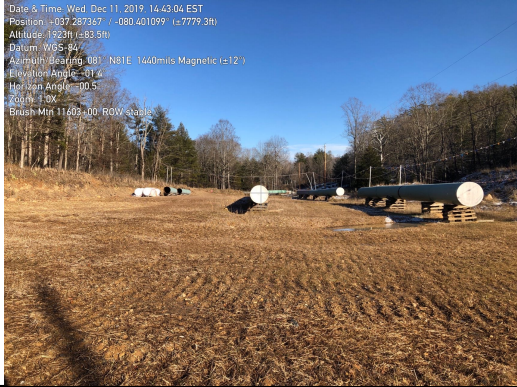
<p><small>Date & Time: Wed, Dec 11, 2019 14:43:04 EST Position: -037.287367 / -080.401099 / 14777.9ft Altitude: 1923ft (+89.3ft) Datum: WGS-84 Azimuth/Bearing: 081° N81E 1440ft Magnetic (+12°) Elevation Angle: -01.6 Horizon Angle: -00.5 Zoom: 1.0x Brush Min 11603+00 ROW stable</small></p>

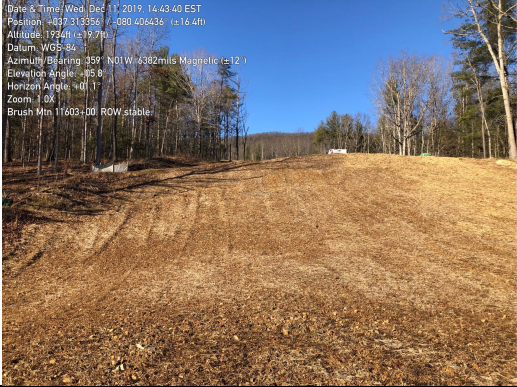
<p><small>Date & Time: Wed, Dec 11, 2019 14:43:40 EST Position: -037.313356 / -080.406436 / 14644ft Altitude: 1924ft (+89.3ft) Datum: WGS-84 Azimuth/Bearing: 359° N01W 4382ft Magnetic (+12°) Elevation Angle: -05.8 Horizon Angle: -01.1 Zoom: 1.0x Brush Min 11603+00 ROW stable</small></p>

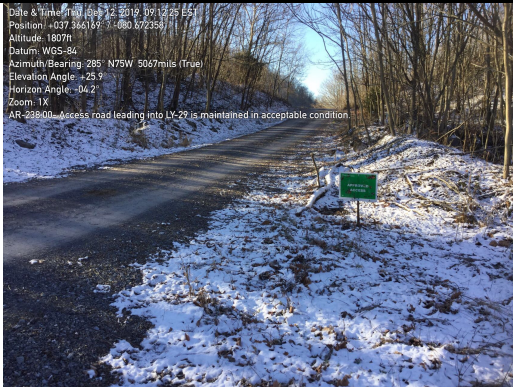
<p>Date & Time: Thu, Dec 12, 2019 09:12:25 EST Position: +017.245189° / -080.672356° Altitude: 1807ft Datum: WGS-84 Azimuth/Bearing: 285° N75W 5067mils (True) Elevation Angle: +25.9° Horizon Angle: -04.2° Zoom: 1X AR-238.00- Access road leading into LY-29 is maintained in acceptable condition.</p>

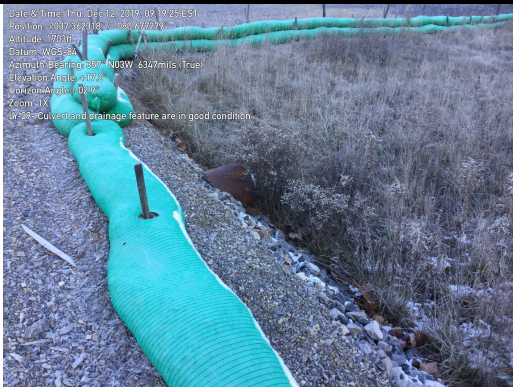
<p>Date & Time: Thu, Dec 12, 2019 09:24:05 EST Position: +012.162182° / -080.677059° Altitude: 1703ft Datum: WGS-84 Azimuth/Bearing: 285° N75W 4347mils (True) Elevation Angle: +33.5° Horizon Angle: -06.2° Zoom: 1X LY-29- Culvert and drainage feature are in good condition.</p>

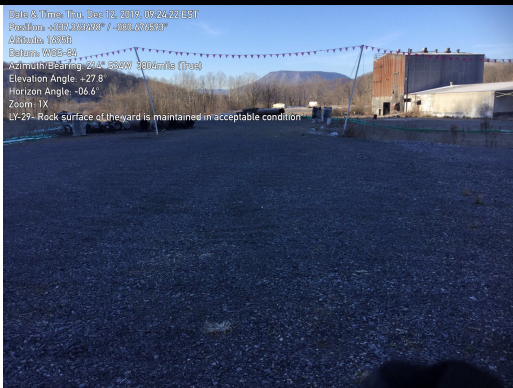
<p>Date & Time: Thu, Dec 12, 2019 09:26:20 EST Position: +010.283907° / -080.683337° Altitude: 1392ft Datum: WGS-84 Azimuth/Bearing: 214° S66W 3906mils (True) Elevation Angle: +27.8° Horizon Angle: -06.6° Zoom: 1X LY-29- Rock surface of the yard is maintained in acceptable condition.</p>
