Visual Site Inspection Report

Project Name	H-600 Pipeline Spread G	AFE	124300137	Spread	H-600 Pipeline Spread G
Contractor	Precision			Report #	7869
Inspector	Chris Burns			Date/Time	2/3/2020 6:56 AM
Permit #	TBD	Inspection Type	VA SWPP	Station Begin	11255+00
State	VA	Inspection Area	Partial	Station End	11354+00
County	Giles	Ground	Damp	Temperature (°F)	64.00
Municipality	N/A	Weather	Cloudy	Rain Gauge (in)	0.10
				Rain Accumulation Time (days)	3.00

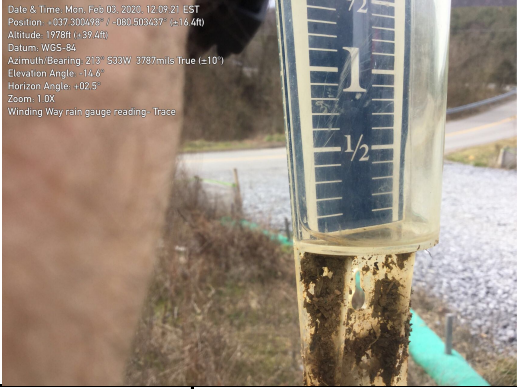
GPS Location	See photo GPS	GPS Location			
Field Station#	11227+00	Field Station#			
Pic 7 Desc.	Winding Way rain gauge reading- Trace amount.	Pic 8 Desc.			
Insert image here		Insert image here			
GPS Location		GPS Location			
Field Station#		Field Station#			
Pic 9 Desc.		Pic 10 Desc.			
Insert image here		Insert image here			
GPS Location		GPS Location			
Field Station#		Field Station#			
Pic 11 Desc.		Pic 12 Desc.

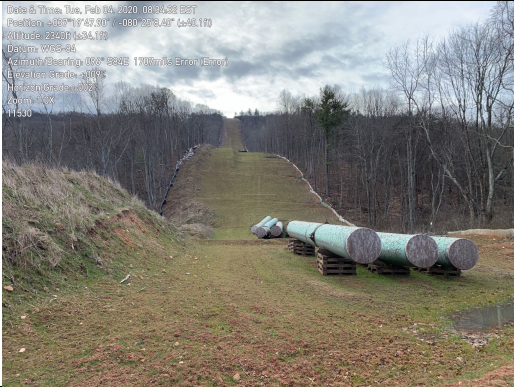
GPS Location	See picture above for GPS coordinates		GPS Location	See picture above for GPS coordinates	
Field Station#	11530+00		Field Station#	11530+00	
Pic 1 Desc.	ECD's and row conditions		Pic 2 Desc.	ECD's and row conditions

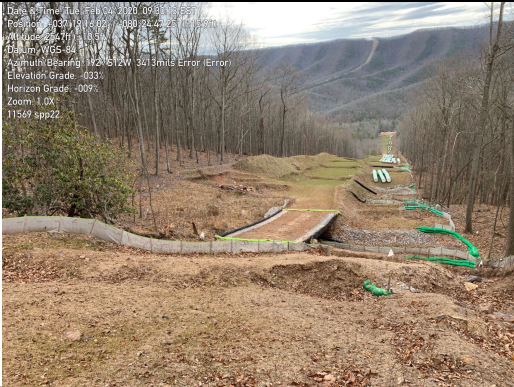
GPS Location	See picture above for GPS coordinates		GPS Location	See picture above for GPS coordinates	
Field Station#	11569+00		Field Station#	11579+00	
Pic 3 Desc.	ECD's and row conditions @ SPP 22		Pic 4 Desc.	ECD's and row conditions

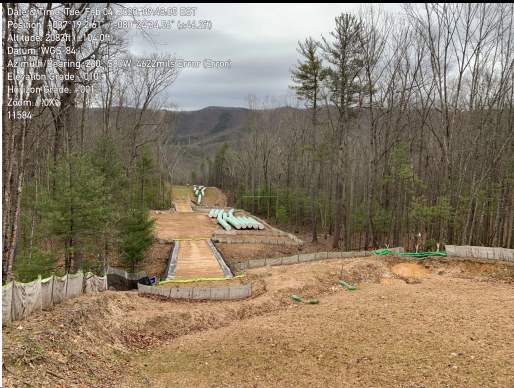
GPS Location	See picture above for GPS coordinates		GPS Location	See picture above for GPS coordinates	
Field Station#	11584+00		Field Station#	11573+00	
Pic 5 Desc.	ECD's and row conditions @ S PPW20 & 21		Pic 6 Desc.	ECD's and row conditions

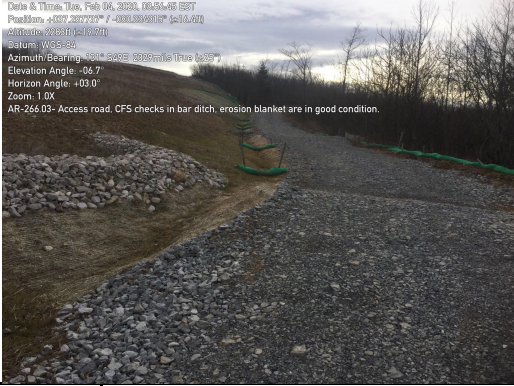
A/E	124300137	Date/Time	2/4/2020 7:28 AM	Report #	
Pictures					
<p>Date & Time: Tue, Feb 04, 2020, 08:56:40 EST Position: +037.23722° / -060.09600° (+16.4ft) Altitude: 2260ft (+262ft) Datum: WGS-84 Azimuth/Bearing: 006° N06E 0.07mils True (+2.0) Elevation Angle: -05.7° Horizon Angle: +03.0° Zoom: 1.0x Start 11900+00- Access road, CFS checks in bar ditch, erosion blanket are in good condition.</p>

GPS Location	See photo GPS		GPS Location	See photo GPS	
Field Station#	11900+00		Field Station#	11921+00	
Pic 1 Desc.	AR-266.03- Access road and controls are in acceptable condition.		Pic 2 Desc.	CFS water bar outlet protection is in acceptable condition.

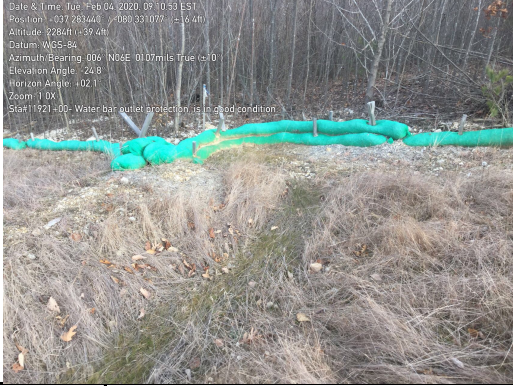
<p>Date & Time: Tue, Feb 04, 2020, 09:10:53 EST Position: +037.23904° / -060.33107° (+16.4ft) Altitude: 2260ft (+262ft) Datum: WGS-84 Azimuth/Bearing: 006° N06E 0.07mils True (+2.0) Elevation Angle: -24.8° Horizon Angle: +02.1° Zoom: 1.0x Start 11921+00- Water bar outlet protection is in good condition.</p>

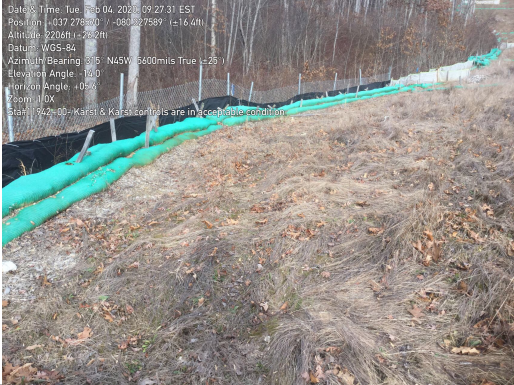
<p>Date & Time: Tue, Feb 04, 2020, 09:27:31 EST Position: +037.27630° / -060.37589° (+16.4ft) Altitude: 2206ft (+262ft) Datum: WGS-84 Azimuth/Bearing: 005° N05W 5.00mils True (+26) Elevation Angle: +10.0° Horizon Angle: +05.5° Zoom: 1.0x Start 11942+00- Karst & Karst controls are in acceptable condition.</p>

GPS Location	See photo GPS		GPS Location	See photo GPS	
Field Station#	11942+00		Field Station#	11952+00	
Pic 3 Desc.	Karst and Karst ECD's are in acceptable condition		Pic 4 Desc.	Row is stable, permanent restoration is acceptable.	
<p>Date & Time: Tue, Feb 04, 2020, 10:50:38 EST Position: +037.27028° / -060.31680° (+16.4ft) Altitude: 1660ft (+197ft) Datum: WGS-84 Azimuth/Bearing: 024° S00W 4200mils True (+26) Elevation Angle: -16.7° Horizon Angle: +07.0° Zoom: 1.0x Start 11976+75- Repaired sink hole mulched & seeded.</p>

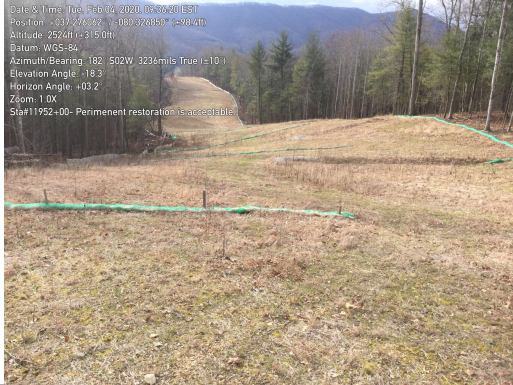
<p>Date & Time: Tue, Feb 04, 2020, 10:36:00 EST Position: +037.27622° / -060.32085° (+20.4ft) Altitude: 2526ft (+315.0ft) Datum: WGS-84 Azimuth/Bearing: 182° S02W 3236mils True (+10) Elevation Angle: -18.3° Horizon Angle: +03.2° Zoom: 1.0x Start 11952+00- Permanent restoration is acceptable.</p>

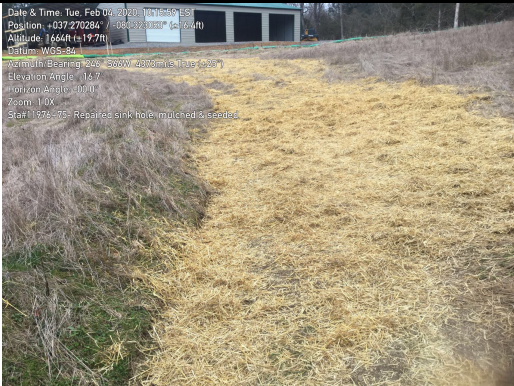
GPS Location	See photo GPS		GPS Location	See photo GPS	
Field Station#	11976+75		Field Station#	12001+00	
Pic 5 Desc.	Contractor has repaired sink hole and stabilized disturbed area.		Pic 6 Desc.	Wetland ECD's are in acceptable condition.

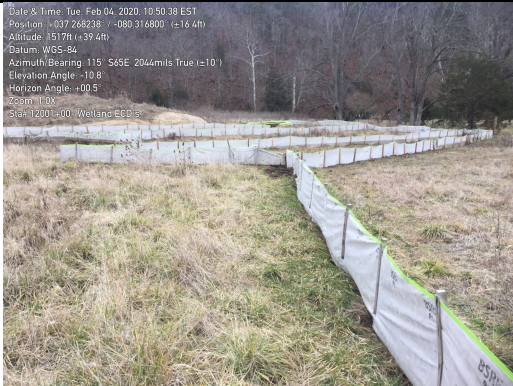
<p>Date & Time: Tue, Feb 04, 2020, 10:50:38 EST Position: +037.26828° / -060.31680° (+16.4ft) Altitude: 1517ft (+29.4ft) Datum: WGS-84 Azimuth/Bearing: 115° S45E 2044mils True (+10) Elevation Angle: -10.8° Horizon Angle: +00.5° Zoom: 1.0x Start 12001+00- Wetland ECD's</p>

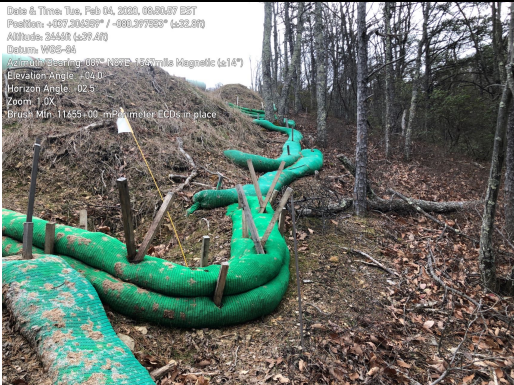
GPS Location	On photo	GPS Location	On photo		
Field Station#	11655+00	Field Station#	11648+75		
Pic 3 Desc.	ECDs in place and effective. No erosion evident.		Pic 4 Desc.	Slope breakers in place. ECDs effective. ROW stable.

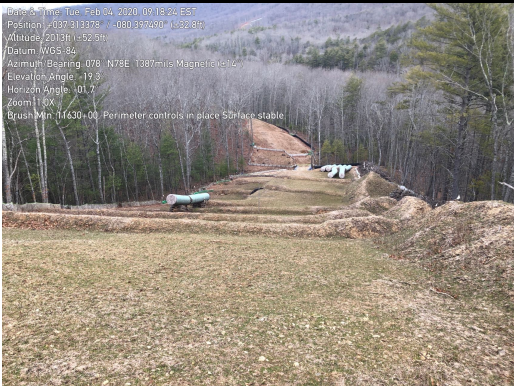
GPS Location	On photo	GPS Location	On photo		
Field Station#	11630+00	Field Station#	11626+04		
Pic 5 Desc.	Perimeter controls and slope breakers in place. ROW currently stable.		Pic 6 Desc.	S-HH18 crossing stable with no impact to resource identified

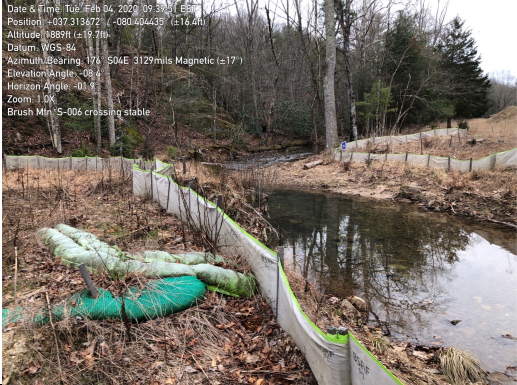
<small>Date & Time: Tue, Feb 04, 2020 09:34:05 EST Position: +037.313472 / -080.404435 (+16.4ft) Altitude: 1889ft (+19.7ft) Datum: WGS-84 Azimuth/Bearing: 173° S04E 3129mils Magnetic (+17°) Elevation Angle: -08.1° Horizon Angle: -01.4° Zoom: 1.0X Brush Mtn. S-006 crossing stable</small>

GPS Location	On photo	GPS Location	On photo		
Field Station#	11614+20	Field Station#	11608+17		
Pic 7 Desc.	S-RR14 crossing stable with no impact to resource located	Pic 8 Desc.	S-006 crossing stable with no impact to resource discovered		
<small>Date & Time: Tue, Feb 04, 2020 09:45:26 EST Position: +037.314477 / -080.402707 (+32.8ft) Altitude: 1941ft (+270.7ft) Datum: WGS-84 Azimuth/Bearing: 137° S41E 2436mils Magnetic (+17°) Elevation Angle: -11.5° Horizon Angle: +00.8° Zoom: 1.0X Brush Mtn. S-RR13 crossing stable</small>

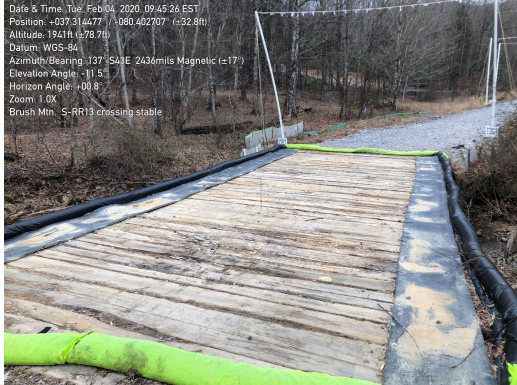
GPS Location	On photo	GPS Location			
Field Station#	11613+69	Field Station#			
Pic 9 Desc.	S-RR13 crossing is stable with no impact to resource identified	Pic 10 Desc.			
Insert image here		Insert image here			
GPS Location		GPS Location			
Field Station#		Field Station#			
Pic 11 Desc.		Pic 12 Desc.

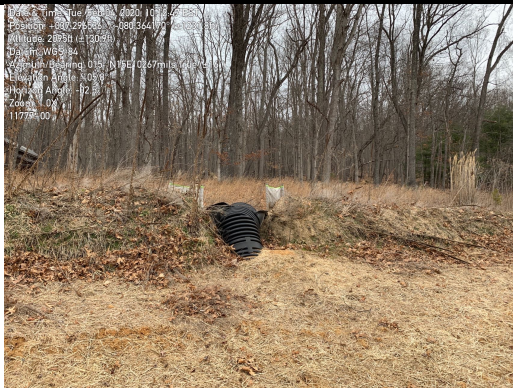
GPS Location		See photo for GPS location.		GPS Location	
Field Station#		11775+00		Field Station#	
Pic 5 Desc.		Clean water diversion pipe and plunge pool in place.		Pic 6 Desc.

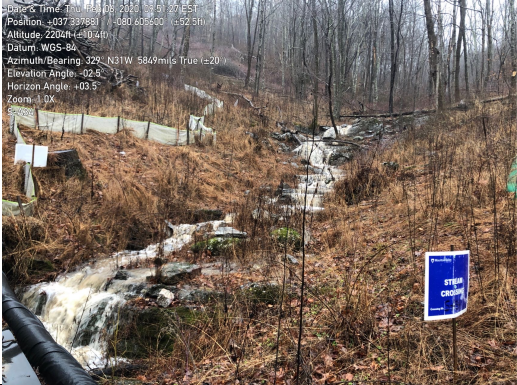
GPS Location	7		GPS Location	8	
Field Station#	10854+70		Field Station#	10862+00	
Pic 7 Desc.	S-A34 entering the RoW during rain event.		Pic 8 Desc.	Waterbar end treatment functional.

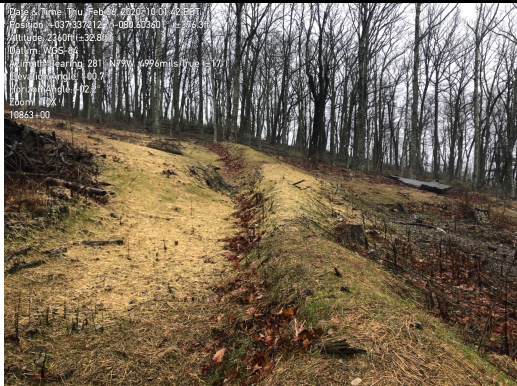
GPS Location	9		GPS Location	10	
Field Station#	10863+00		Field Station#	10868+00	
Pic 9 Desc.	Waterbar in good condition.		Pic 10 Desc.	RoW conditions.	
Insert image here			Insert image here		
GPS Location			GPS Location		
Field Station#			Field Station#		
Pic 11 Desc.			Pic 12 Desc.

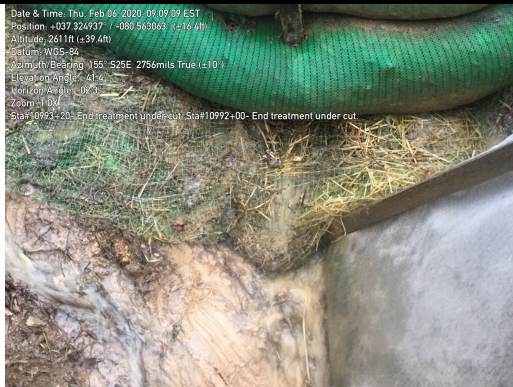
Date & Time: Thu, Feb 06, 2020 09:04:19 EST Position: +037 324743 / -080 562864 (±16.4ft) Altitude: 2576ft (±39.4ft) Datum: WGS-84 Azimuth/Bearing: 154° S24E 2738mils True (±10°) Elevation Angle: -48.2° Horizon Angle: +01.5° Zoom: 1.0X Sta#10993+20: End treatment under cut.		Date & Time: Thu, Feb 06, 2020 09:09:09 EST Position: +037 324737 / -080 563063 (±16.4ft) Altitude: 2611ft (±39.4ft) Datum: WGS-84 Azimuth/Bearing: 155° S25E 2756mils True (±10°) Elevation Angle: -41.2° Horizon Angle: -06.3° Zoom: 1.0X Sta#10993+20: End treatment under cut. Sta#10992+00: End treatment under cut.

GPS Location	See photo GPS		GPS Location	See photo GPS	
Field Station#	10993+20		Field Station#	10992+00	
Pic 3 Desc.	Triple stack end treatment is under cut.		Pic 4 Desc.	Triple stack end treatment is under cut.

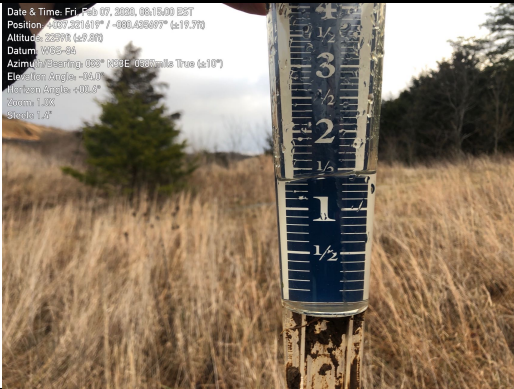
GPS Location	1	GPS Location	2		
Field Station#	11471+00	Field Station#	11265+00		
Pic 1 Desc.	Rain gauge at Steele Acres indicating 1.4" accumulation.		Pic 2 Desc.	P-1 perimeter controls functional.	
<p>Date & Time: Fri, Feb 07, 2020, 09:04:43 EST Position: +037 2957420" / -080.434181" (+78.77m) Altitude: 2262ft (+69.60) Datum: WGS-84 Azimuth Bearing: 220° S59W 424mils True (+17°) Elevation Angle: +37° Horizon Angle: +06.1° Zoom: 1.0x 11278+80</p>

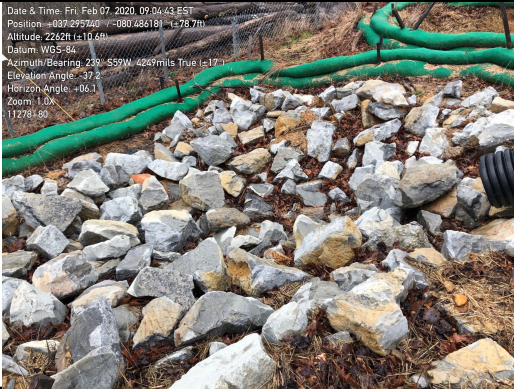
GPS Location	3	GPS Location	4		
Field Station#	11278+80	Field Station#	11327+85		
Pic 3 Desc.	Plunge pool.		Pic 4 Desc.	S-NN12.	
<p>Date & Time: Fri, Feb 07, 2020, 13:35:48 EST Position: +037 3187142" / -080.441594" (+4313.8m) Altitude: 2135ft (+65.11) Datum: WGS-84 Azimuth Bearing: 065° N44E 1173mils True (+25°) Elevation Angle: +01.1° Horizon Angle: +00.0° Zoom: 1.0x S-0013</p>

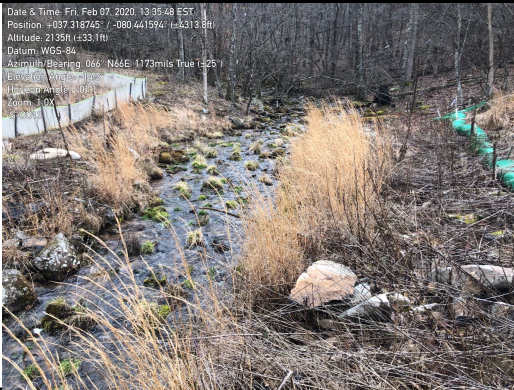
GPS Location	5	GPS Location	6		
Field Station#	11451+18	Field Station#	11459+00		
Pic 5 Desc.	S-0013.		Pic 6 Desc.	Vegetation or stabilization sufficient.
