# Visual Site Inspection Report

<b>Project Name</b>	H-600 Pipeline Spread G	<b>AFE</b>	124300137	<b>Spread</b>	H-600 Pipeline Spread G
<b>Contractor</b>	Precision			<b>Report #</b>	9192
<b>Inspector</b>	Garrett Barclay			<b>Date/Time</b>	3/16/2020 7:38 AM
<b>Permit #</b>	TBD	<b>Inspection Type</b>	VA SWPP	<b>Station Begin</b>	12005+00
<b>State</b>	VA	<b>Inspection Area</b>	Partial	<b>Station End</b>	12005+00
<b>County</b>	Giles	<b>Ground</b>	Wet	<b>Temperature (°F)</b>	38.00
<b>Municipality</b>	N/A	<b>Weather</b>	Sunny	<b>Rain Gauge (in)</b>	0.70
				<b>Rain Accumulation Time (days)</b>	1.00

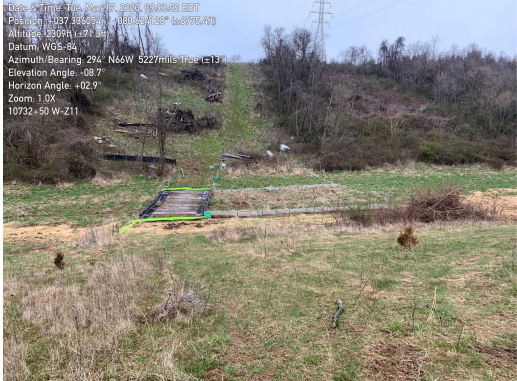
GPS Location	See photo for GPS location.		GPS Location	See photo for GPS location.	
Field Station#	10732+50		Field Station#	10714+00	
Pic 1 Desc.	Sensitive resource buffer in place at wetland W-Z11.		Pic 2 Desc.	Waterbar in place across travel lane.

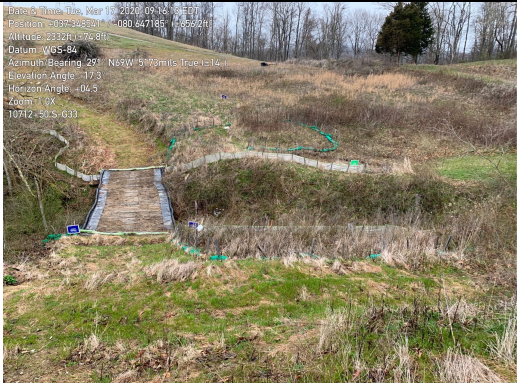
GPS Location	See photo for GPS location.		GPS Location	See photo for GPS location.	
Field Station#	10712+50		Field Station#	10709+00	
Pic 3 Desc.	Sensitive resource buffer in place at stream S-G33.		Pic 4 Desc.	ROW stabilized with natural vegetation.

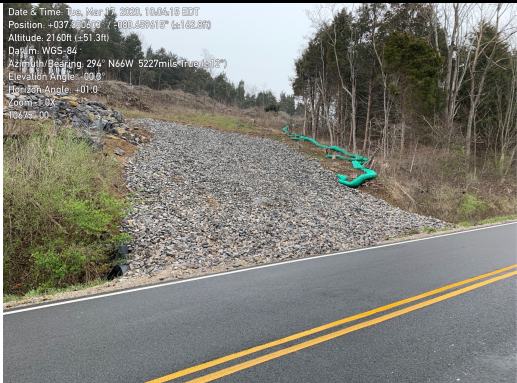
GPS Location	See photo for GPS location.		GPS Location	See photo for GPS location.	
Field Station#	10675+00		Field Station#	10670+00	
Pic 5 Desc.	RCE in place at Big Stoney Road crossing.		Pic 6 Desc.	Reinforced super silt fence in place along LOD.

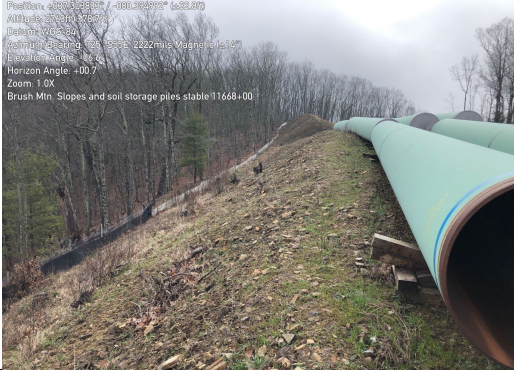
<b>GPS Location</b>	On photo	<b>GPS Location</b>	On photo		
<b>Field Station#</b>	11668+00	<b>Field Station#</b>	11666+00		
<b>Pic 1 Desc.</b>	Perimeter controls are in place and soils stabilized.	<b>Pic 2 Desc.</b>	End treatments are in good condition and functioning as designed.

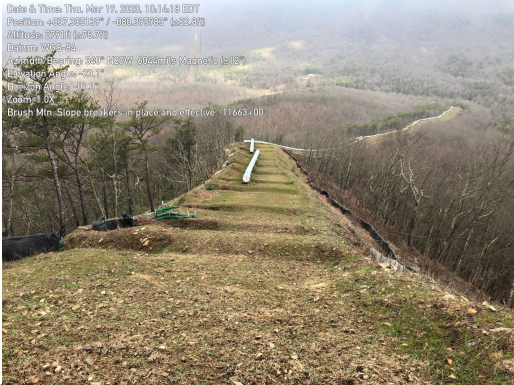
<p>Date &amp; Time: Thu, Mar 19, 2020, 15:14:18 EDT  Position: +407.300128° / -460.377972° (a32.470)  Altitude: 2279 ft (a69.370)  Datum: WGS-84  Azimuth/Bearing: 133° 24' 55" (a13°)  Elevation Angle: +03.4°  Horizon Angle: +00.7°  Zoom: 1.0X  Brush Min. Slope breakers in place and effective 11663+00</p>

<b>GPS Location</b>	On photo	<b>GPS Location</b>	On photo		
<b>Field Station#</b>	11663+00	<b>Field Station#</b>	11649+00		
<b>Pic 3 Desc.</b>	Slope breakers are in place and functioning as designed.	<b>Pic 4 Desc.</b>	The ROW surface and soil storage piles are stable.

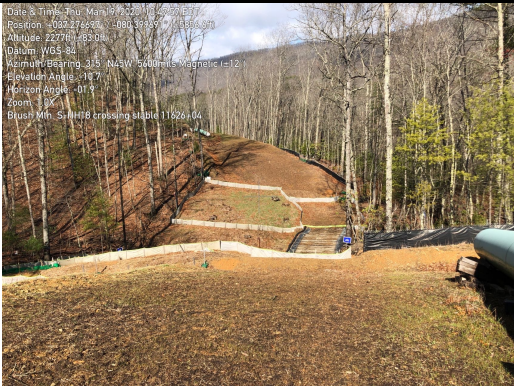
<p>Date &amp; Time: Thu, Mar 19, 2020, 11:04:27 EDT  Position: +407.300128° / -460.377972° (a32.470)  Altitude: 2279 ft (a69.370)  Datum: WGS-84  Azimuth/Bearing: 133° 24' 55" (a13°)  Elevation Angle: +03.4°  Horizon Angle: +00.7°  Zoom: 1.0X  Brush Min. Slope breakers in place 11626+04</p>

<b>GPS Location</b>	On photo	<b>GPS Location</b>	On photo		
<b>Field Station#</b>	11626+04	<b>Field Station#</b>	11614+20		
<b>Pic 5 Desc.</b>	The S-HH18 crossing is stable.	<b>Pic 6 Desc.</b>	The SRR14 crossing is stable. Controls in place.

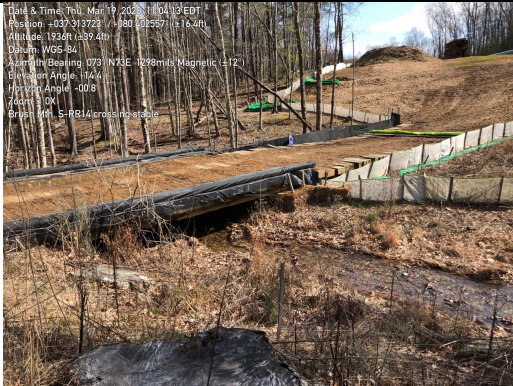
<p>Date &amp; Time: Thu, Mar 19, 2020, 11:04:27 EDT  Position: +407.300128° / -460.377972° (a32.470)  Altitude: 2279 ft (a69.370)  Datum: WGS-84  Azimuth/Bearing: 133° 24' 55" (a13°)  Elevation Angle: +03.4°  Horizon Angle: +00.7°  Zoom: 1.0X  Brush Min. Slope breakers in place 11614+20</p>

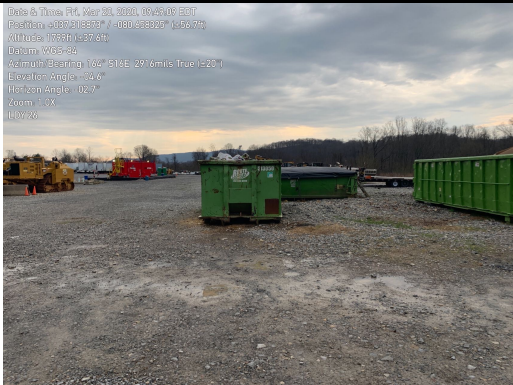
GPS Location		See photo for GPS location.				GPS Location		See photo for GPS location.			
Field Station#		12005+00				Field Station#		12005+00			
Pic 1 Desc.		Dumpsters being utilized for trash management.				Pic 2 Desc.		18 inch compost filter sock in place along LOD.

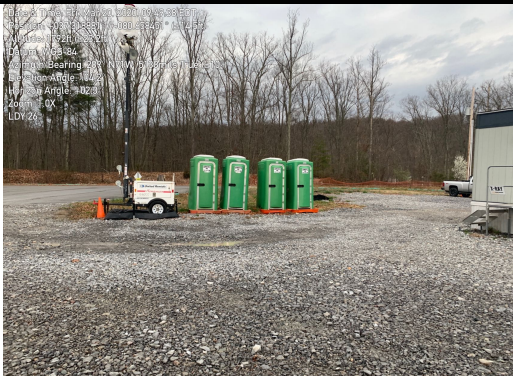
GPS Location		See photo for GPS location.				GPS Location		See photo for GPS location.			
Field Station#		12005+00				Field Station#		12005+00			
Pic 3 Desc.		Secondary containment in place under port-a-potties and light plant.				Pic 4 Desc.		No leaks observed under staged equipment.

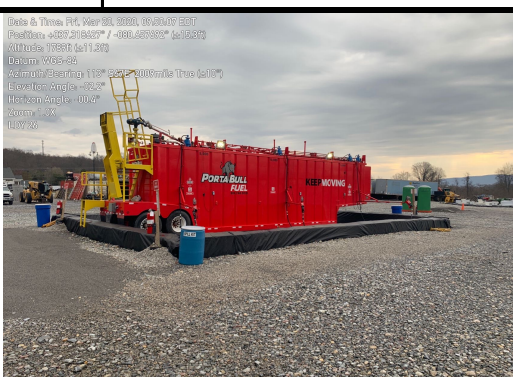
GPS Location		See photo for GPS location.				GPS Location		See photo for GPS location.			
Field Station#		12005+00				Field Station#		12005+00			
Pic 5 Desc.		Secondary containment in place under fuel cell.				Pic 6 Desc.		RCE in place at employee parking lot.
