# Visual Site Inspection Report

<b>Project Name</b>	H-600 Pipeline Spread G	<b>AFE</b>	124300137	<b>Spread</b>	H-600 Pipeline Spread G
<b>Contractor</b>	Precision			<b>Report #</b>	8737
<b>Inspector</b>	Chris Burns			<b>Date/Time</b>	3/2/2020 6:45 AM
<b>Permit #</b>	TBD	<b>Inspection Type</b>	VA SWPP	<b>Station Begin</b>	11254+99
<b>State</b>	VA	<b>Inspection Area</b>	Partial	<b>Station End</b>	11353+67
<b>County</b>	Giles	<b>Ground</b>	Damp	<b>Temperature (°F)</b>	50.00
<b>Municipality</b>	N/A	<b>Weather</b>	Cloudy	<b>Rain Gauge (in)</b>	0.00
				<b>Rain Accumulation Time (days)</b>	1.00

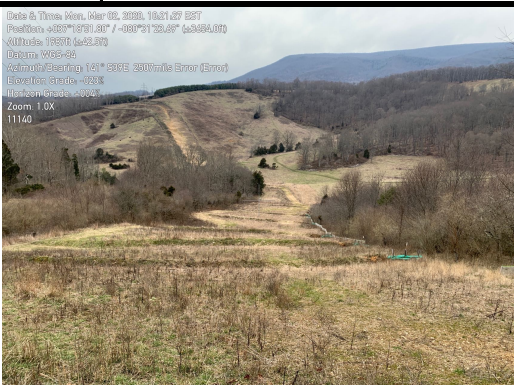
<b>Field Station#</b>	11140+00		<b>Field Station#</b>	11142+00	
<b>Pic 5 Desc.</b>	ECD's and row conditions		<b>Pic 6 Desc.</b>	ECD's and row conditions

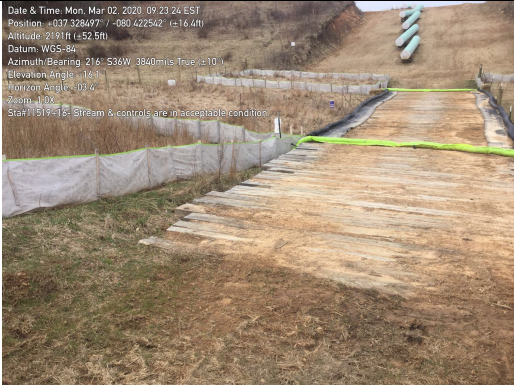
<b>GPS Location</b>	See	<b>GPS Location</b>	See photo GPS		
<b>Field Station#</b>	11519+16	<b>Field Station#</b>	11507+78		
<b>Pic 1 Desc.</b>	Stream S-PP4- and environmental controls are in acceptable condition		<b>Pic 2 Desc.</b>	Stream S-PP3 and environmental controls are in acceptable condition.

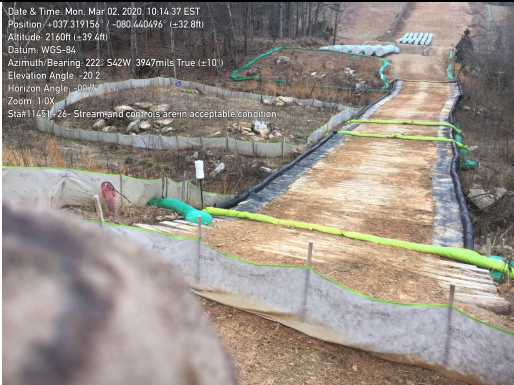
<b>GPS Location</b>	See photo GPS	<b>GPS Location</b>	See photo GPS		
<b>Field Station#</b>	11451+26	<b>Field Station#</b>	11448+93		
<b>Pic 3 Desc.</b>	Stream S-0013 and environmental controls are in acceptable condition.		<b>Pic 4 Desc.</b>	Stream S-0014 and stream ECD's are in acceptable condition.

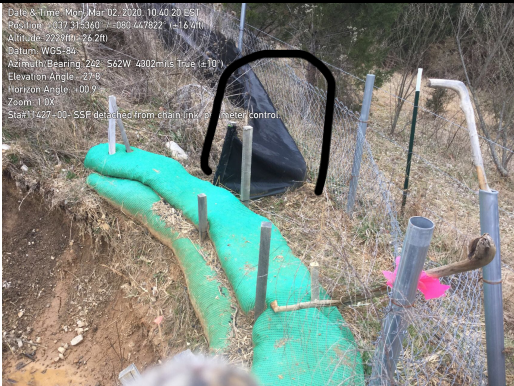
<b>GPS Location</b>	See photo GPS	<b>GPS Location</b>	See photo GPS		
<b>Field Station#</b>	11427+00	<b>Field Station#</b>	11418+00		
<b>Pic 5 Desc.</b>	SSF fabric detached from chain link, contractor has addressed the issue.		<b>Pic 6 Desc.</b>	Contractor trenching in P1 silt fence.

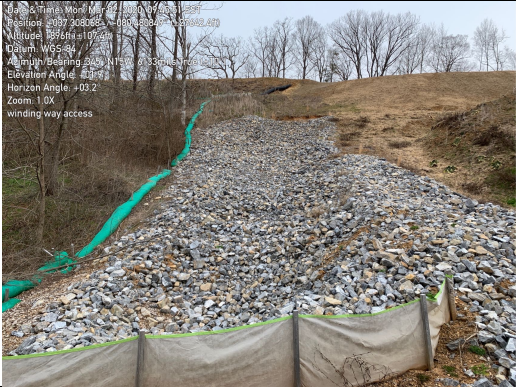
<b>GPS Location</b>	See photo for GPS location.		<b>GPS Location</b>	See photo for GPS location.	
<b>Field Station#</b>	11252+00		<b>Field Station#</b>	11218+00	
<b>Pic 1 Desc.</b>	Rock lined channel in place over fill slope.		<b>Pic 2 Desc.</b>	Waterbar, sump pit, and waterbar end treatment in place.

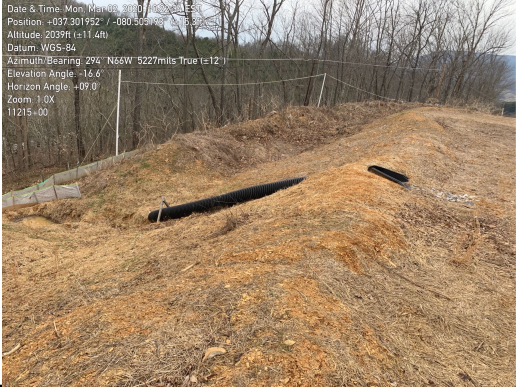
<b>GPS Location</b>	See photo for GPS location.		<b>GPS Location</b>	See photo for GPS location.	
<b>Field Station#</b>	11215+00		<b>Field Station#</b>	11208+00	
<b>Pic 3 Desc.</b>	Slope drain with rock inlet in place over fill slope.		<b>Pic 4 Desc.</b>	Reinforced super silt fence in place.

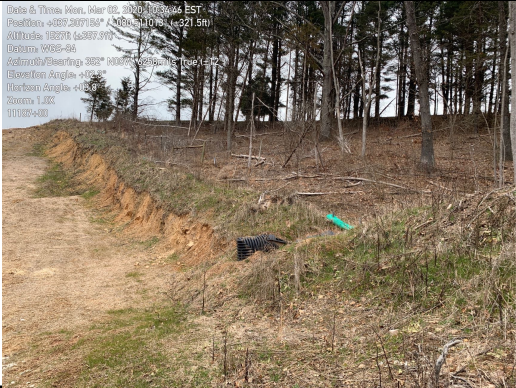
<b>GPS Location</b>	See photo for GPS location.		<b>GPS Location</b>	See photo for GPS location.	
<b>Field Station#</b>	11187+00		<b>Field Station#</b>	11187+00	
<b>Pic 5 Desc.</b>	Clean water diversion berm and clean water diversion pipe inlet in place.		<b>Pic 6 Desc.</b>	Plunge pool in place.

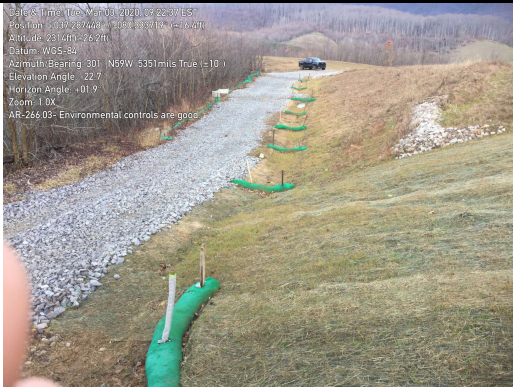
GPS Location		See photo GPS		GPS Location		See photo GPS	
Field Station#		11900+00		Field Station#		11923+93	
Pic 1 Desc.		AR-266.03 and environmental controls are in acceptable condition.		Pic 2 Desc.		Water bar outlet protection is acceptable.

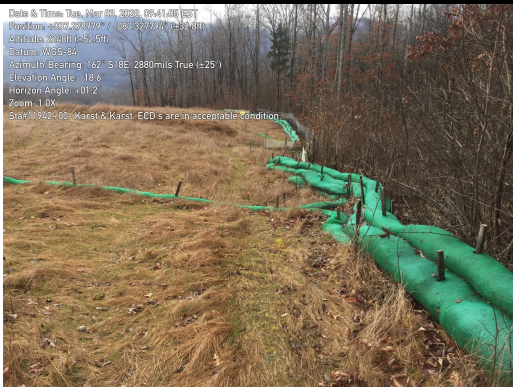
GPS Location		See photo GPS		GPS Location		See photo GPS	
Field Station#		11942+00		Field Station#		11944+00	
Pic 3 Desc.		Karst's and Karst ECD's are in acceptable condition.		Pic 4 Desc.		Permanent restoration is acceptable

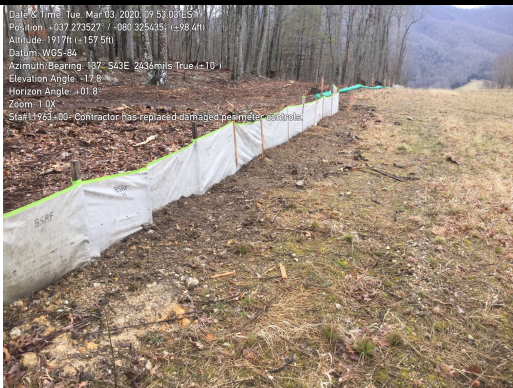
GPS Location		See photo GPS		GPS Location		See photo GPS	
Field Station#		11963+00		Field Station#		11989+00	
Pic 5 Desc.		Perimeter controls have been replaced where damaged.		Pic 6 Desc.		Catawba rain gauge reading- 0.20"

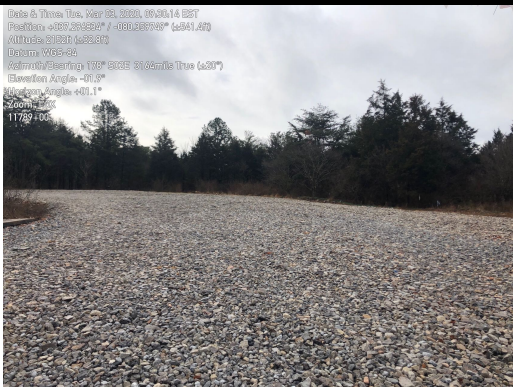
GPS Location	1	GPS Location	2		
Field Station#	11789+00	Field Station#	11797+00		
Pic 1 Desc.	RCE on the South side on Mt Tabor Rd.		Pic 2 Desc.	RoW conditions and controls.

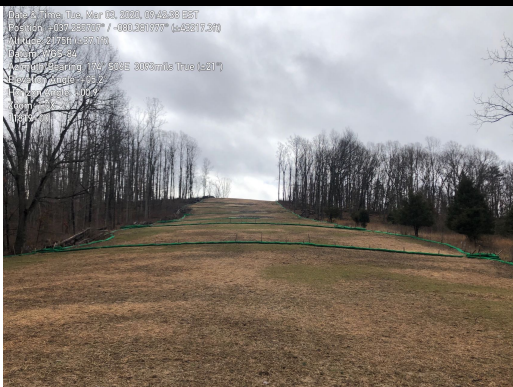
GPS Location	3	GPS Location	4		
Field Station#	11819+00	Field Station#	11842+00		
Pic 3 Desc.	RoW conditions and controls.		Pic 4 Desc.	RoW conditions and controls.

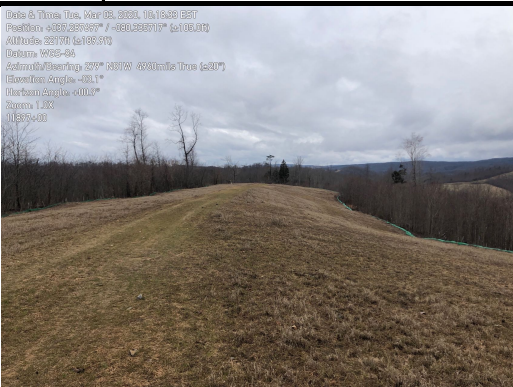
GPS Location	5	GPS Location	6		
Field Station#	11863+65	Field Station#	11897+00		
Pic 5 Desc.	P-KL2.		Pic 6 Desc.	RoW conditions and controls.

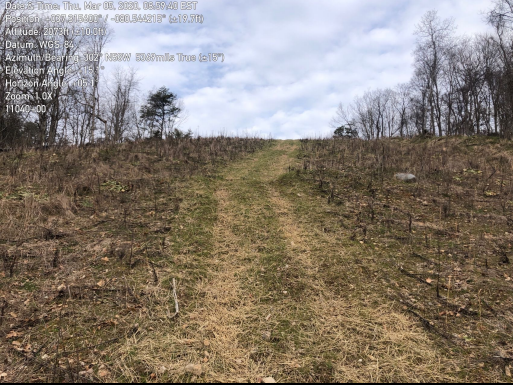
<b>GPS Location</b>	5	<b>GPS Location</b>	6		
<b>Field Station#</b>	11055+00	<b>Field Station#</b>	11040+00		
<b>Pic 5 Desc.</b>	RoW conditions and controls.	<b>Pic 6 Desc.</b>	Vegetation or stabilization.

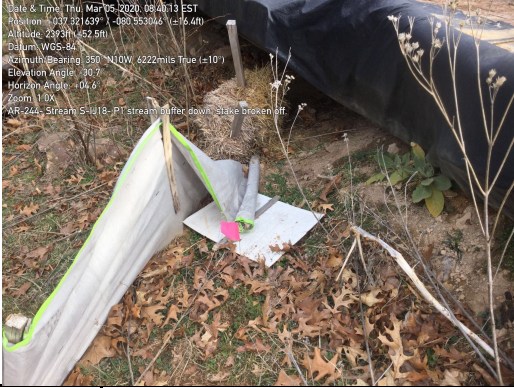
<p>Date &amp; Time: Thu, Mar 05, 2020, 08:40:13 EST Position: +037 322319 / -080 553046 (±16.4ft) Altitude: 2338ft (±39.4ft) Datum: WGS-84 Azimuth/Bearing: 350° N10W 4222mils True (±10°) Elevation Angle: -30.7° Horizon Angle: +04.6° Zoom: 1.0x AR-244-Stream S-IJ18- P1 stream buffer down stake broken off.</p>

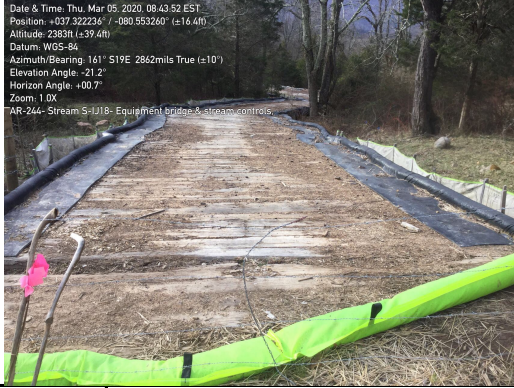
<p>Date &amp; Time: Thu, Mar 05, 2020, 08:43:52 EST Position: +037 322236 / -080 553260 (±16.4ft) Altitude: 2383ft (±39.4ft) Datum: WGS-84 Azimuth/Bearing: 161° S19E 2862mils True (±10°) Elevation Angle: -21.2° Horizon Angle: +00.7° Zoom: 1.0x AR-244-Stream S-IJ18- Equipment bridge &amp; stream controls.</p>			
<b>GPS Location</b>	See photo GPS	<b>GPS Location</b>	See photo GPS		
<b>Field Station#</b>	11024+00	<b>Field Station#</b>	11024+00		
<b>Pic 1 Desc.</b>	Animal damage to P1	<b>Pic 2 Desc.</b>	Stream bridge and stream controls are in acceptable condition, S-IJ18

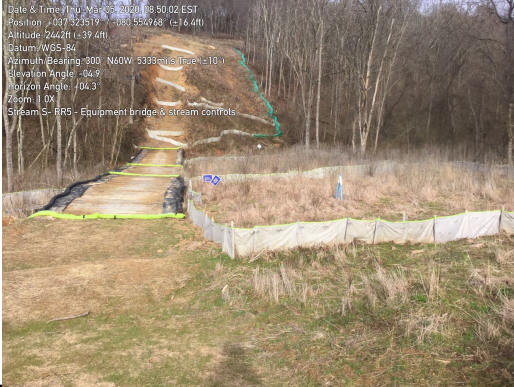
<p>Date &amp; Time: Thu, Mar 05, 2020, 08:50:02 EST Position: +037 325319 / -080 555268 (±16.4ft) Altitude: 2442ft (±39.4ft) Datum: WGS-84 Azimuth/Bearing: 300° N60W 5330mils True (±10°) Elevation Angle: -04.9° Horizon Angle: +04.3° Zoom: 1.0x Stream S-RR5- Equipment bridge &amp; stream controls.</p>

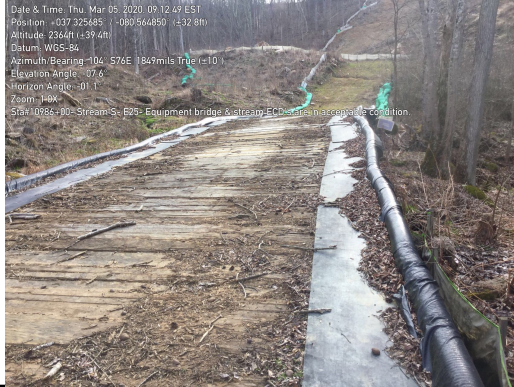
<p>Date &amp; Time: Thu, Mar 05, 2020, 09:12:47 EST Position: +037 325485 / -080 566850 (±32.8ft) Altitude: 2364ft (±39.4ft) Datum: WGS-84 Azimuth/Bearing: +04° 576E 1849mils True (±10°) Elevation Angle: -07.6° Horizon Angle: -01.1° Zoom: 1.0x Sta#10985+00-Stream S-E25- Equipment bridge &amp; stream ECD's are in acceptable condition.</p>			
<b>GPS Location</b>	See photo GPS	<b>GPS Location</b>	See photo GPS		
<b>Field Station#</b>	11017+00	<b>Field Station#</b>	10986+00		
<b>Pic 3 Desc.</b>	Stream S-RR5 and ECD's are in acceptable condition.	<b>Pic 4 Desc.</b>	Stream S-E25 and stream ECD's are in acceptable condition.

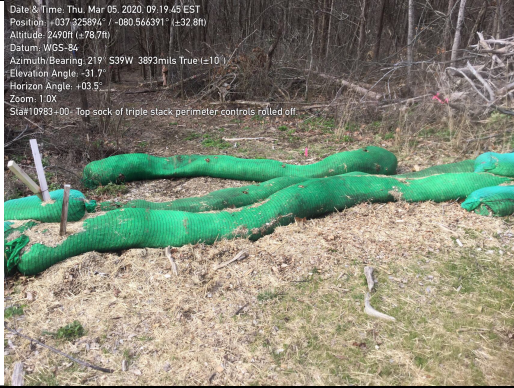
<p>Date &amp; Time: Thu, Mar 05, 2020, 09:19:45 EST Position: +037 325814 / -080 566391 (±32.8ft) Altitude: 2490ft (±78.7ft) Datum: WGS-84 Azimuth/Bearing: 219° S39W 3893mils True (±10°) Elevation Angle: -31.7° Horizon Angle: +03.3° Zoom: 1.0x Sta#10983+00- Top sock of triple stack perimeter controls rolled off.</p>			
<b>GPS Location</b>	See photo GPS	<b>GPS Location</b>	See photo GPS		
<b>Field Station#</b>	10985+00	<b>Field Station#</b>	10983+00		
<b>Pic 5 Desc.</b>	Stream S-E24 and ECD's are in acceptable condition.	<b>Pic 6 Desc.</b>	Landowner removed top CFS perimeter control

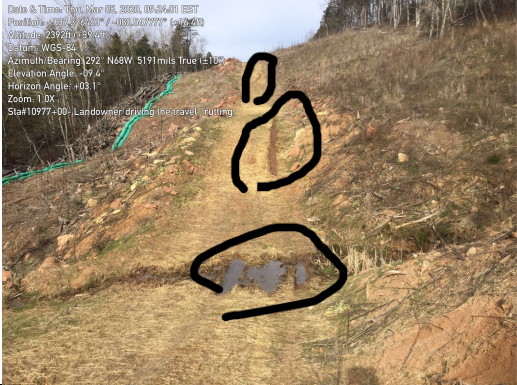
<p><small>Date &amp; Time: Thu, Mar 05, 2020, 09:34:49 EST Position: +037 336951 / -080 570242 (±32.8ft) Altitude: 2422ft (±39.7m) Datum: WGS-84 Azimuth/Bearing: 292° N48W 5191mils True (±10°) Elevation Angle: -39.4° Horizon Angle: +03.1° Zoom: 1.0X Sta#10977+00: Landowner driving the travel rutting</small></p>

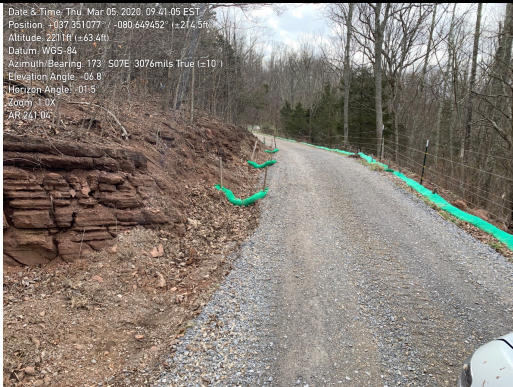
</div></div></div>			
GPS Location		See photo for GPS location.		GPS Location		See photo for GPS location.
Field Station#		10710+00		Field Station#		10712+50
Pic 1 Desc.		Compost filter sock checks in place along access road 241.04.		Pic 2 Desc.		Sensitive resource buffer in place at stream S-G33.

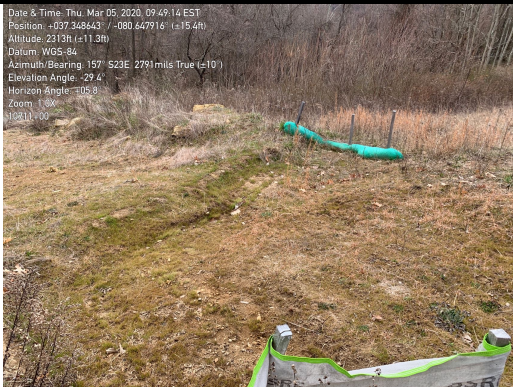
</div></div></div>			
GPS Location		See photo for GPS location.		GPS Location		See photo for GPS location.
Field Station#		10711+00		Field Station#		10698+00
Pic 3 Desc.		Waterbar with CFS end treatment in place across travel.		Pic 4 Desc.		Sensitive resource buffer in place at stream S-G32.
<div><div><div>Date &amp; Time: Thu, Mar 05, 2020, 09:49:23 EST Position: +037.349223 / -080.632600 (+15.4ft) Altitude: 2265ft (+69.3ft) Datum: WGS-84 Azimuth/Bearing: 140° S40E 2489mils True (+10°) Elevation Angle: -07.6 Horizon Angle: -100.0 Zoom: 1.0x 10696+00</div><div>

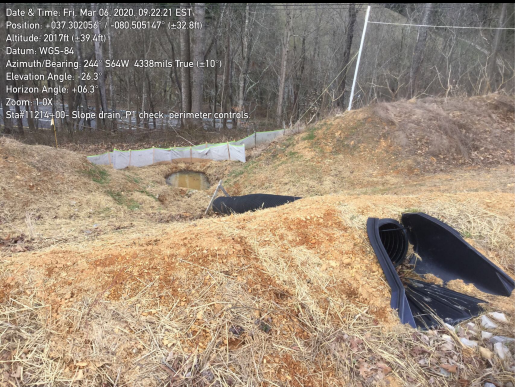
<b>GPS Location</b>	See photo GPS	<b>GPS Location</b>	See photo GPS		
<b>Field Station#</b>	11225+00	<b>Field Station#</b>	1121+40		
<b>Pic 1 Desc.</b>	Slope drain, end treatment and rock channel are in acceptable condition.	<b>Pic 2 Desc.</b>	Slope drain, checks and perimeter controls are in acceptable condition.
