Visual Site Inspection Report

Project Name	H-600 Pipeline Spread G	AFE	124300137	Spread	H-600 Pipeline Spread G
Contractor	Precision			Report #	9596
Inspector	Len Kruizenga			Date/Time	3/30/2020 2:01 PM
Permit #	TBD	Inspection Type	VA SWPP	Station Begin	11254+88
State	VA	Inspection Area	Full	Station End	11161+00
County	Giles	Ground	Dry	Temperature (°F)	55.00
Municipality	N/A	Weather	Sunny	Rain Gauge (in)	0.00
				Rain Accumulation Time (days)	2.00

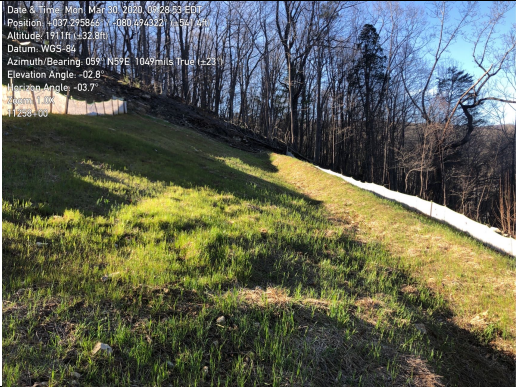
GPS Location	1	GPS Location	2		
Field Station#	11258+00	Field Station#	11265+25		
Pic 1 Desc.	Vegetation or stabilization sufficient.	Pic 2 Desc.	P-1 perimeter controls functional.

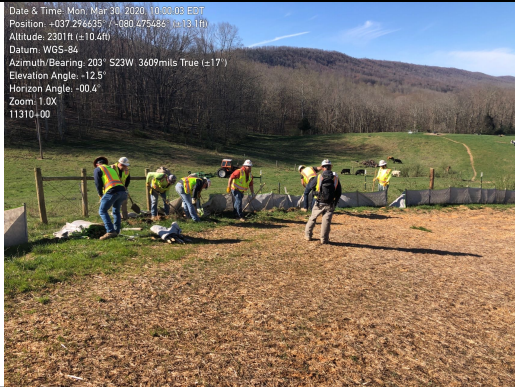
GPS Location	3	GPS Location	4		
Field Station#	11292+80	Field Station#	11310+00		
Pic 3 Desc.	S-MM18.	Pic 4 Desc.	PPL crews replacing P-1 perimeter controls.

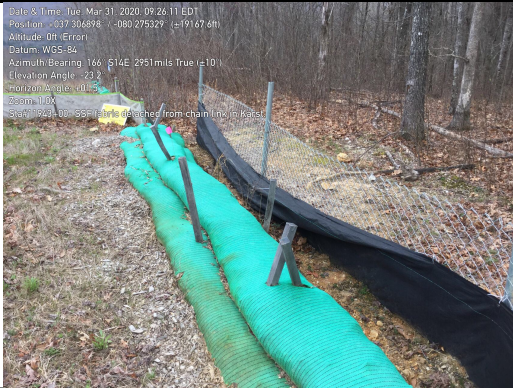
GPS Location	See photo GPS	GPS Location	See photo GPS		
Field Station#	12001+00	Field Station#	11943+00

<p>Date & Time: Tue, Mar 31, 2020, 09:26:11 EDT Position: +037.306598° / -080.275329° (±19.67.6m) Altitude: 017.01m (±1.00) Datum: WGS-84 Azimuth/Bearing: 166.51SE 2951mils True (±10°) Elevation Angle: -23.3° Horizon Angle: +01.3° Zoom: 1.0X Start: 11943+00- SSF fabric sagging, Contractor has been notified</p>

Pic 5 Desc.	Wetland ECD's are in acceptable condition.	Pic 6 Desc.	SSF fabric sagging, Contractor has been notified.

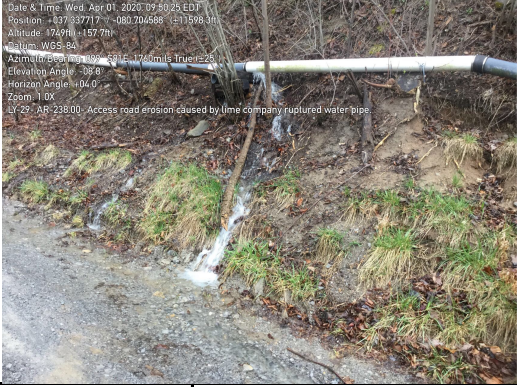
GPS Location	See photo GPS	GPS Location			
Field Station#	12005+00	Field Station#			
Pic 7 Desc.	AR-238.00- Ruptured lime company water line.	Pic 8 Desc.			
Insert image here		Insert image here			
GPS Location		GPS Location			
Field Station#		Field Station#			
Pic 9 Desc.		Pic 10 Desc.			
Insert image here		Insert image here			
GPS Location		GPS Location			
Field Station#		Field Station#			
Pic 11 Desc.		Pic 12 Desc.

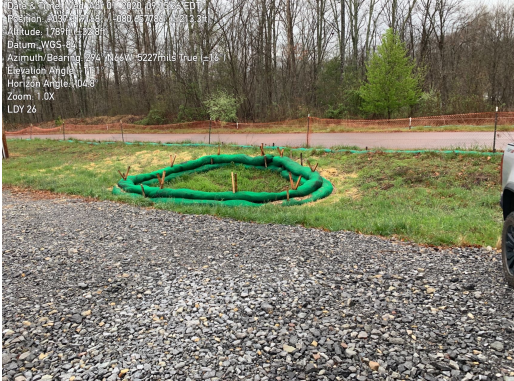
GPS Location	See photo for GPS location.		GPS Location	See photo for GPS location.	
Field Station#	12005+00		Field Station#	12005+00	
Pic 1 Desc.	Triple stack CFS in place at drainage.		Pic 2 Desc.	18 inch CFS in place along LOD.

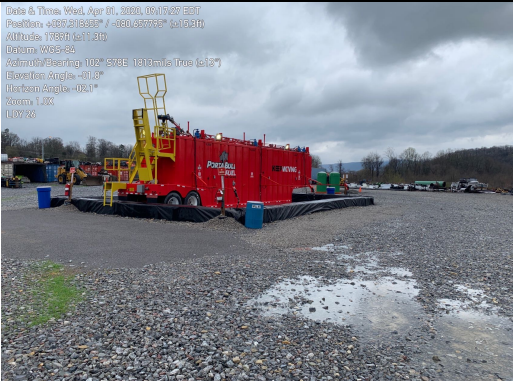
GPS Location	See photo for GPS location.		GPS Location	See photo for GPS location.	
Field Station#	12005+00		Field Station#	12005+00	
Pic 3 Desc.	Checked staged equipment for leaks. No leaks observed.		Pic 4 Desc.	Secondary containment in place under fuel cell.

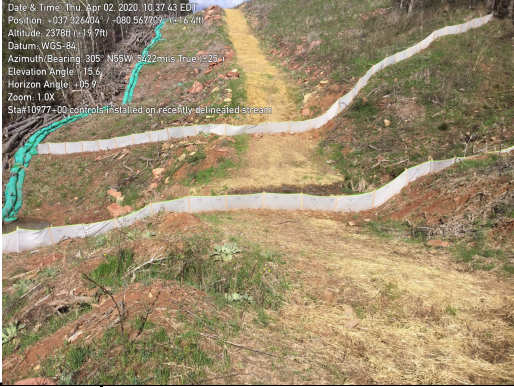
<p>Date & Time: Thu, Apr 02, 2020, 10:37:43 EDT Position: +037.323624 / -080.567359 (+16.4ft) Altitude: 2378ft (+13.7m) Datum: WGS-84 Azimuth/Bearing: 305° 15'W 822mils True (+23°) Elevation Angle: -15.5° Horizon Angle: +15.9° Zoom: 1.0X Sta#10977+00-control isolated on recently delineated stream</p>

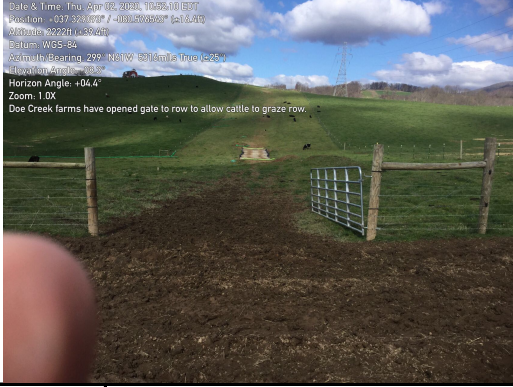
<p>Date & Time: Thu, Apr 02, 2020, 10:56:10 EDT Position: +037.324077 / -080.568027 (+16.4ft) Altitude: 2372ft (+28.6m) Datum: WGS-84 Azimuth/Bearing: 299° 10'W 830mils True (+23°) Elevation Angle: -10.2° Horizon Angle: +04.4° Zoom: 1.0X Doe Creek farms have opened gate to row to allow cattle to graze row.</p>			
GPS Location	See photo GPS	GPS Location	See photo GPS		
Field Station#	10977+00	Field Station#	10950+00		
Pic 5 Desc.	Newly delineated stream and environmental controls.	Pic 6 Desc.	Doe Creek Farms have again opened gates to the row to graze cattle.

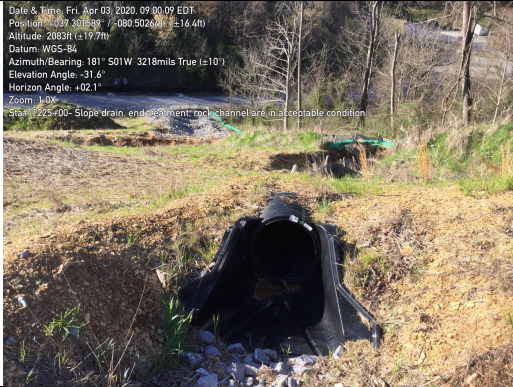
GPS Location	See photo GPS		GPS Location	See photo GPS	
Field Station#	11232+00		Field Station#	11225+00	
Pic 1 Desc.	Row is in stable condition.		Pic 2 Desc.	Slope drain, end treatment and rock channel are in acceptable condition.

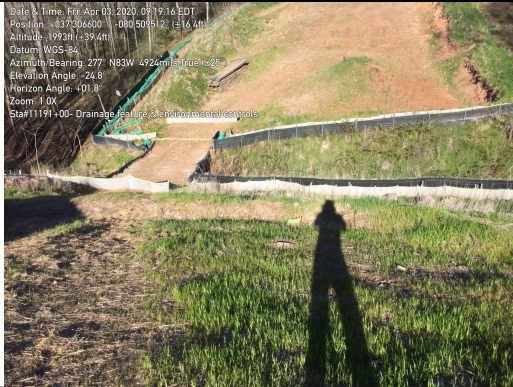
GPS Location	See photo GPS		GPS Location	See photo GPS	
Field Station#	11204+00		Field Station#	11191+00	
Pic 3 Desc.	Topsoil stockpiles are stable & well vegetated.		Pic 4 Desc.	Drainage feature and ECD's are in acceptable condition.

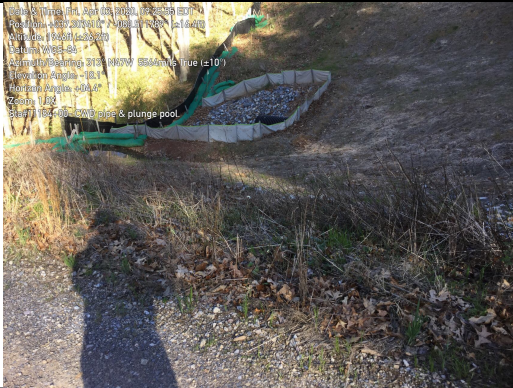
GPS Location	See photo GPS		GPS Location	See photo GPS	
Field Station#	11184+50		Field Station#	11184+00	
Pic 5 Desc.	AR-249.02- Road and environmental controls are in acceptable condition.		Pic 6 Desc.	CWD pipe and plunge pool are in good condition.
