# Visual Site Inspection Report

<b>Project Name</b>	H-600 Pipeline Spread G	<b>AFE</b>	124300137	<b>Spread</b>	H-600 Pipeline Spread G
<b>Contractor</b>	Precision			<b>Report #</b>	8975
<b>Inspector</b>	Len Kruizenga			<b>Date/Time</b>	3/9/2020 7:18 AM
<b>Permit #</b>	TBD	<b>Inspection Type</b>	VA SWPP	<b>Station Begin</b>	11898+00
<b>State</b>	VA	<b>Inspection Area</b>	Full	<b>Station End</b>	12005+00
<b>County</b>	Montgomery	<b>Ground</b>	Dry	<b>Temperature (°F)</b>	54.00
<b>Municipality</b>	N/A	<b>Weather</b>	Sunny	<b>Rain Gauge (in)</b>	0.00
				<b>Rain Accumulation Time (days)</b>	4.00

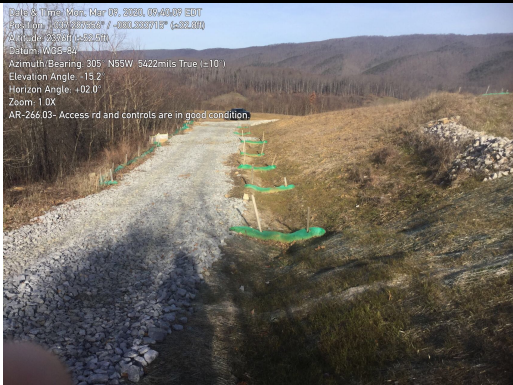
GPS Location		See photo GPS		GPS Location	
Field Station#		11900+00		Field Station#	
Pic 1 Desc.		Ar-266.03- Access road and controls are in acceptable condition.		Pic 2 Desc.	
				Permanent restoration is acceptable.

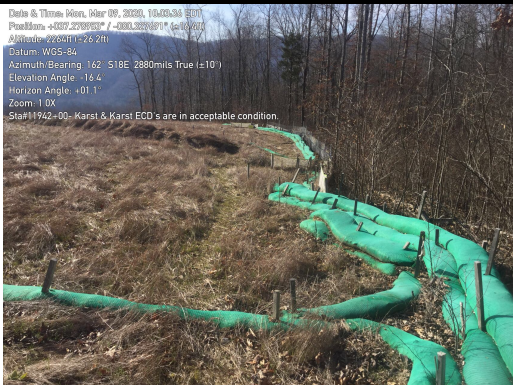
GPS Location		See photo GPS		GPS Location	
Field Station#		11942+00		Field Station#	
Pic 3 Desc.		Karst and Karst ECD's are in acceptable condition.		Pic 4 Desc.	
				Subsidence has not worsened.

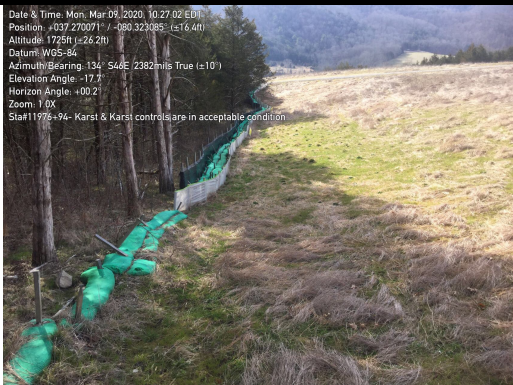
GPS Location		See photo GPS		GPS Location	
Field Station#		11976+94		Field Station#	
Pic 5 Desc.		Karst and Karst ECD's are in acceptable condition.		Pic 6 Desc.	
				Newly installed rock check dams along AR-266.00

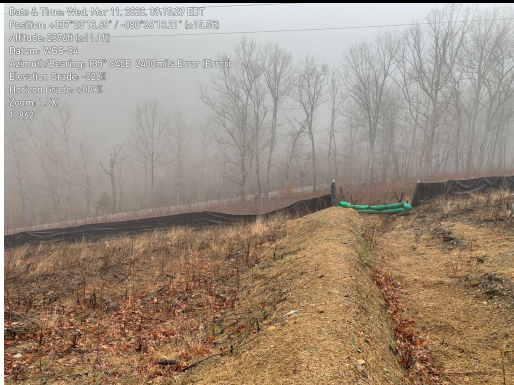
<p>Date &amp; Time: Wed, Mar 11, 2020, 07:10:29 EDT Position: +37°20'13.2" / -80°23'13.1" (+16.8m) Altitude: 5297ft (+63.3ft) Datum: WGS-84 Azimuth/Bearing: 181° S4E 200mils Error (Error) Elevation Grade: +02% Horizon Grade: +000% Zoom: 1.0X 107</p>			
GPS Location	See picture above for GPS coordinates		GPS Location	See picture above for GPS coordinates	
Field Station#	10850+00		Field Station#	10862+00	
Pic 1 Desc.	ECD's and row conditions		Pic 2 Desc.	SSF detached from wire backing

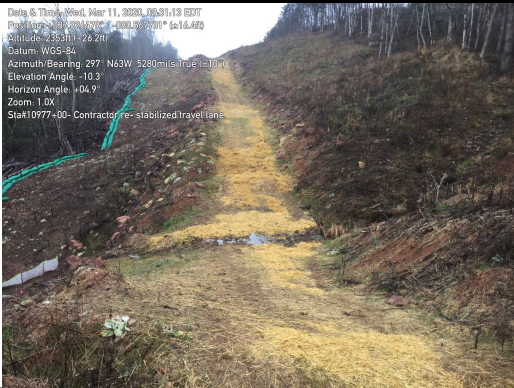
<p>Date &amp; Time: Wed, Mar 11, 2020, 09:59:08 EDT Position: +037.331297 / -080.562915 (±16.4ft) Altitude: 2123ft (±39.4ft) Datum: WGS-84 Azimuth/Bearing: 026° N24E 0646mils True (±10°) Elevation Angle: -10.3° Horizon Angle: +04.9° Zoom: 1.0X Sta#10977+00- Contractor re- stabilized travel lane.</p>

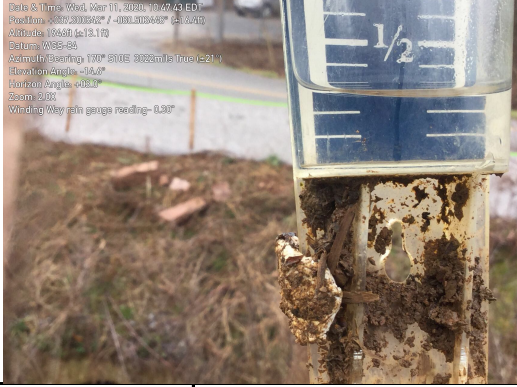
<b>GPS Location</b>	See photo GPS	<b>GPS Location</b>	See photo GPS		
<b>Field Station#</b>	11024+00	<b>Field Station#</b>	11227+00		
<b>Pic 7 Desc.</b>	AR-244 Rain gauge readings- .2"	<b>Pic 8 Desc.</b>	Winding Way rain gauge reading- 0.30"

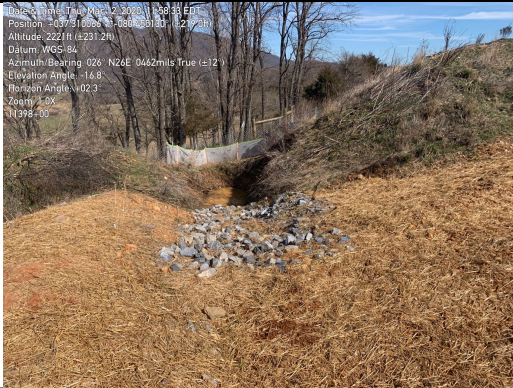
<b>GPS Location</b>	See photo for GPS location.		<b>GPS Location</b>	See photo for GPS location.	
<b>Field Station#</b>	11477+00		<b>Field Station#</b>	11398+00	
<b>Pic 5 Desc.</b>	Two-tone bank stabilized with ECB and slope drain pipes in place to minimize erosion.		<b>Pic 6 Desc.</b>	Rock lined channel in place over fill slope.

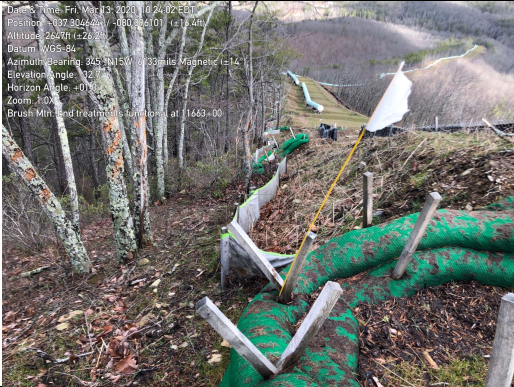
<b>GPS Location</b>	On photo	<b>GPS Location</b>	On photo		
<b>Field Station#</b>	11663+00	<b>Field Station#</b>	11658+00		
<b>Pic 1 Desc.</b>	Perimeter controls are in place. No maintenance needs were identified.	<b>Pic 2 Desc.</b>	End treatments are working properly.

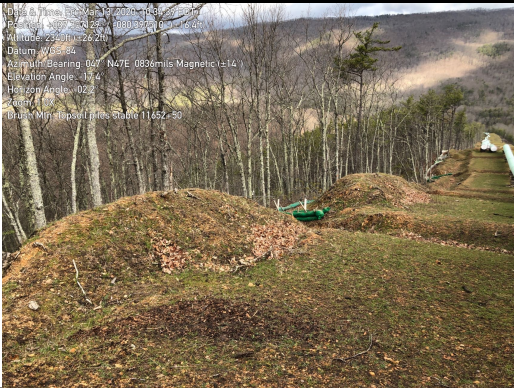
<b>GPS Location</b>	On photo	<b>GPS Location</b>	On photo		
<b>Field Station#</b>	11652+50	<b>Field Station#</b>	11638+00		
<b>Pic 5 Desc.</b>	Topsoil storage piles are stable	<b>Pic 6 Desc.</b>	Perimeter controls are in place and functioning

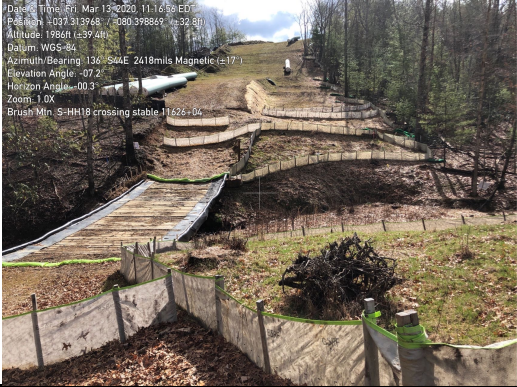
<p><small>Date &amp; Time: Fri Mar 13 2020 11:16:59 EDT Position: +037.313948 / -080.398869 / +32.81 Altitude: 1986ft (+39.4m) Datum: WGS-84 Azimuth/Bearing: 136° S44E 2418mils Magnetic (+17.1) Elevation Angle: -07.2 Horizon Angle: -00.3 Zoom: 1.0X Brush Mtn. S-HH18 crossing stable 11626+04</small></p>

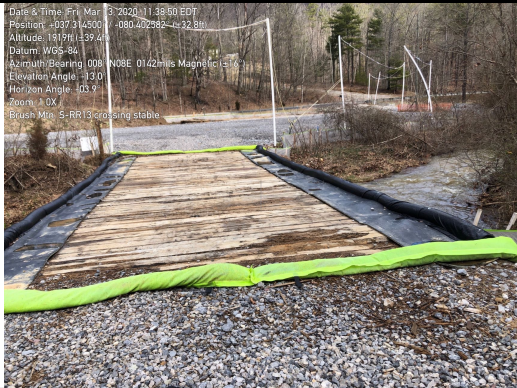
<p><small>Date &amp; Time: Fri Mar 13 2020 11:38:50 EDT Position: +037.314550 / -080.402982 / +32.81 Altitude: 1919ft (+59.4m) Datum: WGS-84 Azimuth/Bearing: 008° N08E 0142mils Magnetic (+17.1) Elevation Angle: -13.0 Horizon Angle: -03.7 Zoom: 1.0X Brush Mtn. S-RR13 crossing stable</small></p>
