Visual Site Inspection Report

Project Name	H-600 Pipeline Spread G	AFE	124300137	Spread	H-600 Pipeline Spread G
Contractor	Precision			Report #	9995
Inspector	Len Kruizenga			Date/Time	4/13/2020 8:27 AM
Permit #	TBD	Inspection Type	VA SWPP	Station Begin	12005+00
State	VA	Inspection Area	Full	Station End	12005+00
County	Giles	Ground	Muddy	Temperature (°F)	62.00
Municipality	N/A	Weather	Cloudy	Rain Gauge (in)	2.90
				Rain Accumulation Time (days)	1.00

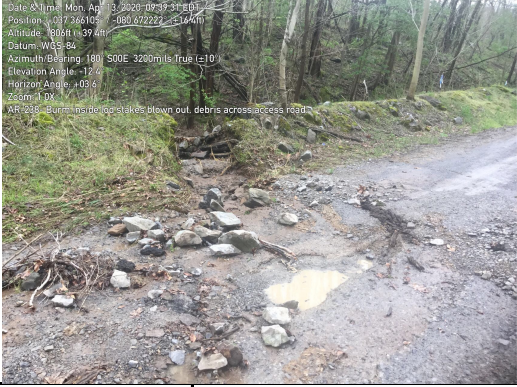
GPS Location	See photo GPS	GPS Location			
Field Station#	12005+00	Field Station#			
Pic 7 Desc.	AR-238.00- Berm at entrance blown out, Contractor notified and repairs made.	Pic 8 Desc.			
Insert image here		Insert image here			
GPS Location		GPS Location			
Field Station#		Field Station#			
Pic 9 Desc.		Pic 10 Desc.			
Insert image here		Insert image here			
GPS Location		GPS Location			
Field Station#		Field Station#			
Pic 11 Desc.		Pic 12 Desc.

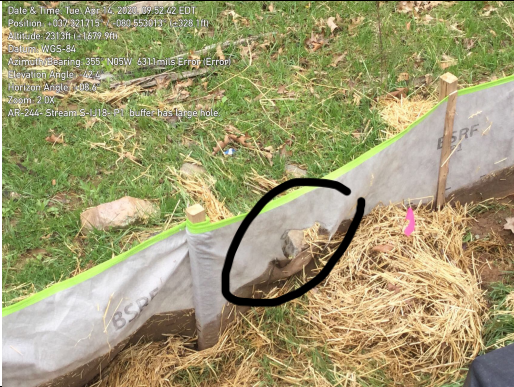
GPS Location	See photo GPS	GPS Location	See photo GPS		
Field Station#	11024+00	Field Station#	11017+00		
Pic 1 Desc.	Hole in P1 fabric.	Pic 2 Desc.	P1 over topped, stakes broken off.

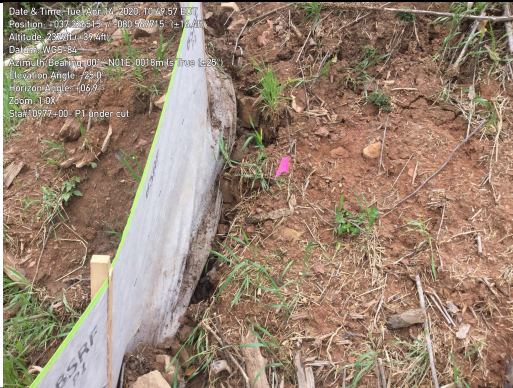
GPS Location	See photo GPS	GPS Location	See photo GPS		
Field Station#	10985+00	Field Station#	10977+00		
Pic 5 Desc.	Stream S- E24	Pic 6 Desc.	P1 under cut

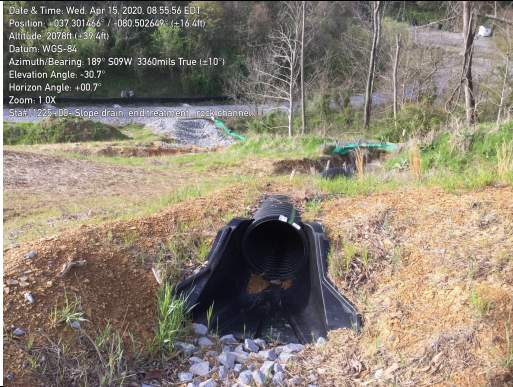
<p>Date & Time: Wed, Apr 15, 2020, 08:55:56 EDT Position: +337.3014667, -80.5026497 (+16.4m) Altitude: 2078ft (+59.4m) Datum: WGS-84 Azimuth/Bearing: 189° 50'W, 3340mils True (±10°) Elevation Angle: -30.7° Horizon Angle: +00.7° Zoom: 1.0x Sta#11225+00- Slope drain, end treatment, rock channel</p>			
GPS Location	See photo GPS		GPS Location	See photo GPS	
Field Station#	11228+00		Field Station#	11225+00	
Pic 1 Desc.	Silt fence perimeter controls are in acceptable condition.		Pic 2 Desc.	Slope drains, end treatment, rock channel are in acceptable condition.

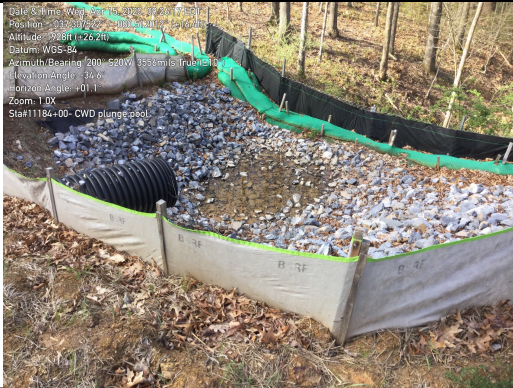
<p>Date & Time: Wed, Apr 15, 2020, 09:17:17 EDT Position: +337.3022367, -80.5009198 (+20.2m) Altitude: 2018ft (+62.4m) Datum: WGS-84 Azimuth/Bearing: 200° 50'W, 3558mils True (±10°) Elevation Angle: -34.6° Horizon Angle: +01.1° Zoom: 1.0x Sta#11184+00- CWD plunge pool</p>

GPS Location	See photo GPS		GPS Location	See photo GPS	
Field Station#	11191+00		Field Station#	11184+00	
Pic 5 Desc.	Drainage feature and ECD's are in acceptable condition.		Pic 6 Desc.	CWD pipe and plunge pool are in good condition.

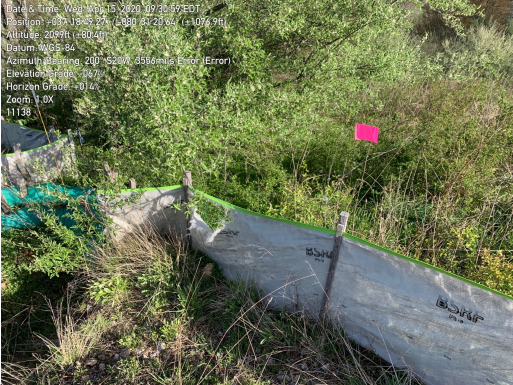
GPS Location	See picture above for GPS coordinates		GPS Location	See picture above for GPS coordinates	
Field Station#	11109+00		Field Station#	11138+00	
Pic 3 Desc.	ECD's and row conditions		Pic 4 Desc.	Damaged P1

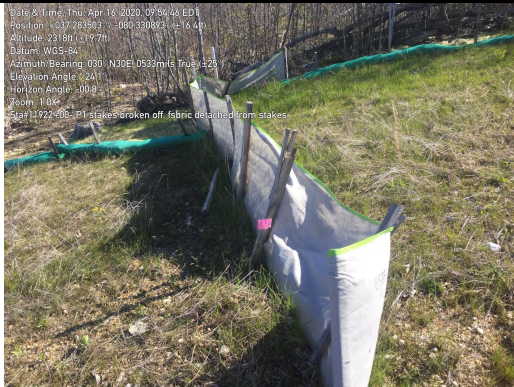
GPS Location		See photo GPS		GPS Location		See photo GPS	
Field Station#		1190300-		Field Station#		11922+00	
Pic 1 Desc.		AR-266.03- Access road and controls are in acceptable condition.		Pic 2 Desc.		P1 fabric detached from stakes. Contractor notified.

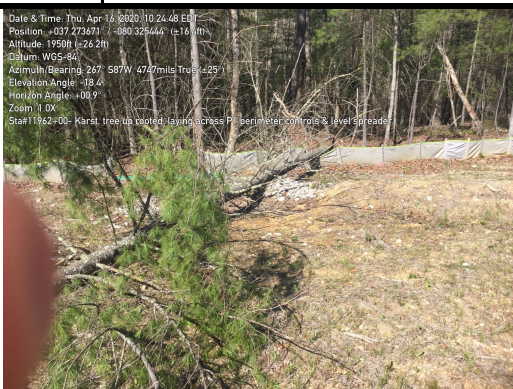
GPS Location		See photo GPS		GPS Location		See photo GPS	
Field Station#		11962+00		Field Station#		11979+00	
Pic 5 Desc.		Tree up rooted in Karst, lasting across P1 perimeter control and level spreader.		Pic 6 Desc.		AR- 266.00- Rock check dams are in acceptable condition.

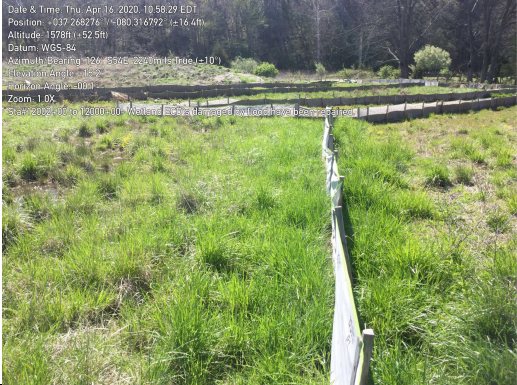
Insert image here			
GPS Location	See photo GPS	GPS Location			
Field Station#	12000+00	Field Station#			
Pic 7 Desc.	Wetland ECD's have been repaired after flood.	Pic 8 Desc.			
Insert image here		Insert image here			
GPS Location		GPS Location			
Field Station#		Field Station#			
Pic 9 Desc.		Pic 10 Desc.			
Insert image here		Insert image here			
GPS Location		GPS Location			
Field Station#		Field Station#			
Pic 11 Desc.		Pic 12 Desc.
