Visual Site Inspection Report

Project Name	H-600 Pipeline Spread G	AFE	124300137	Spread	H-600 Pipeline Spread G
Contractor	Precision			Report #	10439
Inspector	Chris Burns			Date/Time	4/27/2020 8:02 AM
Permit #	TBD	Inspection Type	VA SWPP	Station Begin	11254+99
State	VA	Inspection Area	Partial	Station End	11353+67
County	Giles	Ground	Wet	Temperature (°F)	58.00
Municipality	N/A	Weather	Cloudy	Rain Gauge (in)	0.40
				Rain Accumulation Time (days)	1.00

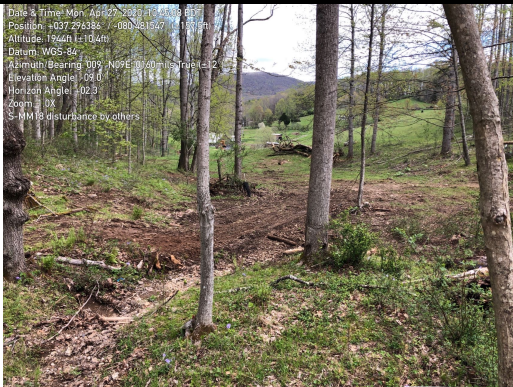
GPS Location	3	GPS Location	4		
Field Station#	11292+80	Field Station#	11292+80		
Pic 3 Desc.	Disturbance by others within S-MM18 downstream and outside of the MVP LoD.	Pic 4 Desc.	S-MM18 and controls.

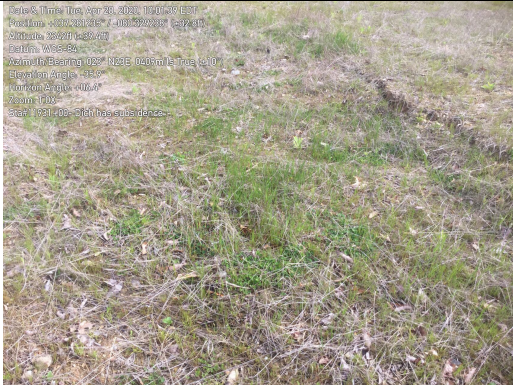
<p>Date & Time: Tue Apr 28, 2020 10:00:39 EDT Position: 433° 281.0m E 4369.333271 N 46621.0m Altitude: 2110ft (643.1m) Datum: WGS-84 Azimuth/Bearing: 02° N02E 46621mils True (±10°) Elevation Angle: +13.9° Horizon Angle: +06.6° Zoom: 1.0X SR-11931.00- Ditch subsidence</p>					
GPS Location		See photo GPS		GPS Location		See photo GPS	
Field Station#		11900+00		Field Station#		11931+00	
Pic 1 Desc.		AR-266.03- Access road & ECD's		Pic 2 Desc.		Some ditch subsidence observed.

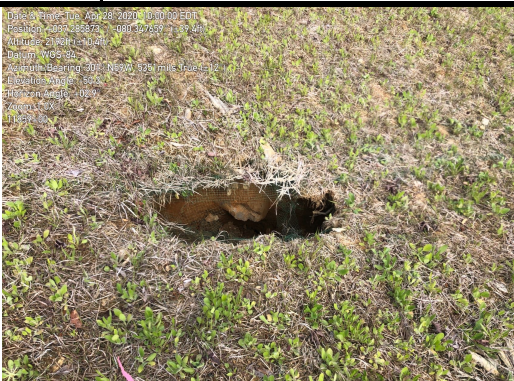
GPS Location	5	GPS Location	6		
Field Station#	11859+00	Field Station#	11863+65		
Pic 5 Desc.	Small sinkhole and current conditions.		Pic 6 Desc.	P-KL2 and controls.

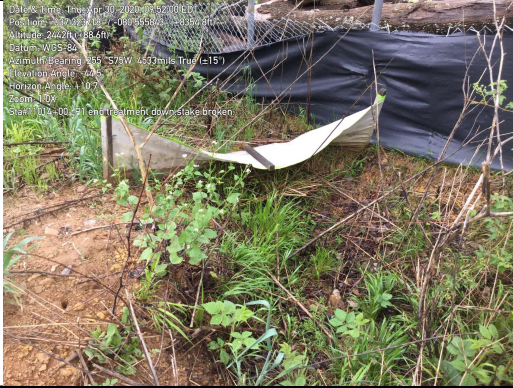
<p>Date & Time: Thu, Apr 30, 2020, 10:50:10 EDT Position: +037.326667, -080.576667 (±32.8ft) Altitude: 2422ft (±30.4ft) Datum: WGS-84 Azimuth/Bearing: 170° S85W 4533mils True (±15°) Elevation Angle: -04.5° Horizon Angle: +11.7° Zoom: 1.0X Sta#11014+00- silt fence to be repaired down stake broken</p>			
GPS Location	See photo GPS		GPS Location	See photo GPS	
Field Station#	10965+00		Field Station#	11014+00	
Pic 5 Desc.	Sta#10965+00- Sensitive resource, bat habitat		Pic 6 Desc.	Silt fence down, contractor has made repairs

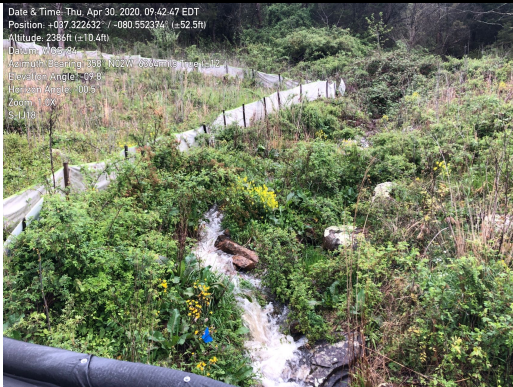
GPS Location	1	GPS Location	2		
Field Station#	11025+50	Field Station#	11024+80		
Pic 1 Desc.	S-IJ18.	Pic 2 Desc.	Landowner/tenant disturbance and tree piling.

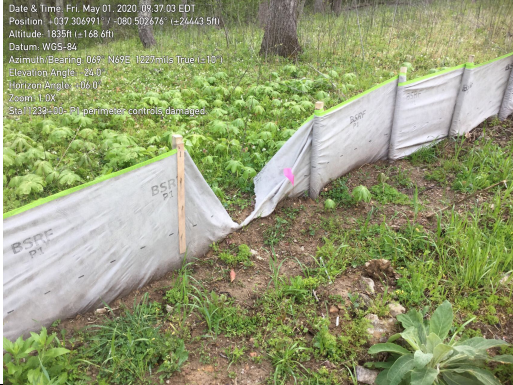
<p>Date & Time: Fri, May 01, 2020 08:37:03 EDT Position: +337.304991° / -080.502676° (+26443.5ft) Altitude: 1835ft (+165.6ft) Datum: WGS-84 Azimuth/Bearing: 065° N49° 12.2mils True (±10°) Elevation Angle: -34.9° Horizon Angle: +100.0° Zoom: 1.0x Sta# 11233+00 - P1 perimeter controls damaged</p>

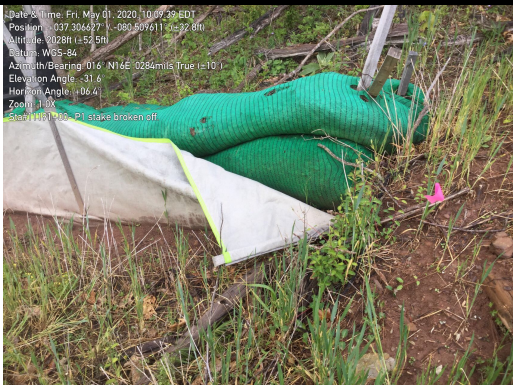
<p>Date & Time: Fri, May 01, 2020 10:07:39 EDT Position: +337.304991° / -080.502676° (+26443.5ft) Altitude: 1835ft (+165.6ft) Datum: WGS-84 Azimuth/Bearing: 016° N16° 02.8mils True (±10°) Elevation Angle: -31.6° Horizon Angle: +06.4° Zoom: 1.0x Sta# 11191+00 - P1 stake broken off</p>
