Visual Site Inspection Report

Project Name	H-600 Pipeline Spread G	AFE	124300137	Spread	H-600 Pipeline Spread G
Contractor	Precision			Report #	9796
Inspector	Len Kruizenga			Date/Time	4/6/2020 2:43 PM
Permit #	TBD	Inspection Type	VA SWPP	Station Begin	11899+00
State	VA	Inspection Area	Full	Station End	12005+00
County	Montgomery	Ground	Dry	Temperature (°F)	55.00
Municipality	N/A	Weather	Light Rain	Rain Gauge (in)	0.00
				Rain Accumulation Time (days)	1.00

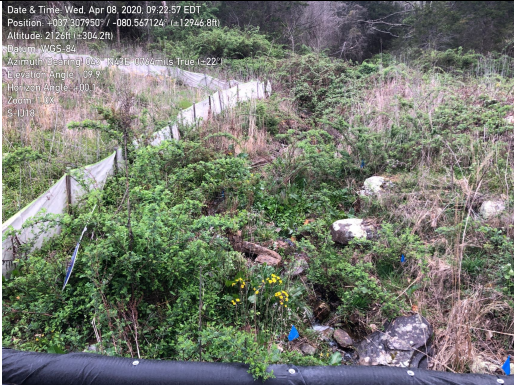
GPS Location	1	GPS Location	2		
Field Station#	11025+50	Field Station#	11027+00		
Pic 1 Desc.	S-IJ18 and controls.	Pic 2 Desc.	SSF perimeter controls functional.

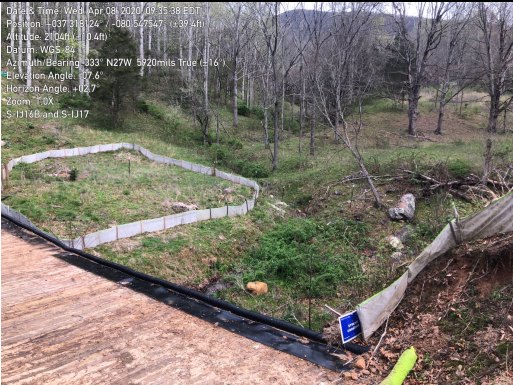
GPS Location	3	GPS Location	4		
Field Station#	11034+00	Field Station#	11050+10		
Pic 3 Desc.	RoW conditions and controls.	Pic 4 Desc.	S-IJ16B and S-IJ17 and controls.

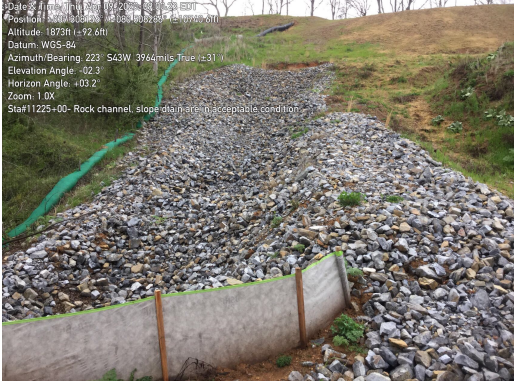
GPS Location		See photo GPS		GPS Location	
Field Station#		11225+00		Field Station#	
Pic 1 Desc.		Rock channel is in acceptable condition.		Pic 2 Desc.

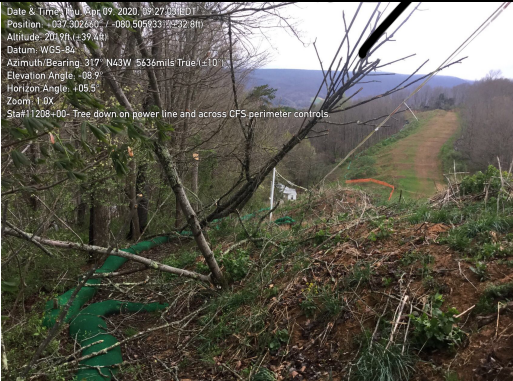
GPS Location		See photo GPS		GPS Location	
Field Station#		11209+00		Field Station#	
Pic 3 Desc.		P1 damaged by fallen branches, contractor made repairs.		Pic 4 Desc.

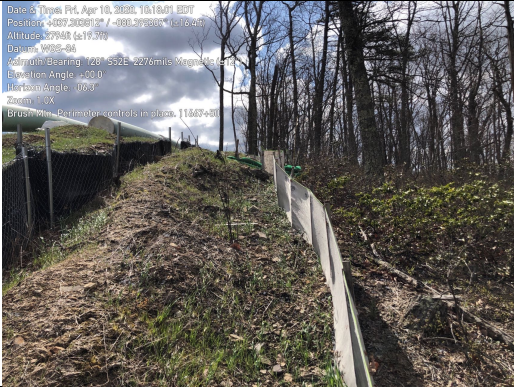
GPS Location	On photo	GPS Location	On photo		
Field Station#	11667+50	Field Station#	11661+00		
Pic 1 Desc.	Perimeter controls are in place and functional.	Pic 2 Desc.	Perimeter controls are in place and functioning.

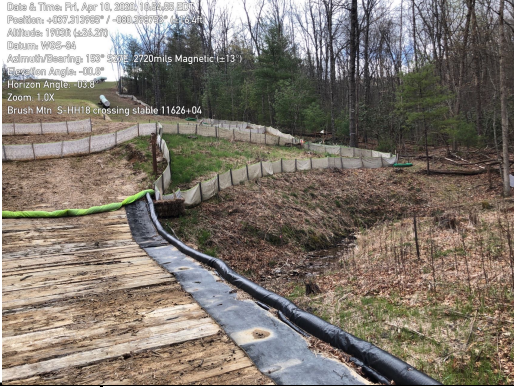
GPS Location	On photo	GPS Location	On photo		
Field Station#	11626+04	Field Station#	11614+75		
Pic 5 Desc.	S-HH18 crossing is stable with ECDs in place.	Pic 6 Desc.	Perimeter controls in place and effective.
