Visual Site Inspection Report

Project Name	H-600 Pipeline Spread G	AFE	124300137	Spread	H-600 Pipeline Spread G
Contractor	Precision			Report #	11274
Inspector	Chris Burns			Date/Time	5/26/2020 7:54 AM
Permit #	TBD	Inspection Type	VA SWPP	Station Begin	11254+99
State	VA	Inspection Area	Partial	Station End	11353+67
County	Giles	Ground	Damp	Temperature (°F)	73.00
Municipality	N/A	Weather	Cloudy	Rain Gauge (in)	0.00
				Rain Accumulation Time (days)	1.00

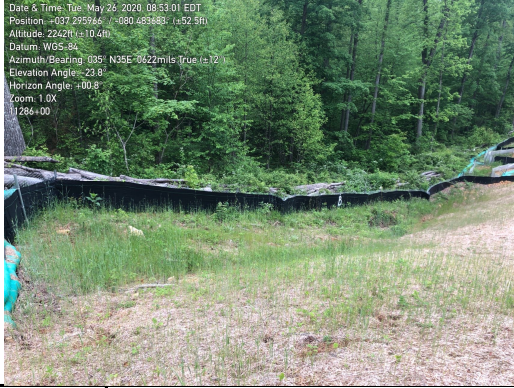
<p>Date & Time: Tue, May 26, 2020, 08:53:01 EDT Position: +037.295966 / -080.463683 (+152.9ft) Altitude: 2242ft (+104ft) Datum: WGS-84 Azimuth/Bearing: 035.1395E 3622mils True (+12) Elevation Angle: -23.8 Horizon Angle: +00.8 Zoom: 1.0X 11286+00</p>			
GPS Location	1	GPS Location	2		
Field Station#	11327+85	Field Station#	11286+00		
Pic 1 Desc.	S-NN12 and controls.	Pic 2 Desc.	Perimeter controls functional.

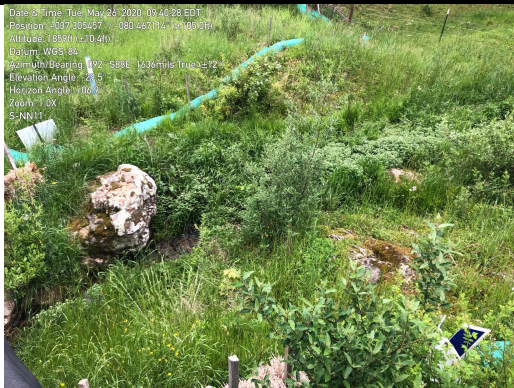
<p>Date & Time: Tue, May 26, 2020, 09:40:28 EDT Position: +037.309527 / -080.471449 (+169.3ft) Altitude: 1853ft (+104ft) Datum: WGS-84 Azimuth/Bearing: 102.588E 1636mils True (+12) Elevation Angle: -21.5 Horizon Angle: +00.8 Zoom: 1.0X S-NN11</p>			
GPS Location	5	GPS Location	6		
Field Station#	11333+00	Field Station#	11352+97		
Pic 5 Desc.	RoW conditions or controls.	Pic 6 Desc.	S-NN11 and controls.

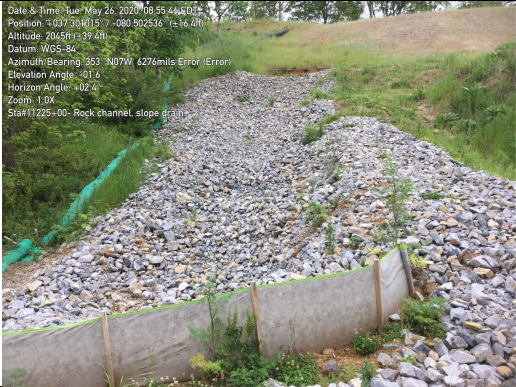
<p>Date & Time: Tue, May 26, 2020 08:55:44 EDT Position: +037.304167, -080.502536 (+16.4ft) Altitude: 2041ft (+39.6ft) Datum: WGS-84 Azimuth/Bearing: 353° N07W 6276mils True (±10°) Elevation Angle: -01.6° Horizon Angle: +02.4° Zoom: 1.0x Sta#11225+00- Rock channel, slope drain.</p>

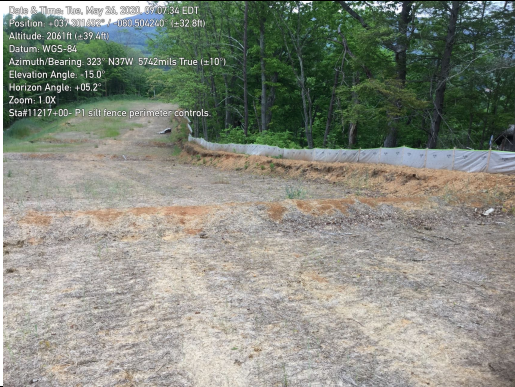
<p>Date & Time: Tue, May 26, 2020 09:07:34 EDT Position: +037.305140, -080.500240 (+32.8ft) Altitude: 2041ft (+39.6ft) Datum: WGS-84 Azimuth/Bearing: 323° N37W 5742mils True (±10°) Elevation Angle: -15.0° Horizon Angle: +05.2° Zoom: 1.0x Sta#11217+00- P1 silt fence perimeter controls.</p>			
GPS Location	See photo GPS		GPS Location	See photo GPS	
Field Station#	11225+00		Field Station#	11217+00	
Pic 1 Desc.	Rock channel & ECD's		Pic 2 Desc.	P1 silt fence perimeter controls.

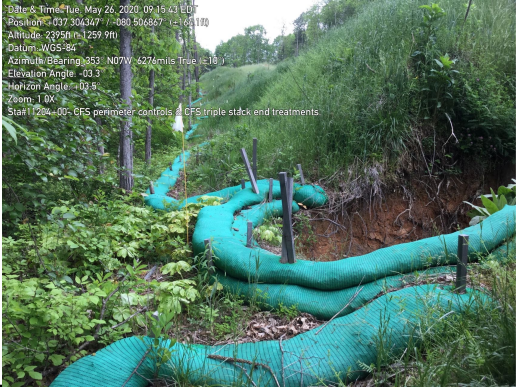
<p>Date & Time: Tue, May 26, 2020 09:15:21 EDT Position: +037.304347, -080.506867 (+16.1ft) Altitude: 2395ft (+729.9ft) Datum: WGS-84 Azimuth/Bearing: 353° N07W 6276mils True (±10°) Elevation Angle: -03.3° Horizon Angle: -06.5° Zoom: 1.0x Sta#11204+00- CFS perimeter controls & CFS triple stack end treatments.</p>

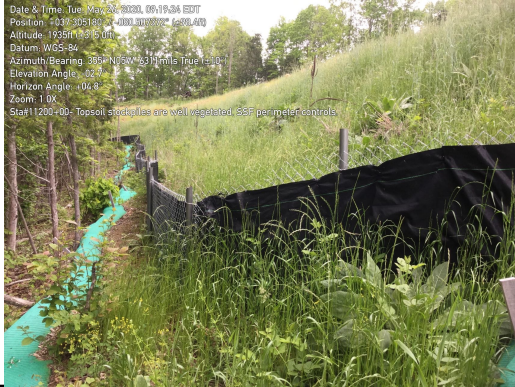
<p>Date & Time: Tue, May 26, 2020 09:16:04 EDT Position: +037.305140, -080.500240 (+32.8ft) Altitude: 1935ft (+595.1ft) Datum: WGS-84 Azimuth/Bearing: 388° N06W 6371mils True (±10°) Elevation Angle: -02.4° Horizon Angle: -06.8° Zoom: 1.0x Sta#11200+00- Topsoil stockpiles are well vegetated. SSF perimeter controls.</p>

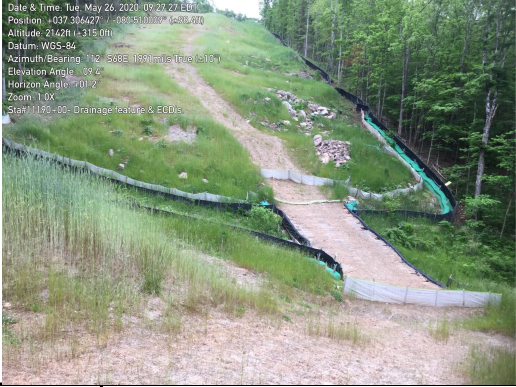
<p>Date & Time: Tue, May 26, 2020 09:27:27 EDT Position: +037.304427, -080.510000 (+33.0ft) Altitude: 2142ft (+651.0ft) Datum: WGS-84 Azimuth/Bearing: 112° S88E 1831mils True (±10°) Elevation Angle: -07.4° Horizon Angle: +01.7° Zoom: 1.0x Sta#11193+00- Drainage feature & ECD's.</p>

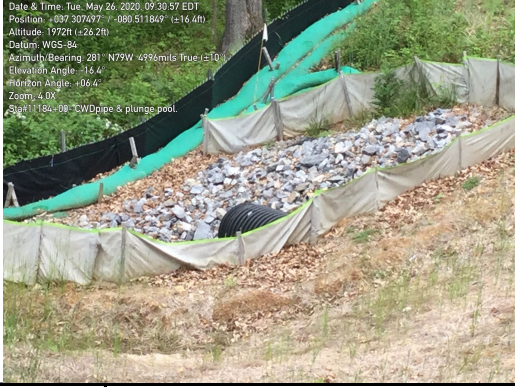
Pic 5 Desc.	Drainage feature and ECD's		Pic 6 Desc.	CWD pipe and plunge pool are in good condition.

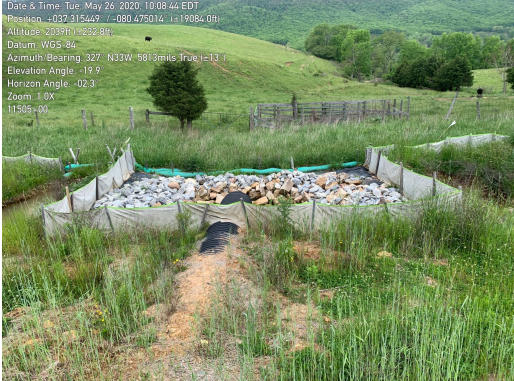
GPS Location	See photo for GPS location.		GPS Location	See photo for GPS location.	
Field Station#	11505+00		Field Station#	11493+00	
Pic 1 Desc.	Clean water diversion pipe and plunge pool in place.		Pic 2 Desc.	ROW is stabilized with vegetation growth.

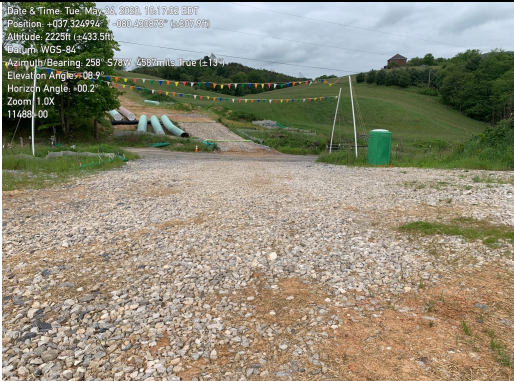
GPS Location	See photo for GPS location.		GPS Location	See photo for GPS location.	
Field Station#	11489+00		Field Station#	11413+00	
Pic 3 Desc.	RCE in place Stevers Gap Road.		Pic 4 Desc.	Priority one silt fence needs retrenched.

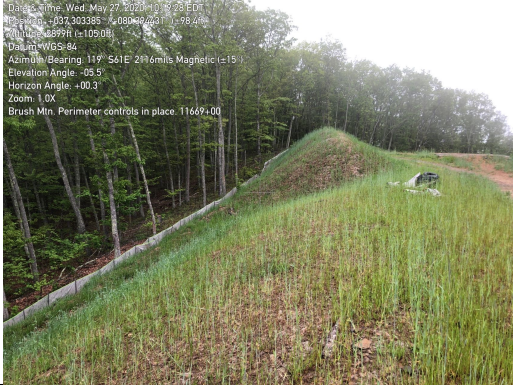
<p>Date & Time: Wed, May 27, 2020, 1:15:28 EDT Position: +429.30338° / -88.39748° (±1.6 mi) Altitude: 2459 ft (±105.0 ft) Datum: WGS-84 Azimuth: Bearing: 119° S 41° E 289.6 mls Magnetic (±15°) Elevation Angle: -05.5° Horizon Angle: +00.3° Zoom: 1.0x Brush Min. Perimeter controls in place. 11669+00</p>

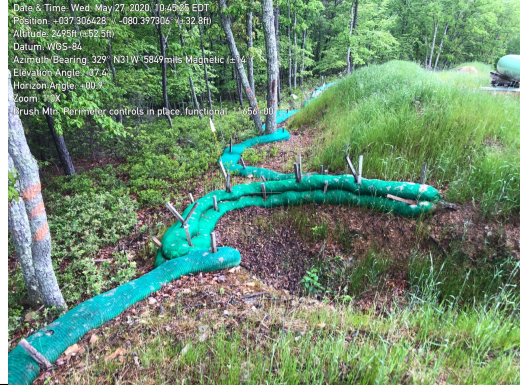
<p>Date & Time: Wed, May 27, 2020, 10:45:51 EDT Position: +429.30422° / -88.39730° (±1.6 mi) Altitude: 2459 ft (±105.0 ft) Datum: WGS-84 Azimuth: Bearing: 329° N 31° W 584.9 mls Magnetic (±15°) Elevation Angle: -07.6° Horizon Angle: +00.3° Zoom: 1.0x Brush Min. Perimeter controls in place. functional. 11656+00</p>			
GPS Location		On photo		GPS Location	
Field Station#		11669+00		Field Station#	
Pic 1 Desc.		Perimeter controls in place and functioning. ROW stable.		Pic 2 Desc.	
				End treatments and sumps working properly.

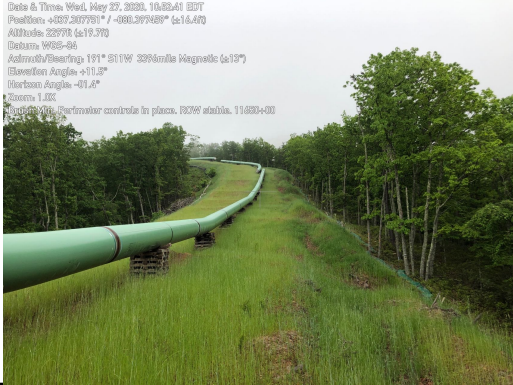
<p>Date & Time: Wed, May 27, 2020, 10:51:41 EDT Position: +429.30770° / -88.39748° (±1.6 mi) Altitude: 2470 ft (±105.0 ft) Datum: WGS-84 Azimuth: Bearing: 191° S 11° W 339.6 mls Magnetic (±13°) Elevation Angle: +11.3° Horizon Angle: -01.6° Zoom: 1.0x Brush Min. Perimeter controls in place. ROW stable. 11650+00</p>

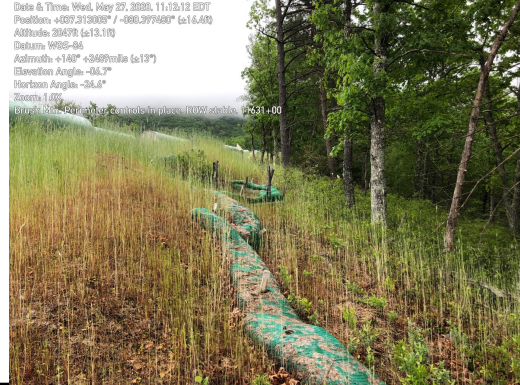
<p>Date & Time: Wed, May 27, 2020, 11:15:13 EDT Position: +429.31300° / -88.39748° (±1.6 mi) Altitude: 2469 ft (±105.0 ft) Datum: WGS-84 Azimuth: Bearing: +149° -0348 ft mls (±13°) Elevation Angle: -06.5° Horizon Angle: -06.5° Zoom: 1.0x Brush Min. Perimeter controls in place. ROW stable. 11631+00</p>			
GPS Location		On photo		GPS Location	
Field Station#		11650+00		Field Station#	
Pic 3 Desc.		Slope breakers in place and functioning. ROW surface stable.		Pic 4 Desc.	
				Perimeter controls in place and functional.

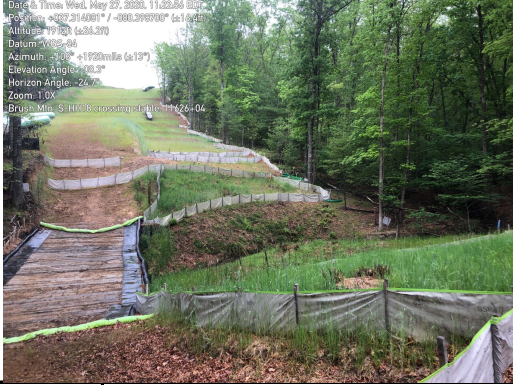
<p>Date & Time: Wed, May 27, 2020, 11:22:56 EDT Position: +429.31489° / -88.39670° (±1.6 mi) Altitude: 2472 ft (±105.0 ft) Datum: WGS-84 Azimuth: Bearing: -100° -1192 mls (±13°) Elevation Angle: +00.3° Horizon Angle: -24.2° Zoom: 1.0x Brush Min. S-HH18 crossing stable. 11626+04</p>

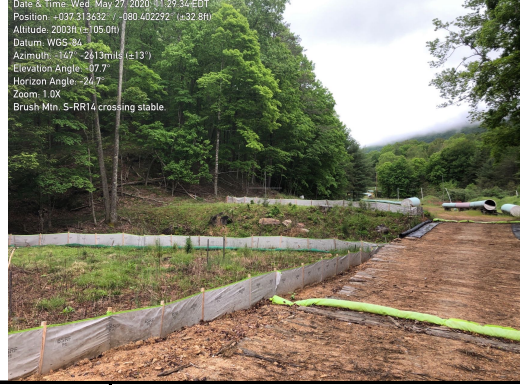
<p>Date & Time: Wed, May 27, 2020, 11:29:36 EDT Position: +429.31262° / -88.40227° (±1.6 mi) Altitude: 2003 ft (±105.0 ft) Datum: WGS-84 Azimuth: Bearing: -147° -2813 mls (±13°) Elevation Angle: +07.7° Horizon Angle: -24.7° Zoom: 1.0x Brush Min. S-RR14 crossing stable.</p>

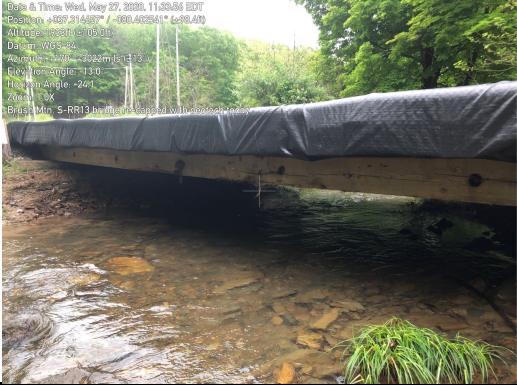
GPS Location	On photo	GPS Location	On photo		
Field Station#	11613+69	Field Station#	11607+81		
Pic 7 Desc.	S-RR13 equipment bridge in good condition.	Pic 8 Desc.	S-006 crossing stable.		
Insert image here		Insert image here			
GPS Location		GPS Location			
Field Station#		Field Station#			
Pic 9 Desc.		Pic 10 Desc.			
Insert image here		Insert image here			
GPS Location		GPS Location			
Field Station#		Field Station#			
Pic 11 Desc.		Pic 12 Desc.

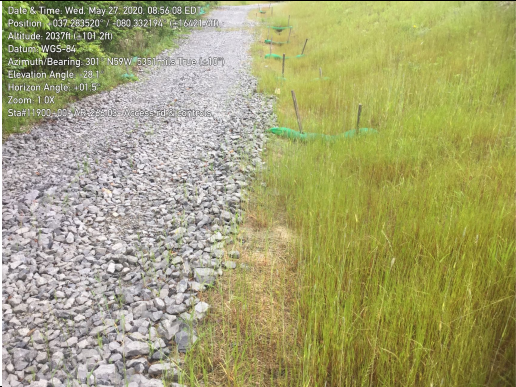
GPS Location	See photo GPS	GPS Location	See photo GPS		
Field Station#	11900+00	Field Station#	11915+00		
Pic 1 Desc.	AR-266.03	Pic 2 Desc.	Row vegetation, ECD's, level spreaders.

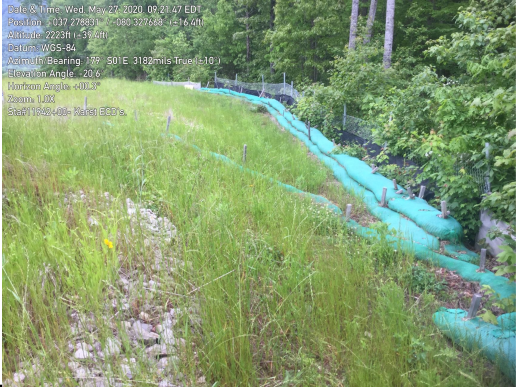
GPS Location	See photo GPS	GPS Location	See photo GPS		
Field Station#	11942+00	Field Station#	11987+00		
Pic 3 Desc.	Karst ECD's	Pic 4 Desc.	Drainage feature and ECD's

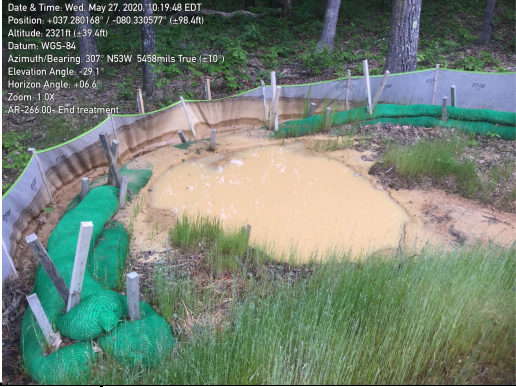
GPS Location	See photo GPS	GPS Location	See photo GPS		
Field Station#	11930+00	Field Station#	11989+00		
Pic 5 Desc.	AR-266.00- Sump and broad base dip end treatment.	Pic 6 Desc.	Catawba rain gauge reading- 0.00"

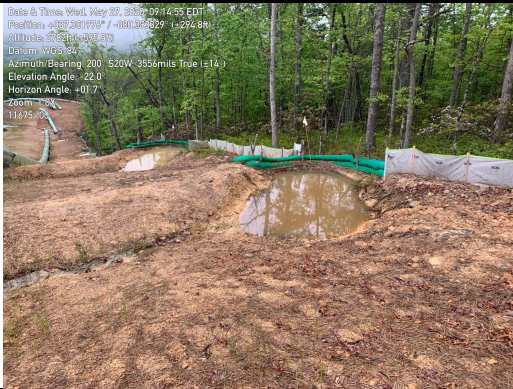
GPS Location	See photo for GPS location.		GPS Location	See photo for GPS location.	
Field Station#	11675+00		Field Station#	11687+40	
Pic 1 Desc.	Waterbar, sump pit, and waterbar end treatment in place.		Pic 2 Desc.	Sensitive resource buffer in place at stream S-MN21.

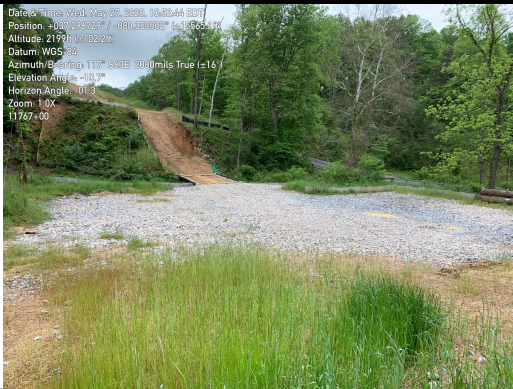
GPS Location	See photo for GPS location.		GPS Location	See photo for GPS location.	
Field Station#	11767+00		Field Station#	11770+00	
Pic 3 Desc.	RCE in place at Main Line Valve 26.		Pic 4 Desc.	Clean water diversion berm and clean water diversion pipe inlet.

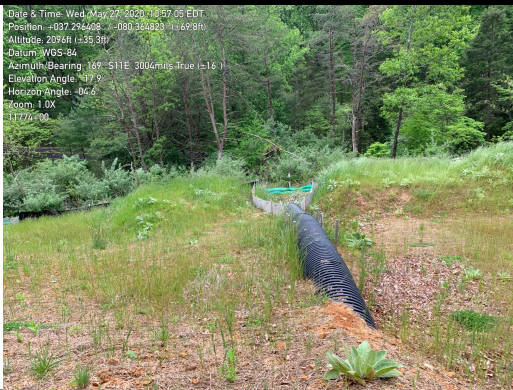
Insert image here			
GPS Location	See photo for GPS location.		GPS Location		
Field Station#	11774+00		Field Station#		
Pic 5 Desc.	Clean water diversion pipe and plunge pool in place.		Pic 6 Desc.

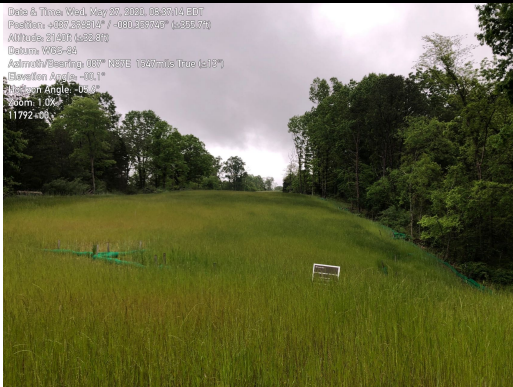
</div></div></div>			
GPS Location	1	GPS Location	2		
Field Station#	11792+00	Field Station#	11806+00		
Pic 1 Desc.	Section of restored RoW showing conditions and controls.		Pic 2 Desc.	Section of restored RoW showing conditions and controls.	
<div><div><div>Date & Time: Wed, May 27, 2020 08:14:58 EDT Position: +48.25977° / -80.34977° (-80.34977) Altitude: 21390 (-80.34977) Datum: WGS-84 Azimuth/Bearing: 159° S28E 200mils True (-81°) Elevation Angle: -44.3° Horizon Angle: -44.3° Zoom: 1.0X 11817+00</div><div>

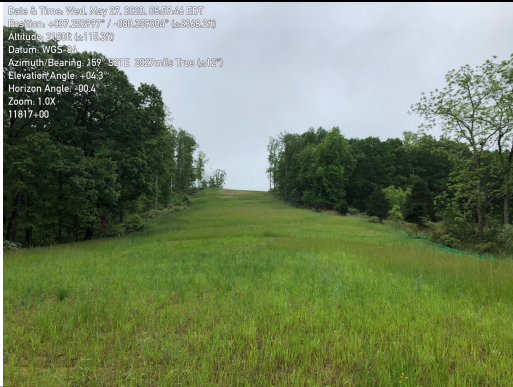
GPS Location	3	GPS Location	4		
Field Station#	11817+00	Field Station#	11836+00		
Pic 3 Desc.	Section of restored RoW showing conditions and controls.		Pic 4 Desc.	Section of restored RoW showing conditions and controls.	
<div><div><div>Date & Time: Wed, May 27, 2020 07:52:30 EDT Position: +48.25977° / -80.34977° (-80.34977) Altitude: 21424 (-80.34977) Datum: WGS-84 Azimuth/Bearing: 013° N13E 023mils True (-124°) Elevation Angle: -47.7° Horizon Angle: -40.1° Zoom: 1.0X P-KL2</div><div>

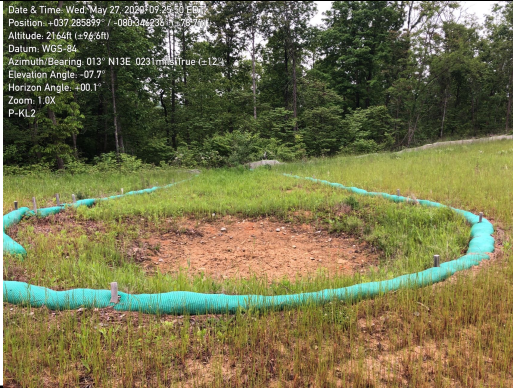
</div></div></div>			
GPS Location	5	GPS Location	6		
Field Station#	11863+65	Field Station#	11899+00		
Pic 5 Desc.	P-KL2 and controls.		Pic 6 Desc.	Section of restored RoW showing conditions and controls.

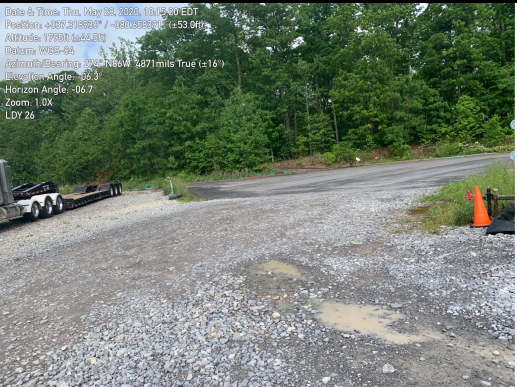
<p>Date & Time: Thu, May 28, 2020, 10:14:30 EDT Position: +37° 21'13.5" / -80° 55'76.7" (+213.3ft) Altitude: 1846ft (+63.7ft) Datum: WGS-84 Azimuth/Bearing: 311° N45W 5529mils True (+16°) Elevation Angle: -67.5° Horizon Angle: -06.7° Zoom: 1.0x LDY 26</p>			
GPS Location	See photo for GPS location.		GPS Location	See photo for GPS location.	
Field Station#	12005+00		Field Station#	12005+00	
Pic 1 Desc.	Triple stack compost filter sock in place around drainage.		Pic 2 Desc.	RCE in place and lay down yard 26 entrance.

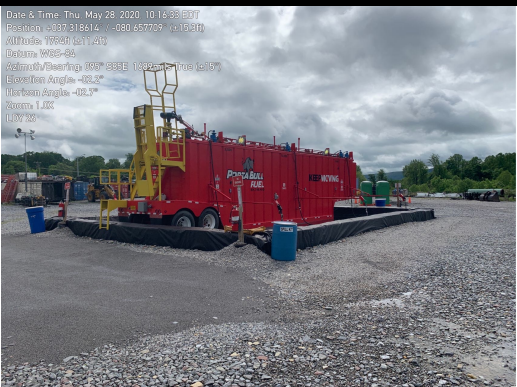
<p>Date & Time: Thu, May 28, 2020, 10:14:30 EDT Position: +37° 21'13.5" / -80° 55'76.7" (+213.3ft) Altitude: 1846ft (+63.7ft) Datum: WGS-84 Azimuth/Bearing: 311° N45W 5529mils True (+16°) Elevation Angle: -67.5° Horizon Angle: -02.5° Zoom: 1.0x LDY 26</p>			
GPS Location	See photo for GPS location.		GPS Location	See photo for GPS location.	
Field Station#	12005+00		Field Station#	12005+00	
Pic 3 Desc.	18 inch compost filter sock in place along LOD.		Pic 4 Desc.	Secondary containment in place under fuel cell.
