Visual Site Inspection Report

Project Name	H-600 Pipeline Spread G	AFE	124300137	Spread	H-600 Pipeline Spread G
Contractor	Precision			Report #	10655
Inspector	Len Kruizenga			Date/Time	5/4/2020 12:40 PM
Permit #	TBD	Inspection Type	VA SWPP	Station Begin	11899+00
State	VA	Inspection Area	Full	Station End	12005+00
County	Montgomery	Ground	Dry	Temperature (°F)	66.00
Municipality	N/A	Weather	Sunny	Rain Gauge (in)	0.10
				Rain Accumulation Time (days)	1.00

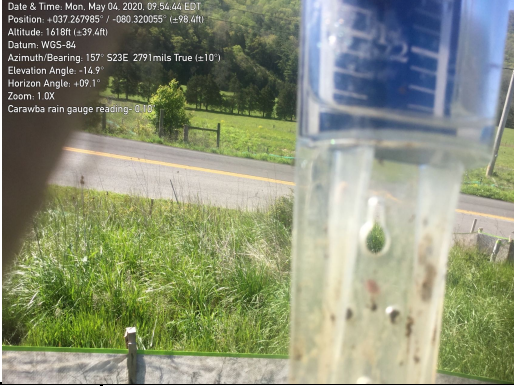
AFE	124300137	Date/Time	5/4/2020 12:40 PM	Report #	
Pictures					
<p>Date & Time: Mon, May 04, 2020, 09:54:44 EDT Position: +037.237965 / -080.320055 (+98.4ft) Altitude: 1618ft (+39.4ft) Datum: WGS-84 Azimuth/Bearing: 157.523E 2791mils True (+10°) Elevation Angle: -14.7° Horizon Angle: +09.1° Zoom: 1.0X Catawba rain gauge reading- 0.10"</p>

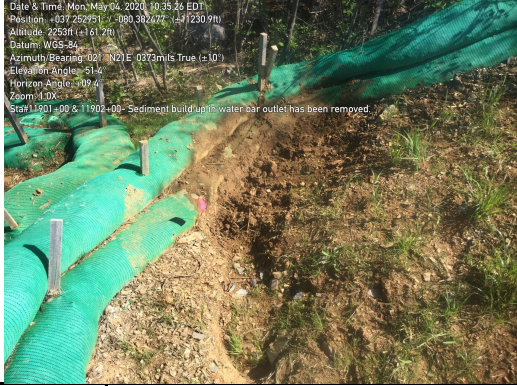
<p>Date & Time: Mon, May 04, 2020, 10:35:26 EDT Position: +037.252951 / -080.382771 (+1230.9ft) Altitude: 2531ft (+41.9ft) Datum: WGS-84 Azimuth/Bearing: 021° N21E 0273mils True (+10°) Elevation Angle: 51.4° Horizon Angle: 109.4° Zoom: 1.0X Sta# 11901+00 - Sediment build up in water bar outlet has been removed.</p>

GPS Location	See photo GPS	GPS Location	See photo GPS		
Field Station#	11989+00	Field Station#	11901+00		
Pic 1 Desc.	Catawba rain gauge reading- 0.10"	Pic 2 Desc.	Sediment build up has been removed from water bar outlet		
<p>Date & Time: Mon, May 04, 2020, 10:39:29 EDT Position: +037.287543 / -080.333482 (+16.4ft) Altitude: 2287ft (+26.2ft) Datum: WGS-84 Azimuth/Bearing: 275° NSW 4889mils True (+10°) Elevation Angle: -24.8° Horizon Angle: +07.8° Zoom: 1.0X AR-266.03- Access road & controls.</p>

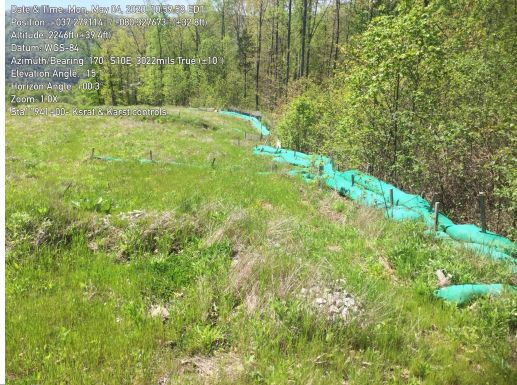
<p>Date & Time: Mon, May 04, 2020, 11:00:00 EDT Position: +037.277111 / -080.327643 (+37.4ft) Altitude: 2746ft (+39.4ft) Datum: WGS-84 Azimuth/Bearing: 170° S10E 3022mils True (+10°) Elevation Angle: -15.1° Horizon Angle: +00.3° Zoom: 1.0X Sta# 11941+00- Karst & Karst controls.</p>

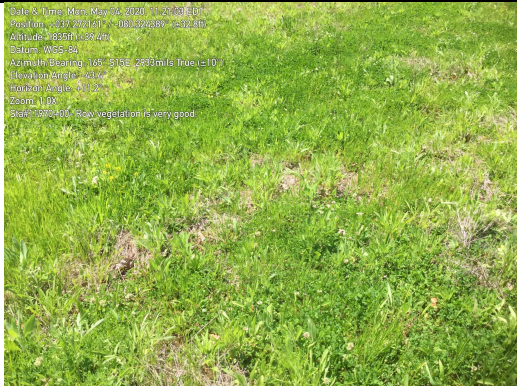
<p>Date & Time: Mon, May 04, 2020, 11:20:01 EDT Position: +037.231701 / -080.327469 (+50.2ft) Altitude: 1835ft (+24.4ft) Datum: WGS-84 Azimuth/Bearing: 165° S10E 2833mils True (+10°) Elevation Angle: -24.6° Horizon Angle: +0.7° Zoom: 1.0X Sta# 11970+00- Row vegetation is very good.</p>

GPS Location	See photo GPS	GPS Location	See photo GPS		
Field Station#	11964+00	Field Station#	11970+00		
Pic 5 Desc.	All P1 damage repaired.	Pic 6 Desc.	Row vegetation is in good condition.

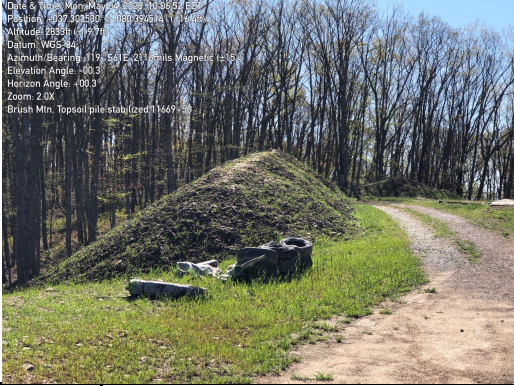
<p>Date & Time: Mon May 04, 2020 10:56:59 EDT Position: -037.302631, -080.394669, 11669.00 Altitude: 2723ft (11669.00) Datum: WGS-84 Azimuth/Bearing: 031.19°E, 2.19mils Magnetic (±15.1) Elevation Angle: -00.3 Horizon Angle: -00.3 Zoom: 2.0x Brush Mtn. Topsoil pile stable (FS#11669+00)</p>

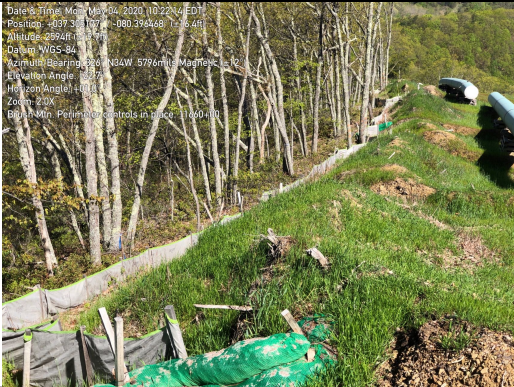
<p>Date & Time: Mon May 04, 2020 10:22:49 EDT Position: -037.302631, -080.394669, 11660.00 Altitude: 2700ft (11660.00) Datum: WGS-84 Azimuth/Bearing: 031.19°E, 2.19mils Magnetic (±15.1) Elevation Angle: -00.0 Horizon Angle: -00.0 Zoom: 2.0x Brush Mtn. Perimeter controls in place. 11660+00</p>

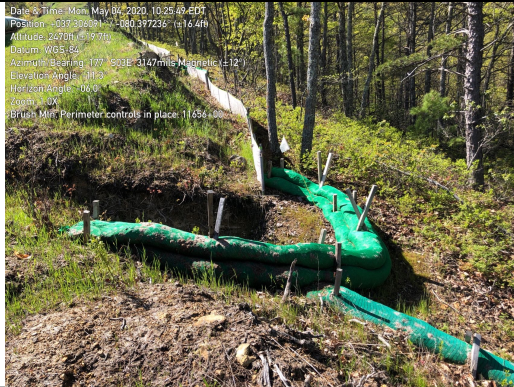
<p>Date & Time: Mon May 04, 2020 10:25:49 EDT Position: -037.302631, -080.394669, 11656.00 Altitude: 2670ft (11656.00) Datum: WGS-84 Azimuth/Bearing: 031.19°E, 2.19mils Magnetic (±15.1) Elevation Angle: -00.0 Horizon Angle: -00.0 Zoom: 2.0x Brush Mtn. Perimeter controls in place. 11656+00</p>			
GPS Location	On photo	GPS Location	On photo		
Field Station#	11660+00	Field Station#	11656+00		
Pic 3 Desc.	Perimeter controls in place and effective.	Pic 4 Desc.	Perimeter controls in place. End treatments are functioning as designed.

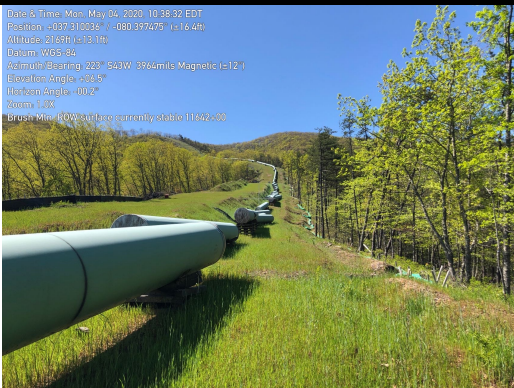
<p>Date & Time: Mon May 04, 2020 10:38:32 EDT Position: -037.302631, -080.394669, 11642.00 Altitude: 2165ft (11642.00) Datum: WGS-84 Azimuth/Bearing: 203.54°W, 396mils Magnetic (±12.1) Elevation Angle: -03.5 Horizon Angle: -00.2 Zoom: 1.2x Brush Mtn. ROW stable, currently stable 11642+00</p>

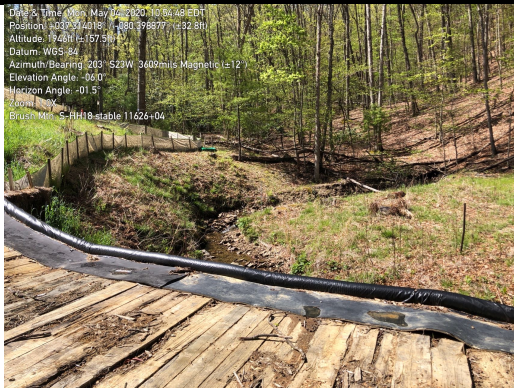
<p>Date & Time: Mon May 04, 2020 10:44:48 EDT Position: -037.302631, -080.394669, 11626.00 Altitude: 1945ft (11626.00) Datum: WGS-84 Azimuth/Bearing: 203.52°W, 360mils Magnetic (±12.1) Elevation Angle: -00.0 Horizon Angle: -01.5 Zoom: 1.2x Brush Mtn. S-HH18 stable 11626+04</p>

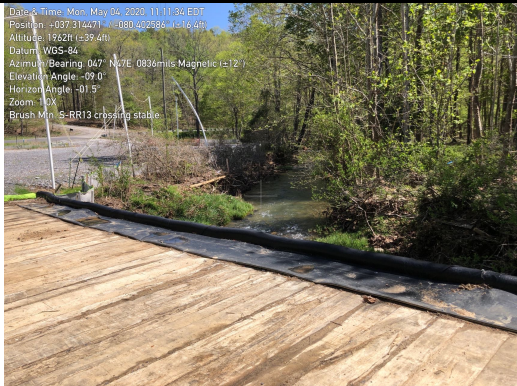
<p><small>Date & Time: Mon May 04 2020 11:11:36 EDT Position: +037.3142711, -080.402585, +16.411 Altitude: 1923ft (+39.4ft) Datum: WGS-84 Azimuth/Bearing: 047° N47E 0836mits Magnetic (+12°) Elevation Angle: -09.0° Horizon Angle: -01.5° Zoom: 1.0X Brush Min: S-RR13 crossing stable</small></p>

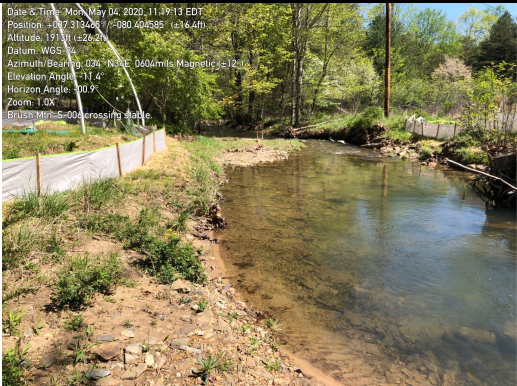
<p><small>Date & Time: Mon May 04 2020 11:19:13 EDT Position: +037.3142711, -080.402585, +16.411 Altitude: 1910ft (+28.9ft) Datum: WGS-84 Azimuth/Bearing: 024° N24E 0404mits Magnetic (+12°) Elevation Angle: -11.4° Horizon Angle: -00.9° Zoom: 1.0X Brush Min: S-006 crossing stable</small></p>

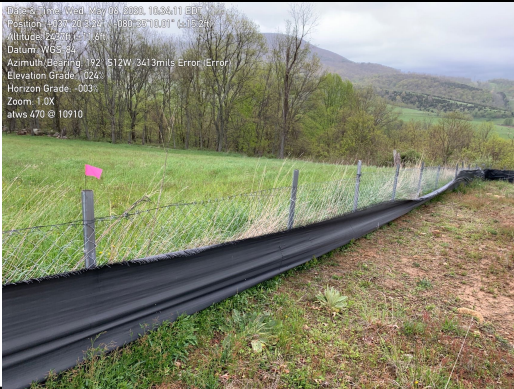
GPS Location	See picture above for GPS coordinates		GPS Location	See picture above for GPS coordinates	
Field Station#	10910+00		Field Station#	10909+00	
Pic 3 Desc.	SSF detached from wire backing		Pic 4 Desc.	Damaged P1

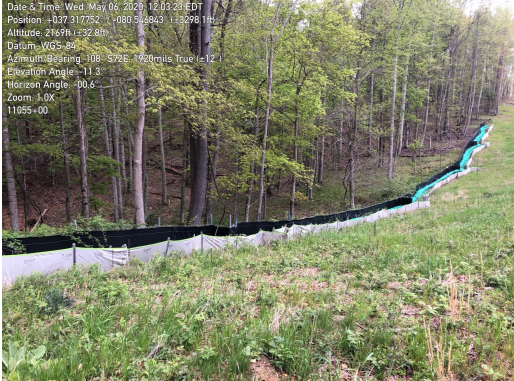
GPS Location	5	GPS Location	6		
Field Station#	11055+00	Field Station#	11064+50		
Pic 5 Desc.	Karst protection perimeter controls functional.	Pic 6 Desc.	Perimeter controls functional.

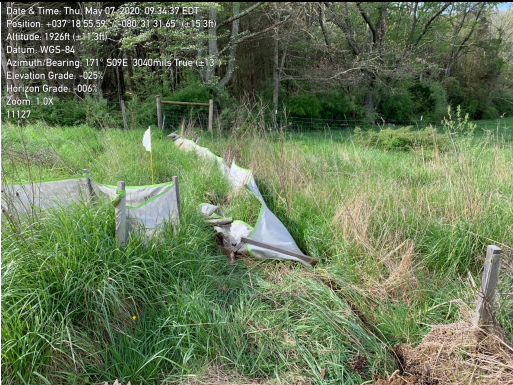
GPS Location	See picture above for GPS coordinates		GPS Location	See picture above for GPS coordinates	
Field Station#	11111+00		Field Station#	11127+00	
Pic 3 Desc.	ECD's and row conditions		Pic 4 Desc.	Crews replacing P1SF

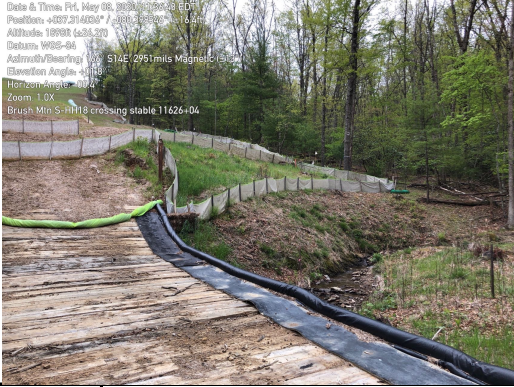
GPS Location	On photo	GPS Location	On photo		
Field Station#	11626+04	Field Station#	11614+20		
Pic 5 Desc.	S-HH18 crossing stable. No resource impact.	Pic 6 Desc.	S-RR14 crossing stable. No resource impact.

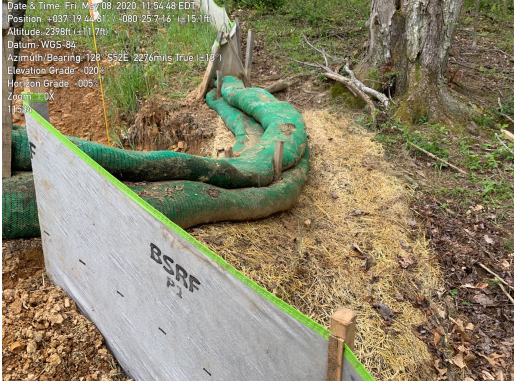
GPS Location	See picture above for GPS coordinates		GPS Location	See picture above for GPS coordinates	
Field Station#	11534+00		Field Station#	11549+00	
Pic 1 Desc.	Confirmed repairs to end treatments		Pic 2 Desc.	ECD's and row conditions
